**UNITED STATES ENVIRONMENTAL PROTECTION AGENCY  
REGION 8**

Re: Inspection Report for Fort Belknap Mission Wastewater Lagoons, MTU000031

## NPDES Wastewater Lagoon Inspection Report

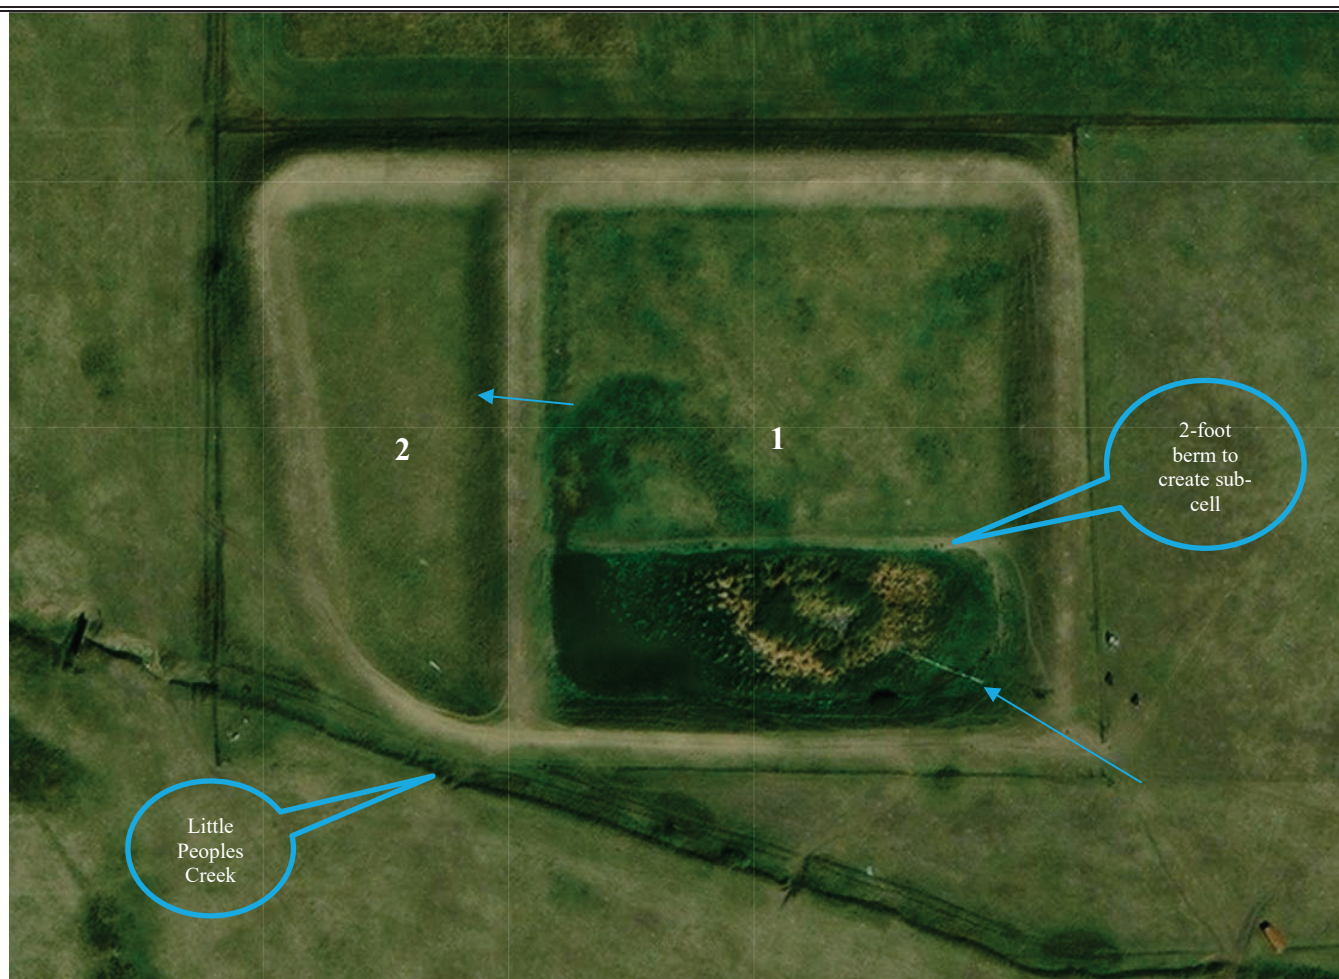
Mission Lagoons wastewater treatment facility was originally constructed in 1981 as a 2-cell lagoon system. The facility serves a population of approximately 20 homes, and processes domestic waste only. The facility consists of a collection system and two bentonite floor-lined cells. The cells operate in series by gravity with no pumps for aeration or flow. Lagoon cell one is approximately 3.18-acres to include a sub-cell area of approximately 1-acre. The sub-cell area is an approximate 2-foot berm located approximately 120-feet from the southern berm of cell 1 and stretching from west to east. Lagoon cell two is approximately 1.28-acres, located to the west of cell 1. Wastewater from collection system enters cell one in the southeast corner and into the center of the sub-cell area, wastewater would flow to cell two in the center of the adjoining dike walls. There is not a constructed discharge pipe. Sludge removal has not occurred in this lagoon system.
