## REGION 10 Enforcement Division

### INSPECTION REPORT

| <b>Company Name:</b> | Ravn Alaska | | |

Type of inspection: CEI - Compliance Evaluation Inspection

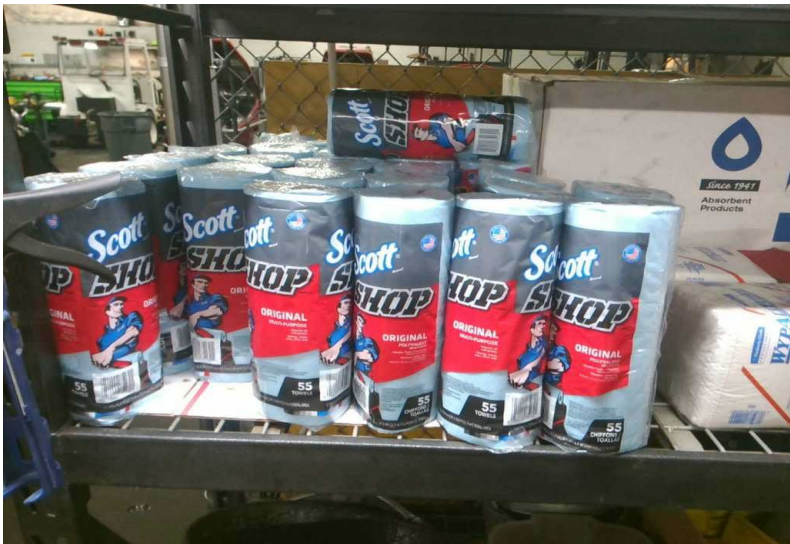
| <p>View of the Blue shop wipes used at the facility. According to Mr. Bennett, MEK is used for cleaning of aircraft parts and to reactivate certain adhesives. Mr. Bennett said that the blue paper wipes are used with the MEK and then disposed of into the trash. He also said that just because you might find a blue paper wipe in the trash doesn't necessarily mean it was contaminated with MEK.</p> | |

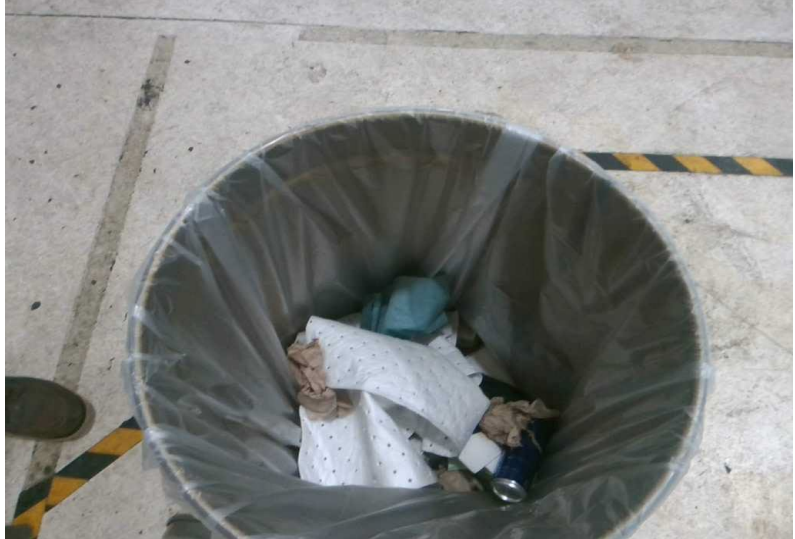
| View of a blue wipe in a trash can. According to Mr. Bennett, MEK is used for cleaning of aircraft parts and to certain adhesives. Mr. Bennett said that the blue paper wipes are used with the MEK and then disposed of into the trash. He also said that just because you might find a blue paper wipe in the trash doesn't necessarily mean it was contaminated with MEK. | |

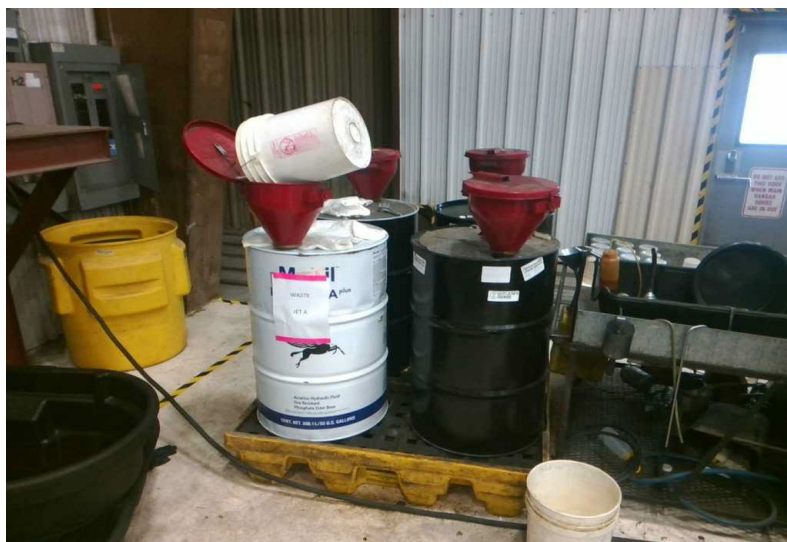
One 55-gallon container was labeled "Waste Jet A", one 55-gallon container was labeled "Used Skydrol", which Mr. Santiago said was hydraulic fluid, and one 55-gallon container was labeled as "Used Oil." According to Mr. Santiago, the unlabeled 55-gallon container also held used oil.

At the time of the inspection, the container of waste jet A was not labeled with the words "Hazardous Waste," or a hazard indicator and the container was open.

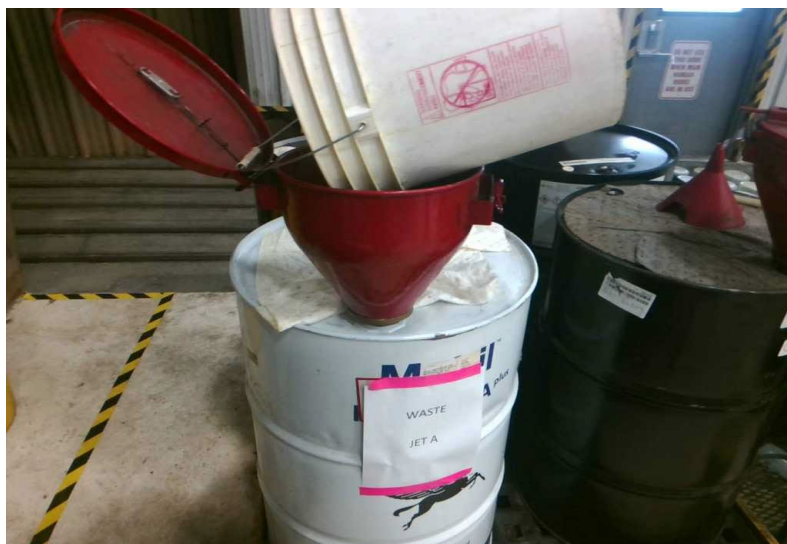
IMG-202201191219281928803405.jpg

One 55-gallon container was labeled "Waste Jet A", one 55-gallon container was labeled "Used Skydrol", which Mr. Santiago said was hydraulic fluid, and one 55-gallon container was labeled as "Used Oil." According to Mr. Santiago, the unlabeled 55-gallon container also held used oil.

At the time of the inspection, the container of waste jet A was not labeled with the words "Hazardous Waste," or a hazard indicator and the container was open.

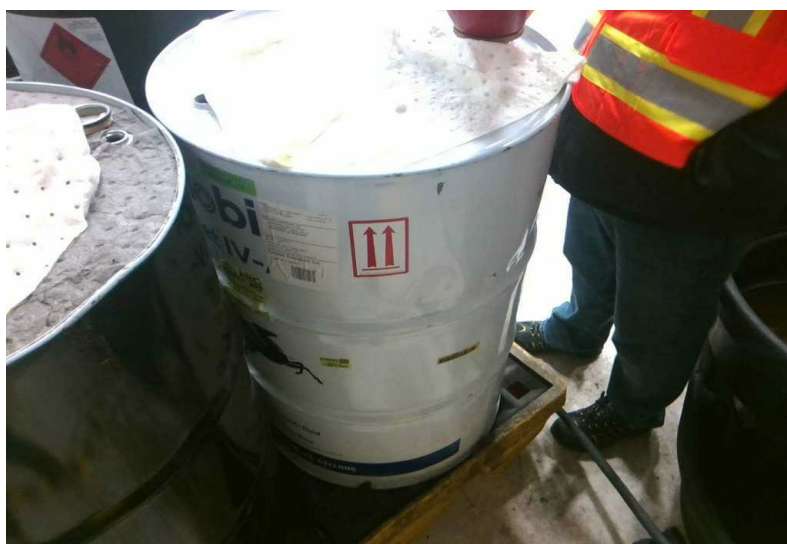
IMG-202201191219541954697054.jpg

At the time of the inspection, the container of waste jet A was not labeled with the words "Hazardous Waste," or a hazard indicator and the container was open.

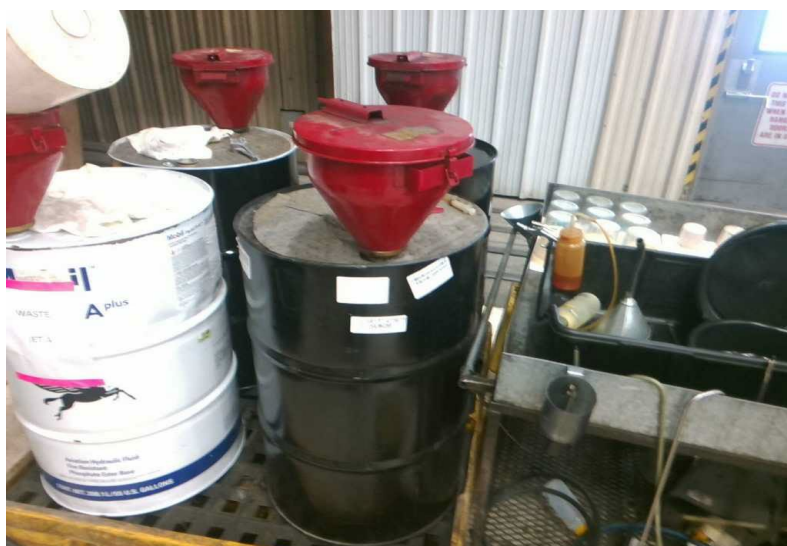
The 55-gallon container of used hydraulic fluid (Skydrol) was not labeled with the words used oil.

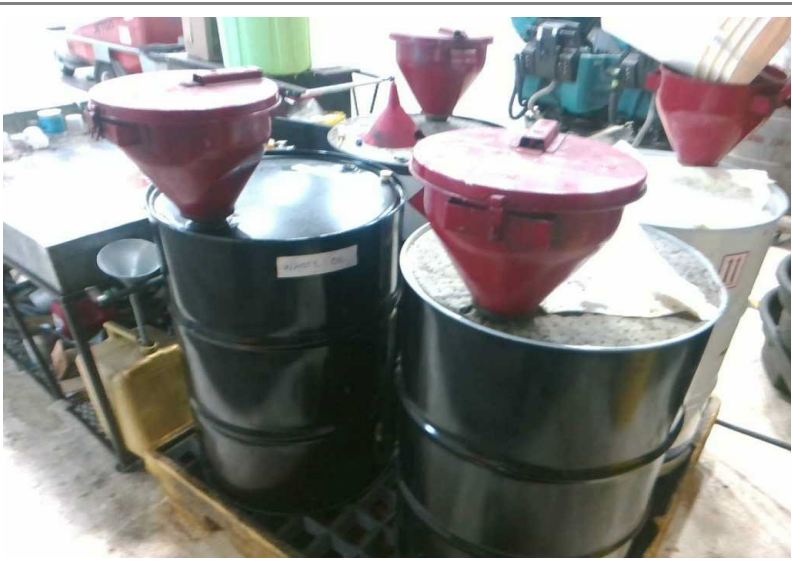
| <p>[Title]</p> <p>IMG-202201191226172617811768.jpg</p> <p>01/19/2022 12:26 PM (AKT)</p> <p>Jon Jones</p> <p>Hangar/ Hazardous Waste Storage Area</p> <p>No CBI</p> <p>No PII</p> <p>One of the two 55-gallon containers of used oil was labeled "Waste oil," not used oil as Mr. Santiago first said, and the other was not labeled at all.</p> | |

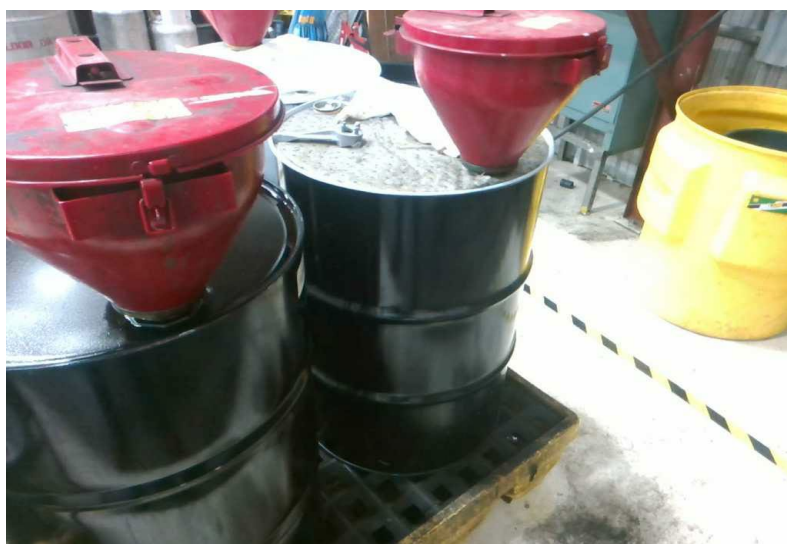
| IMG-202201191226342634824978.jpg |

| One of the two 55-gallon containers of used oil was labeled "Waste oil," not used oil as Mr. Santiago first said, and the other was not labeled at all. |

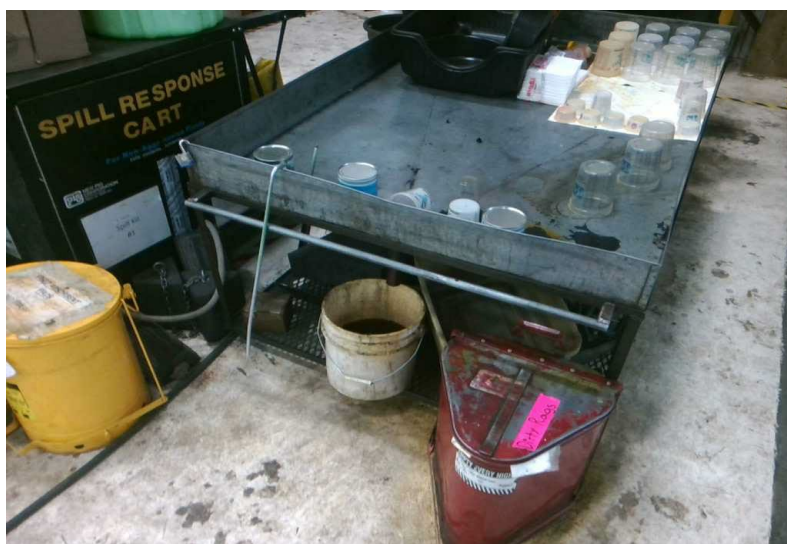
| IMG-2022011912371237121026195.jpg |

| I also saw a small one-gallon bucket that according to Mr. Santiago, held used oil. At the time of the inspection the bucket was not labeled with the words "Used Oil." |

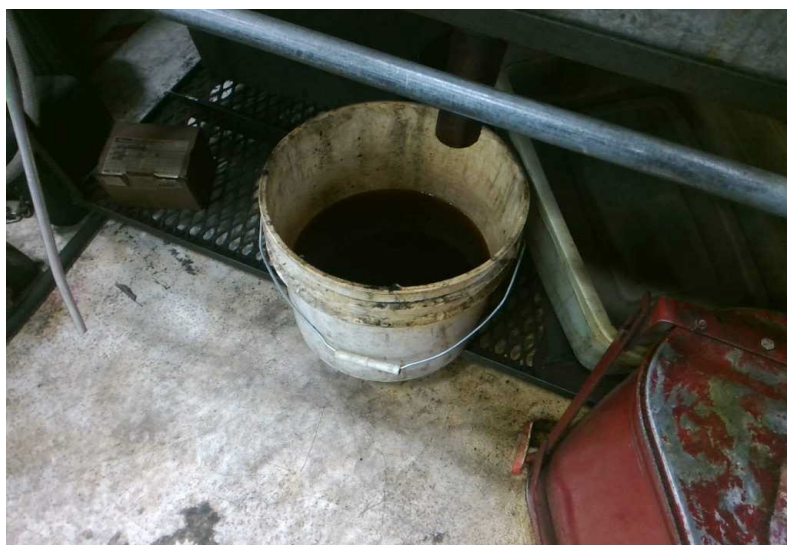
| IMG-202201191237223722939657.jpg |

| I also saw a small one-gallon bucket that according to Mr. Santiago, held used oil. At the time of the inspection the bucket was not labeled with the words "Used Oil." |

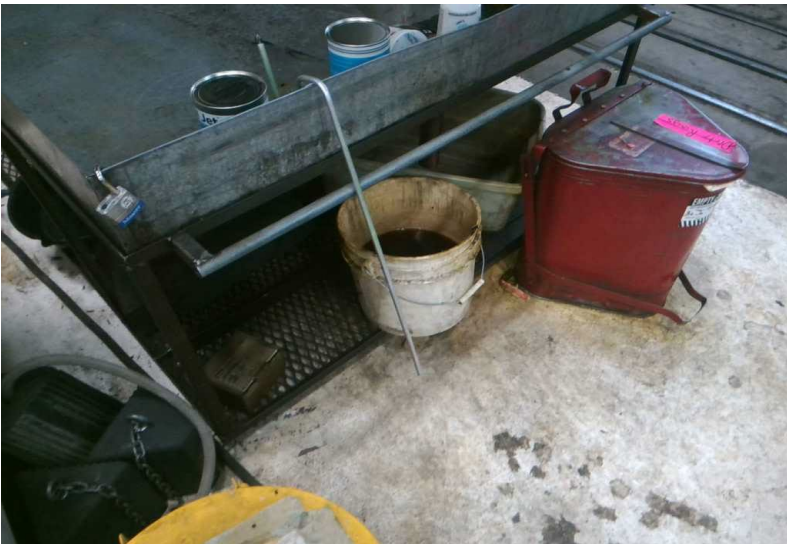
| <p>[Title]</p> <p>IMG-202201191237443744975060.jpg</p> <p>01/19/2022 12:37 PM (AKT)</p> <p>Jon Jones</p> <p>Hangar/ Hazardous Waste Storage Area</p> <p>No CBI</p> <p>No PII</p> <p>I also saw a small one-gallon bucket that according to Mr. Santiago, held used oil. At the time of the inspection the bucket was not labeled with the words "Used Oil."</p> | |

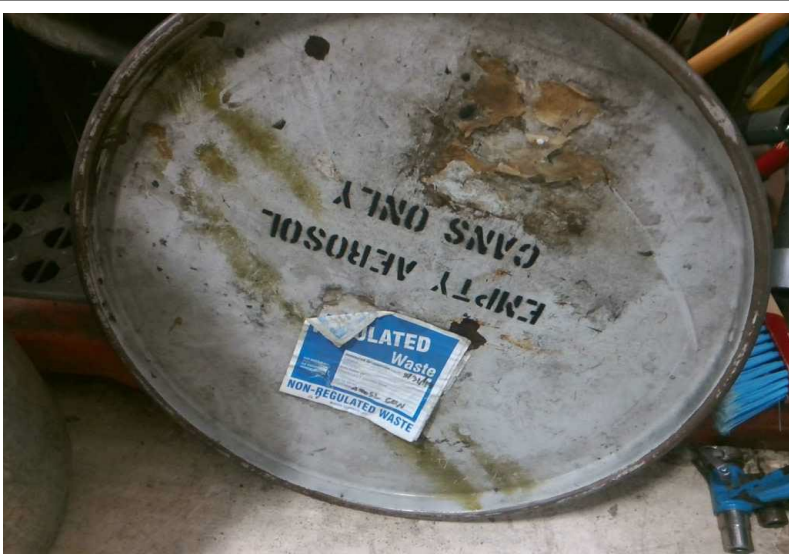
| Adjacent to the HW storage area, I saw a 55-gallon container. The lid was stenciled with the words "Empty Aerosol Cans Only." Mr. Santiago opened the container, and it was full of waste aerosol cans. According to Mr. Stenehjem, the aerosol cans are not punctured, and they are managed for disposal through Environmental Compliance Consultants (ECC). | |

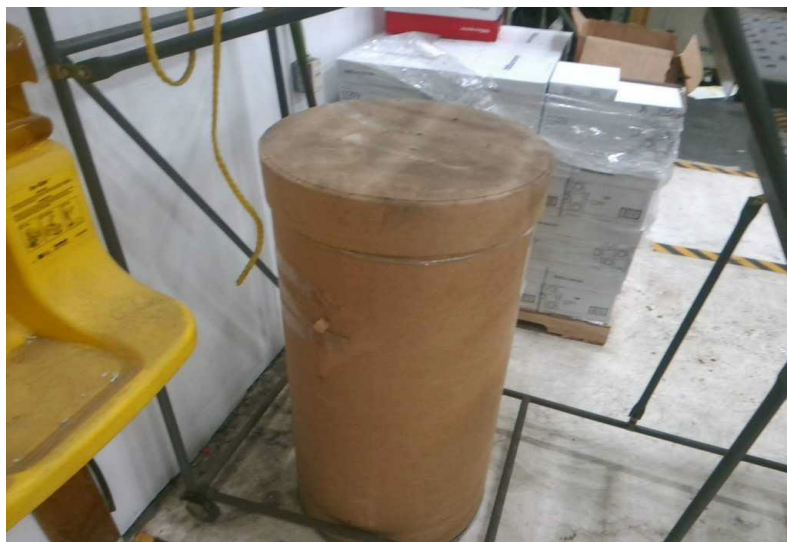
IMG-202201191053575357784900.jpg

While waiting for someone that was familiar with the Hangar operations, I saw an unlabeled fiberboard container, like those used to hold waste fluorescent lamps. I lifted the lid on the container and saw that it held, what appeared to be 40+ waste fluorescent lamps. Several of the lamps had darkened or burnt looking ends, indicative of waste fluorescent lamps. At the time of the inspection, the fiberboard container was not labeled as Universal Waste.

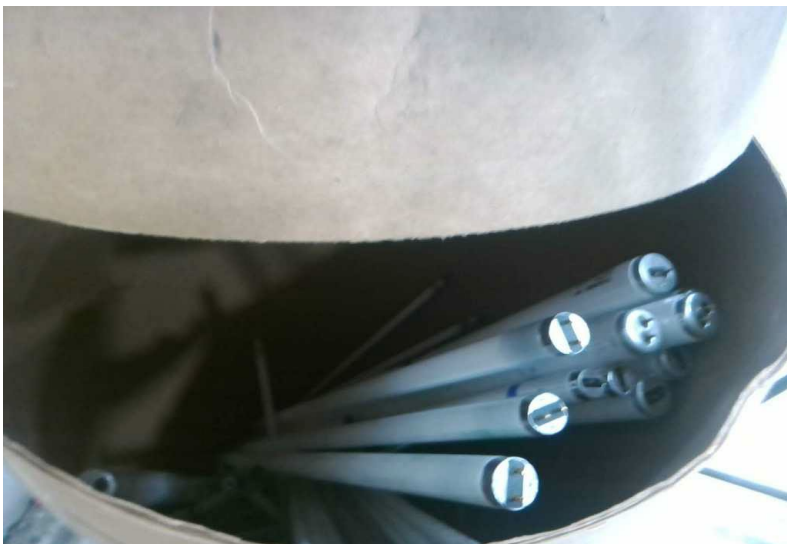
| While waiting for someone that was familiar with the Hangar operations, I saw an unlabeled fiberboard container, like those used to hold waste fluorescent lamps. I lifted the lid on the container and saw that it held, what appeared to be 40+ waste fluorescent lamps. Several of the lamps had darkened or burnt looking ends, indicative of waste fluorescent lamps. At the time of the inspection, the fiberboard container was not labeled as Universal Waste. | |
