## Region 6 - Enforcement & Compliance Assurance Division

### INSPECTION REPORT

| Company Name: | <b>Sinclair Operating Co., LLC</b> | |
| Facility Name: | <b>Crain 6 SWD Tank Battery</b> | |

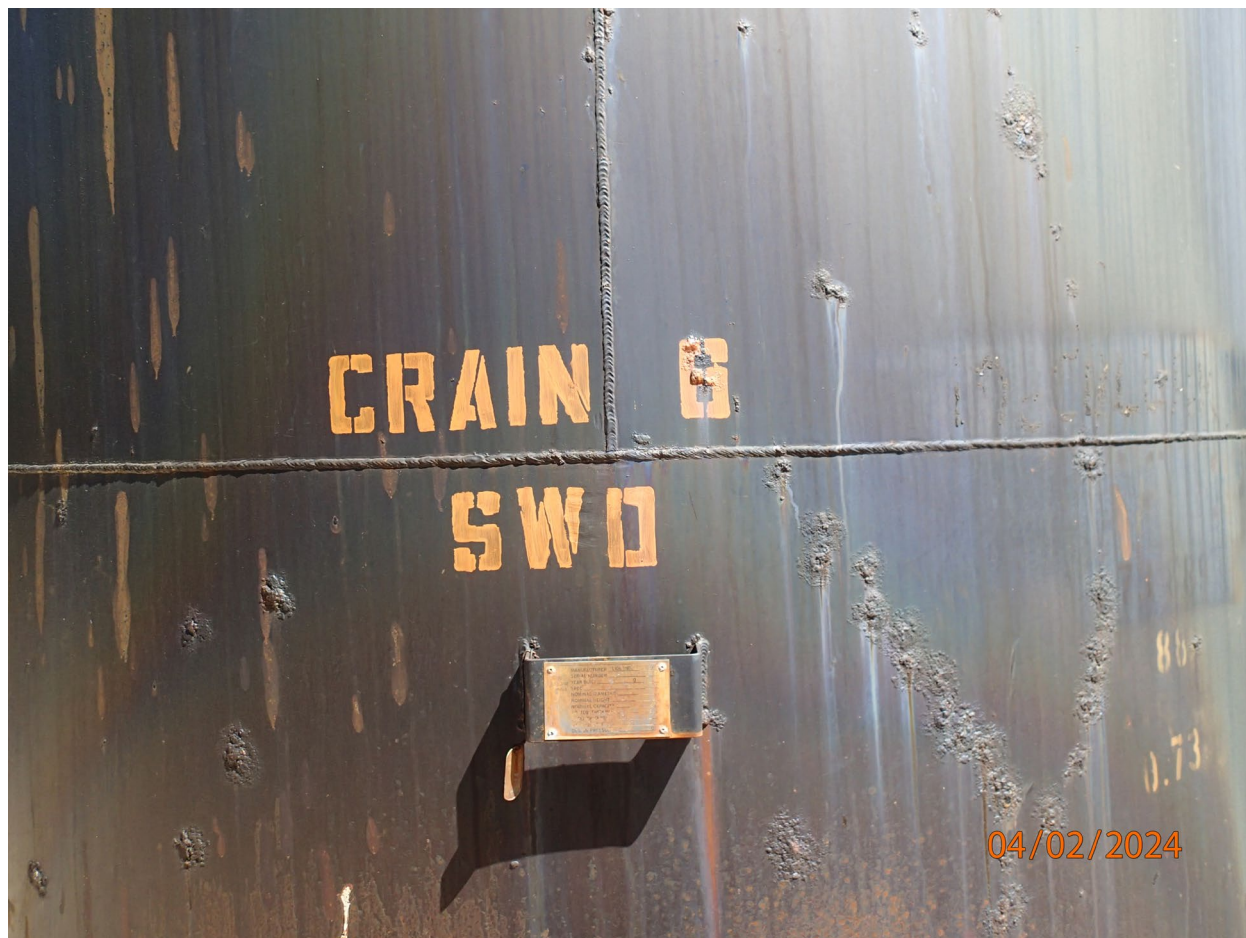
I observed the facility sign, secondary containment, oil-water separator, pipes and valves, storage tanks, and the production well located at the facility; see Appendix 1 (Photographs Log), Photo No. 1 and No. 2. For additional GPS location and photo metadata, see Appendix 1.

**Description:** Looking SW, this photo showed the signage at the facility.

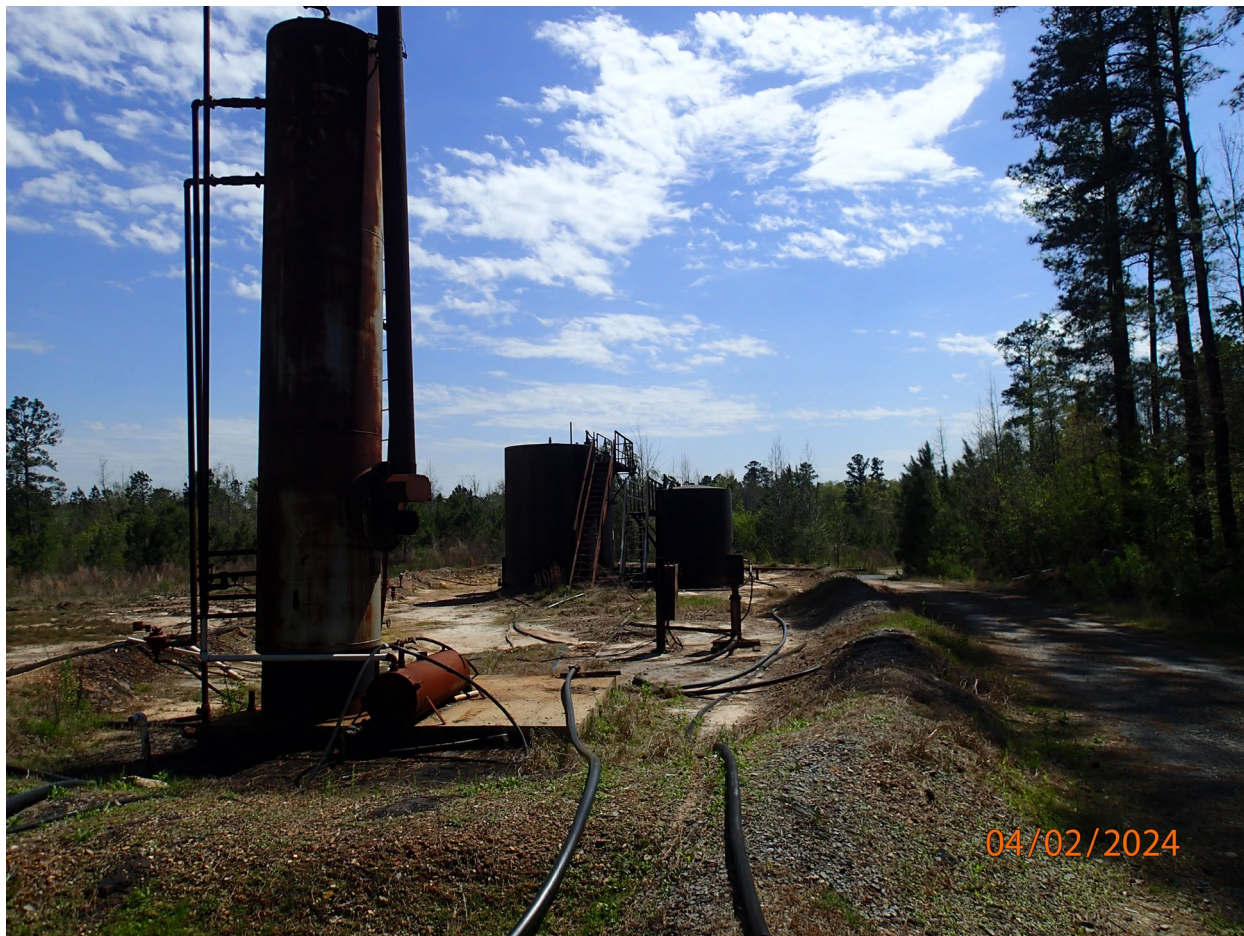
Photo No. 2

**Description:** Looking S, this photo showed an overview of the facility.

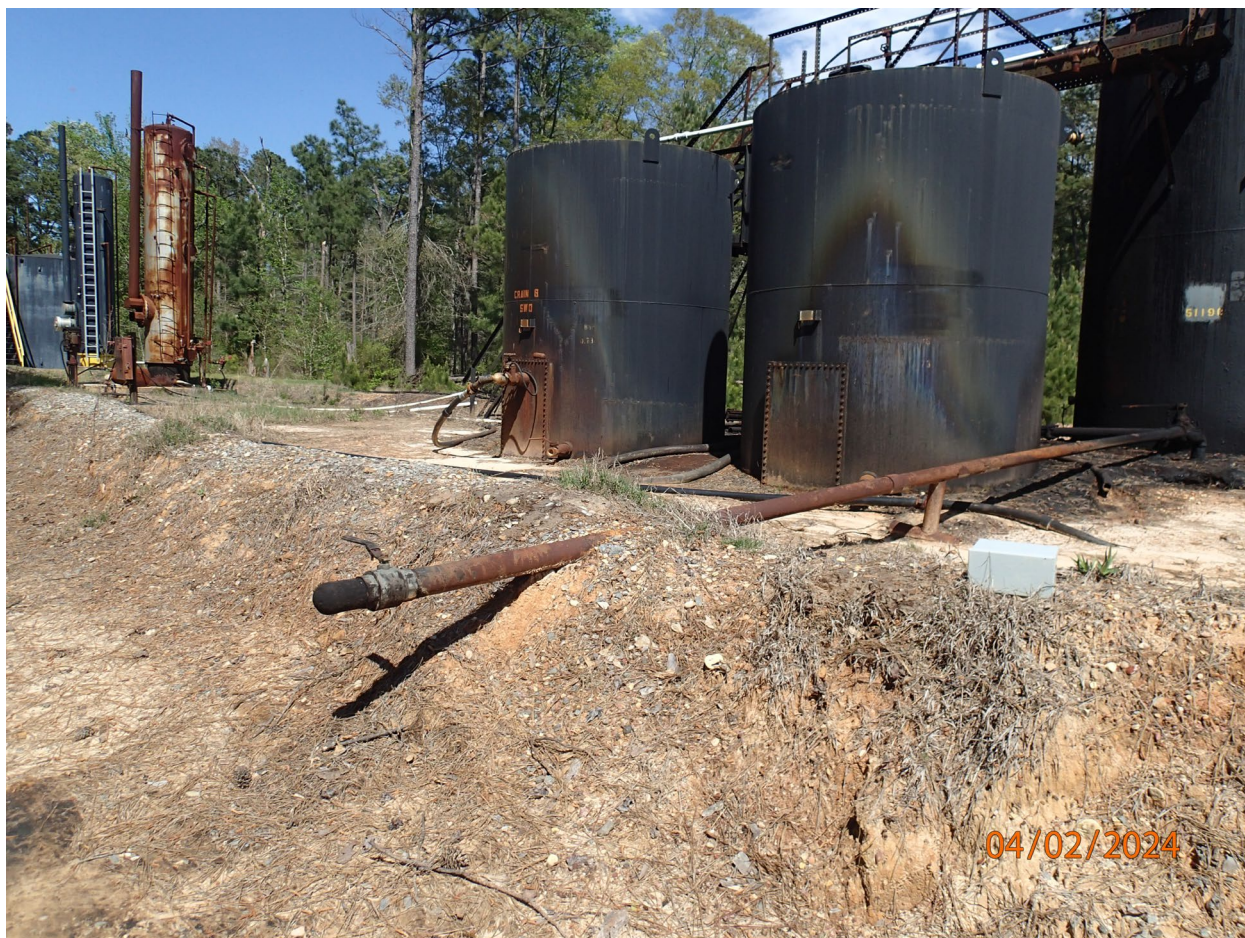
Photo No. 3

I observed a transfer pipe from secondary containment with no catch bucket, see Photo No. 3.

No closing conference was held due to no personnel with Sinclair Operating Co., LLC being present during the inspection. Areas of concern at the time of the inspection include the transfer pipe through secondary containment with no catch bucket, loose oil around the storage tanks, the drainpipe for secondary containment with no shutoff valve, and loose oil on the ground and in vegetation around the SWD well.

**Description:** Looking W, this photo showed a transfer pipe through secondary containment without a catch bucket.

Inspector will conduct follow-up phone calls with the company representative(s) over the coming weeks and months to ensure areas of concern are properly addressed.

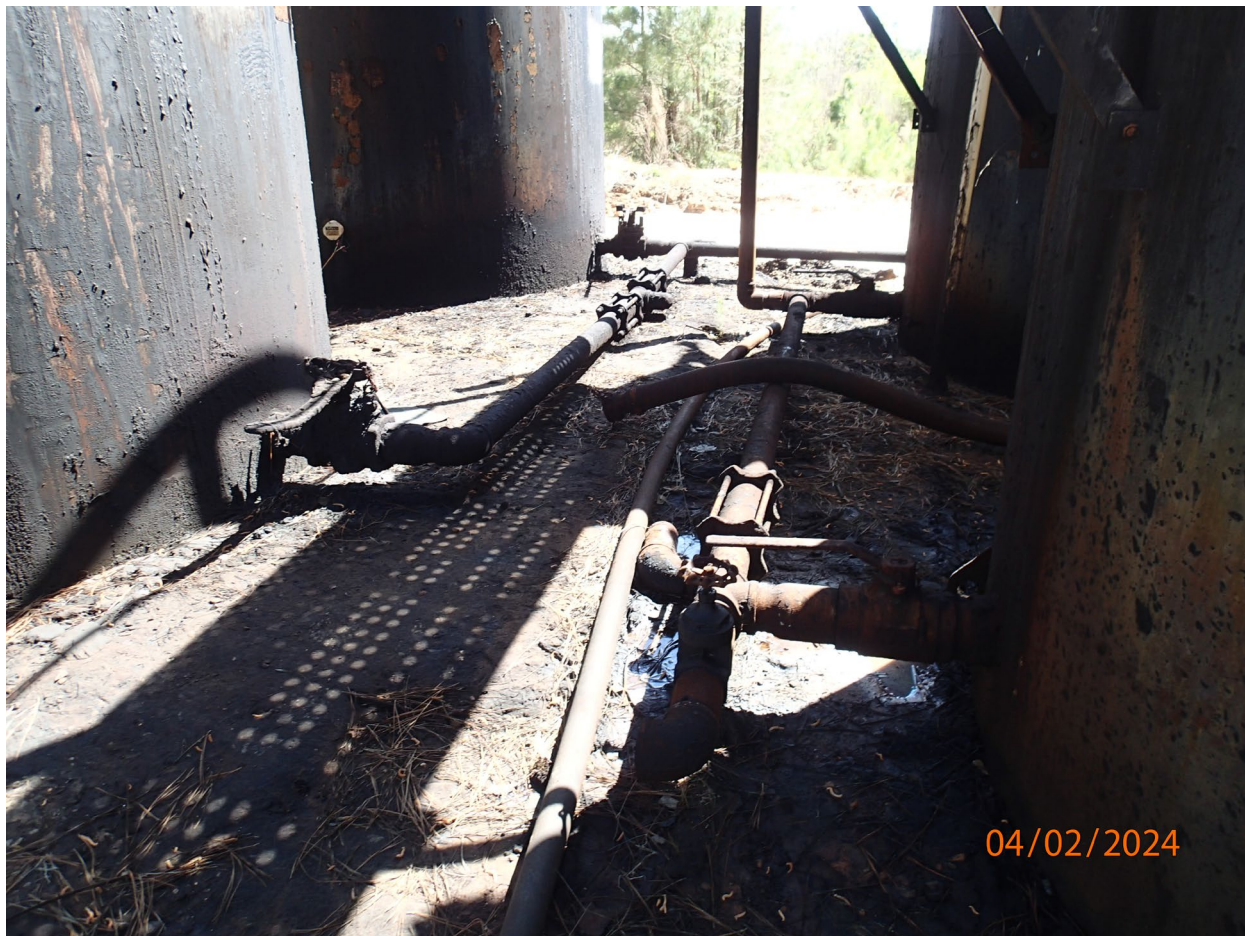
Photo No. 4

I observed loose oil around the storage tanks inside secondary containment, see Photo No. 4.

**Description:** Looking S, this photo showed loose oil around the tank conduits inside secondary containment.

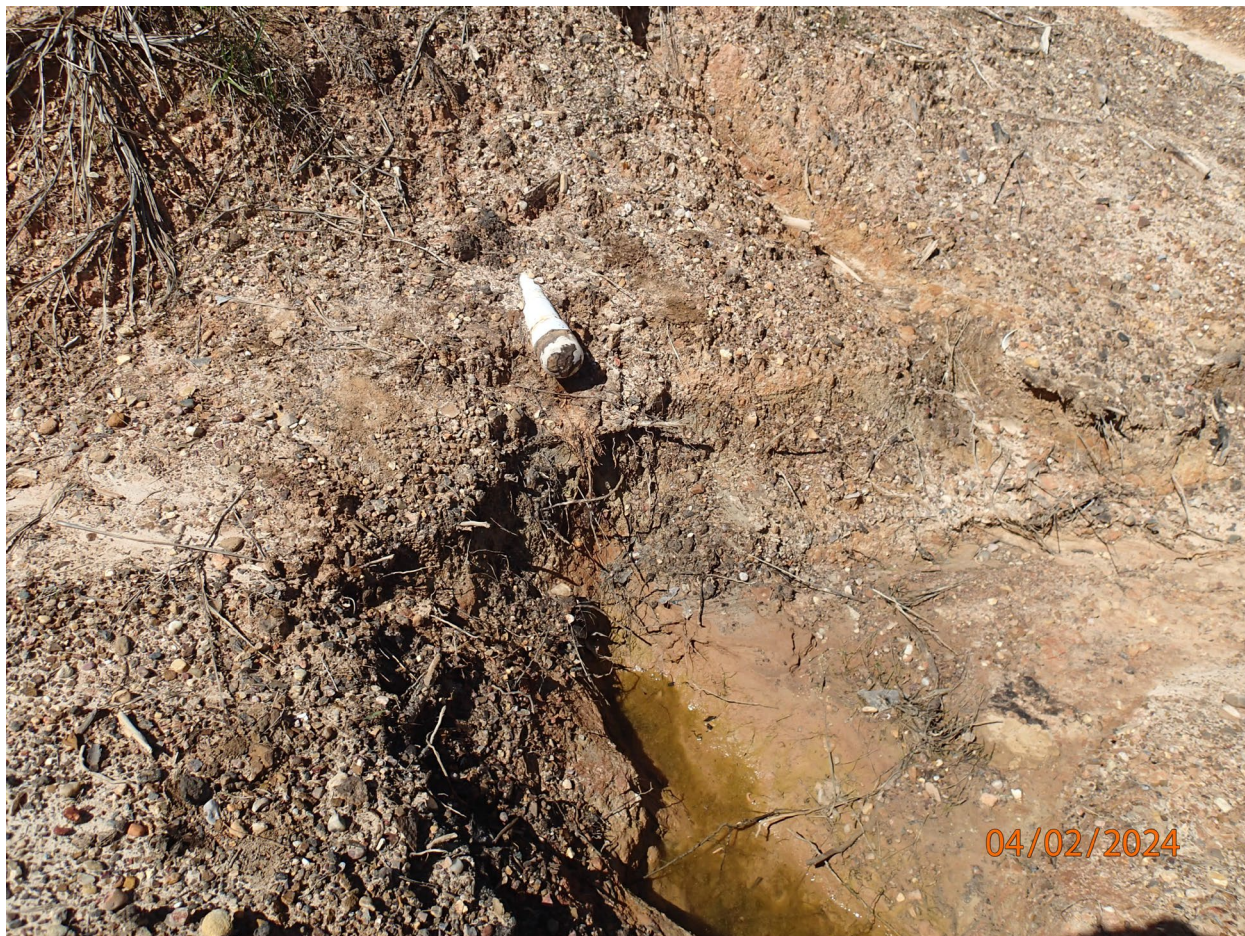
I observed the drainpipe for secondary containment without a shutoff valve; a cap is attached to the drainpipe; see Photo No. 5 and No. 6.

**Description:** Looking N-NW, this photo showed the drainpipe for secondary containment with a cap on the drainpipe.

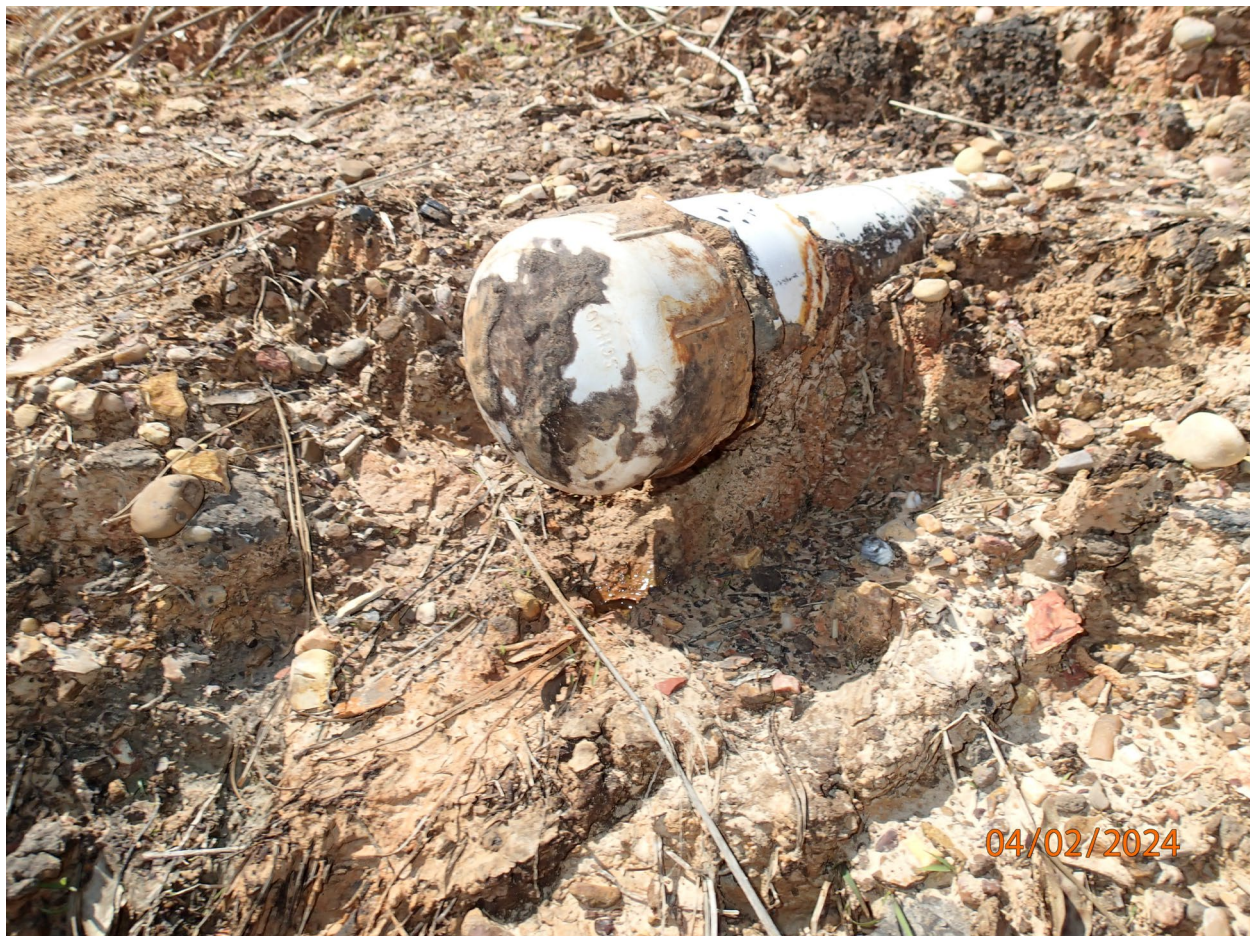
Photo No. 6

**Description:** Looking E, this photo showed a closeup of the cap and drainpipe for secondary containment.

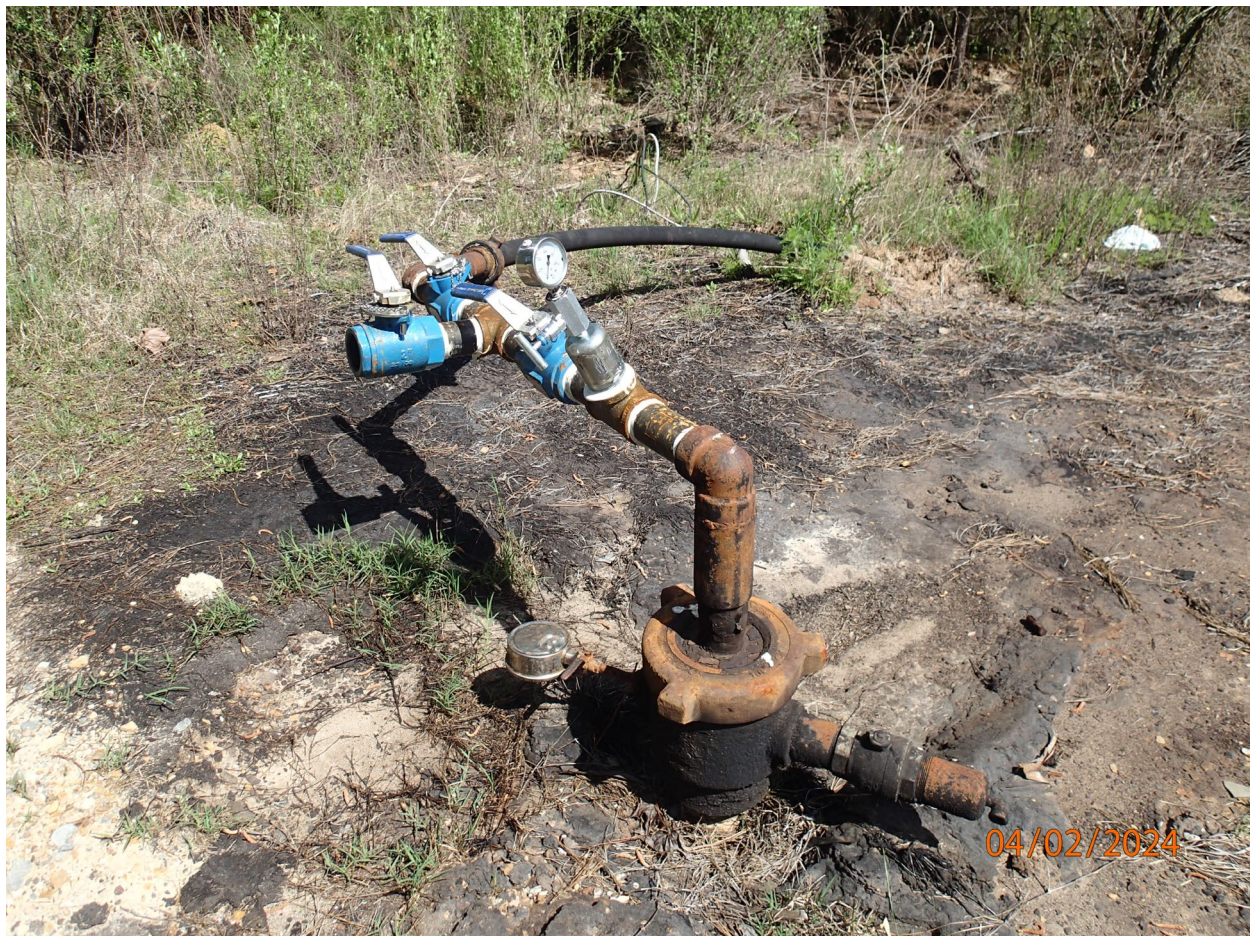
I observed loose oil on the ground and in the vegetation around the SWD well onsite, see Photo No. 7 and No. 8.

**Description:** Looking SW, this photo showed the saltwater disposal (SWD) well for the facility.

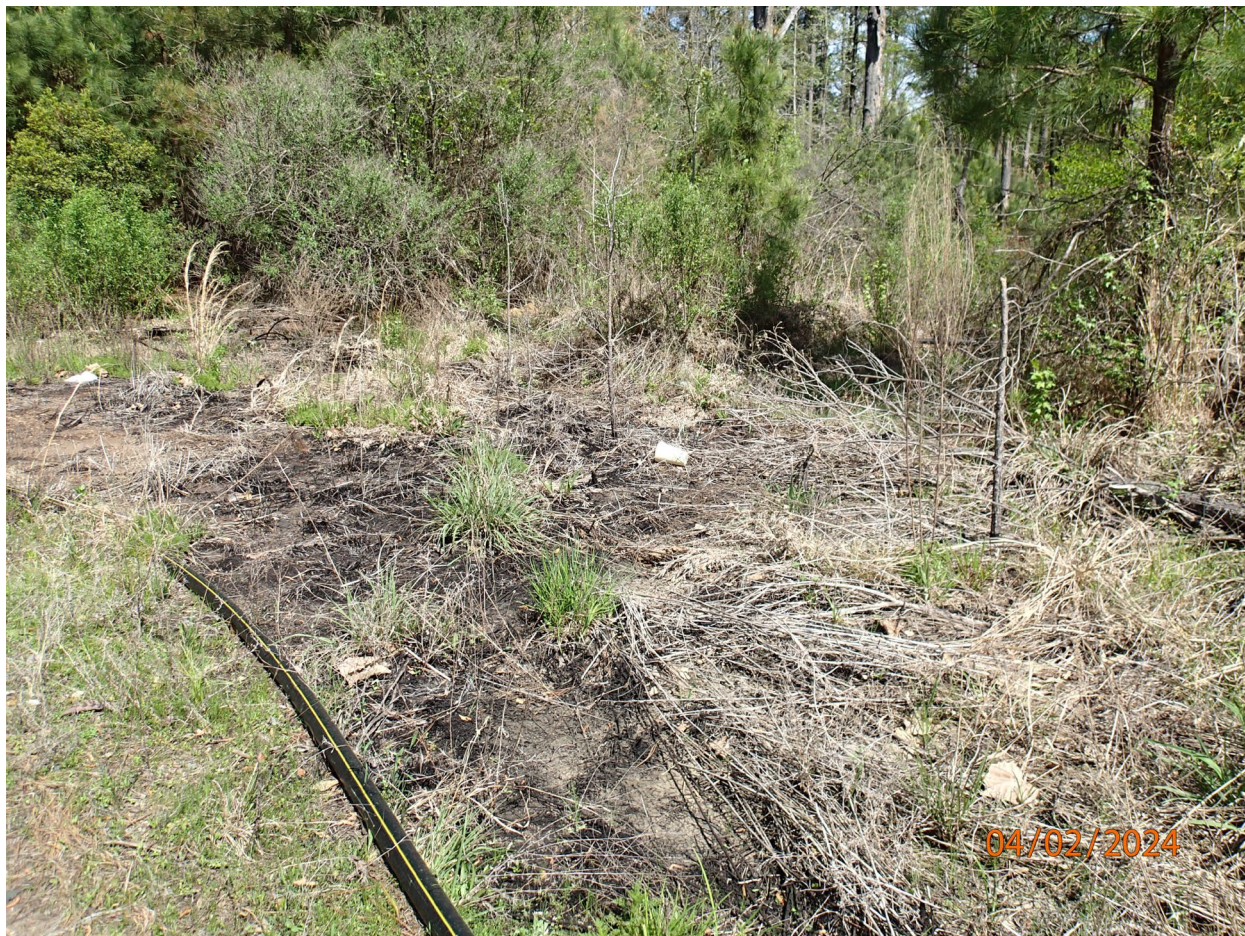
Photo No. 8

**Description:** Looking SW, this photo showed a release from the SWD well with staining on the ground and dead vegetation.
