**UNITED STATES ENVIRONMENTAL PROTECTION AGENCY  
REGION 8**

RE: Inspection report for Ridgewater Development construction site (previous permit MTR10I010)

## NPDES Stormwater Inspection Report - Construction

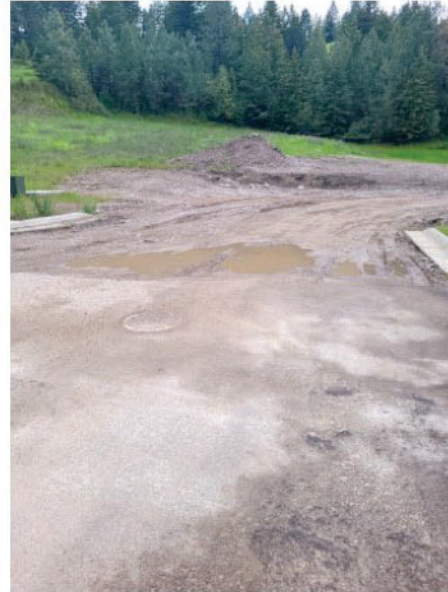
Photo number 1 taken by Evan Smith on 06/15/2022.

Construction site was not maintaining best management practices. Specifically, it was noted by the inspectors that both entrance/exit points of the construction site were lacking sediment control for sediment leaving construction site; see photos 1 and 2.

East entrance to construction site. Note no vehicle tracking BMP, no BMP for material stockpile.

Install appropriate sediment control measures to minimize vehicle tracking from entrances to the construction site. Provide a description of these BMPs in the SWPPP and photo documentation showing adequate Best Management Practices (BMP) installation for sediment and/or erosion controls.

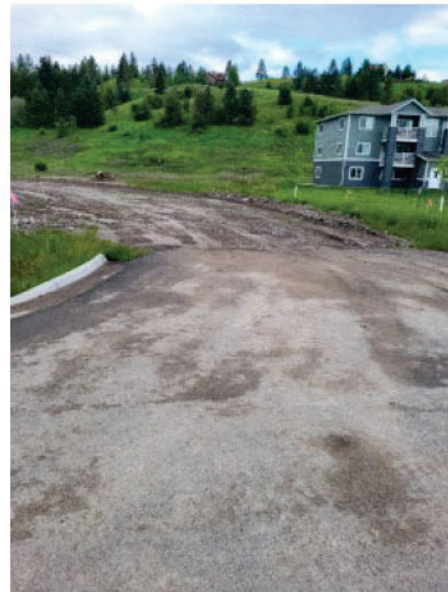
Photo number 2 taken by Evan Smith on 06/15/2022.

Specifically, the inspectors noted there was a lack of perimeter controls on the down-gradient portion of the project site; see photos 2 and 3.

Western entrance to construction site. Note no vehicle tracking BMP and sediment on the pavement. Also no perimeter BMP between construction site and adjacent property.

Install appropriate BMPs along the down-gradient perimeter to prevent sediment from leaving the site. Provide a description of these BMPs in the SWPPP and photo documentation showing adequate BMP installation for sediment and/or erosion controls.

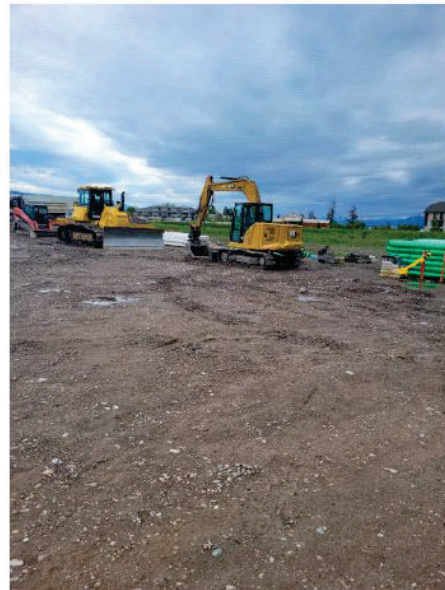
Photo number 4 taken by Evan Smith on 06/15/2022.

Equipment staging area on project site.

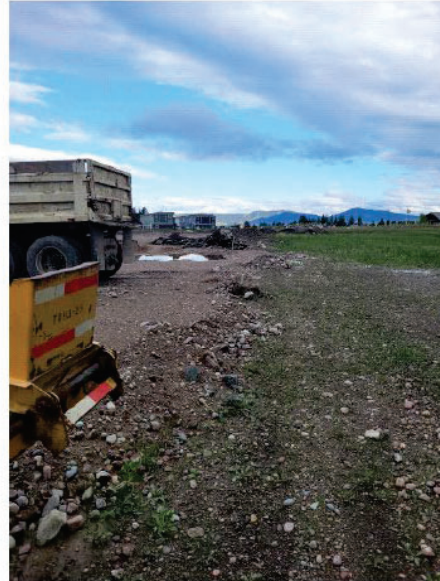
Photo number 6 taken by Evan Smith on 06/15/2022.

Vehicle staging area on the north center of the project site.

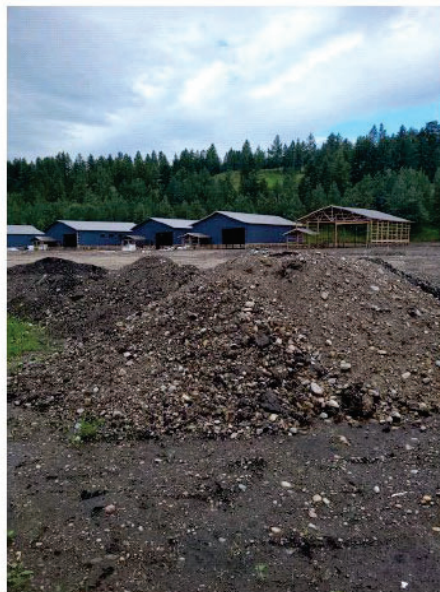
Photo number 7 taken by Evan Smith on 06/15/2022.

Specifically, the inspectors noted there were several material stockpiles on site with no structural or erosion controls installed/implemented; see photos 5, 7 and 8.

Material stockpiles on-site. New construction of buildings in the background.

Install appropriate BMPs to protect the downgradient perimeter and stabilize stockpile surfaces. Provide a SWPPP with these BMP descriptions and photo documentation showing adequate BMP installation for sediment and/or erosion controls.

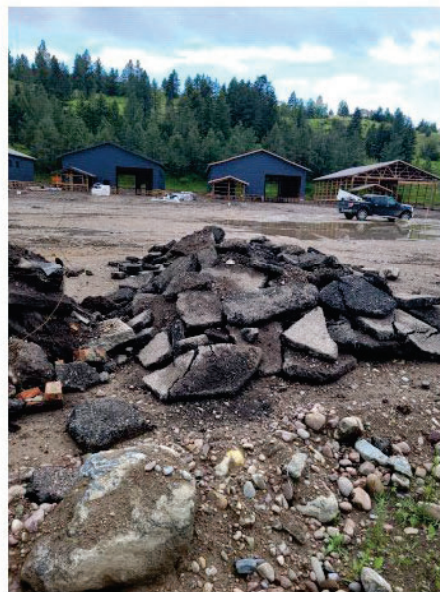
Photo number 8 taken by Evan Smith on 06/15/2022.

Material stockpiles on site.

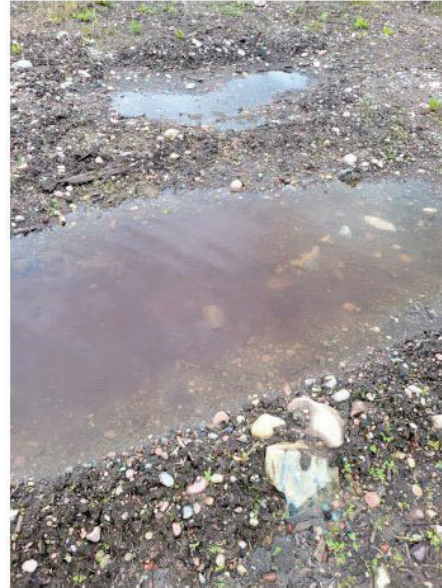
Photo number 9 taken by Evan Smith on 06/15/2022.

Puddle on-site from rain within past 24-hours, showing petroleum sheen.

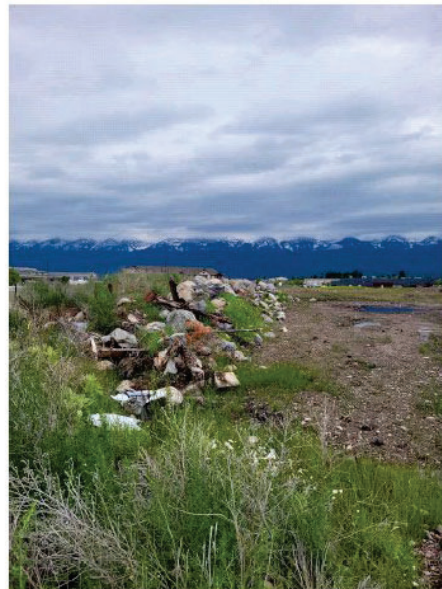
Photo number 10 taken by Evan Smith on 06/15/2022.

Rocks and other materials piled as 'berm' along the northern boundary of project site.

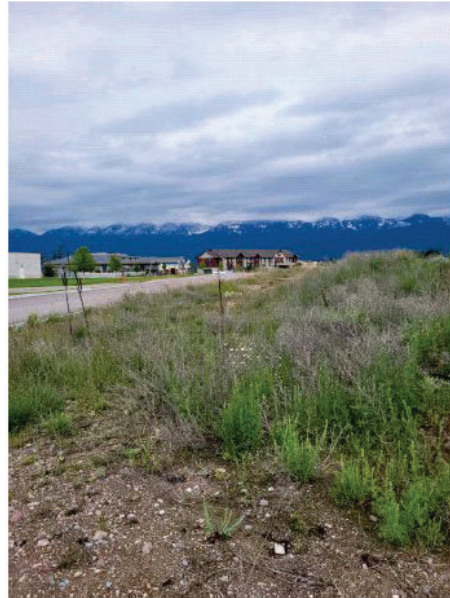
Photo number 11 taken by Evan Smith on 06/15/2022.

Project site along Ridgewater Drive and property boundary. Vegetated stockpile/rock 'berm' to the right of the photo.

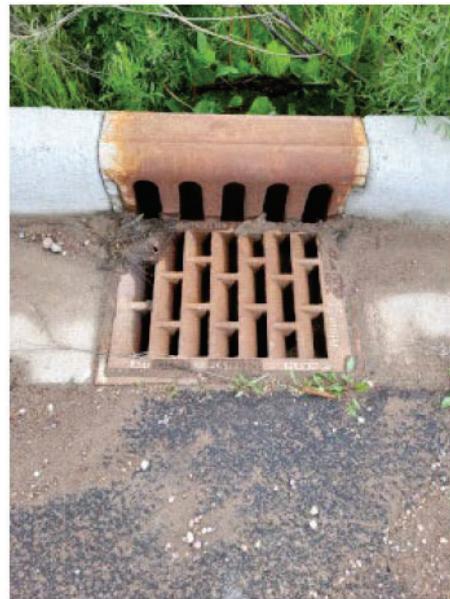
Photo number 12 taken by Evan Smith on 06/15/2022.

Specifically, the inspectors noted there were no inlet protection BMPs installed along Ridgewater Drive; see photo 12.

Inlet along Ridgewater Drive near west entrance to project site. Note no inlet protection, and sediment entering the drain.

Install appropriate BMPs at all storm drain inlets where potential sediment leaving the site would be impacted. Provide a description of these BMPs in the SWPPP and photo documentation showing adequate BMP installation for sediment and/or erosion controls.

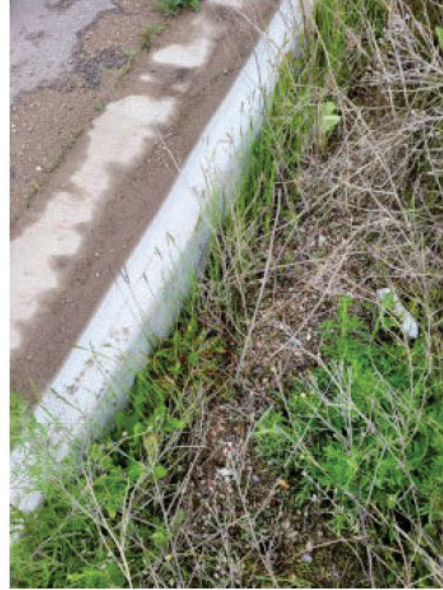
Photo number 13 taken by Evan Smith on 06/15/2022.

Interface between concrete curb lip on Ridgewater Drive and the northern boundary of the project site. Note sediment in the road drainage.

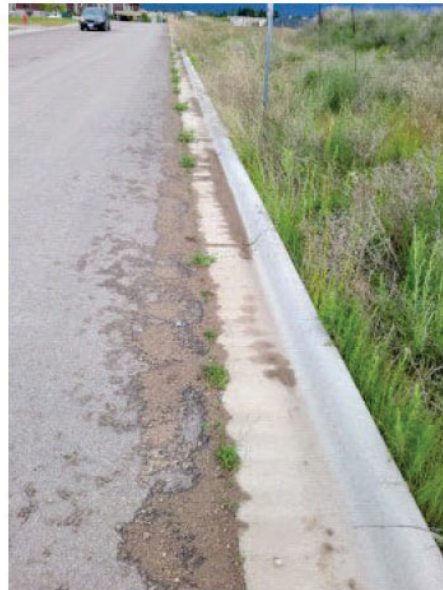
Photo number 14 taken by Evan Smith on 06/15/2022.

Concrete curb lip on Ridgewater Drive and the northern boundary of the project site. Note sediment in the road drainage from project site tracking.
