**Inspection Report Addendum for Well: MT20000-01124**  
**Inspection Date: 10/25/2023**

| <b>U.S. Environmental Protection Agency</b><br><b>Region 8</b> | | <b>UIC PHOTOGRAPHIC LOG</b> | |
| <b>Facility Location:</b><br>MT20000-01124 (90-W5), Glacier County, UT | | <b>Photographer:</b><br>Gary Wang | <b>Camera:</b><br>Ricoh WG-5 |

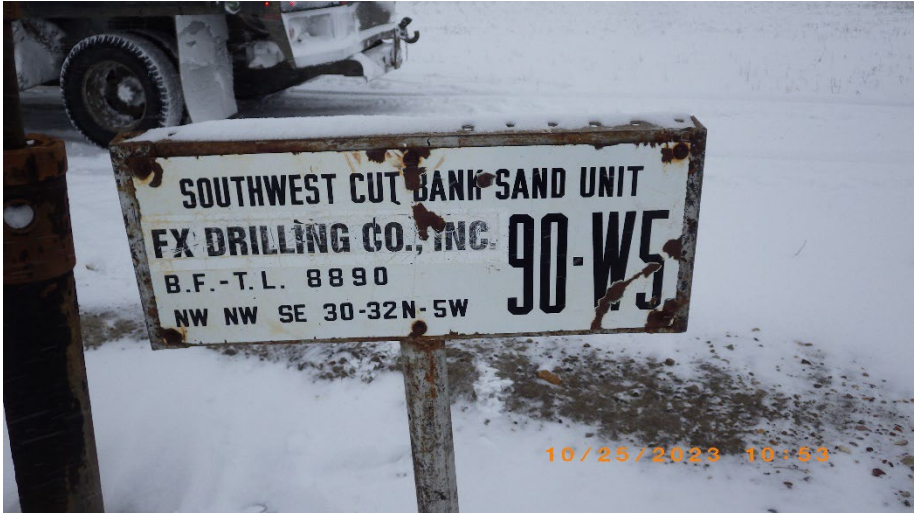
| <b>Photo No.</b><br>1 of 5 | <b>Time:</b><br>10:53 am | | |

| <b>Photo Description:</b><br>Well sign by wellhead. | | | |

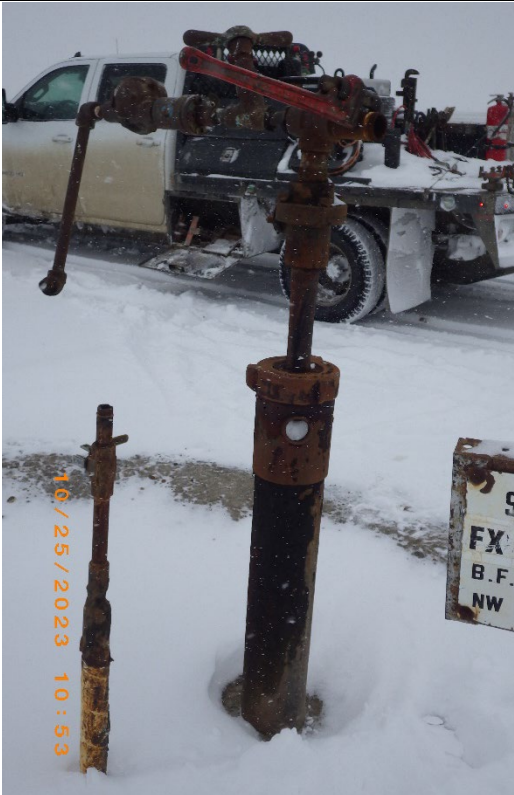
| <b>Photo Description:</b><br>Wellhead was observed to be disconnected from pipe flowline (left of the wellhead).<br><br>Records indicated last monthly injection was April 2022. | | | |

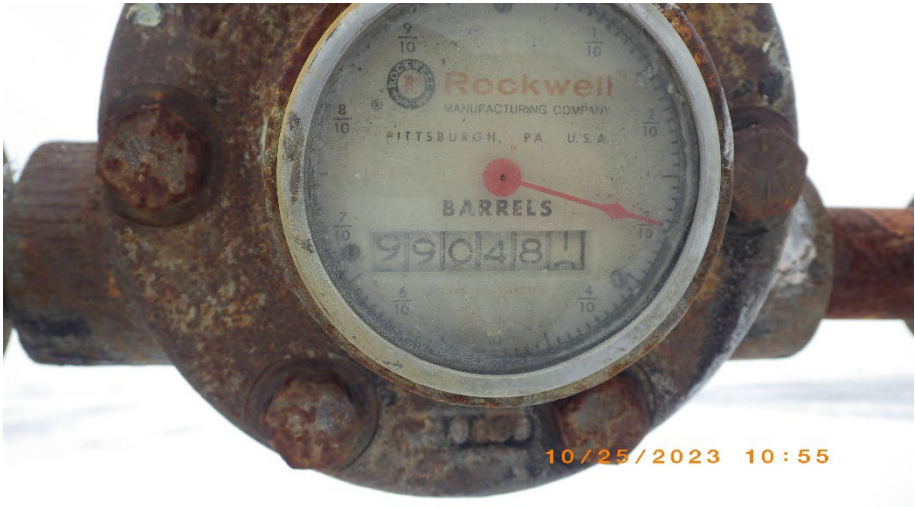
| <b>Photo No.</b><br>3 of 5 | <b>Time:</b><br>10:55 am | | |

| <b>Photo Description:</b><br>Volume meter on wellhead read 990481 bbl. | | | |

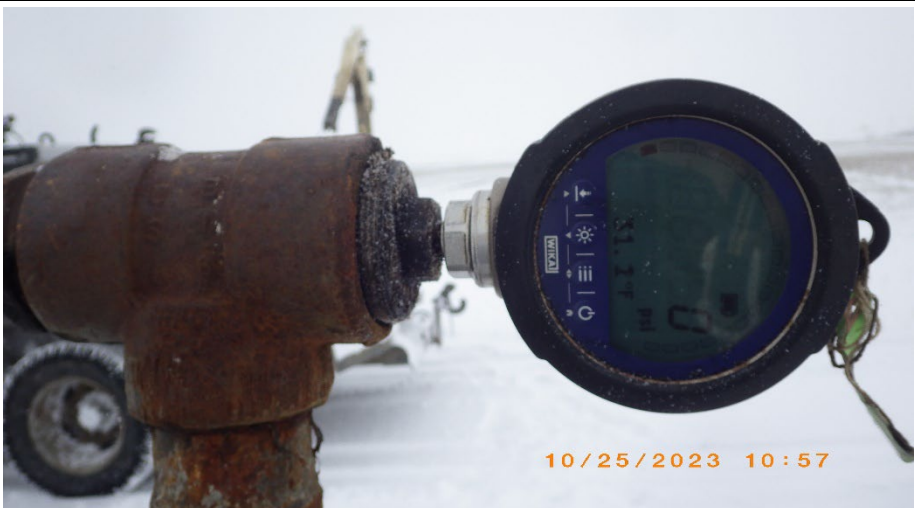
| <b>Photo No.</b><br>4 of 5 | <b>Time:</b><br>10:57 am | | |

| <b>Photo Description:</b><br>EPA's digital pressure gauge on tubing read 0 psi on a 3000-psi range gauge.<br><br>MAIP for well is at 2609 psi. | | | |

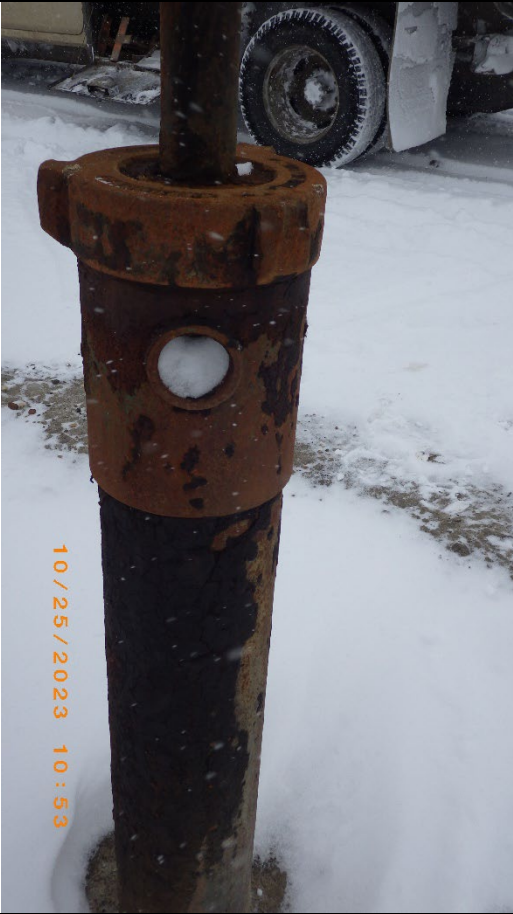
| <b>Photo No.</b><br>5 of 5 | <b>Time:</b><br>10:53 am | | |

| <b>Photo Description:</b><br>Tubing-casing annulus observed to be maintained continuously open to atmospheric pressure. | | | |
