**Well Inspection**  
**Osage DNR / Environmental Protection Agency**  
**1201 Elm Street, Suite 500**  
**Dallas, Texas 75270**

| | | <b>Lease Name</b> | Whitetail | | |
| | | <b>Well ID</b> | 6 | | |

## UNITED STATES ENVIRONMENTAL PROTECTION AGENCY

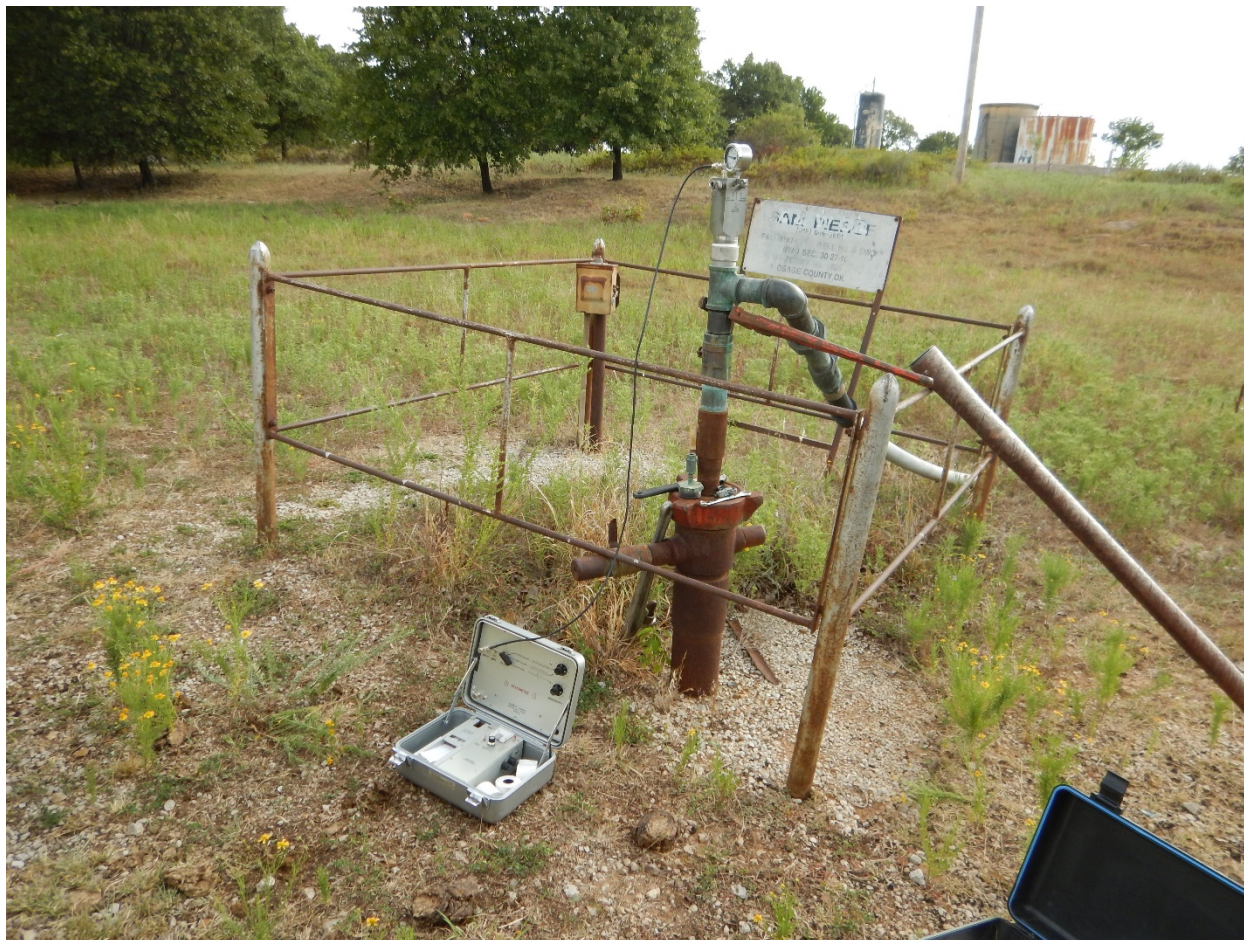
Photo No. 1

**Description:** This was well OS1936000 (Whitetail No. 6) with the EPA Echometer attached, just prior to obtaining a fluid level measurement.

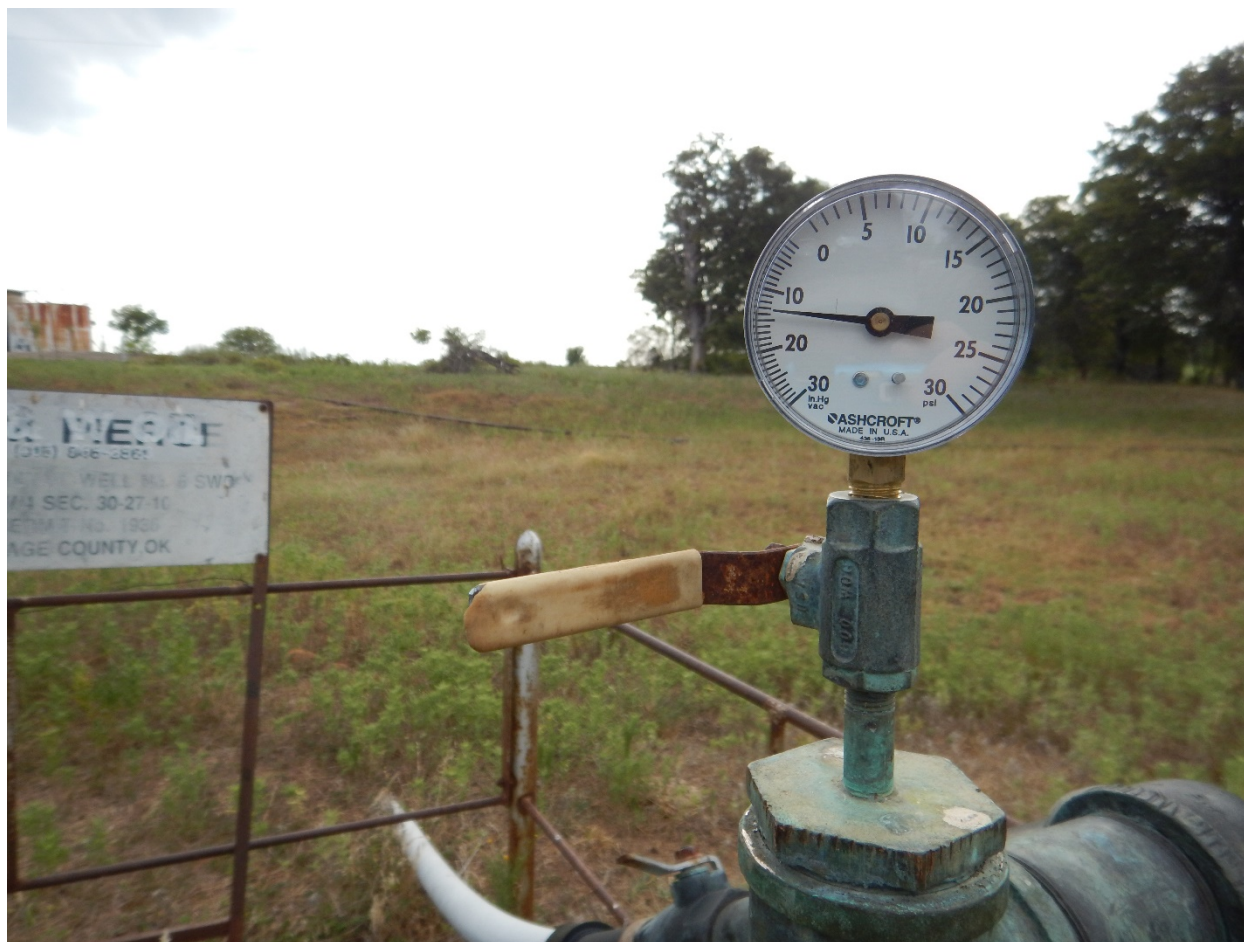
Photo No. 2

| <b>Inspection Comments</b> | Well OS1936 (Whitetail No. 6) was connected to the flowline at the time of the inspection and the 2 inch ball valve on the tubing and flowline were both closed, preventing injection. At the time of the inspection there was 14 in.Hg vacuum on the tubing and 0 psi pressure on the annulus of the well. I observed the fluid level down the tubing of the well using an Echometer, the fluid level was 1088.70 feet below the top of the tubing. The well sign should be updated. There were no areas of concern at the time of the inspection. | | | | |

**Description:** This was the EPA gauge displaying 13 in.Hg of vacuum on the tubing of well OS1936000.
