## **RCRA Inspection Report**

PharmaLink, Inc.  
8285 Bryan Dairy Road  
Largo, Pinellas County, Florida 33777

March 22, 2023

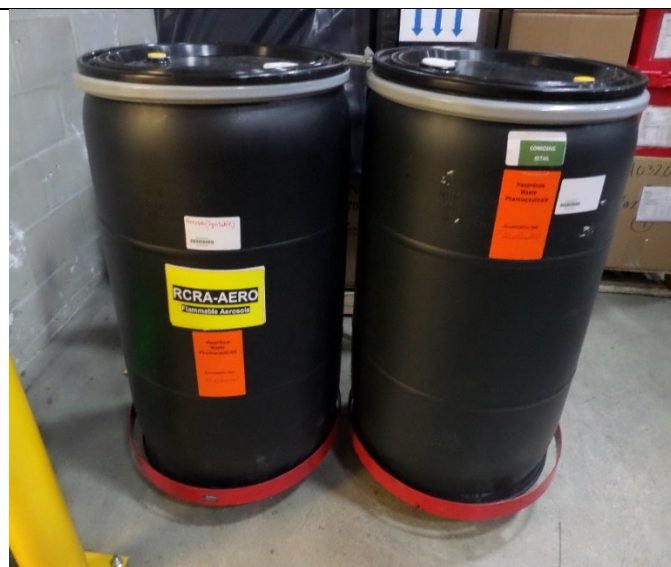
Process Area SAA. The inspectors observed one 55-gallon SAA and a second 55-gallon SAA. Photograph 2 taken at 12:21 p.m.

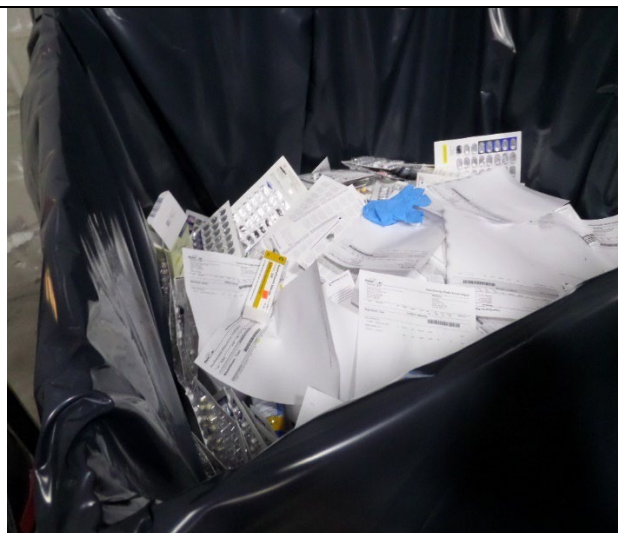
Process Area SAA. The inspectors observed a one cubic yard container accumulating closed pharmaceutical solid packages and marked with a date. Photograph 4 taken at 12:249 p.m.

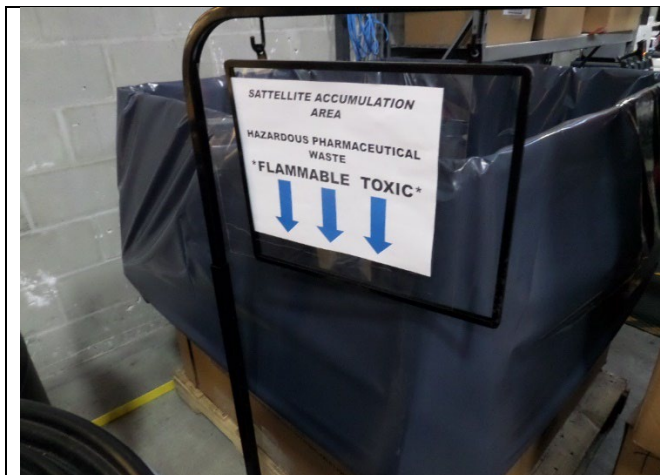
The accumulation area (AA) is located outside the entrance to the Process Room. PharmaLink manages four AAs in this area. The inspectors observed one 55-gallon container accumulating waste pharmaceutical aerosols in the first AA and one 55-gallon container accumulating waste pharmaceutical corrosives in a second AA. The containers were closed, in good condition, labeled with the words “hazardous waste pharmaceuticals”, marked with a hazard indicator and each marked with the date February 23, 2023 (Photograph 2). The inspectors observed a one cubic yard container accumulating more than 55-gallons of waste pharmaceutical flammable and toxic solids in a third AA (Photograph 4). The inspectors observed a sign next to the container with the words “satellite accumulation area, hazardous pharmaceutical waste, flammable and

toxic” (Photograph 5). The inspectors observed the container was labeled with the words “hazardous waste pharmaceuticals”. A pallet of cardboard boxes next to the one cubic yard container limited the inspectors from observing a hazard indicator and a date on the container (Photograph 3). The inspectors asked the facility to move the boxes so that the container could be inspected. After the facility moved the boxes for aisle space, the inspectors observed the container was labeled with a hazard indicator and marked with the date March 21, 2023.

Process Area SAA. Sign indicating the SAA. The inspectors observed a one cubic yard container accumulating closed pharmaceutical solid packages and marked with a date. Photograph 5 taken at 12:24 p.m.

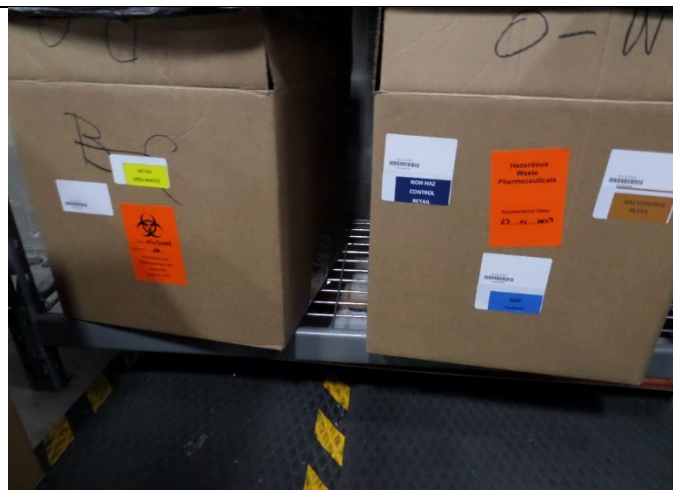
The inspectors observed a 20 to 30-pound cardboard container on a metal shelf next to the wall was accumulating waste pharmaceuticals in a fourth AA. The container was closed, in good condition, labeled with the words “hazardous waste pharmaceuticals” and marked with the date March 21, 2023. The inspectors observed the container was not marked or labeled with a hazard indicator (Photograph 6). PharmaLink representatives marked the container with a hazard indicator during the inspection (Photograph 7).

Process Area SAA. The inspectors observed a third SAA. Container was not marked/labeled with a hazard indicator. Photograph 6 taken at 12:32 p.m.

**Pursuant to F.A.C. Chapter 62-730.181(1) [40 C.F.R. § 266.508(a)(1)(i-ii), a healthcare facility must ship non-creditable hazardous waste pharmaceuticals and a reverse distributor must ship evaluated hazardous waste pharmaceuticals off-site to a designated facility (such as a permitted or interim status treatment, storage, or disposal facility) in compliance with the following pre-transport requirements, before transporting or offering for transport off-site.**

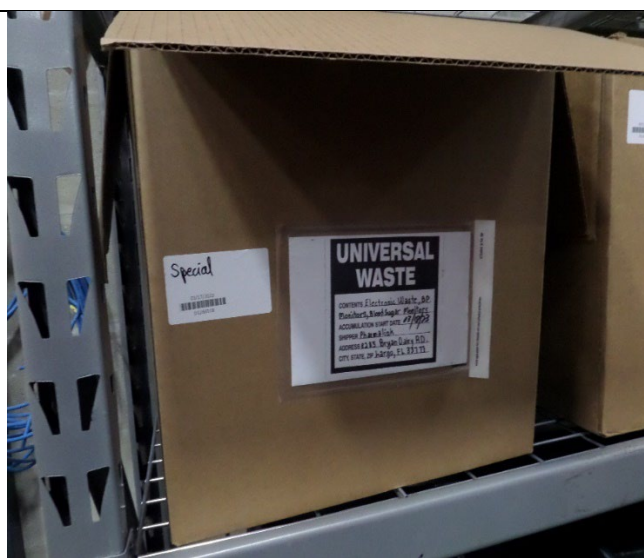
The inspectors also observed a 20 to 30-pound container on the metal shelf accumulating universal waste electronics. The container was closed, in good condition, labeled with the words “universal waste” and marked with the date March 18, 2023 (Photograph 8).

Process Area SAA. The inspectors observed a container of universal waste. Photograph 8 taken at 12:35 p.m.

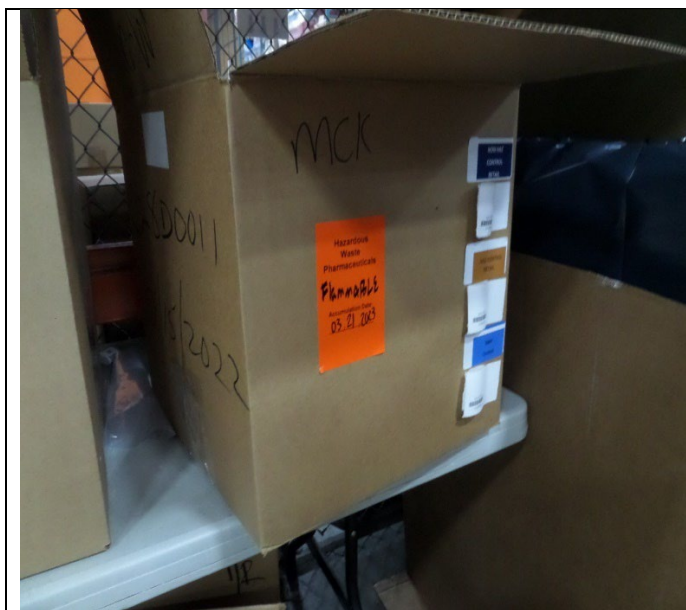
PharmaLink manages three accumulation areas (AA) in Batch Packing accumulating different types of pharmaceuticals. The inspectors observed one 20 to 30-pound cardboard container accumulating waste pharmaceuticals in the first AA and one 55-gallon container accumulating waste pharmaceuticals in a second AA. The inspectors observed the containers were closed, in good condition, labeled with the words “hazardous waste pharmaceuticals”, and marked with the date March 21, 2023 and February 23, 2023. The inspectors observed the 20 to 30-pound container in the first AA was not marked or labeled with a hazard indicator. PharmaLink representatives marked the container with a hazard indicator during the inspection (Photograph 9 and 12).

Batch Packing Area. Refractory Area. The inspectors observed the container was not marked/labeled with a hazard indicator. The facility marked the container with a hazard indicator. Photograph 9 taken at 12:49 p.m.

**Pursuant to F.A.C. Chapter 62-730.181(1) [40 C.F.R. § 266.508(a)(1)(i-ii)], a healthcare facility must ship non-creditable hazardous waste pharmaceuticals and a reverse distributor must ship evaluated hazardous waste pharmaceuticals off-site to a designated facility (such as a permitted or interim status treatment, storage, or disposal facility) in compliance with the following pre-transport requirements, before transporting or offering for transport off-site.**

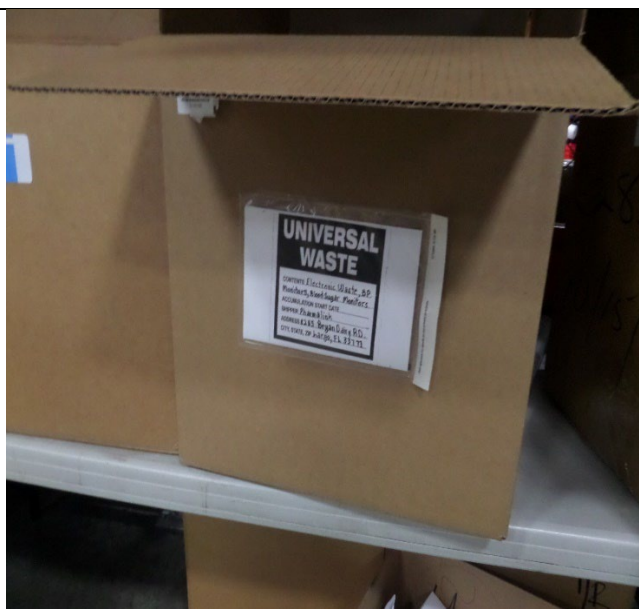
The inspectors observed a 20 to 30-pound cardboard container accumulating universal waste electronics. The inspectors observed the container was closed, in good condition and labeled with the words “universal waste”. The inspectors observed the container was not marked with a date (Photograph 10). PharmaLink representatives marked the container with the date March 8, 2023 (Photograph 11 and 12).

Batch Packing Area. Refractory Area. The inspectors observed the universal waste container was not marked with a date Photograph 10 taken at 12:51 p.m.

**Pursuant to F.A.C. Chapter 62-730.185(1) [40 C.F.R. § 273.15(c)], a SQHUW must be able to demonstrate the length of time that the universal waste has been accumulated from the date it becomes a waste or is received. The handler may make this demonstration by following F.A.C. Chapter 62-730.185(1) [40 C.F.R. § 273.15(c)(1-6)].**

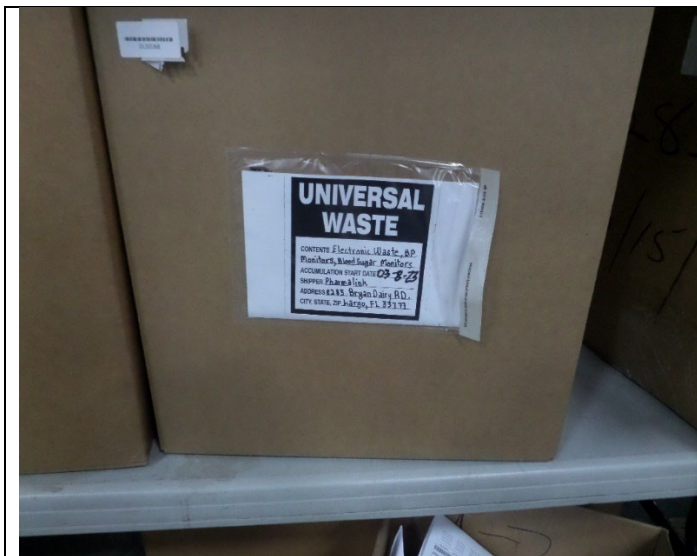
Batch Packing Area. Refractory Area. The inspectors observed the universal waste container was not marked with a date The facility marked the container with the date March 8, 2023. Photograph 11 taken at 12:52 p.m.

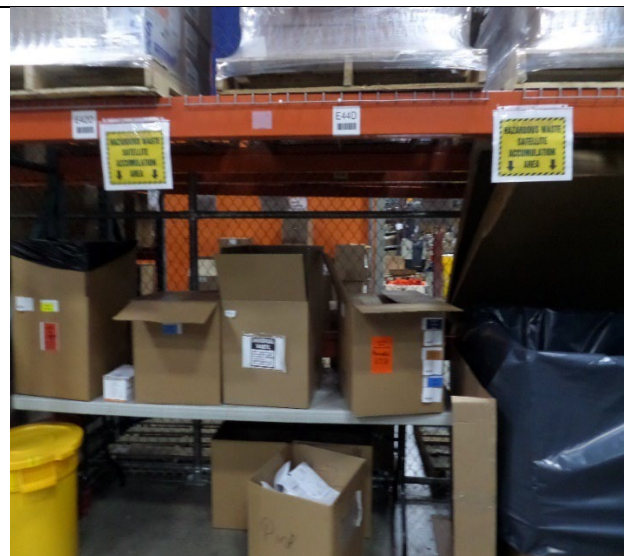
Batch Packing Area. The inspectors observed a view of containers of hazardous waste pharmaceuticals and universal waste. Photograph 12 taken at 12:52 p.m.

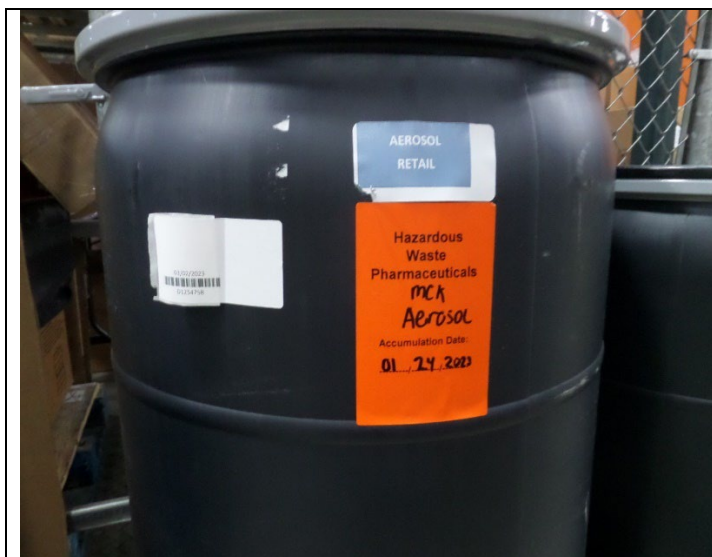
The inspectors observed one 55-gallon container accumulating waste pharmaceutical aerosols in a third SAA. The inspectors observed the container was closed, in good condition, labeled with the words “hazardous waste pharmaceuticals” and marked with the date January 24, 2023. The inspectors observed the container was not marked or labeled with a hazard indicator. PharmaLink representatives indicated the container was not accumulating hazardous waste pharmaceuticals and the container should be labeled with the words “nonhazardous waste” (Photograph 13). A follow up email from PharmaLink dated April 12, 2023 indicated the 55-gallon container was accumulating waste pharmaceutical aerosols.

Batch Packing Area. The inspectors observed a 55-gallon container of hazardous waste pharmaceutical aerosols not marked/labeled with a hazard indicator. The facility indicated it was accumulating nonhazardous waste. Photograph 13 taken at 12:59 p.m.

**Pursuant to F.A.C. Chapter 62-730.181(1) [40 C.F.R. § 266.508(a)(1)(i-ii)], a healthcare facility must ship non-creditable hazardous waste pharmaceuticals and a reverse distributor must ship evaluated hazardous waste pharmaceuticals off-site to a designated facility (such as a permitted or interim status treatment, storage, or disposal facility) in compliance with the following pre-transport requirements, before transporting or offering for transport off-site.**

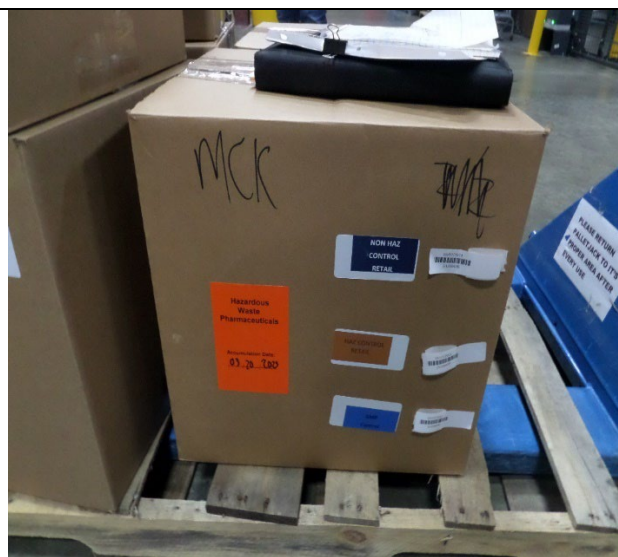
The inspectors observed two 20 to 30-pound cardboard containers on a wooden pallet accumulating waste pharmaceuticals. The containers were closed, in good condition, labeled with the words “hazardous waste pharmaceuticals” and marked with the date March 20, 2023. The inspectors observed the containers were not marked or labeled with a hazard indicator (Photograph 14). PharmaLink representatives marked the containers with a hazard indicator (Photograph 15).

Schedule III through V DEA Controlled Substance Area. The inspectors observed the container was not marked or labeled with a hazard indicator. Photograph 14 taken at 1:04 p.m.

**Pursuant to F.A.C. Chapter 62-730.181(1) [40 C.F.R. § 266.508(a)(1)(i-ii)], a healthcare facility must ship non-creditable hazardous waste pharmaceuticals and a reverse distributor must ship evaluated hazardous waste pharmaceuticals off-site to a designated facility (such as a permitted or interim status treatment, storage, or disposal facility) in compliance with the following pre-transport requirements, before transporting or offering for transport off-site.**

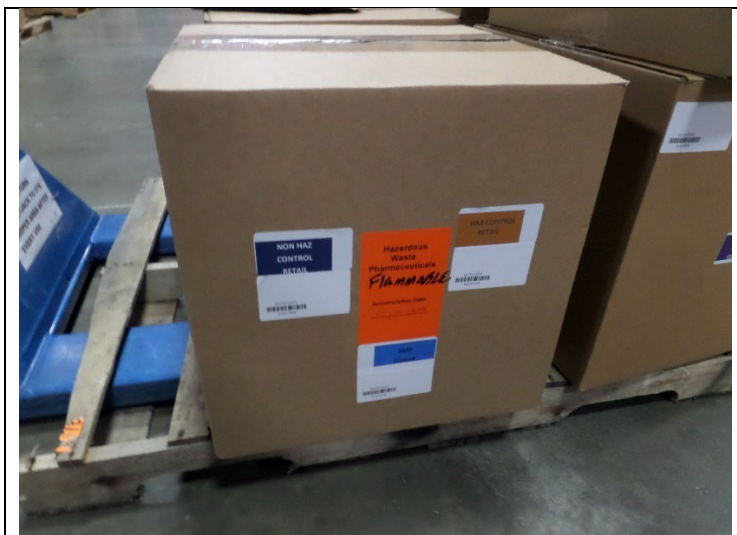
Schedule III through V DEA Controlled Substance Area. The inspectors observed the container was not marked or labeled with a hazard indicator. The facility marked the container with a hazard indicator. Photograph 15 taken at 1:04 p.m.
