# **NPDES Compliance Inspection Report**

## **River City Redemix Salmon, Idaho**

**NPDES Permit Tracking Number  
#IDR053220**

**Inspection Date: May 2, 2023**

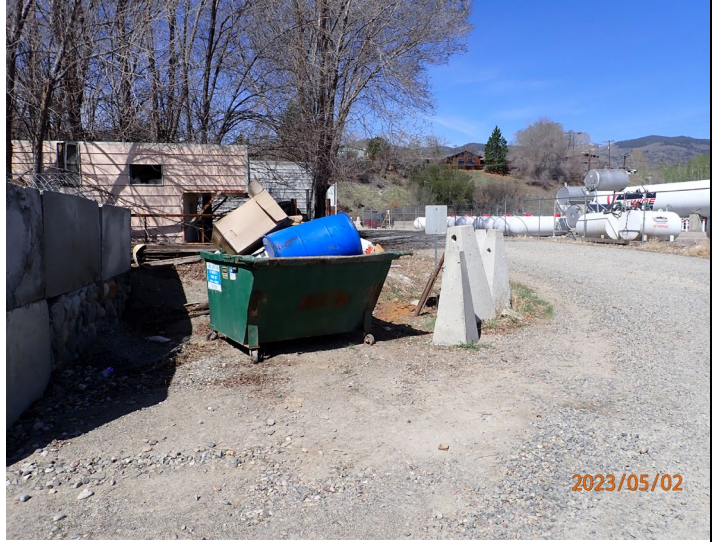
After the opening conference, Ms. Younger guided us through a site review of the Facility. During the review, we discussed operations and observed site activities at various locations within the site. **Attachment C** includes photographs taken during the site review. Our review started at the northwestern corner of the site, near the entrance and exit area (**Photo 1**). At this location, I observed an uncovered dumpster (**Photo 2**). Ms. Younger informed me that Lemhi Sanitation empties the dumpster when it is full.

Photo #:02  
Description: Facing west, photo of an uncovered dumpster.

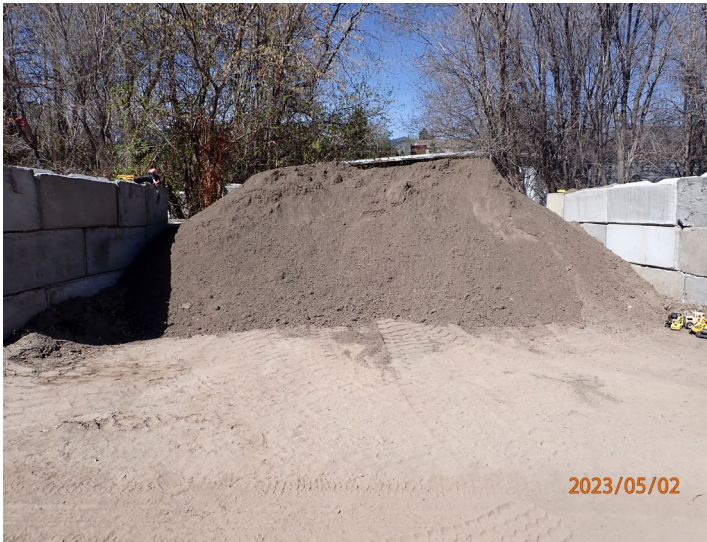
Upon touring the property's western boundary, I noticed sizable concrete blocks housing stockpiles of topsoil and gravel (**Photos 3-4**). Ms. Younger informed me that these materials are brought to the site from an external location and are available for purchase at the Facility.

Photo #:03  
Description: Facing west, photo of topsoil for purchase.

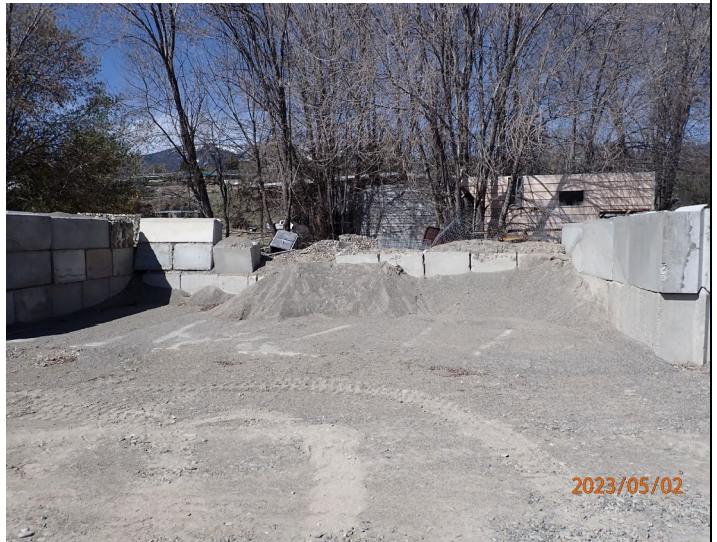
Photo #:04  
Description: Facing west, photo of gravel for purchase.

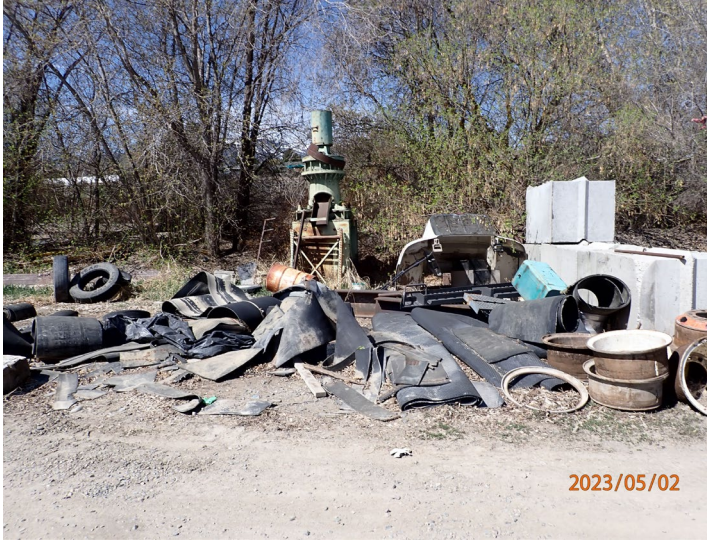
As I was observing the site's western perimeter, I noticed several stacks of conveyor mats, tires, and old machinery parts (**Photo 5**). The Facility utilizes these items for repairing heavy equipment. In this area, I observed the covered maintenance shop as well as the location where concrete forms are poured and kept as finished products. Ms. Younger stated that the covered shop did not have any drains within the building.

Photo #:05  
Description: Facing west, photo of relict equipment and debris.

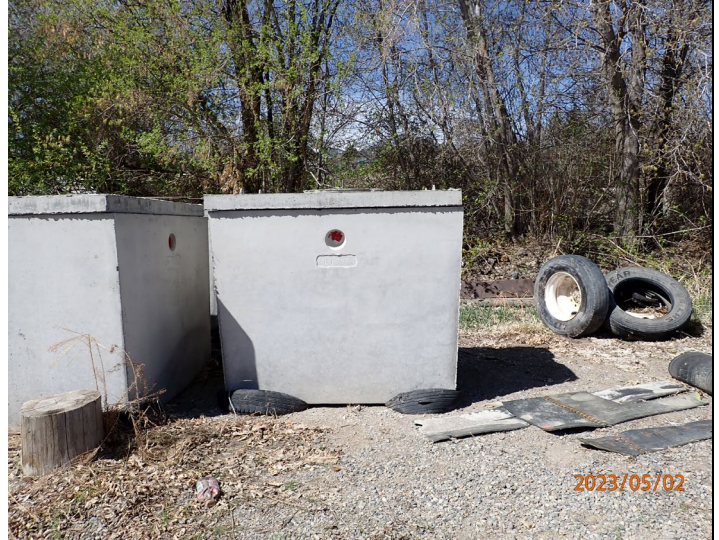
I observed some concrete septic tanks that had been poured and were waiting to be picked up (**Photo 6**). Ms. Younger informed me that the concrete forms could be picked up within four days of being poured. She also mentioned that the Facility did not use water to wash the concrete forms. Furthermore, I saw some batteries and scrap materials made of wood and metal stored outside near the covered shop (**Photo 7**). In that same area, I noticed some unlabeled drums. Ms. Younger explained that some of those drums would be cut in half to be used as storage containers. There was a drum that Ms. Younger said contained used oil that was waiting for pick-up. She also told me that the Facility disposes of waste, such as oil and batteries, a couple of times per year.

Photo #:06  
Description: Facing west, photo of poured concrete septic tank.

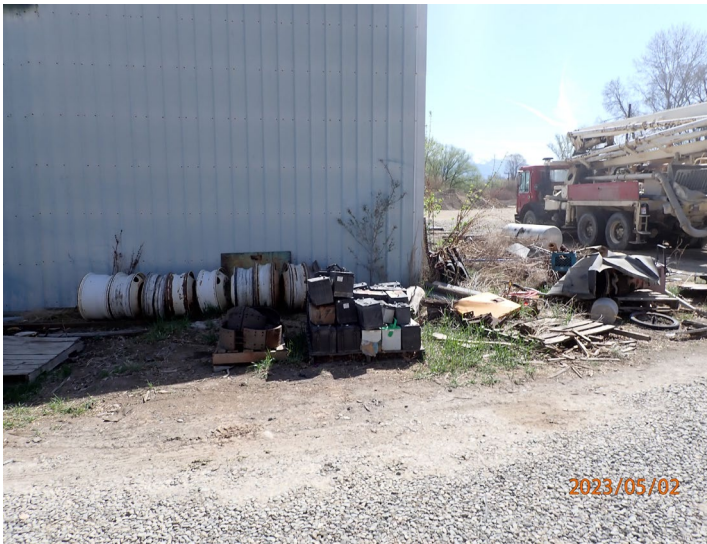
During the inspection, I observed an uncovered dumpster, old equipment, batteries, and waste uncovered. Additionally, I noticed some unlabeled drums containing used oil and a spill kit that appeared to be unusable as it

Photo #:07  
Description: Facing east, photo of metal, batteries, and debris by the covered shop.

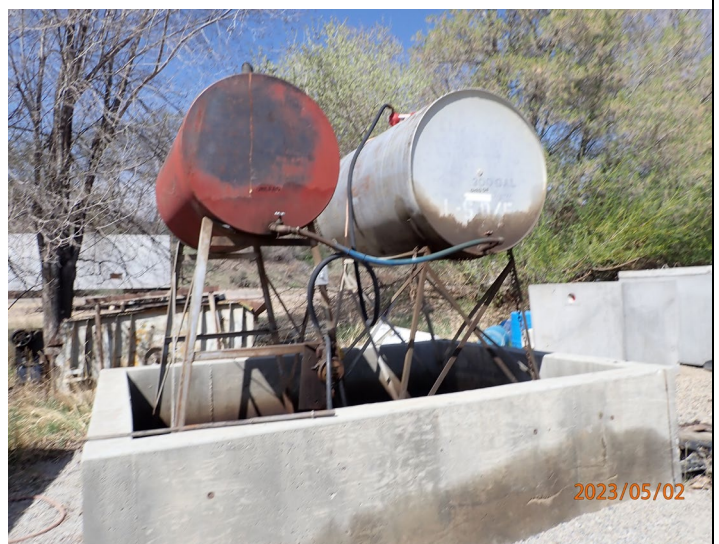
While in this vicinity, I observed two diesel fuel tanks (**Photo 8**). According to Ms. Younger, the capacity of both tanks is around 250-300 gallons. These tanks were situated in a secondary containment crib made of concrete. Ms. Younger mentioned that the Facility regularly maintains the containment area by cleaning up any debris within the concrete crib and disposing of it properly.

Photo #:08  
Description: Facing west, photo of two tanks containing fuel.

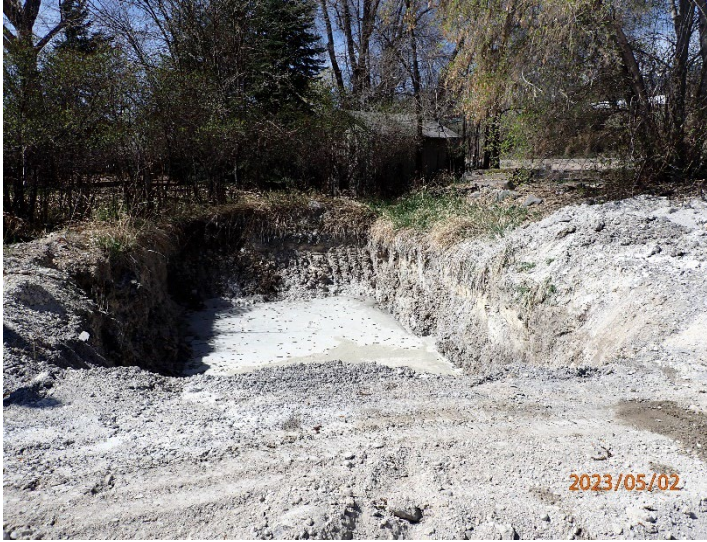
I observed the truck washout basin in the property's southwestern corner (**Photo 9**). This is where trucks dispose of water used to wash and rinse them. According to Ms. Younger, no chemicals or detergents are used during washing. She also mentioned that the washout area is used by less than 5 trucks every week. Ms. Younger stated that the highest the rinse water in the basin typically rises to is about  $\frac{1}{2}$  of its depth, and the area is cleaned out twice a year by dredging the material out and piling it beside the basin (**Photo 10**).

Photo #:09  
Description: Facing south, photo of the truck washout area.

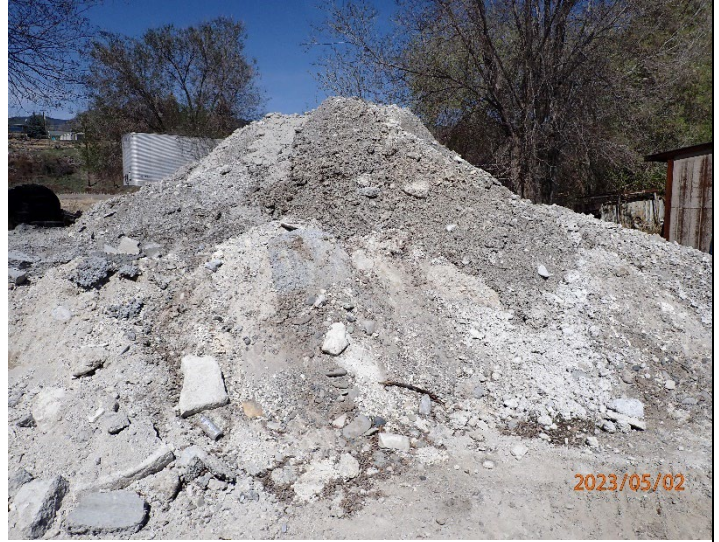
Photo #:10  
Description: Facing west, photo of pile of debris from truck washout.

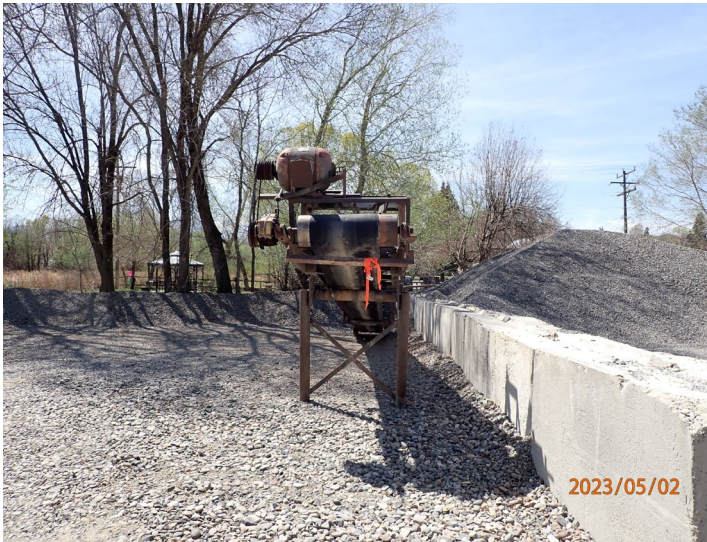
As we walked along the property's southern edge, I observed piles of aggregate material and a gravel berm adjacent to the yard's boundary (**Photo 11**). The berm continued along the entire southern perimeter. Moving towards the eastern boundary, I observed rock stockpiles waiting to be crushed (**Photo 12**). A well-maintained vegetation buffer separated the stockpiles from the nearby Norton Ditch.

Photo #:11  
Description: Facing south, photo of berm around southern perimeter.

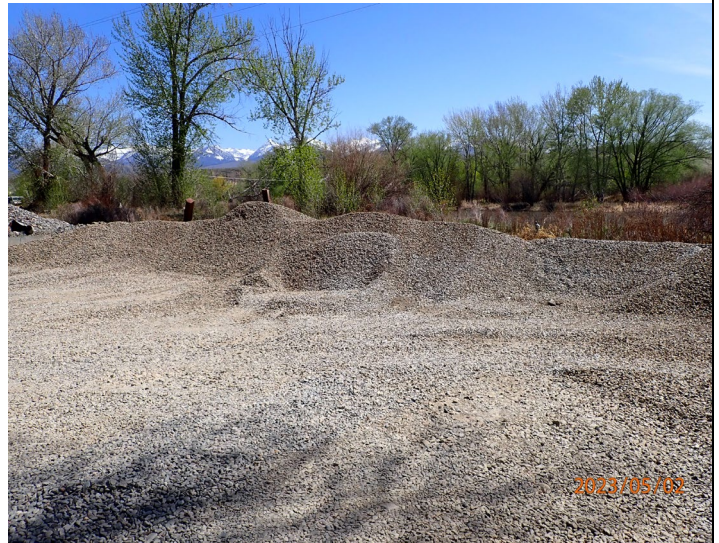
Photo #:12  
Description: Facing east, photo of stockpile material for batch plant. .

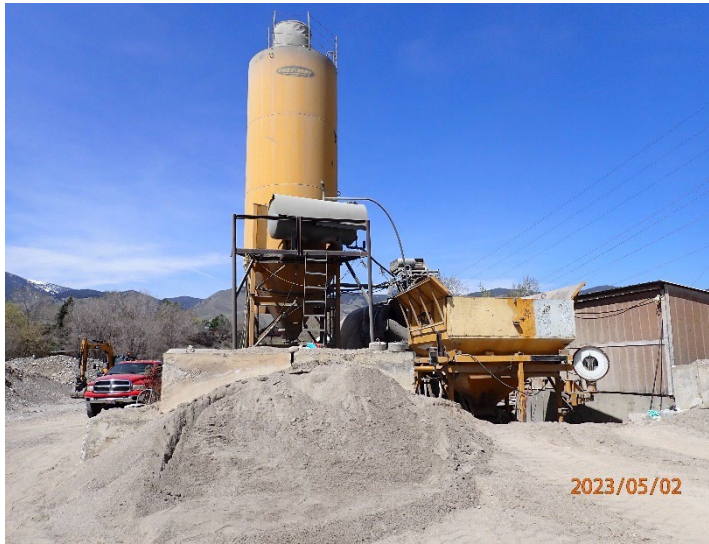
As we proceeded toward the northeastern corner of the property, I observed the material handling and mixing section. The concrete batch plant and a wash water holding basin were situated in this area (**Photo 13**). The batch plant is where the raw materials are mixed with water to produce the ready mix, which is spun in the truck and transported to construction sites off-site. After washing the aggregate, including rock and gravel, the resulting wash water is released into the holding basin (**Photo 14**). According to Ms. Younger, the wash basin doesn't fill up enough to discharge water due to infiltration. She mentioned that the basin is only used around three times a month. While inspecting the holding basin, I observed an eroded area within the northern end of the holding basin, in the direction of the Norton Ditch.

Photo #:13  
Description: Facing north, photo of the batch plant.

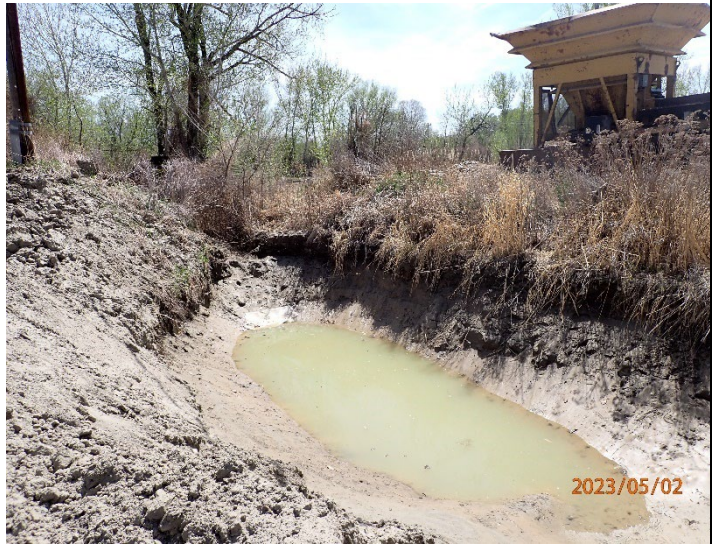
was full of water. At the northern end of the property, I observed that the shed storing the oil did not have any secondary containment measures in place. At the northeastern corner of the property, I observed an area where the perimeter berm appeared to be experiencing erosion, and the topography was sloped in a way that could cause stormwater runoff to leave the property. I also noticed an erosion feature in the wall of the wash water holding basin which could result in process water being released into the Norton Ditch.

Photo #:14  
Description: Facing east, photo of the truck wash water holding basin.

Post-inspection, the Facility shared photos documenting their purchase of a new spill kit and the implementation of berming measures around the wash water holding basin and the northeastern corner of the property. See **Attachment D**.

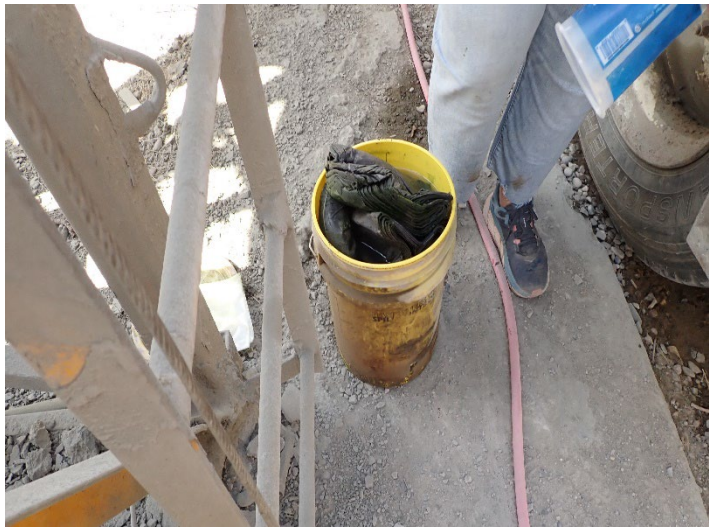
As we walked north of the mixing and material handling area, I observed a covered storage structure for salt and oil. However, I did not observe any secondary containment measures in place for this storage area. Additionally, I observed a spill kit full of water that needed replacing (**Photo 15**).

Photo #:15  
Description: Facing down, photo of spill kit filled with water.

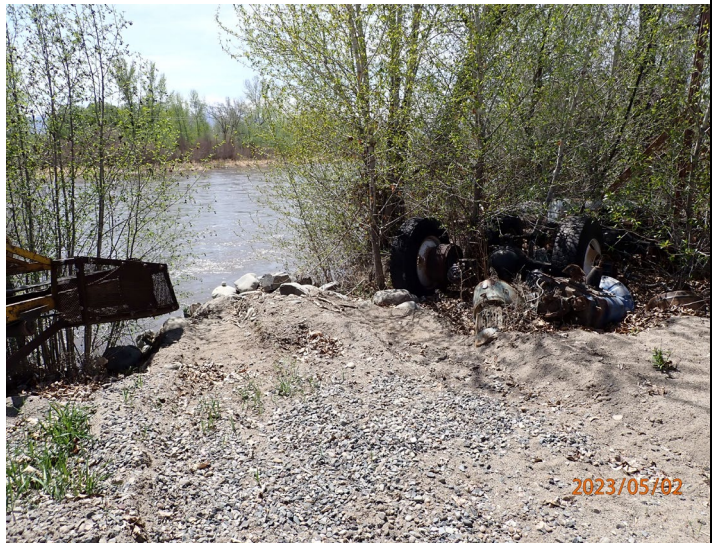
As we ventured towards the far northeastern section of the property, we crossed a bridge over the Norton Ditch and arrived at a small corner of the property where older equipment and sand were stored. The Salmon River bordered this area on the east side. In this area, I observed an eroded area that could potentially allow stormwater to flow into the Salmon River (**Photo 16**).

The concern is that at the time of the inspection, potential sources of pollutants were exposed to stormwater, and the control measures, such as berming, were not being adequately maintained.

Photo #:16  
Description: Facing east, photo of area of potential erosion on the northeastern corner of the property.
