## **RCRA Inspection Report**

Precision Flooring Products, Inc.  
1735 West First North Street  
Morristown, Tennessee 37815  
Hamblen County

EPA ID: TNR000034496  
NAICS: 321918 - Other Millwork (including flooring)

May 20, 2024, at 9:00 a.m. EDT

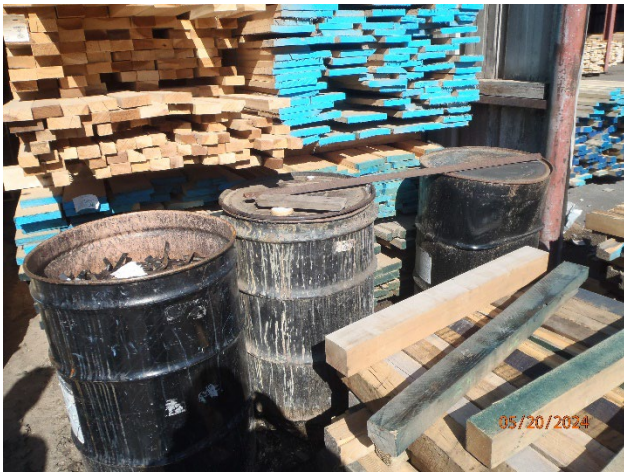
Picture 1 – Rough Mill/Storage metal binds to recycle

The facility tour began in Millworks (carpentry) where the incoming lumber is stored outside, in open-sided sheds. The lumber is already dried and machine ready to cut to size. The inspectors observed three 55-gallon containers of metal binds to be recycled (Picture 1). Mr. Wallace

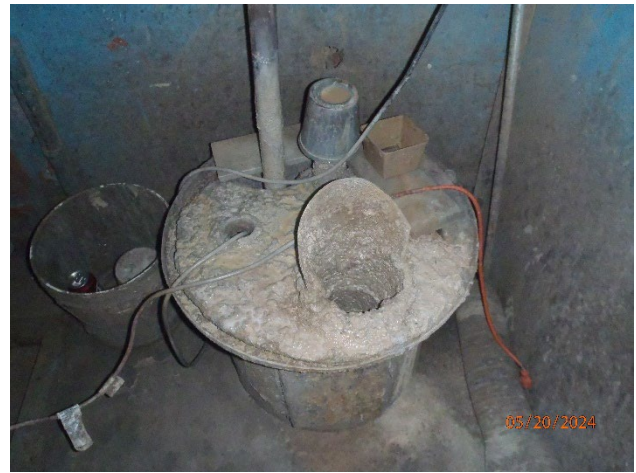
Picture 4 – Sanding Staining WW sump and used cloths

At the entrance of the grid staining area is the stain room with water-based stains. Cloths are used to apply stains into the hardwood. The facility launders the used cloths in a washing machine on site. The washing machine water is discharged to the sewer via a floor sump because the original building did not have sewer piping connected in this area (Pictures 3-4). No hazardous waste was observed in this room.

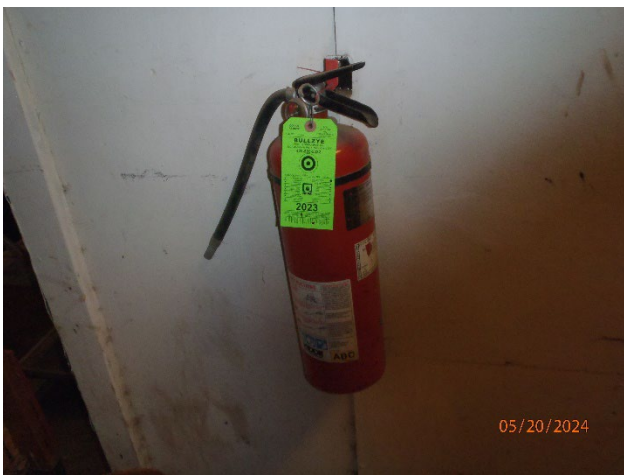
Picture 2 – Expired fire extinguisher annual certification tag

Inside the building is the Rough Mill where the lumber is cut to size. The inspectors observed throughout the facility that several fire extinguishers had expired annual certification tags dated 2022 (pink) and (green) 2023 (Picture 2). No hazardous waste was observed in this area.

**Pursuant to Tenn. Comp. R. & Regs. 0400-12-01-.03(1)(g)2.(viii)(III) [40 C.F.R. 262.16(b)(8)(iii)], which incorporates, and is a condition of the SQG Permit Exemption, All communications or alarm systems, fire protection equipment, spill control equipment, and decontamination equipment, where required, must be tested, and maintained as necessary to assure its proper operation in time of emergency.**

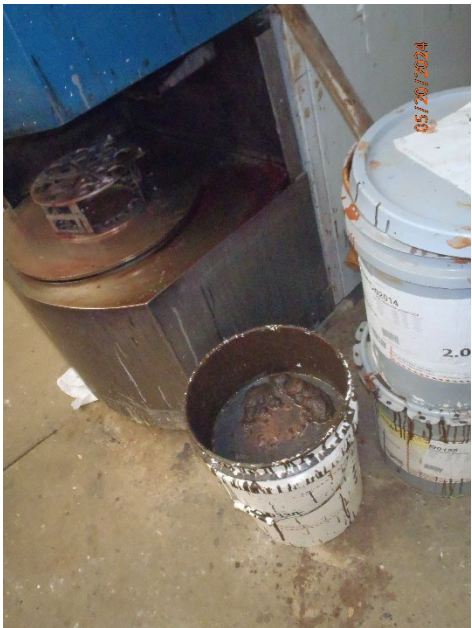
Picture 14 – Mixing Room water-based paint waste

The mixing room is where the sample colors are mixed per customer request. All the stains are water-based tints, and if a color is not correct, then the stain is adjusted to obtain the requested color. Discarded stain is non-hazardous and collected in a 5-gallon container (Picture 14). No hazardous waste was generated in this area.

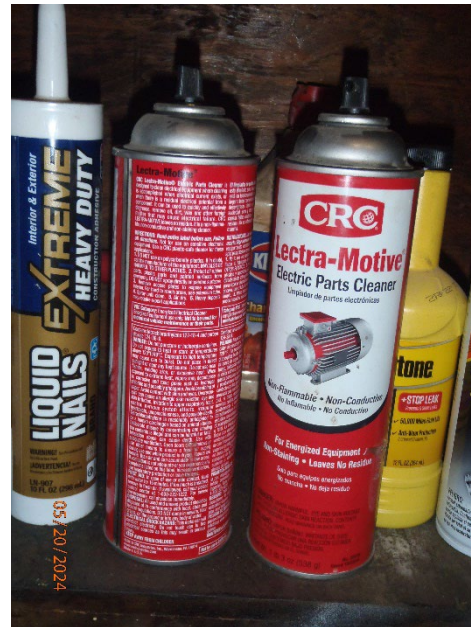
Picture 15 – Maintenance aerosol cans

The inspectors observed aerosol cans stored in a metal cabinet (Picture 15). A can of Lectra-Motive electric parts cleaner contained the volatile organic compound Tetrachloroethylene (PCE). The aerosol cans were still in use and in good condition. The inspectors stated that when any of the aerosol cans in the cabinet become spent and are ready to be discarded the facility is required to collect and store the spent cans as universal waste under 40 C.F.R. 273 or as hazardous waste under 40 C.F.R. 262.16. At the time of the inspection, the inspectors did not observe any spent aerosol can in the trash. No hazardous waste was observed in the area.

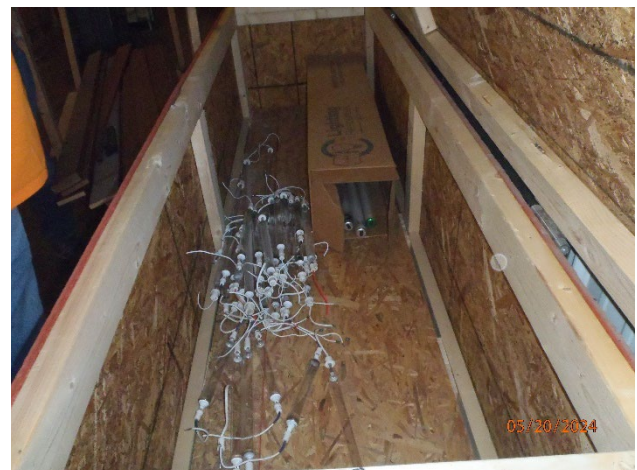
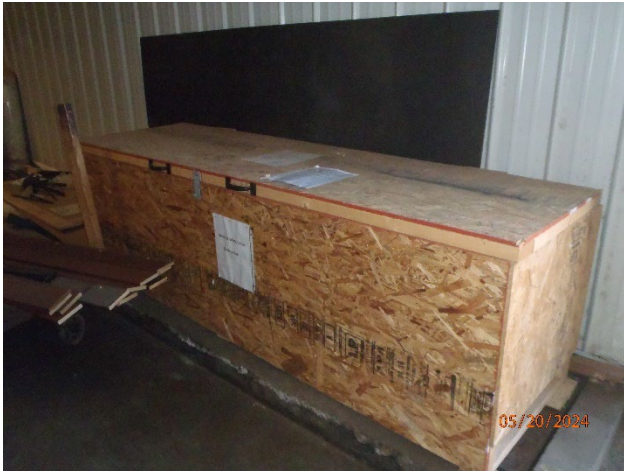
Outside the Maintenance Shop was a large warehouse used as equipment storage. A large wooden box marked as 'Universal Waste Lamps for Recycling' was stored along the rear wall (Pictures 16-18). Inside the box was spent lamps. The box was closed, labeled, and dated February 22, 2024.

Picture 16 – Equipment Storage Universal Waste Lamps

Picture 17 – Equipment Storage Universal Waste Lamps

Picture 18 – Equipment Storage Universal Waste Lamps

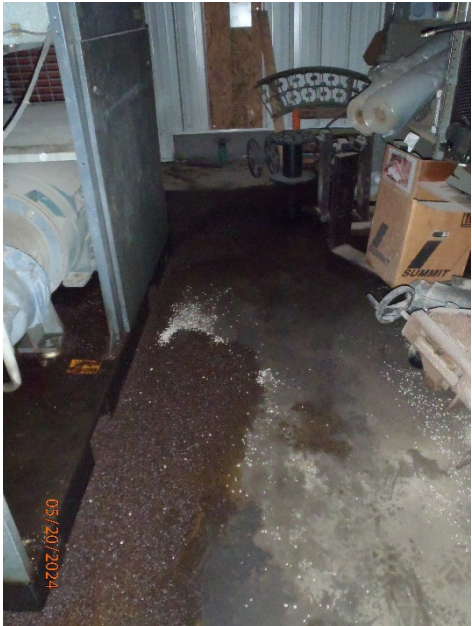
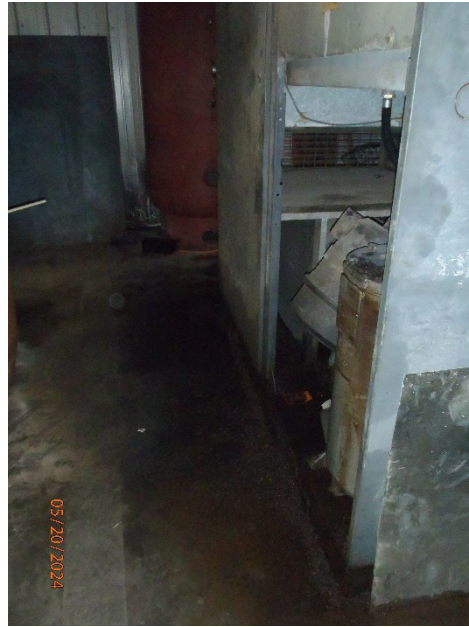
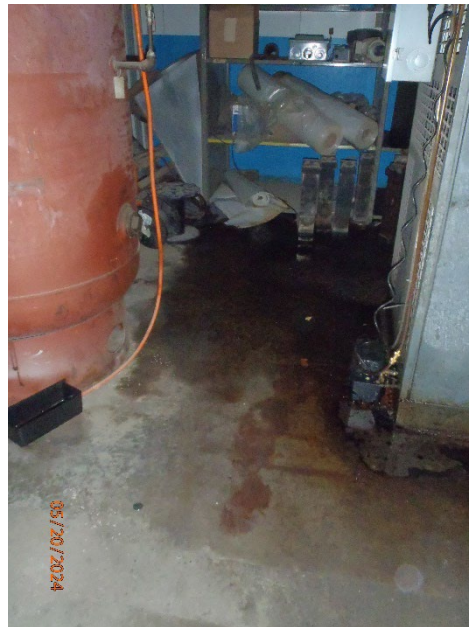
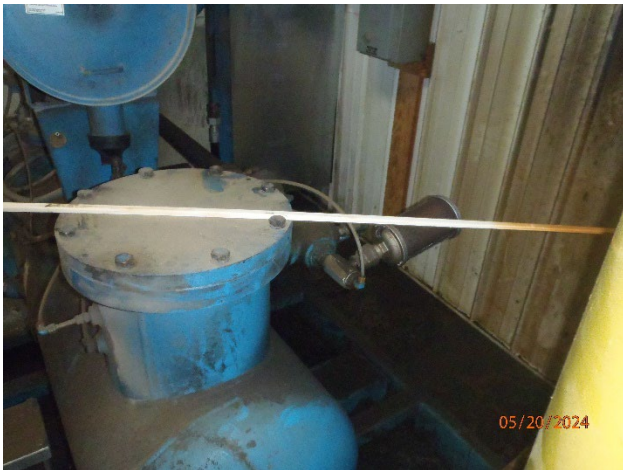
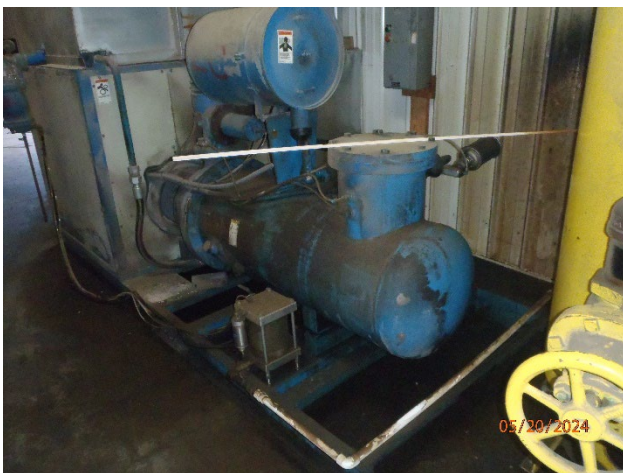
Next to the equipment storage warehouse was a room with two air compressors. Mr. Wallace explained that a contractor changes the oil from the compressors. The inspectors observed that both air compressors were releasing used oil on the ground around the units (Pictures 19-23). Absorbent oil dri was randomly placed around the units, but the used oil had not been cleaned up immediately.

Picture 20 – Air Compressor Room used oil release

Picture 19 – Air Compressor Room used oil release

Picture 21 – Air Compressor Room used oil release

Picture 22 – Air Compressor Room used oil release

Picture 23 – Air Compressor Room used oil release

**Pursuant to Tenn. Comp. R. & Regs. 0400-12-01-.11(3)(c)4. [40 C.F.R. § 279.22(d)], upon detection of a release of used oil to the environment, the facility must clean up and manage properly the released used oil and other materials.**

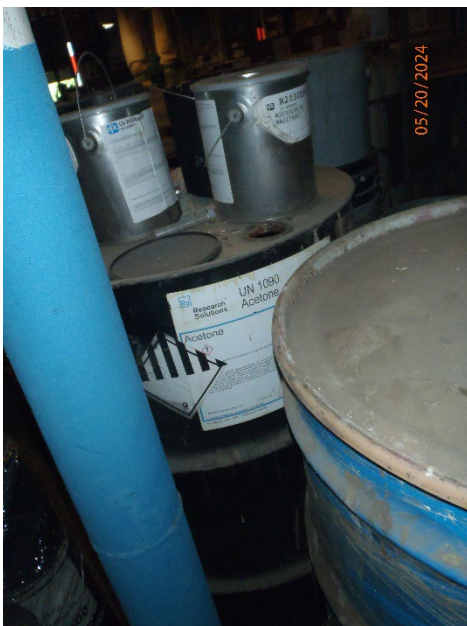
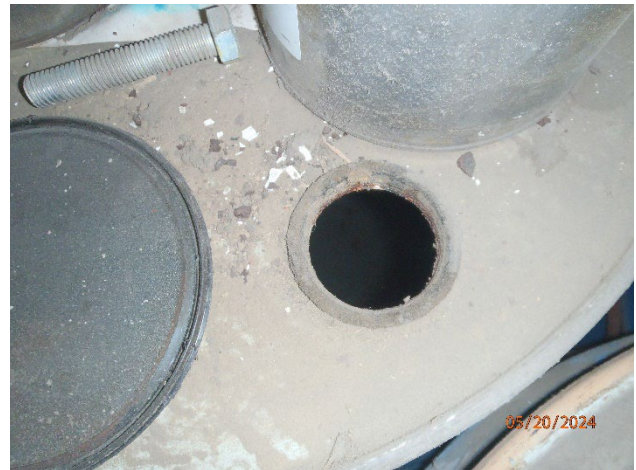
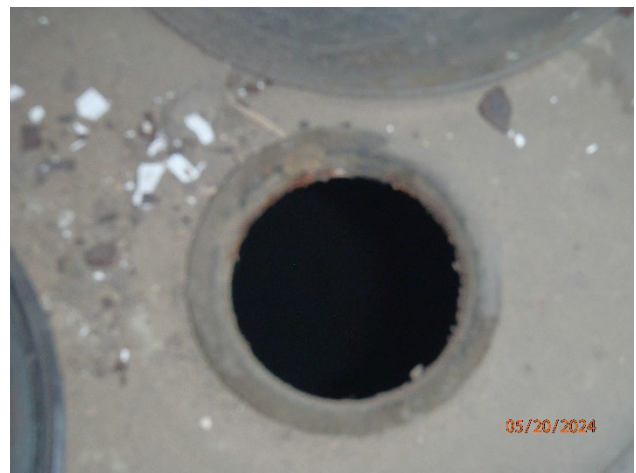
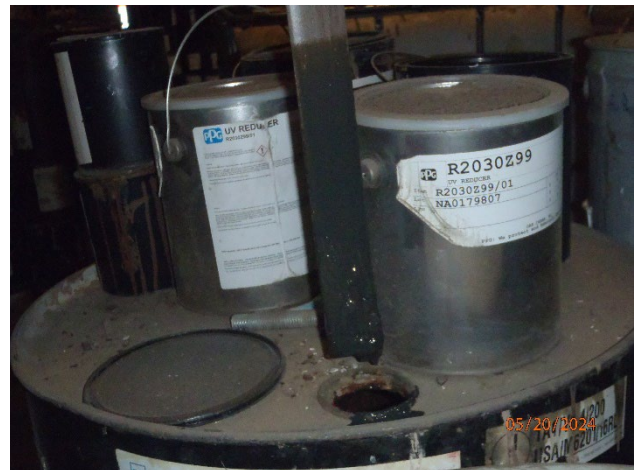
- One 55-gallon container with a bung opening that was not closed, had contained a sludge consistency of an unknown substance (Pictures 24-27)

Picture 25 – Drum Consolidation open container

Picture 26 – Drum Consolidation open container

Picture 24 – Drum Consolidation open container

Picture 27 – Drum Consolidation open container

**Pursuant to Tenn. Comp. R. & Regs. 0400-12-01-.03(1)(b) [40 C.F.R. § 262.11], a person who generates a solid waste, as defined in Tenn. Comp. R. & Regs. 0400-12-01-.02(1)(b) (2021) [40 C.F.R. § 261.2], must make an accurate determination as to whether that waste is a hazardous waste in order to ensure wastes are properly managed according to applicable RCRA regulations articulated in Tenn. Comp. R. & Regs. 0400-12-01-.03(1)(b) [40 C.F.R. § 262.11].**

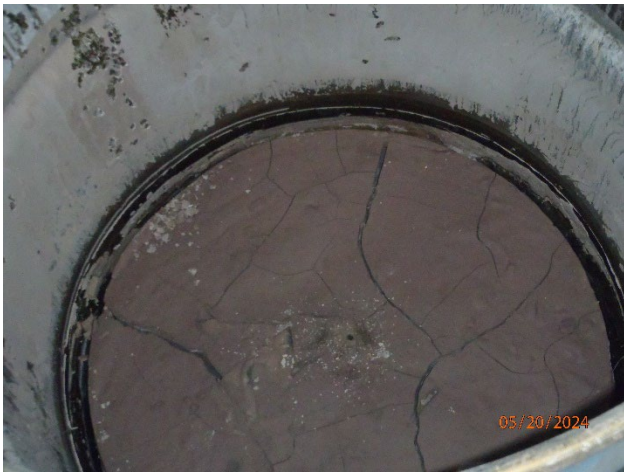
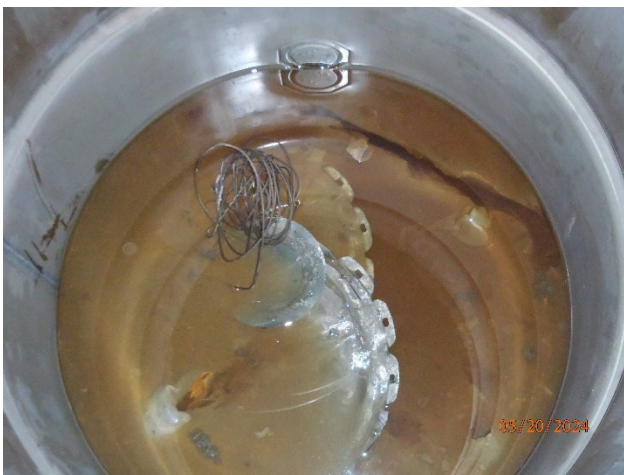
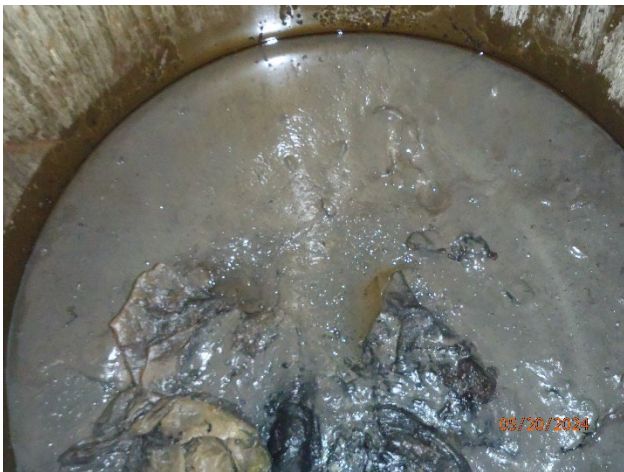
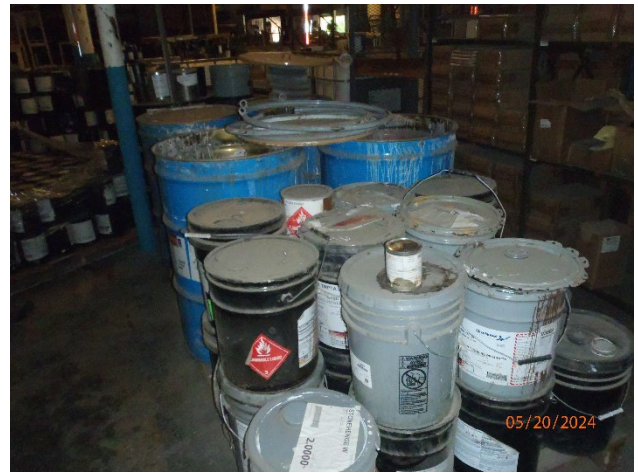
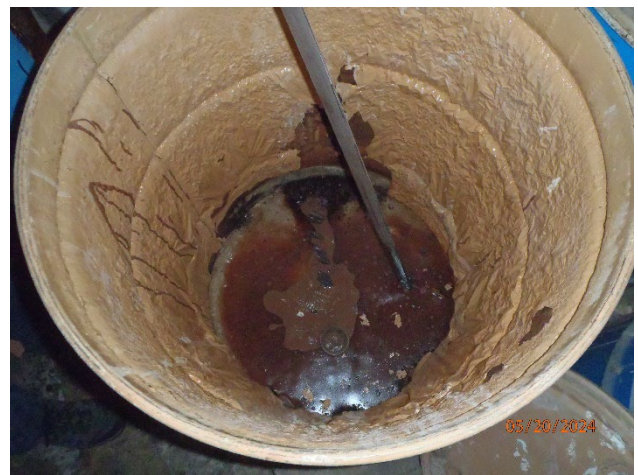
Picture 28 – Drum Consolidation dried water based paint

Picture 31 – Drum Consolidation spent water based paint

Picture 29 – Drum Consolidation spent water based paint

Picture 32 – Drum Consolidation spent paint waste - HW

Picture 30 – Drum Consolidation spent water based paint

**Pursuant to Tenn. Comp. R. & Regs. 0400-12-01-.03(1)(b) [40 C.F.R. § 262.11], a person who generates a solid waste, as defined in Tenn. Comp. R. & Regs. 0400-12-01-.02(1)(b) (2021) [40 C.F.R. § 261.2], must make an accurate determination as to whether that waste is a hazardous waste in order to ensure wastes are properly managed according to applicable RCRA regulations articulated in Tenn. Comp. R. & Regs. 0400-12-01-.03(1)(b) [40 C.F.R. § 262.11].**

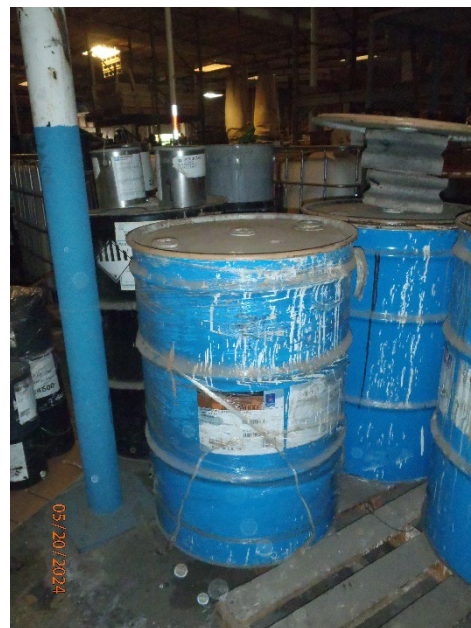
Picture 33 – Drum Consolidation

- Multiple 55-gallon containers of spent paint waste (Picture 33)
- The cardboard compressor was leaking oil on the ground (Picture 35)

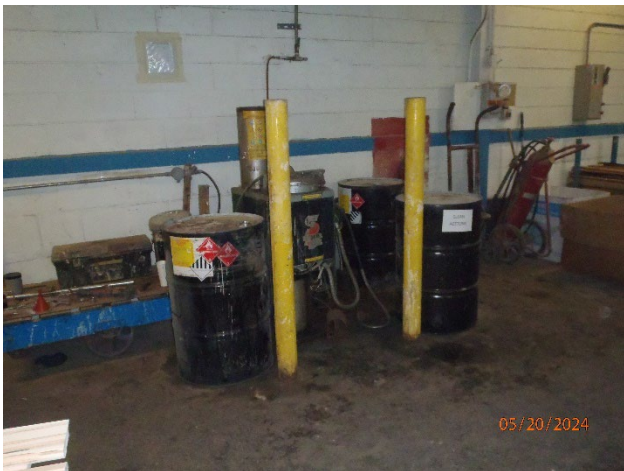
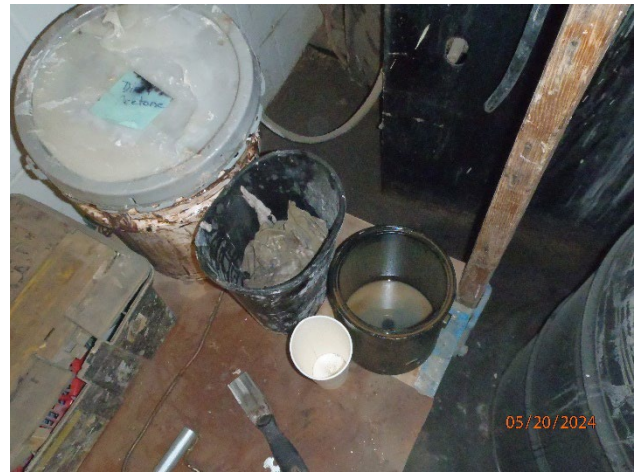
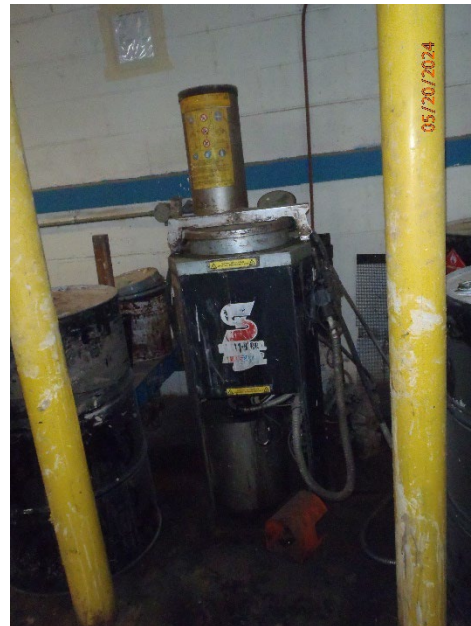
The distillation and recycling center is located inside the Stain Room. The inspectors observed a SAA with a 55-gallon CAA container of waste solvent and stain from Grid Staining dated April 1, 2024, a 55-gallon container of acetone product to be used, a 55-gallon SAA container of waste still bottoms that was almost full, and a Safety-Kleen distillation unit (Pictures 36-38). Mr.

Canuta explained that the distillation unit only processes 5-gallons at a time, and the process takes a week to distill the 5 gallons. Thus, the 55-gallon container of waste solvent and stain is a CAA container waiting to be distilled. The waste containers were closed, labeled with the words 'hazardous waste' and hazard indicators, and dated.

Picture 37 – Distill/Recycle Area

Picture 38 – Distill/Recycle Area

Picture 36 – Distill/Recycle Area

**Pursuant to Tenn. Comp. R. & Regs. 0400-12-01-.03(1)(g)2.(ix)(II) [40 C.F.R. 262.16(b)(9)(ii)], which incorporates, and is a condition of the SQG Permit Exemption, the small quantity generator must post the following information next to telephones or in areas directly involved in the generation and accumulation of hazardous waste: (A) The name and emergency telephone number of the emergency coordinator; (B) Location of fire extinguishers and spill control material, and, if present, fire alarm; and (C) The telephone number of the fire department, unless the facility has a direct alarm.**

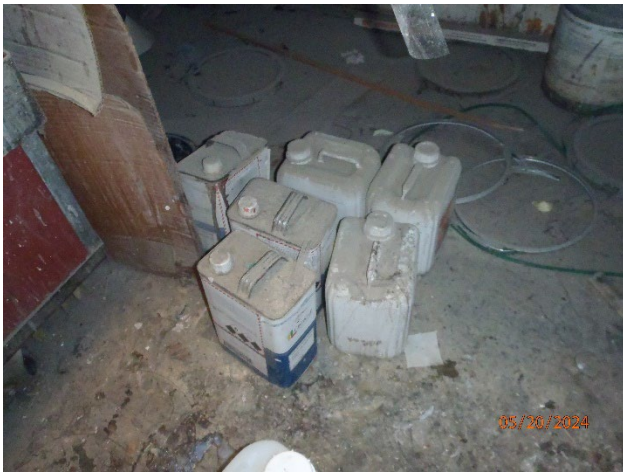
Picture 46 – Spray Booth expired chemicals

The inspectors observed six one-gallon containers of expired solvent (Picture 46). The containers were stored underneath a table beside the spray booth and were covered in dust. Mr. Wallace was not aware that the cans were onsite. Behind the spray booth was a 55-gallon

**Pursuant to Tenn. Comp. R. & Regs. 0400-12-01-.03(1)(b) [40 C.F.R. § 262.11], a person who generates a solid waste, as defined in Tenn. Comp. R. & Regs. 0400-12-01-.02(1)(b) (2021) [40 C.F.R. § 261.2], must make an accurate determination as to whether that waste is a hazardous waste in order to ensure wastes are properly managed according to applicable RCRA regulations articulated in Tenn. Comp. R. & Regs. 0400-12-01-.03(1)(b) [40 C.F.R. § 262.11].**

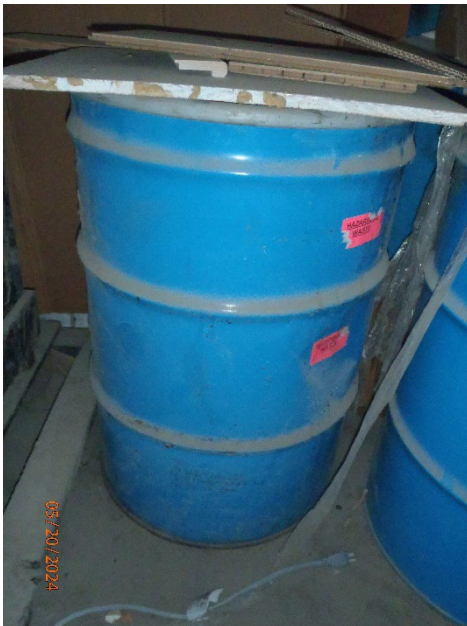
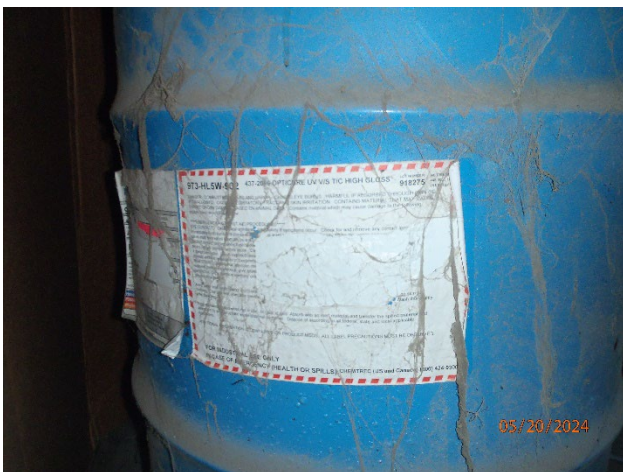
container of unknown content with a hazardous waste label (Pictures 47-49). The container was turned around and Mr. Wallace identified the container as ultraviolet stain that was no longer in use.

Picture 49 – Spray Booth HW container label

Picture 47 – Spray Booth HW container and label

Picture 48 – Spray Booth HW container label

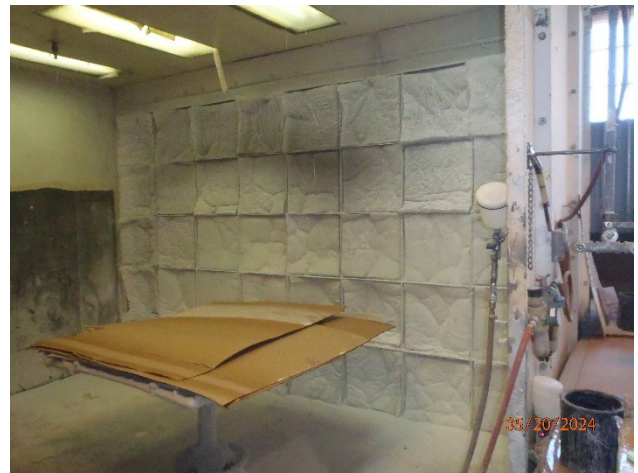
Picture 50 – Spray Booth paint filters

The spray booth is a three-sided area where non-hazardous, water-based urethane is applied to wood strips (Picture 50). The spray booth technician explained that the discarded filters are given to Tim Garrett, EHS, and placed in a box outside. The inspectors asked where the box is kept but Mr. Wallace and Mr. Canuta were not aware of the location. The inspectors stated prior to disposal that the discarded filter needed a hazardous waste determination, and an application for a special disposal permit for the discarded filters.

**Pursuant to Tenn. Comp. R. & Regs. 0400-12-01-.03(1)(b) [40 C.F.R. § 262.11], a person who generates a solid waste, as defined in Tenn. Comp. R. & Regs. 0400-12-01-.02(1)(b) (2021) [40 C.F.R. § 261.2], must make an accurate determination as to whether that waste is a hazardous waste in order to ensure wastes are properly managed according to applicable RCRA regulations articulated in Tenn. Comp. R. & Regs. 0400-12-01-.03(1)(b) [40 C.F.R. § 262.11].**

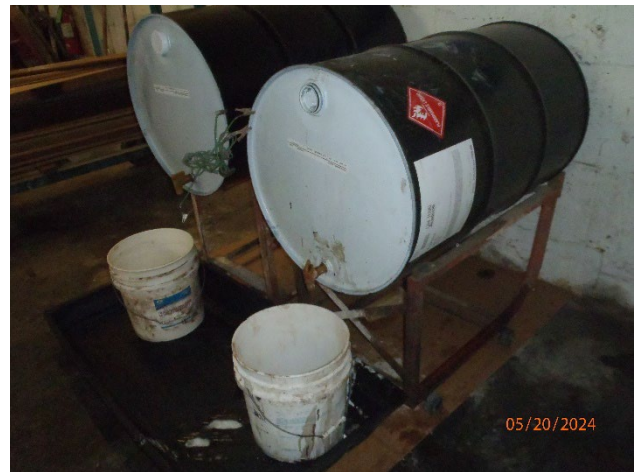
Beside the distill/recycle area where two 55-gallon product containers laid on their sides in a drum holder. The first container held new alcohol and the second container held new acetone with a runoff bucket underneath (Pictures 51-52). Mr. Canuta explained that the contents of the runoff bucket were generated when the employees poured up small containers of acetone for their workstations. The accumulated runoff was then placed into the SAA container by the distillation unit. The inspectors observed the runoff bucket was not closed when not in use, and not labeled. In addition, the emergency response contact form was not posted above this SAA. The inspectors then asked why the runoff bucket contents were not being used considering the new acetone was not contaminated.

Picture 51 – Acetone/Alcohol Fill Station

Picture 52 – Acetone/Alcohol Fill Station spill container

**Pursuant to Tenn. Comp. R. & Regs. 0400-12-01-.03(1)(f)1.(iv) [40 C.F.R. § 262.15(a)(4)], which is a condition of the SAA Permit Exemption, a generator is required to keep containers of hazardous waste closed at all times during accumulation, except when adding, removing, or consolidating waste; or when temporary venting of a container is necessary for the proper operation of equipment, or to prevent dangerous situations, such as build-up of extreme pressure.**

Pursuant to Tenn. Comp. R. & Regs. 0400-12-01-.03(1)(f)1.(v) [40 C.F.R. § 262.15(a)(5)], which is a condition of the SAA Permit Exemption, a generator is required to mark or label its containers (i) with the words “Hazardous Waste” and (ii) with an indication of the hazards of the contents.
