## Clean Water Act Section 404: Site Visit/Case Development

| Site Name | Hotel Media Luna | | | | |
| Site Address* | Tax Parcel 196-000-009-39 | | | | |

## Attachment A: Map with GPS Data

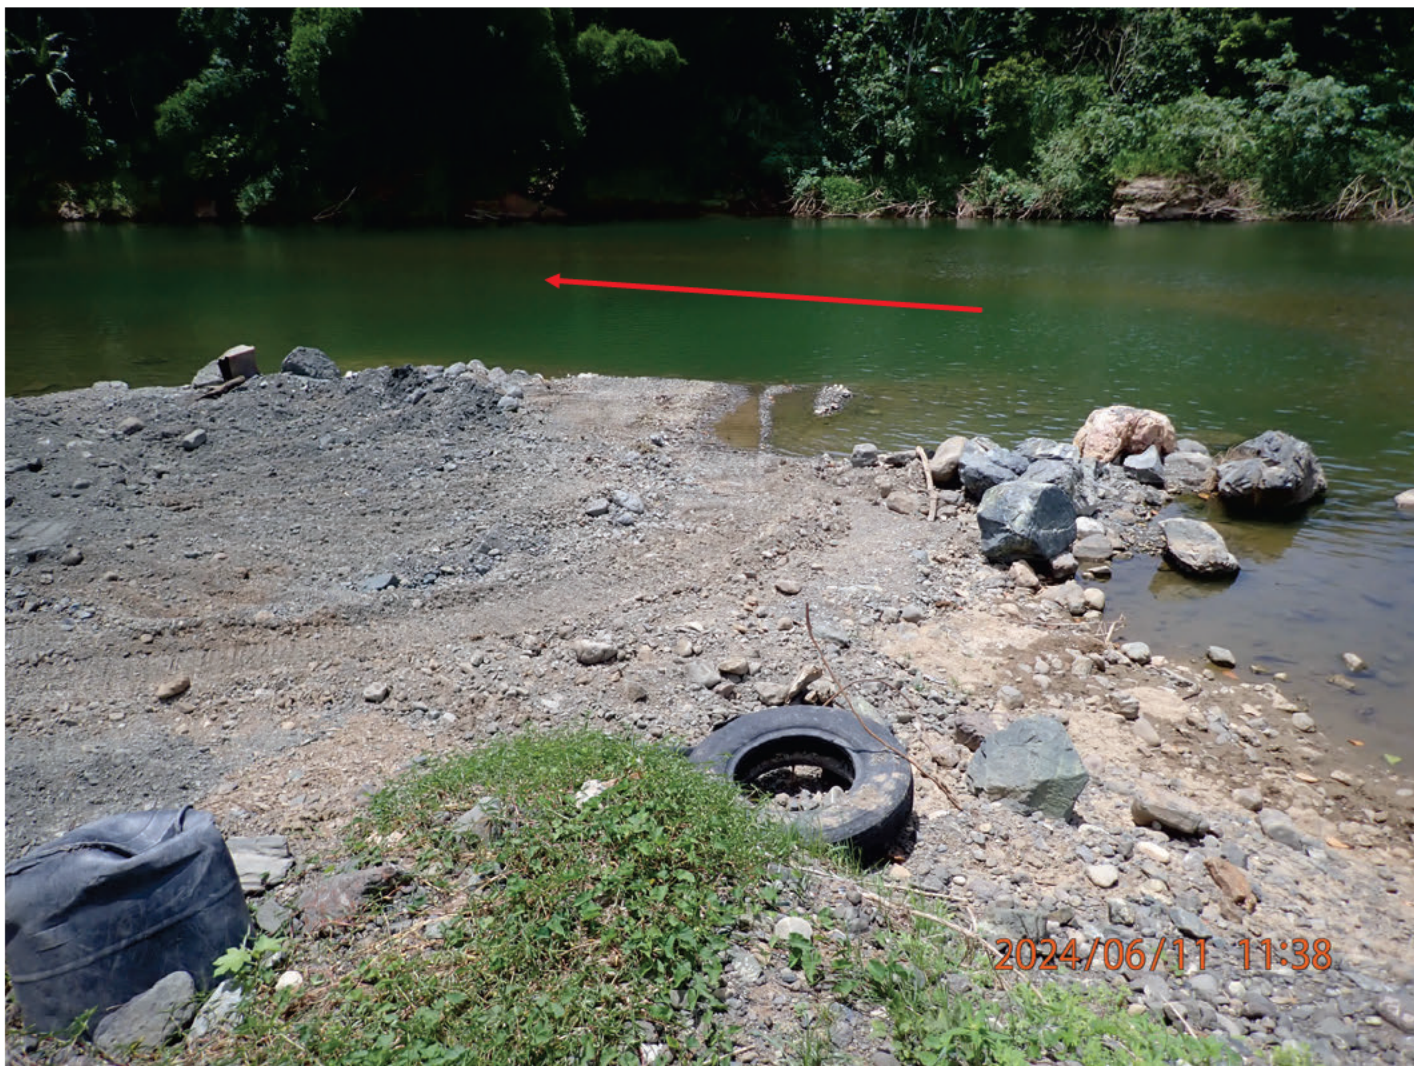
**Photo ID:** P6111005

**Description:** Within the bank, below ordinary high water of the Río de la Plata, earth moving work and fill material was observed along with trash debris.

The red arrow shows the direction of flow of the Río de la Plata.

| EPA recommended to the Municipality and Comerío Sand to consult with the Corps on the possible need for CWA permits for the work being conducted below the ordinary high water mark of the Río de la Plata. | | | |

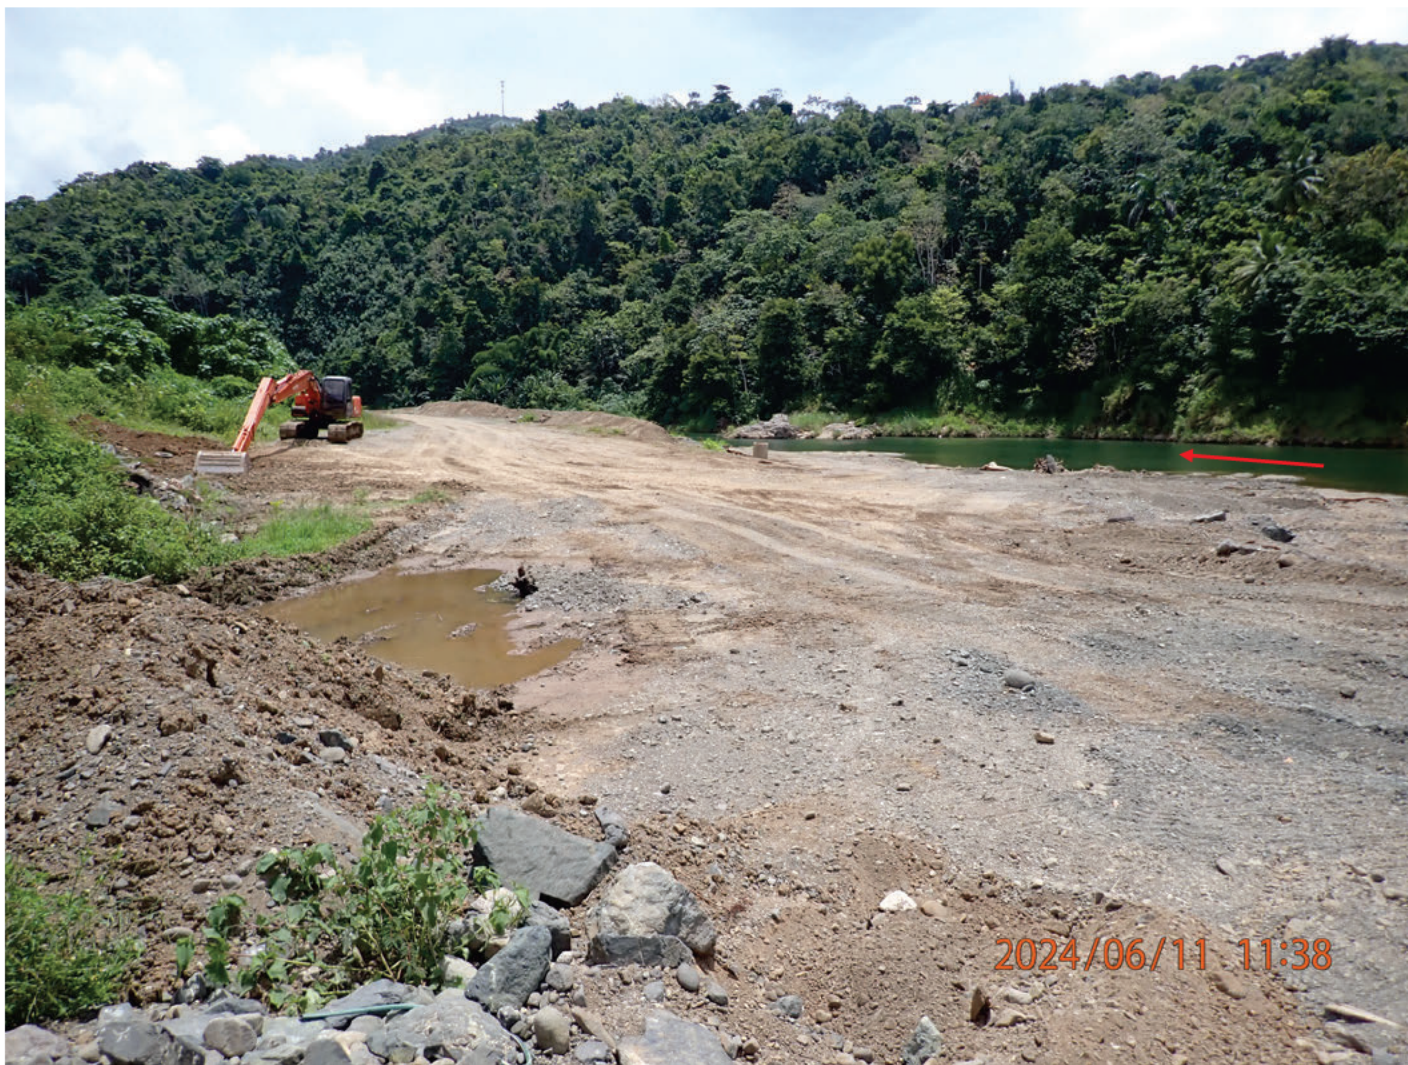
**Photo ID:** P6111007

**Description:** Earth moving work and fill material was observed. Construction machinery was observed parked within the area where earth moving work had occurred.

The red arrow shows the direction of flow of the Río de la Plata.

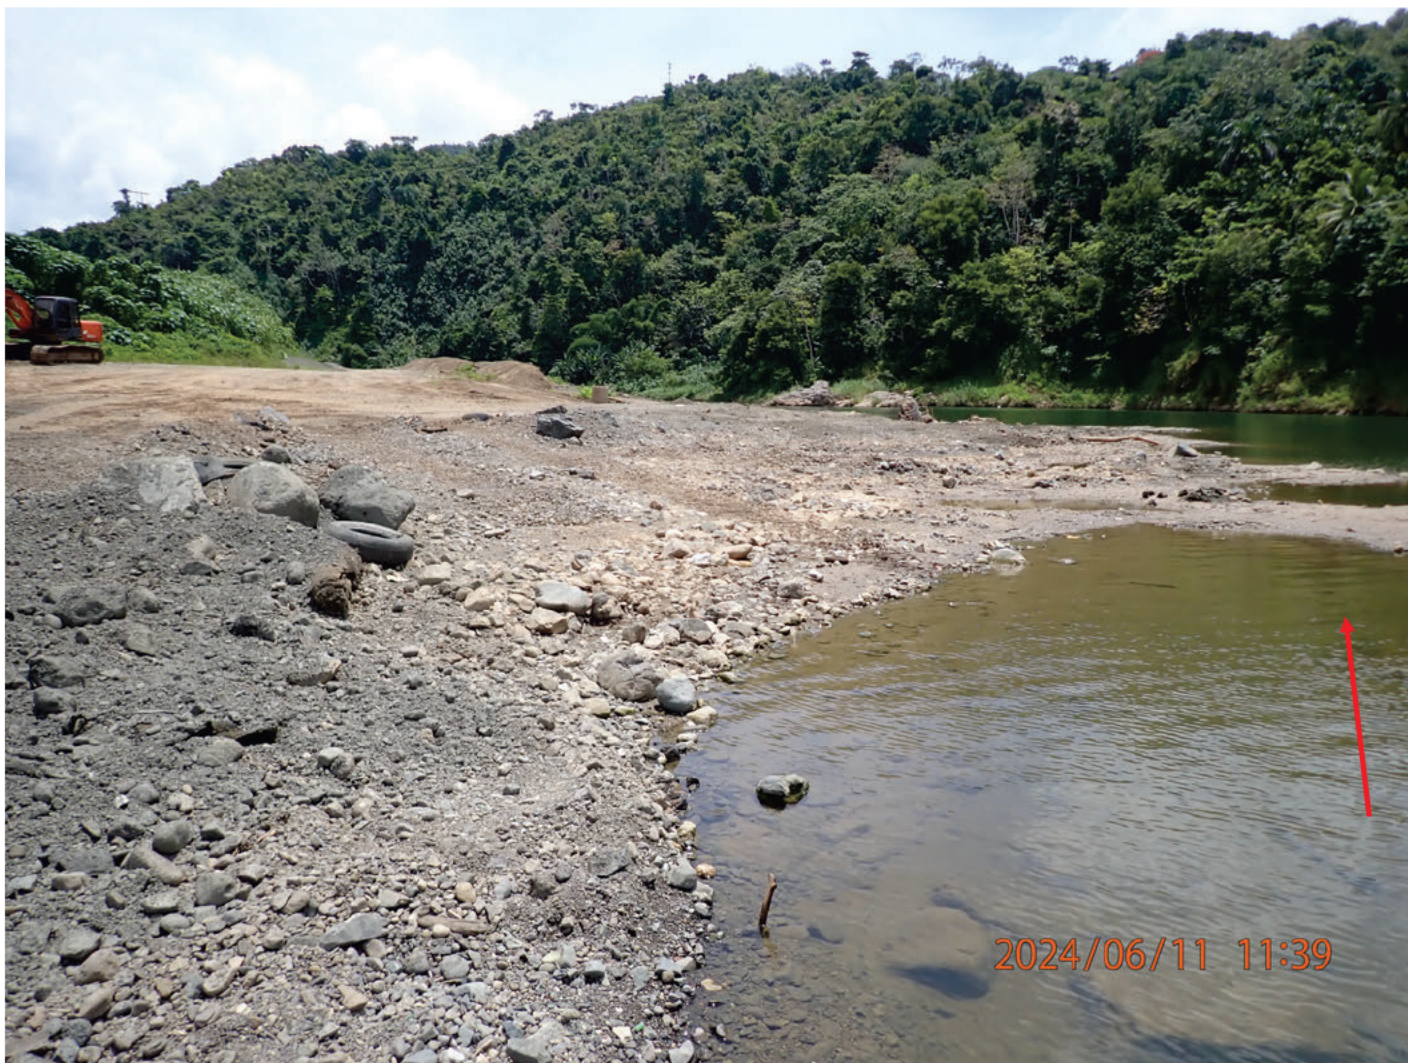
**Photo ID:** P6111010

**Description:** Within the bank of the Río de la Plata, earth moving work and fill material was observed. Construction machinery was observed parked within the area where earth moving work had occurred.

The red arrow shows the direction of flow of the Río de la Plata.

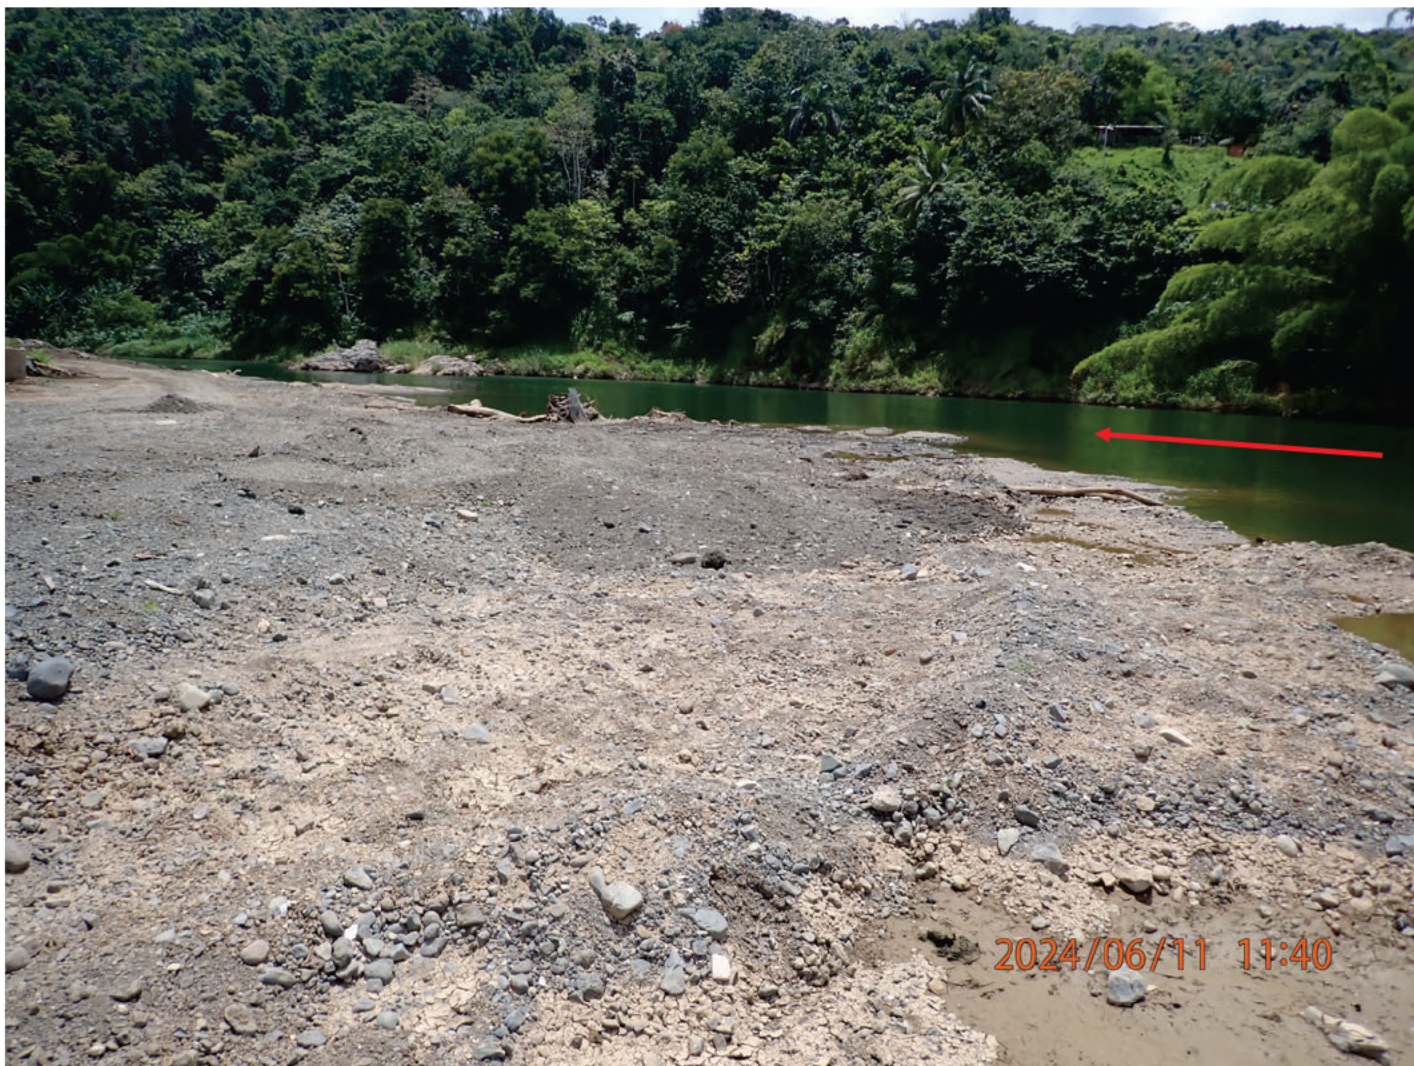
**Photo ID:** P6111012

**Description:** Within the bank of the Rio de la Plata, earth moving work and fill material was observed.

The red arrow shows the direction of flow of the Río de la Plata.

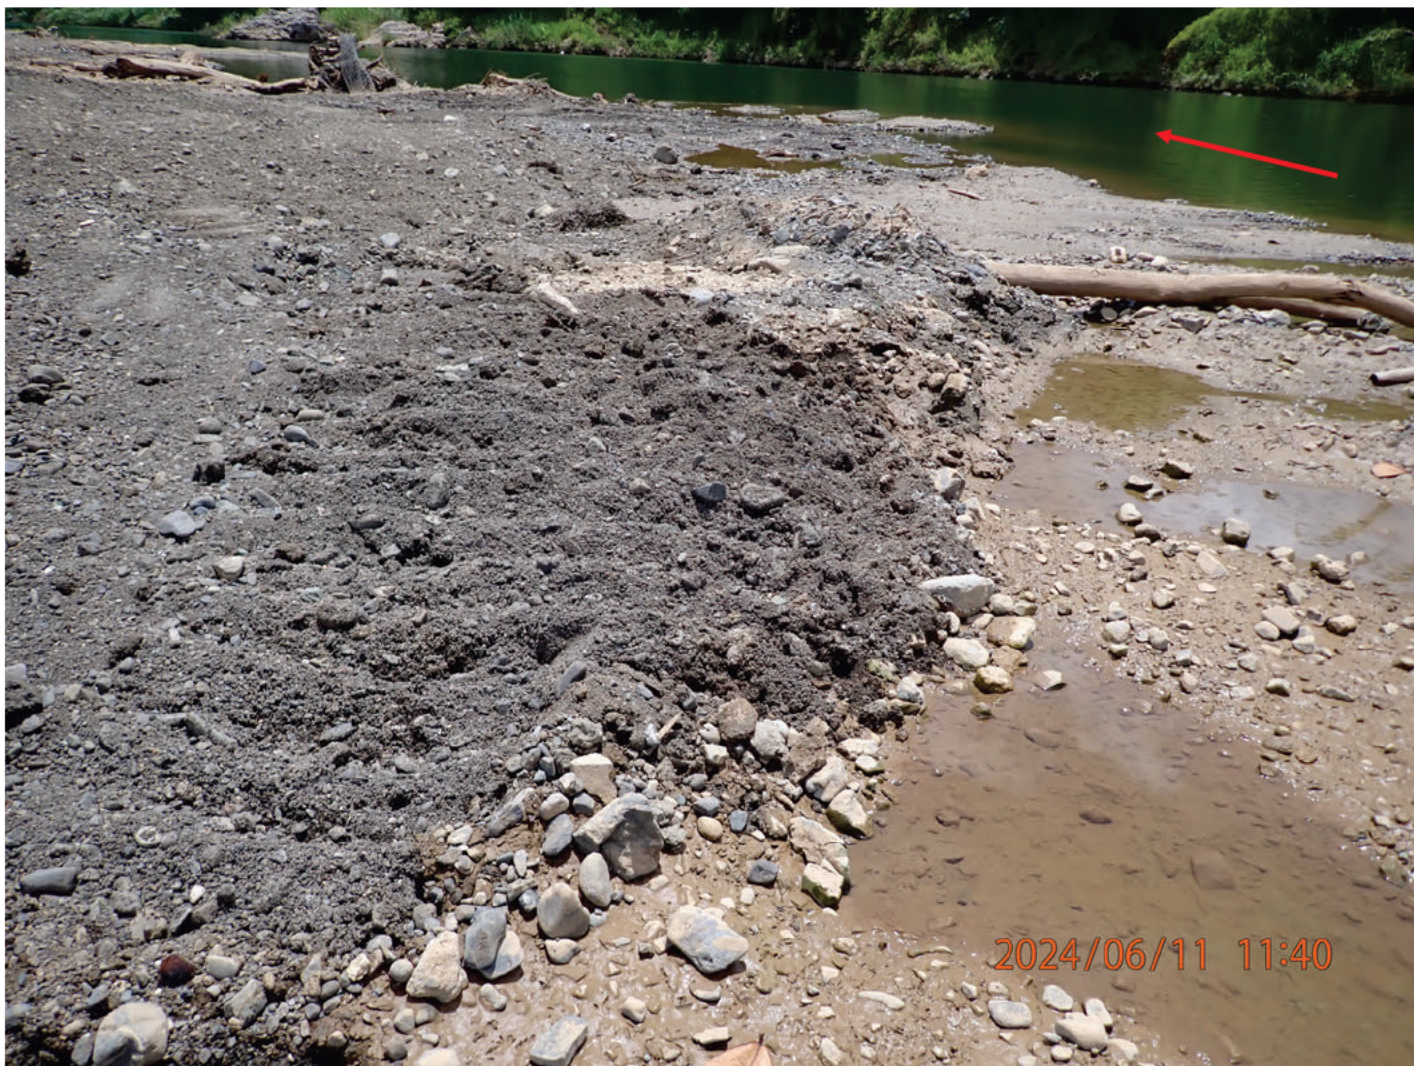
**Photo ID:** P6111013

**Description:** Within the bank of the Rio de la Plata, earth moving work and fill material was observed.

The red arrow shows the direction of flow of the Río de la Plata.

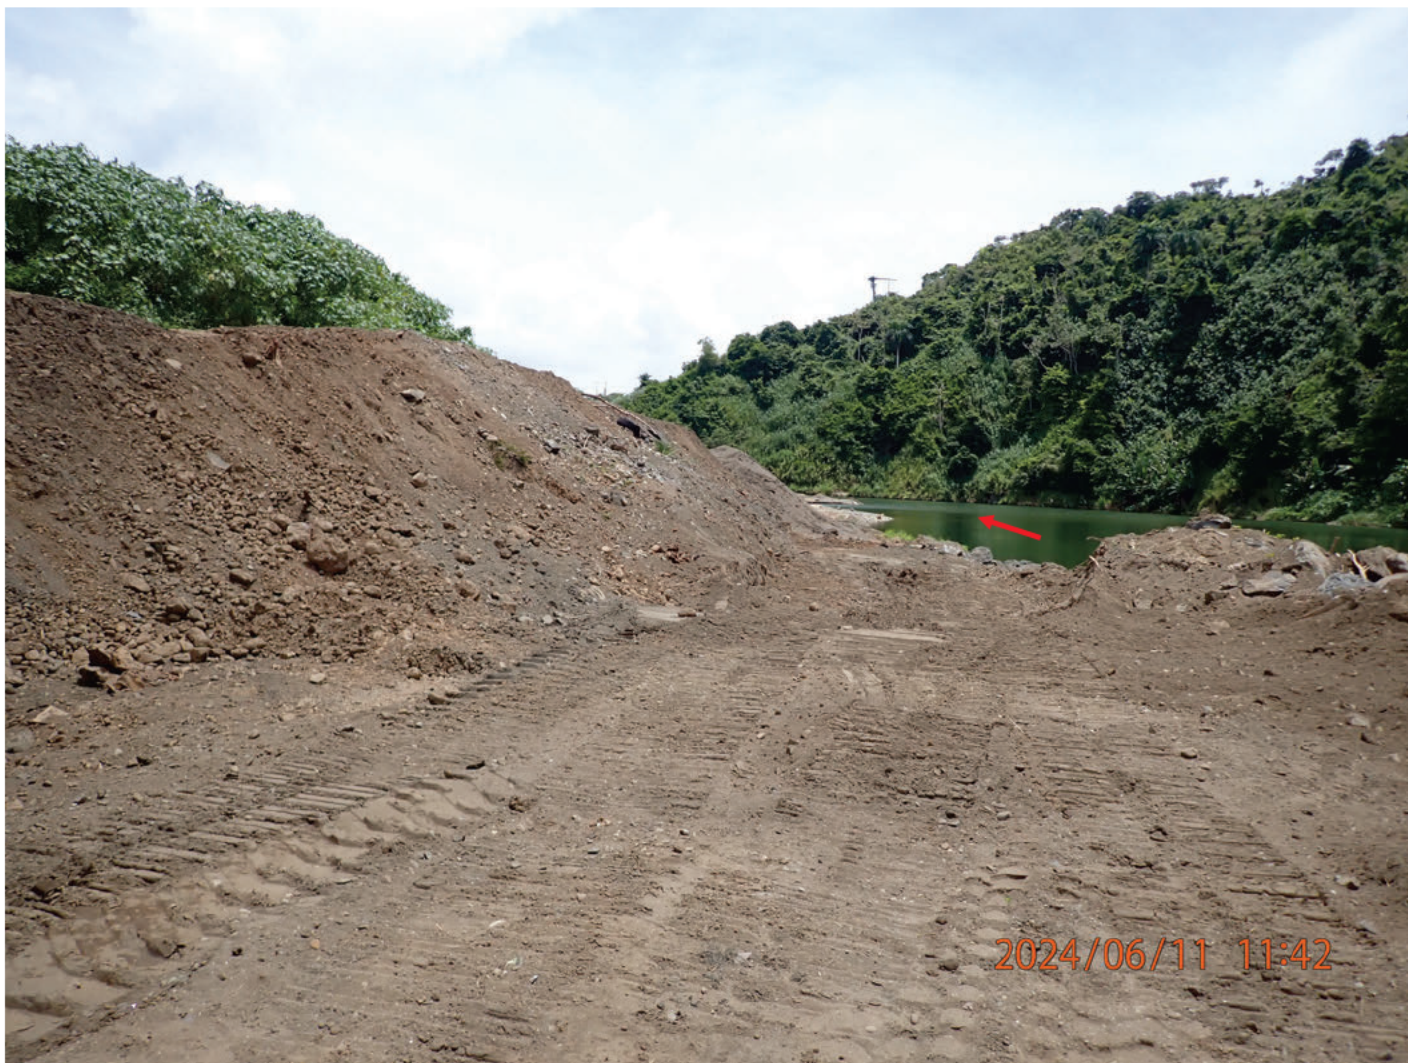
**Photo ID:** P6111016

**Description:** Within the bank of the Río de la Plata, earth moving work and fill material was observed.

The red arrow shows the direction of flow of the Río de la Plata.

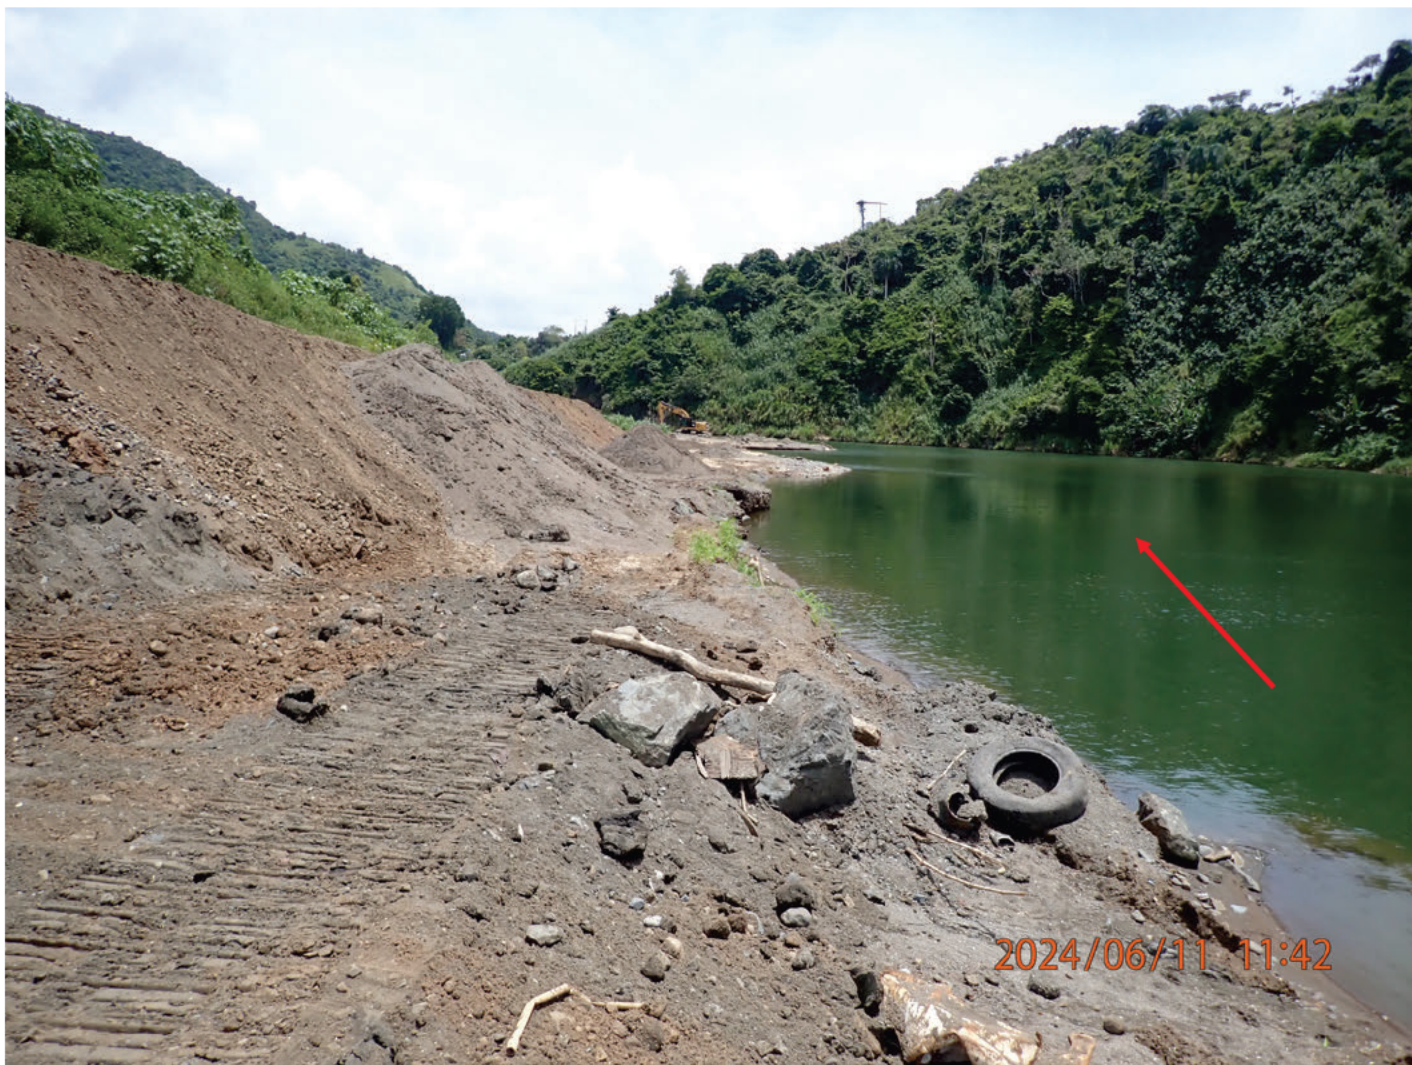
**Photo ID:** P6111017

**Description:** Within the bank of the Río de la Plata, earth moving work and fill material was observed along with trash debris. Construction machinery was observed parked within the area where earth moving work had occurred.

The red arrow shows the direction of flow of the Río de la Plata.

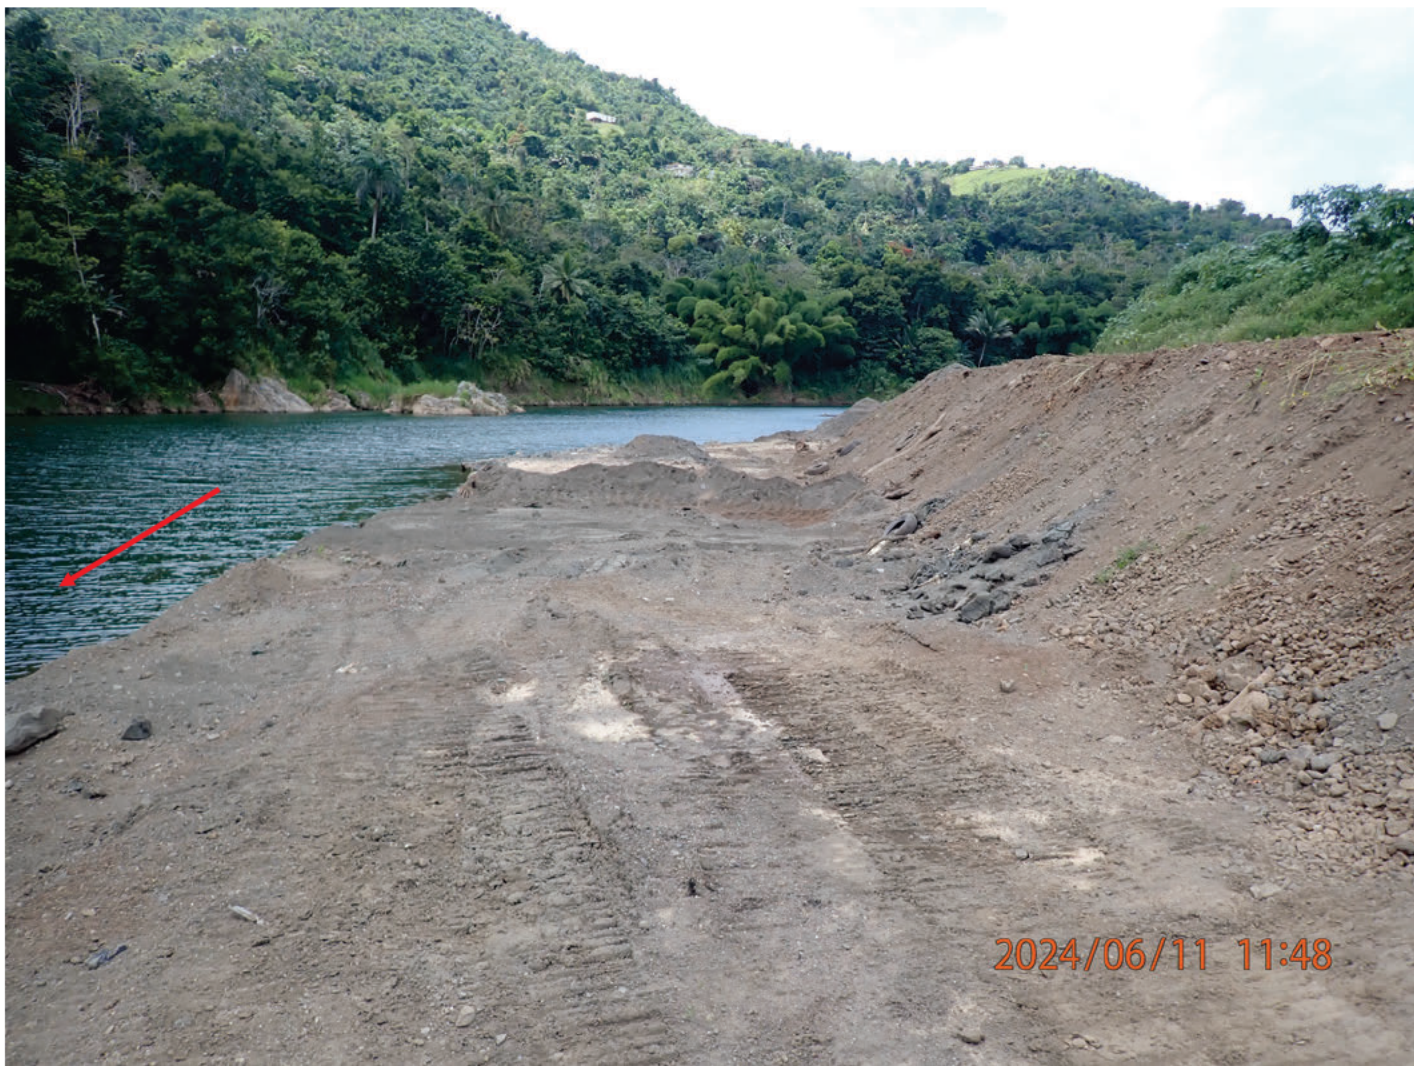
**Photo ID:** P61110018

**Description:** Within the bank of the Rio de la Plata, earth moving work and fill material was observed.

The red arrow shows the direction of flow of the Río de la Plata.

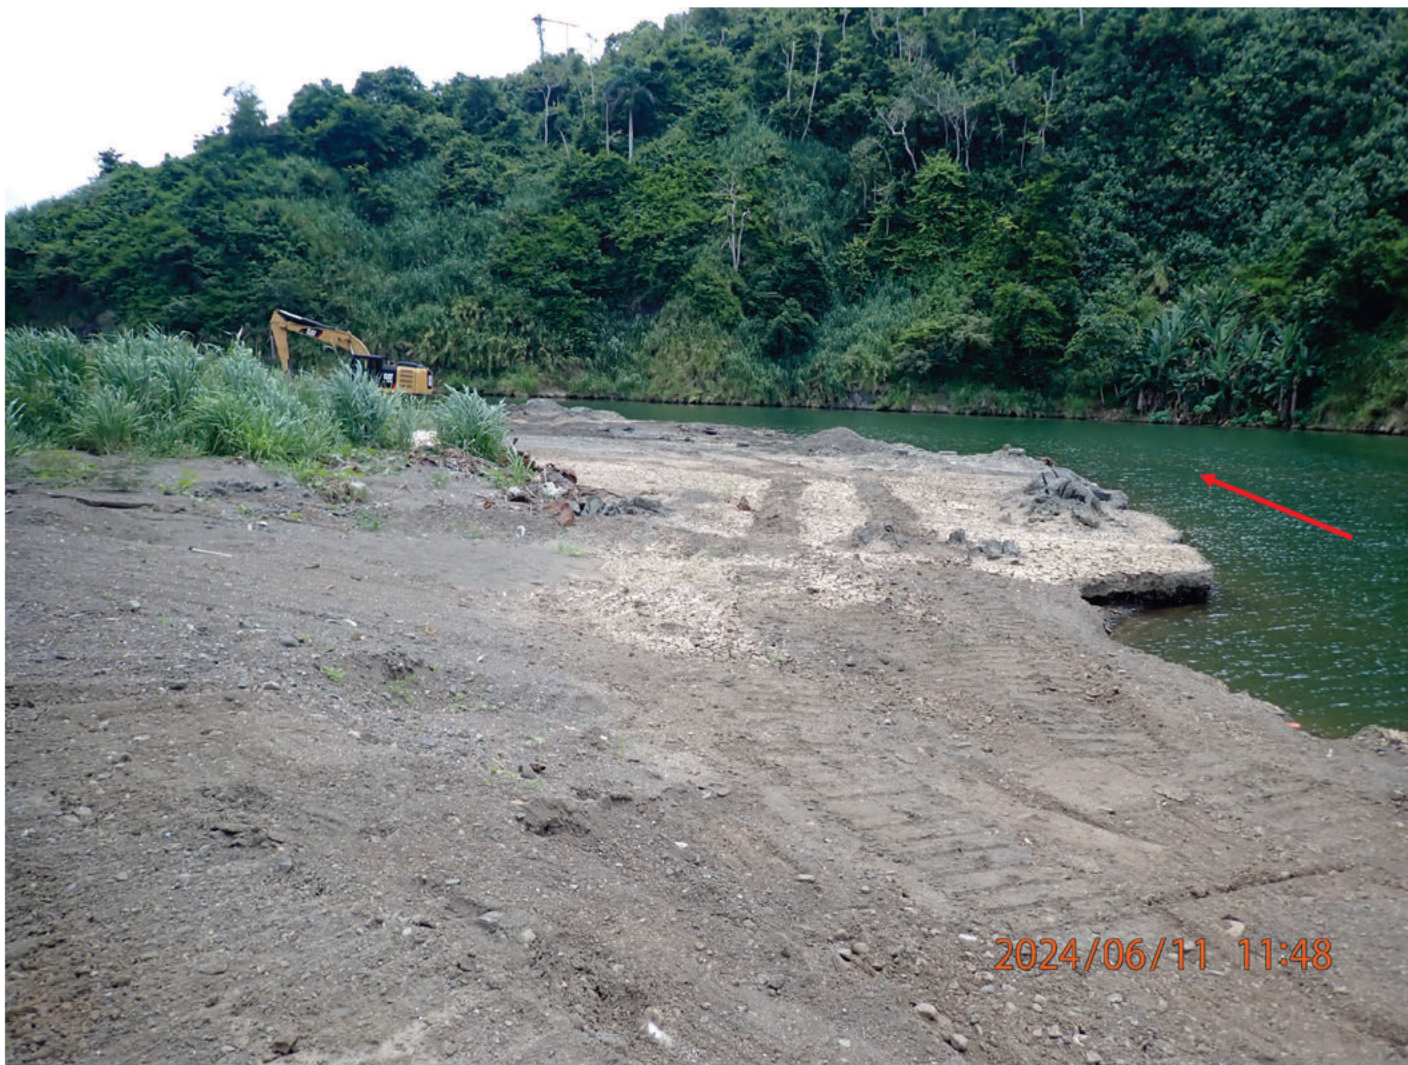
**Photo ID:** P6111019

**Description:** Within the bank of the Río de la Plata, earth moving work and fill material was observed. Construction machinery was observed parked within the area where earth moving work had occurred.

The red arrow shows the direction of flow of the Río de la Plata.

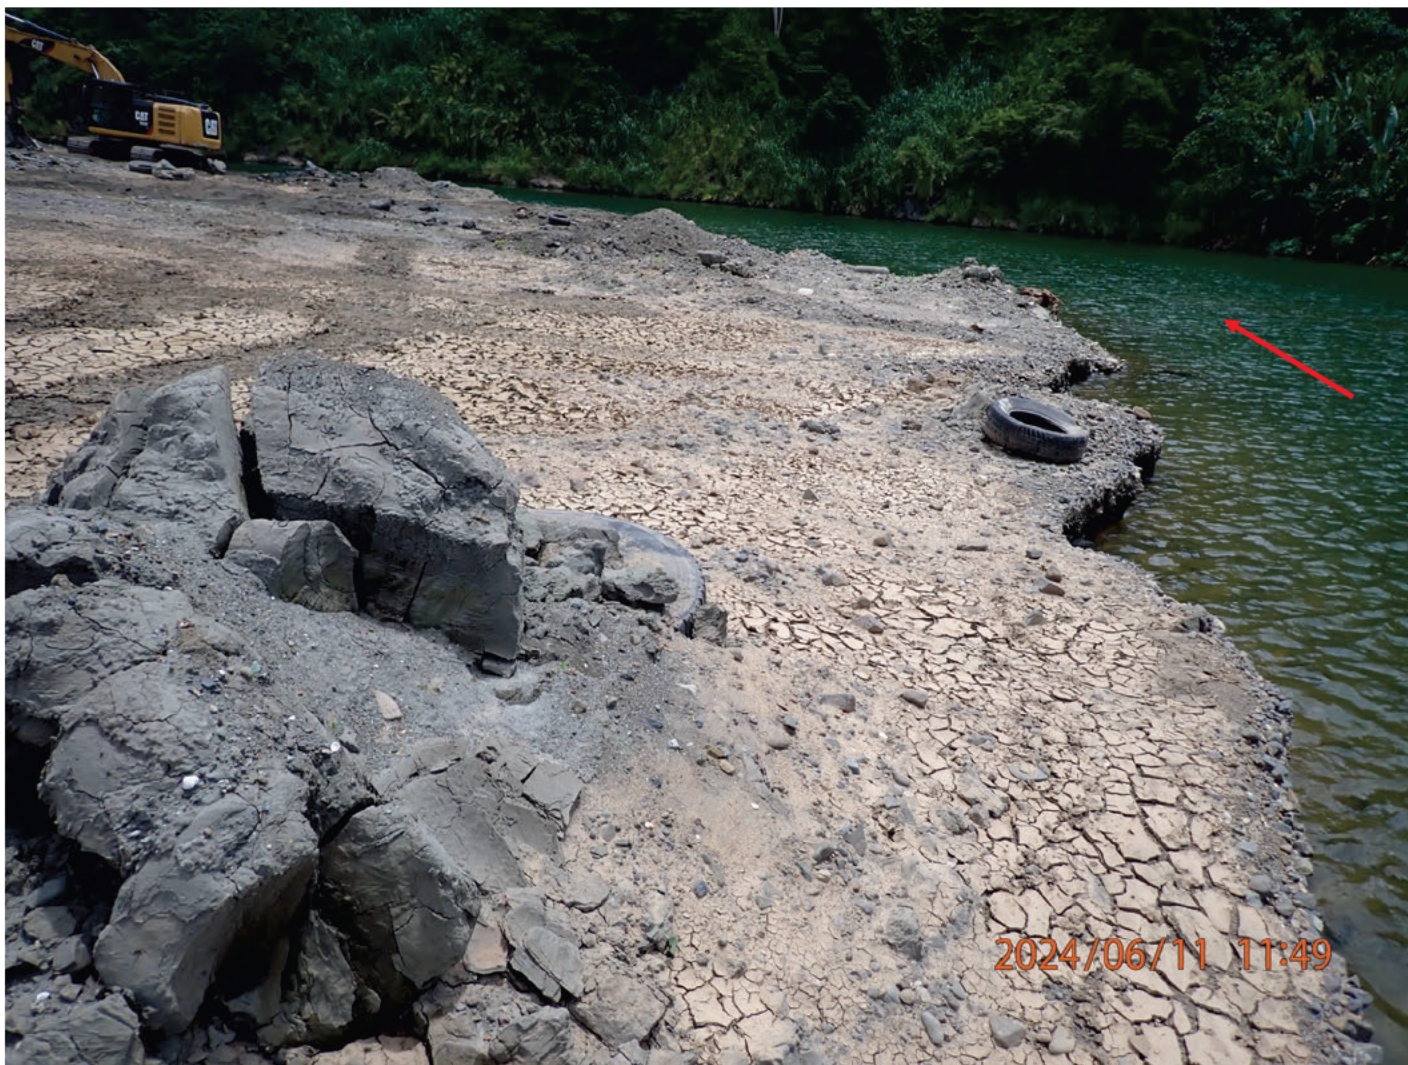
**Photo ID:** P6111020

**Description:** Within the bank of the Rio de la Plata, earth moving work and fill material was observed along with trash debris. Construction machinery was observed parked within the area where earth moving work had occurred.

Mud cracks were observed within the area of work.

The red arrow shows the direction of flow of the Río de la Plata.

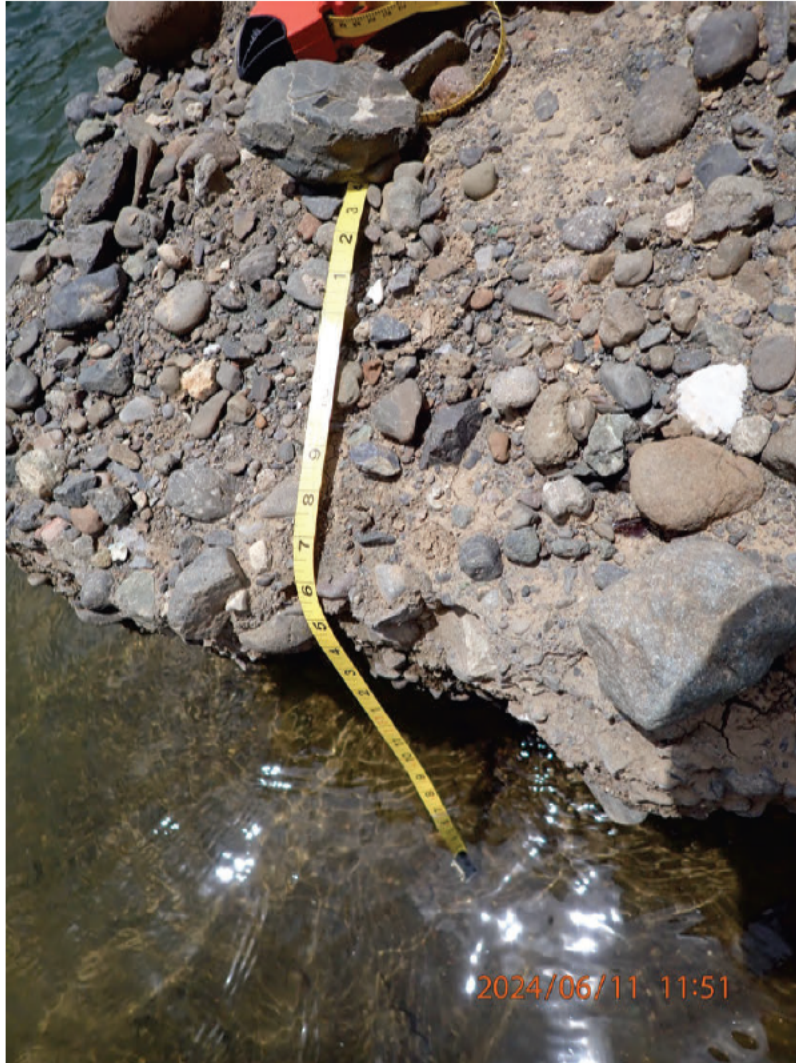
**Photo ID:** P6111021

**Description:** Within the bank of the Rio de la Plata, earth moving work and fill material was observed. Approximately 18 inches of fill material as measured from the bottom of the bank.

The red arrow shows the direction of flow of the Río de la Plata.

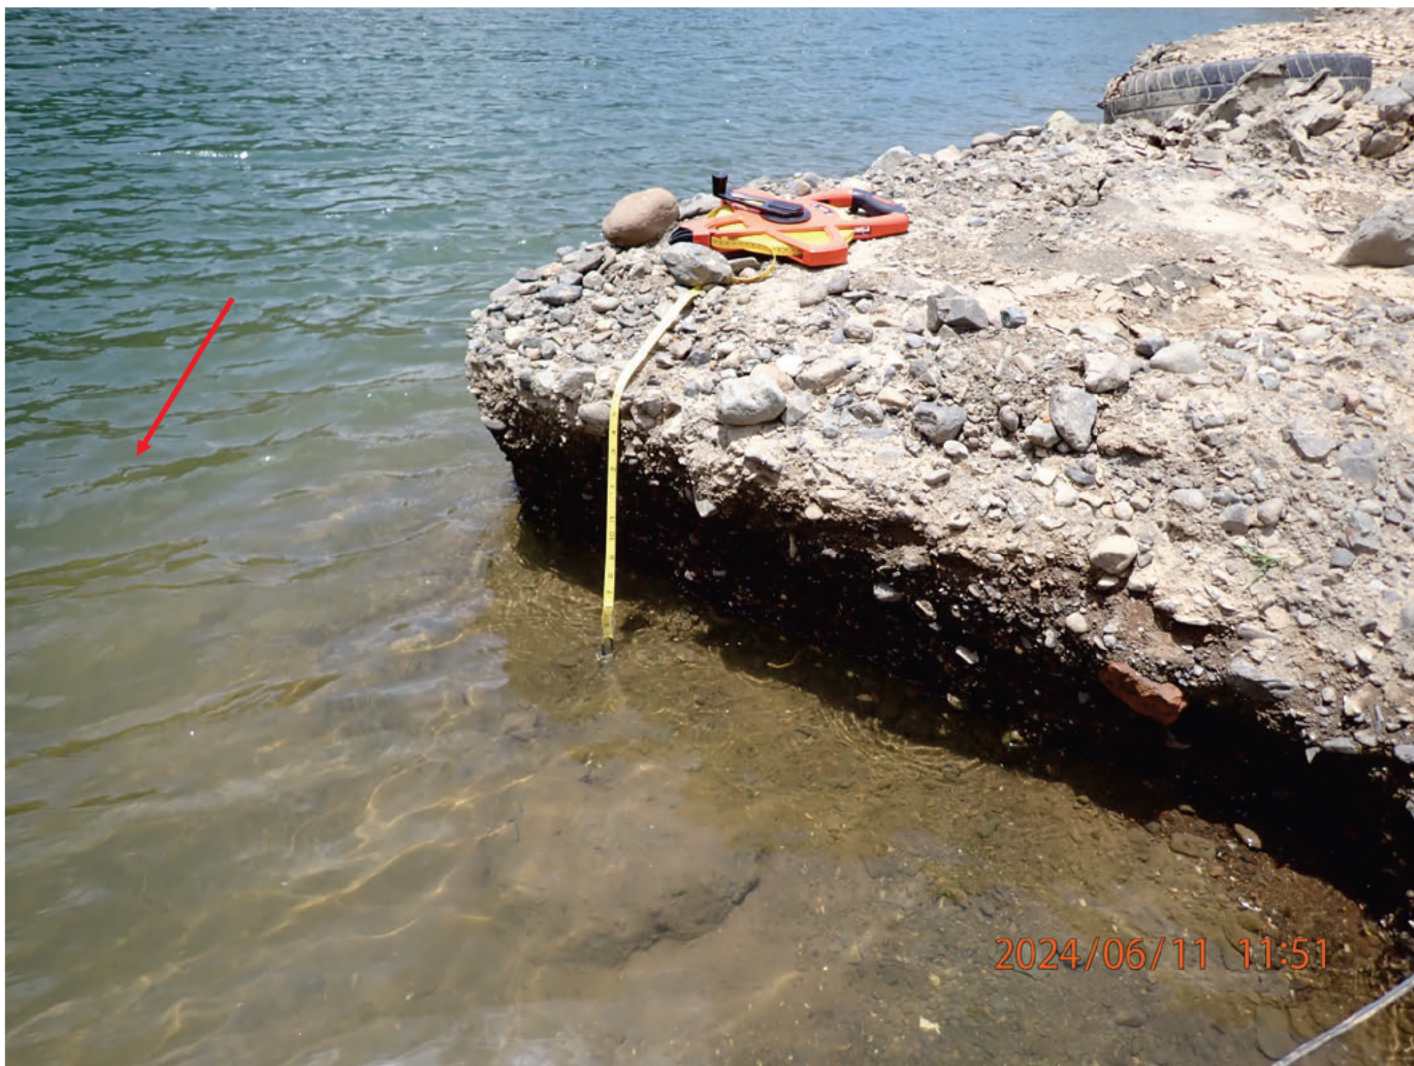
**Photo ID:** P6111022

**Description:** Within the bank of the Río de la Plata, earth moving work and fill material was observed. Approximately 18 inches of fill material as measured from the bottom of the bank.

The red arrow shows the direction of flow of the Río de la Plata.

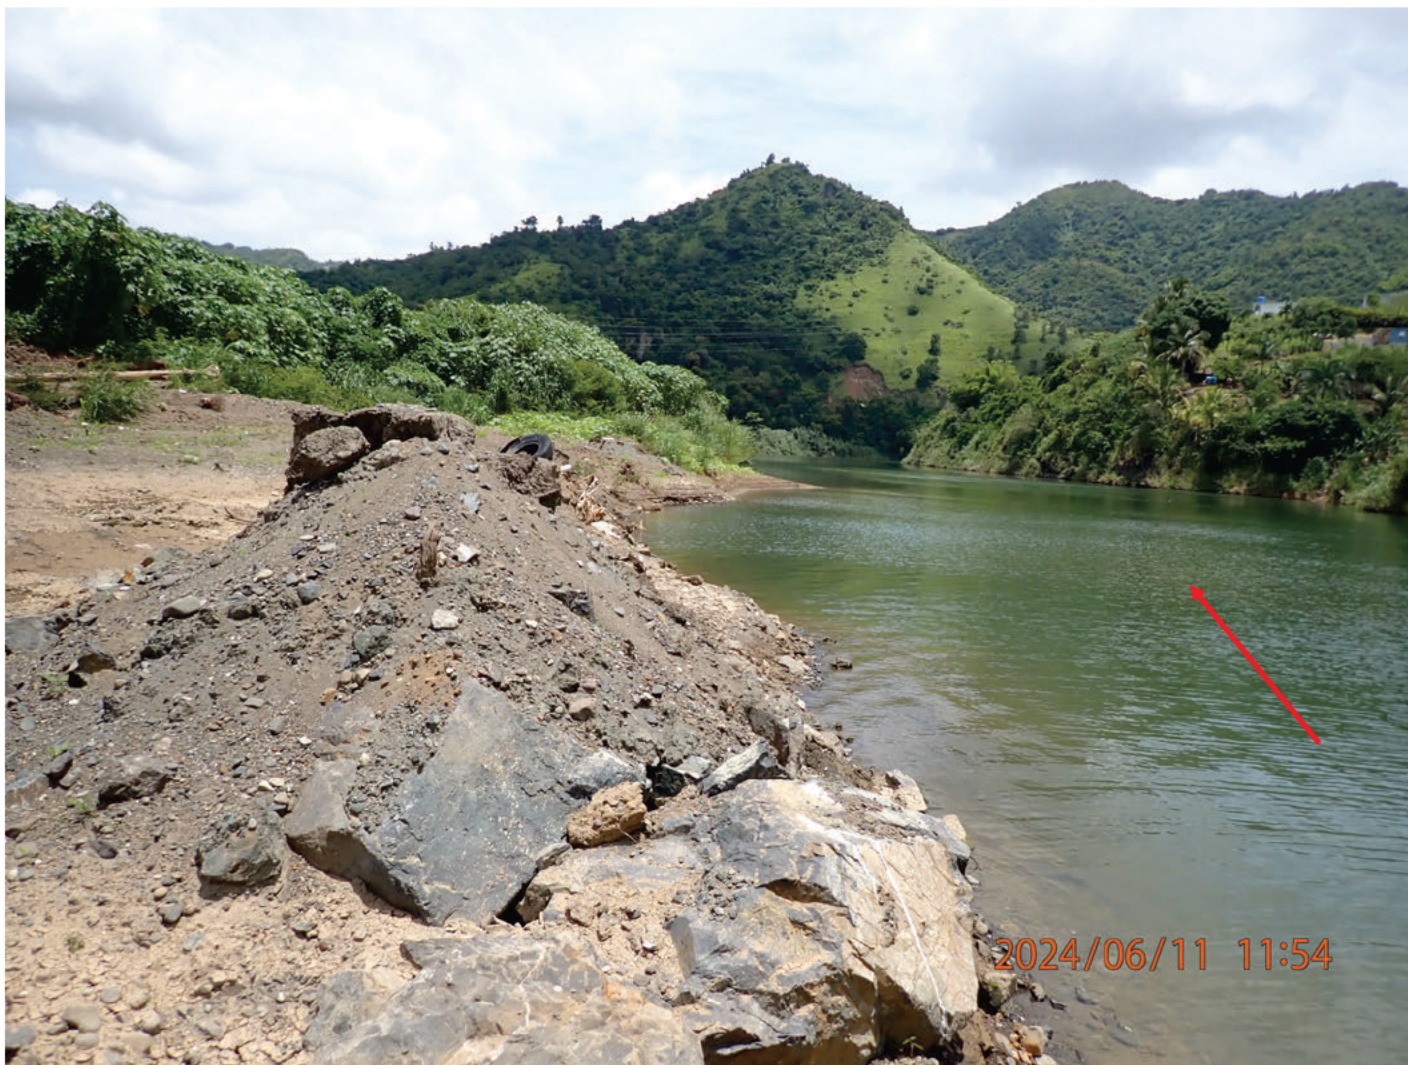
**Photo ID:** P6111025

**Description:** Within the bank of the Rio de la Plata, earth moving work and fill material was observed along with trash debris.

The red arrow shows the direction of flow of the Río de la Plata.

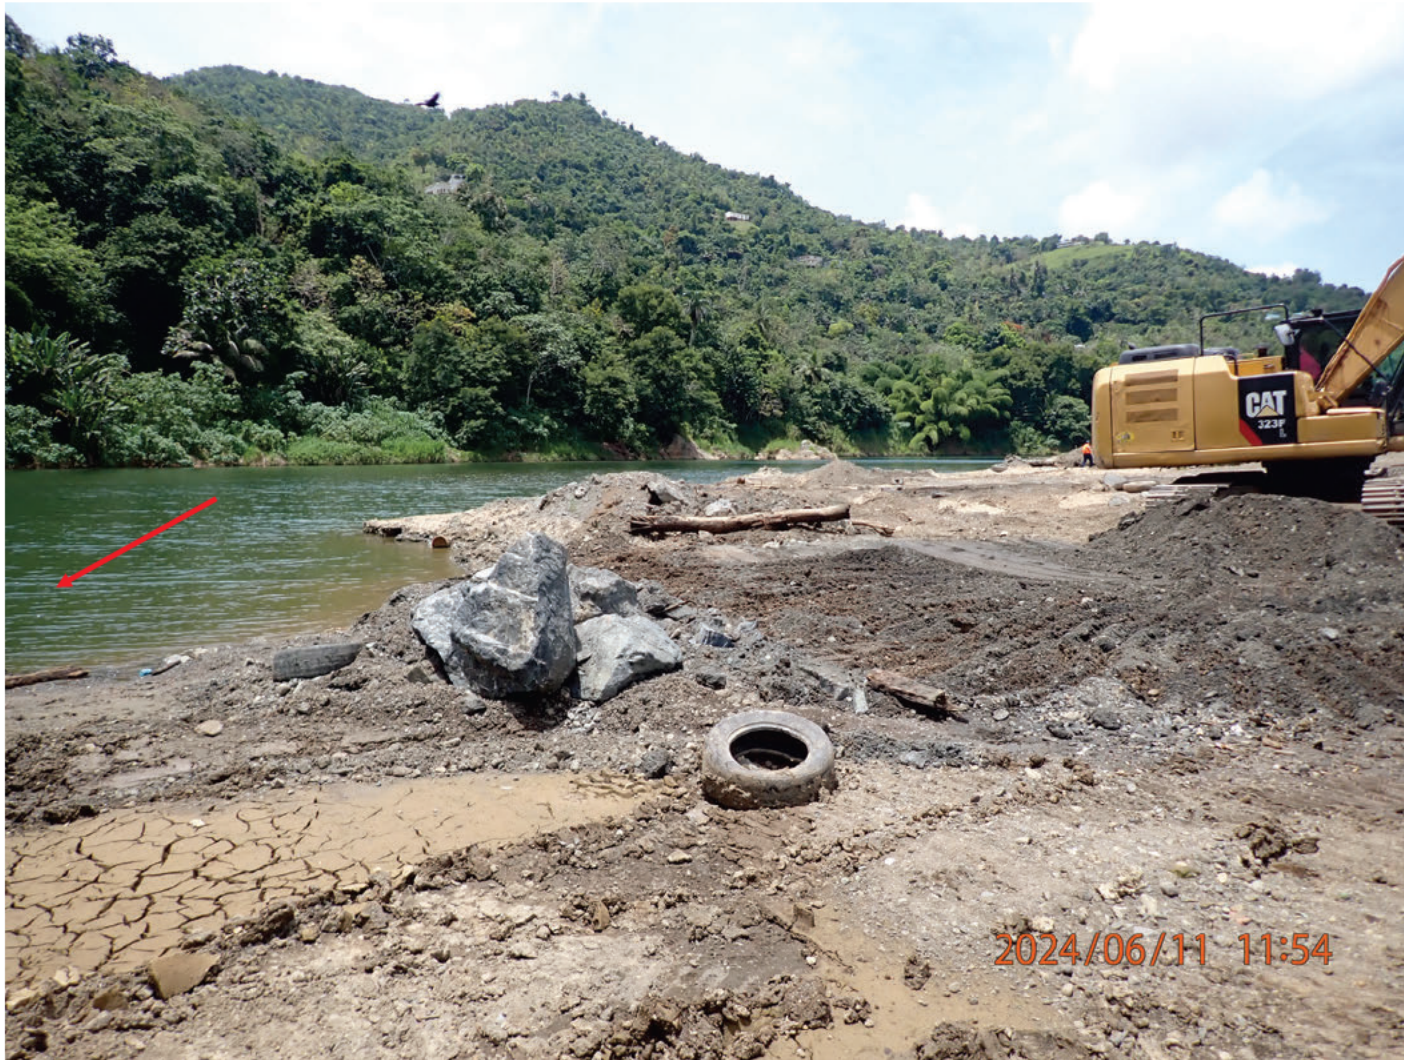
**Photo ID:** P6111026

**Description:** Within the bank of the Río de la Plata, earth moving work and fill material was observed along with trash debris. Construction machinery was observed parked within the area where earth moving work had occurred.

Mud cracks were observed within the area of work.

The red arrow shows the direction of flow of the Río de la Plata.

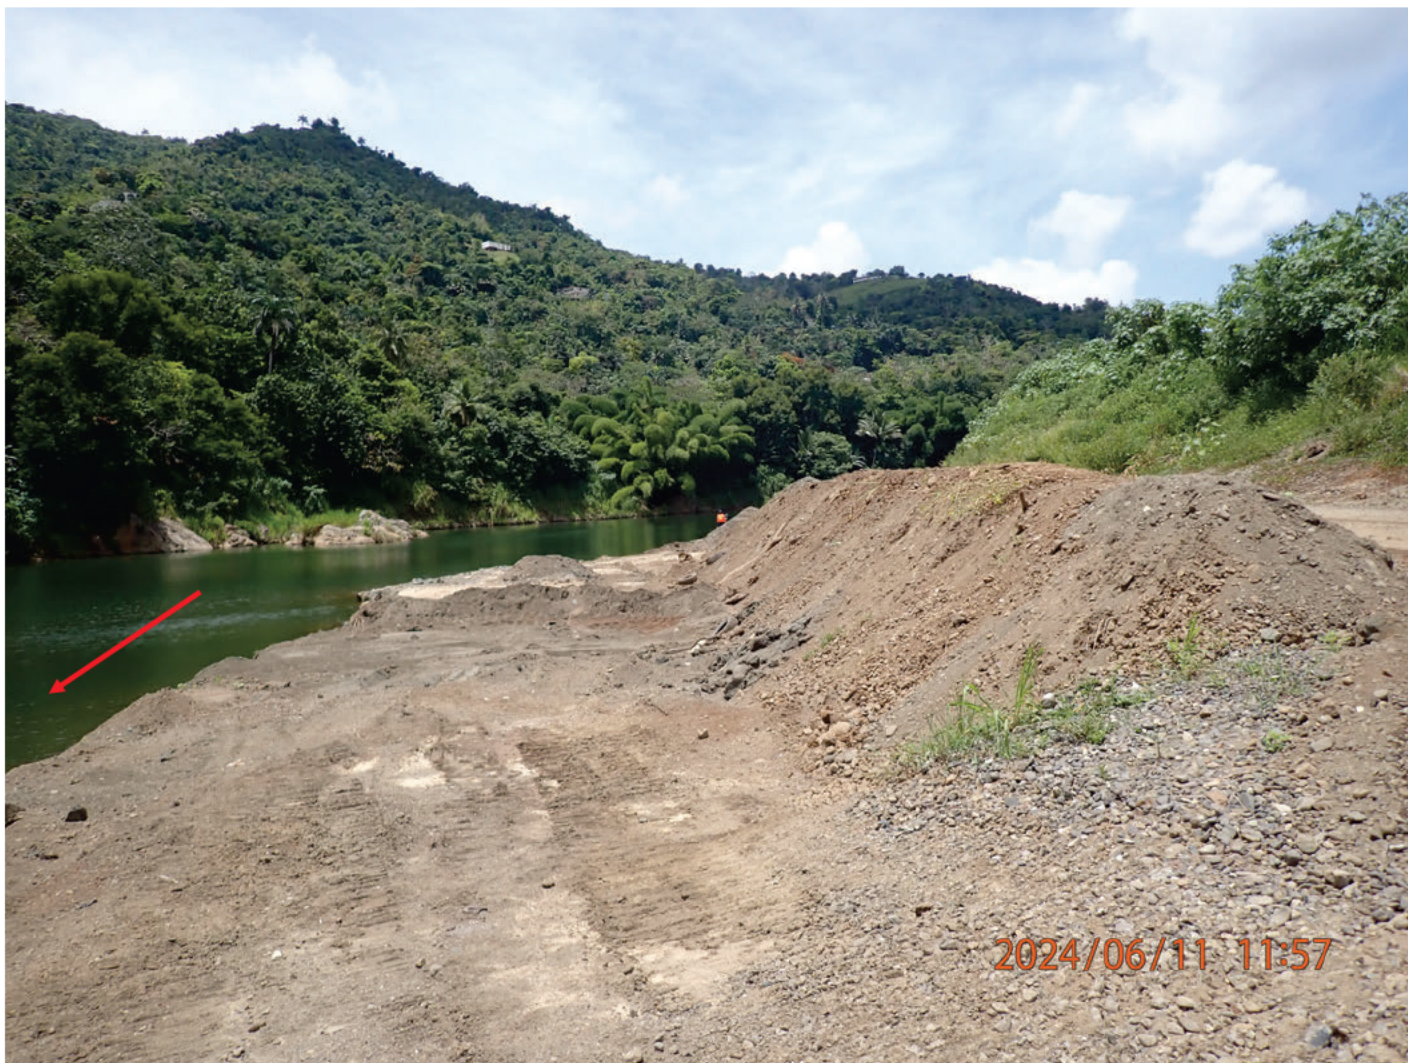
**Photo ID:** P6111030

**Description:** Within the bank of the Rio de la Plata, earth moving work and fill material was observed.

The red arrow shows the direction of flow of the Río de la Plata.
