## **RCRA Inspection Report**

Parker Meggitt  
669 Goodyear Street  
Rockmart, GA 30153

EPA ID# GAD003279981

December 5, 2022, at 9:10am

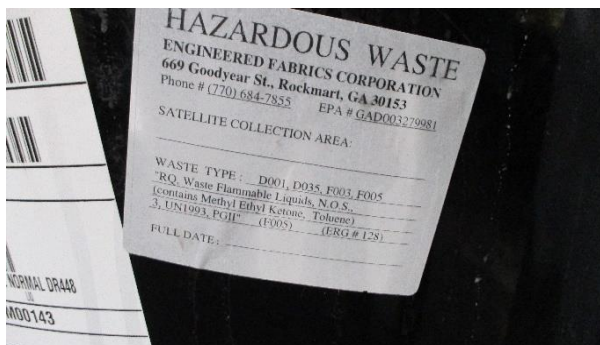
Figure 8: 11:26 AM Building 14 - Reactor Room

On the first floor of the Reactor Room, Meggitt manages a SAA for managing hazardous waste flammable liquids and trash that are generated by two 150-gallon reactors (R-211 and R-212) on the second floor. In the Reactor Room, the inspectors observed a total of four 55-gallon containers and one 3-gallon container. Two 55-gallon containers were used for the reactors (Figures 7 and 9), one 55-gallon container was stored Amidol solvent, referred to the facility as “Boil out” (Figure 6), one 55-gallon container for “trash contaminated with MEK” (Figure 4), and one 3-gallon container for parts washing (Figure 5). The two containers under the reactors were equipped with a funnel, which were not closed. The two containers under the reactors were labeled D001, D035, F003, F005 hazardous waste “RQ, Waste Flammable Liquids (contains MEK, Toluene),” and identified with a DOT flammable placard (Figure 8 and 10).

**Pursuant to Ga. Comp. R. and Regs. 391-3-11-.08(1) [40 C.F.R. § 262.15(a)(4)], which is a condition of the SAA Permit Exemption, a generator is required to keep containers of hazardous waste closed at all times during accumulation, except when adding, removing, or consolidating waste; or when temporary venting of a container is necessary for the proper operation of equipment, or to prevent dangerous situations, such as build-up of extreme pressure.**

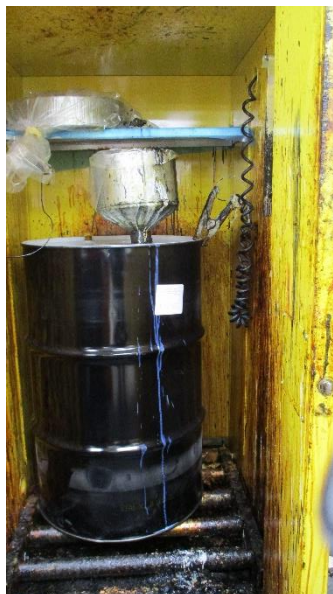
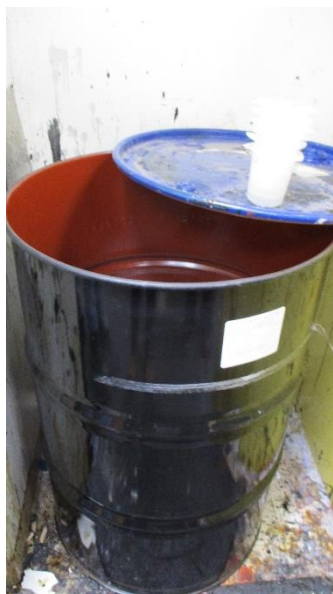
Figure 11: 11:31 AM Building 14 – Lab Room

The facility manages a SAA in their Lab Room for managing hazardous waste flammable liquids and trash that is generated by lab sampling. The inspectors observed two 55-gallon containers in this SAA (Figures 11 and 13). One container was located inside a flammable cabinet and the other container adjacent to the flammable cabinet. One of the 55-gallon containers was equipped with a funnel, which was not closed. The container was labeled D001, D035, F003, F005 hazardous waste “RQ, Waste Flammable Liquids (contains MEK, Toluene),” and identified with a DOT flammable placard (Figure 12). The other 55-gallon container was equipped with a drum cover, which was not closed. The container was labeled D035 hazardous waste “trash contaminated with MEK,” and identified with a DOT flammable placard (Figure 14).

**Pursuant to Ga. Comp. R. and Regs. 391-3-11-.08(1) [40 C.F.R. § 262.15(a)(4)], which is a condition of the SAA Permit Exemption, a generator is required to keep containers of hazardous waste closed at all times during accumulation, except when adding, removing, or consolidating waste; or when temporary venting of a container is necessary for the proper operation of equipment, or to prevent dangerous situations, such as build-up of extreme pressure.**

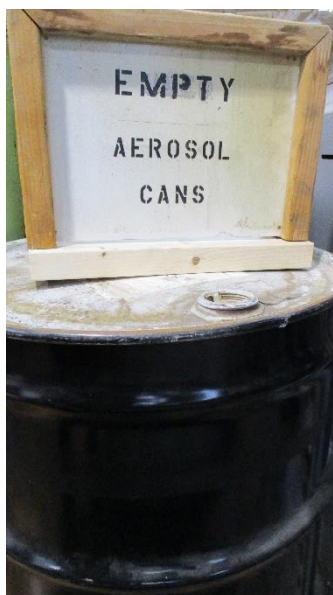
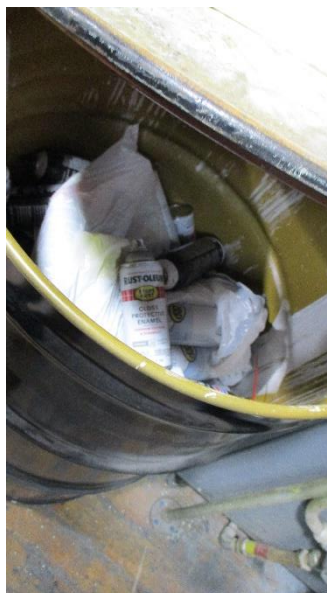
Figure 19: 11:55 AM - Building 1 - String Fittings Area

The facility manages a SAA in their String Fittings Area for managing empty aerosol cans that is generated by providing protective film on the plastic forms. The inspectors observed one 55-gallon container in this SAA (Figures 19 and 20). The 55-gallon container was equipped with a drum cover, which was closed. The container was not labeled and not identified with an indication of hazard.

**Pursuant to Ga. Comp. R. and Regs. 391-3-11-.08(1) [40 C.F.R. § 262.15(a)(5)], which is a condition of the SAA Permit Exemption, a generator is required to mark or label its containers (i) with the words “Hazardous Waste” and (ii) with an indication of the hazards of the contents.**

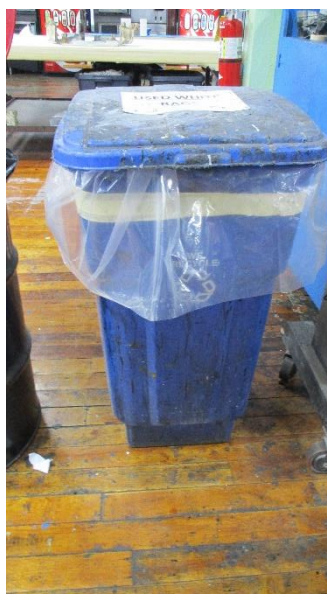
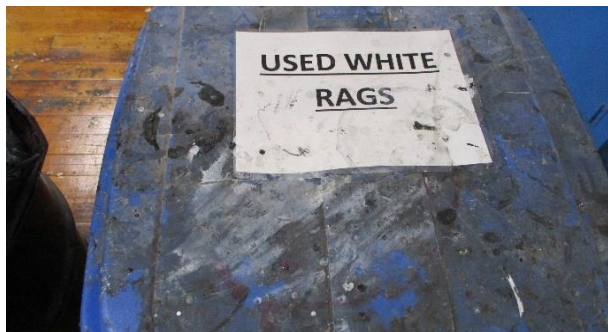
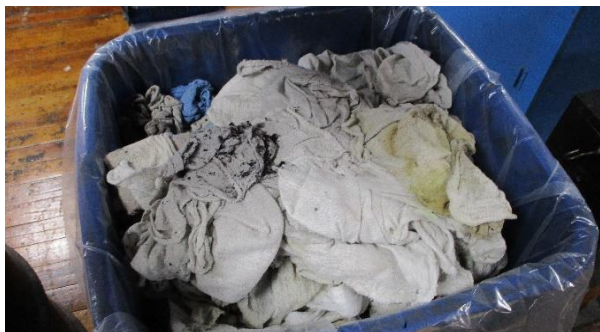
Figure 22: 12:12 PM - Building 1 - Crashworthy Build Area

The inspectors observed one 50-gallon container of used solvent contaminated reusable wipes in the Crashworthy Build Area (Figures 22-24). The container was closed, and it was not labeled “excluded solvent contaminated wipes.”

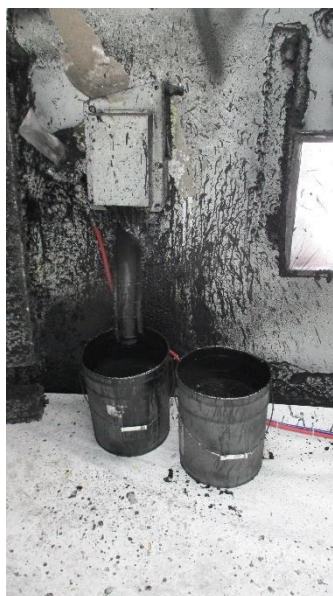
Figure 25: 12:19 PM - Building 1 - Spray Booth

The Spray Booth is located on the second floor of Building 1. The facility manages a SAA outside their Spray Booth for managing hazardous waste flammable liquids that is generated by the Spray Booth. The inspectors observed two 5-gallon containers left open, with no hazardous waste label or indication of hazard (Figure 25). The 5-gallon containers capture waste coming from the Spray Booth that is then sent to the SAA outside the Spray Booth. The inspectors observed one 55-gallon container in this SAA. The container was located inside a flammable cabinet. The 55-gallon container was equipped with a funnel, which was not closed. The container was labeled D001, D035, F003, F005 hazardous waste “RQ, Waste Flammable Liquids (contains MEK, Toluene),” and identified with a DOT flammable placard.

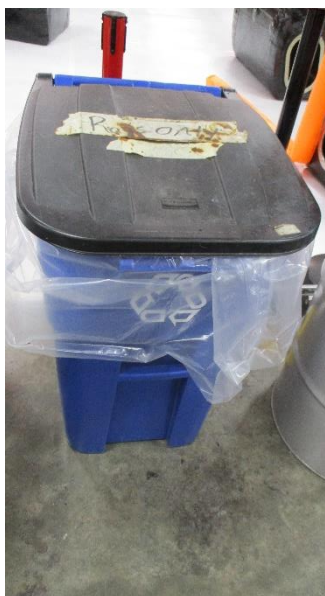
Figure 26: 1:48 PM Building 29 - Completion Center

This area consists of the product after the cardboard forms are removed. Fixtures are checked within the product for perfect fittings and are hand wiped for cleaning. The inspectors observed one 50-gallon container of used solvent contaminated reusable wipes in the Completion Center (Figure 26). The container was closed, and it was not labeled “excluded solvent contaminated wipes.”

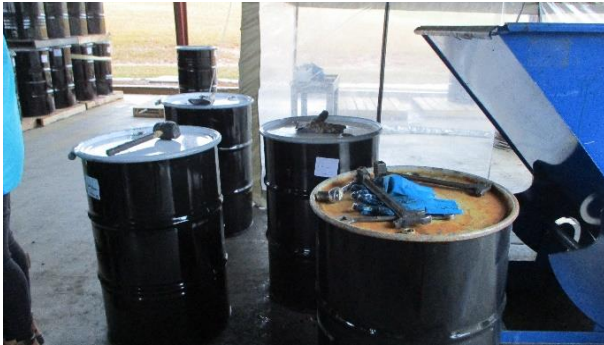
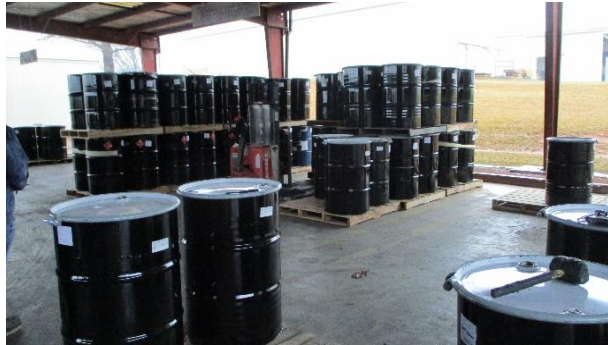
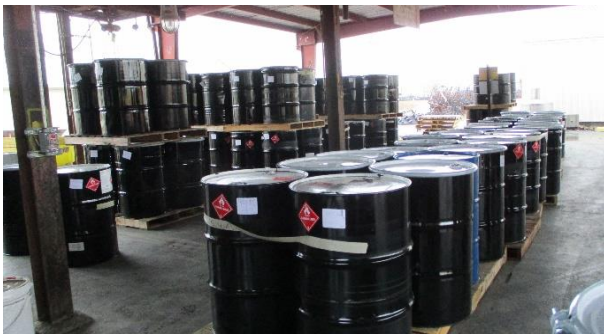
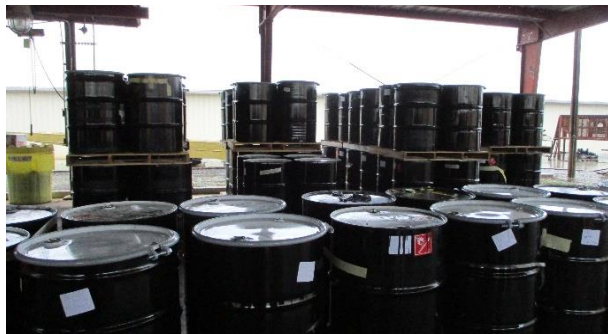
Figure 27: 1:54 PM 90 Day Storage Area

Meggitt manages a hazardous waste CAA in the 90 Day Storage Area (Figures 27-30). This area is separate from the main facility, designated outside and covered with an overhead roof with secondary containment. Universal waste batteries are stored in the Batteries Storage Area within the CAA (Figure 39). The inspectors observed one 55-gallon container and one 35-gallon container labeled “Used Batteries for Recycle.” There was no accumulation start dates for these containers.

Inspectors observed a total of two hundred fifteen (215) 55-gallon containers. In the center of the CAA were thirty-two (32) 55-gallon containers recently brought from the facility's operations/waste generated (Figure 29). The 32 containers were not included in the last weekly inspection but included in the drum count. Seven 55-gallon containers did not have an accumulation start date (Figure 31-36, 38). Multiple instances of 55-gallon containers stacked on top of other containers appeared to have no indication of hazards (Figure 30). One 55-gallon container appeared to have an updated label that did not appear to be legible (Figure 37). The oldest accumulation date at the time of the inspection was dated November 8, 2022.

**Pursuant to Ga. Comp. R. and Regs. 391-3-11-.08(1) [40 C.F.R. § 262.17(a)(5)(i)], which is a condition of the LQG Permit Exemption, a generator must mark or label its containers with the following: the words "Hazardous Waste"; an indication of the hazards of the contents; and the date upon which each period of accumulation begins clearly visible for inspection on each container.**

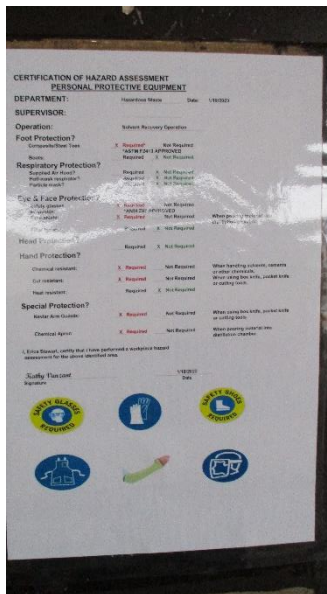
Figure 40: 2:14 PM 90 Day Storage Area

The area was identified with a sign which read “danger, hazardous waste storage.” Meggitt manages ignitable waste in this CAA, and the inspectors observed “No Smoking” signs just outside its entrance (Figure 42). Inspectors observed hazard assessment certifications posted on the wall (Figures 40-41).

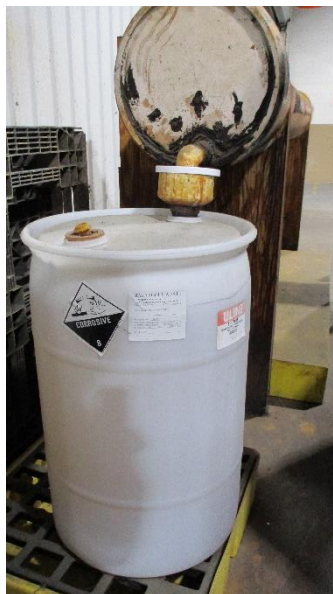
Figure 43: 2:25 PM Building 21 - Acid Wash Station

Meggitt manages a SAA in the Acid Wash Station for managing hazardous waste corrosive liquids that is generated by aluminum etching (Figure 43). The inspectors observed one 30-gallon container that appeared to be full in this SAA. The drum was connected to the aluminum etching machine, which was not secure. The container was labeled D002 "RQ Waste Corrosive Liquids, Acidic, Inorganic," and identified with a DOT corrosive placard.

**Pursuant to Ga. Comp. R. and Regs. 391-3-11-.08(1) [40 C.F.R. § 262.15(a)(4)], which is a condition of the SAA Permit Exemption, a generator is required to keep containers of hazardous waste closed at all times during accumulation, except when adding, removing, or consolidating waste; or when temporary venting of a container is necessary for the proper operation of equipment, or to prevent dangerous situations, such as build-up of extreme pressure.**

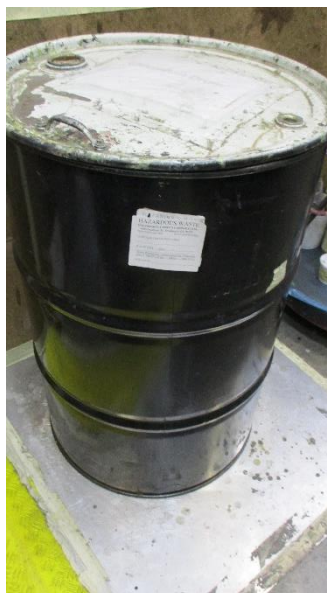
Figure 44: 2:30 PM Building 21 - Spray Booth 7

The facility manages a SAA outside Spray Booth 7 for managing hazardous waste chromium that is generated by the spray booth (Figure 45). The inspectors observed one 55-gallon container located outside the spray booth, equipped with a drum cover, which was closed (Figure 44). The container was labeled D007 hazardous waste "wipes, brushes contaminated with Chromium," and identified with no indication of hazard. The inspectors observed a vacuum in this SAA. The vacuum was covered over a plastic sheet and labeled "For Use in Chrome Spray Booth Only"

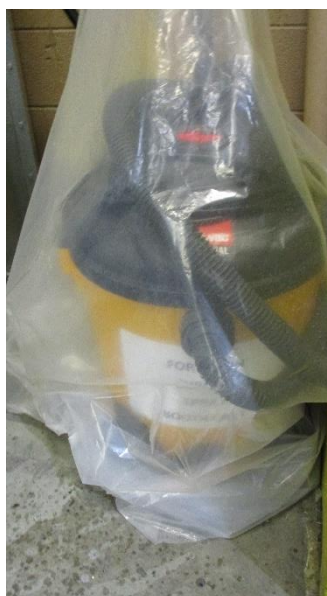
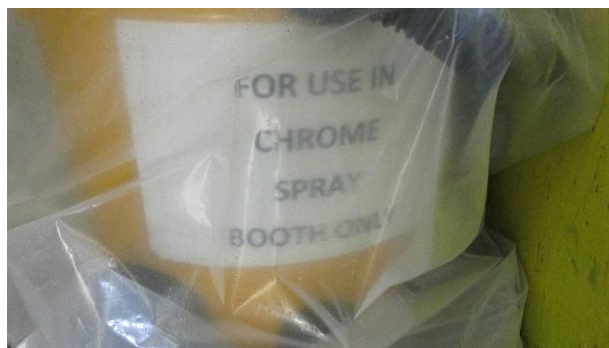
Figure 46: 2:32 PM Building 21 - Spray Booth 7

(Figure 46-47). The vacuum did not appear to have a hazardous waste label and did not have an indication of hazard. The inspectors observed one 55-gallon container located outside the spray booth, equipped with a funnel, which was not closed (Figure 48). The container was labeled D035, D001, F003, F005 hazardous waste “RQ, Waste Flammable Liquids (contains MEK, Toluene),” and identified with a DOT flammable placard. On December 14, 2022, facility personnel provided through email stating “On 5/16/2019, a TCLP was performed on a solid waste sample from building 1. The solid waste sample, KC 135, contains product that are found on the spray booth filter of building 1 as well as the paper flooring. TCLP results included in attachment.” After review of the documents, TCLP results do not appear to be representative to distinguish or identify the waste stream in question.

**Pursuant to Ga. Comp. R. and Regs. 391-3-11-.08(1) [40 C.F.R. § 262.15(a)(5)], which is a condition of the SAA Permit Exemption, a generator is required to mark or label its containers (i) with the words “Hazardous Waste” and (ii) with an indication of the hazards of the contents.**

**Pursuant to Ga. Comp. R. and Regs. 391-3-11-.08(1) [40 C.F.R. § 262.15(a)(4)], which is a condition of the SAA Permit Exemption, a generator is required to keep containers of hazardous waste closed at all times during accumulation, except when adding, removing, or consolidating waste; or when temporary venting of a container is necessary for the proper operation of equipment, or to prevent dangerous situations, such as build-up of extreme pressure.**

**Pursuant to Ga. Comp. R. and Regs. 391-3-11-.08(1) [40 C.F.R. § 262.11], a person who generates a solid waste, as defined in Ga. Comp. R. and Regs. 391-3-11-.07(1) [40 C.F.R. § 261.2], must determine if that waste is a hazardous waste following the methods articulated in Ga. Comp. R. and Regs. 391-3-11-.08(1) [40 C.F.R. § 262.11].**

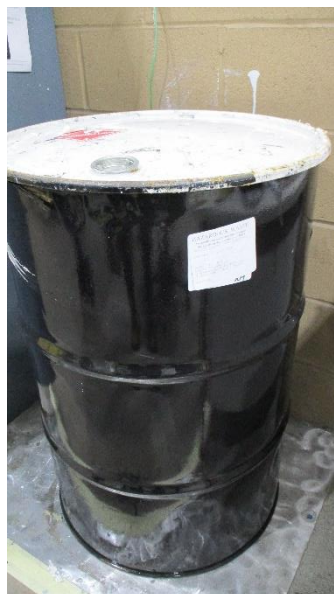
Figure 49: 2:45 PM Building 21 - Spray Booth 7

The facility manages a SAA outside Spray Booth 8 for managing hazardous waste MEK and polyurethane that is generated by the spray booth. The inspectors observed one 55-gallon container located outside the spray booth which was closed (Figure 49). The container was labeled D035 hazardous waste solids (trash contaminated with MEK) and identified with a DOT flammable placard. The spray booth filters are replaced weekly. Inspectors asked facility personnel for a waste profile on the spray booth filters. On December 14, 2022, facility personnel provided through email stating “No waste determination for Building 21 spray booth filters for non-chromium use spray booth. Based off of generator knowledge, the filters are included with general waste.”

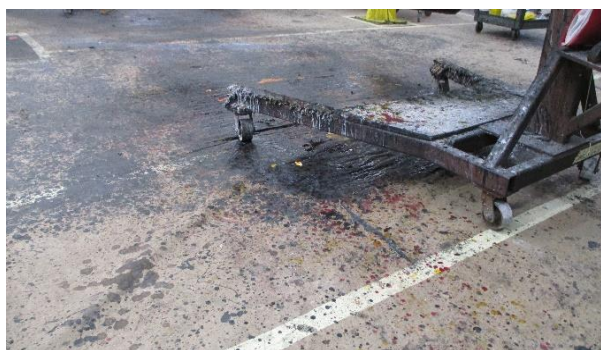
Figure 50: 3:05 PM Building 1

Inspectors observed the floor covered with paper to capture dripping paint from painted products (Figure 50). Inspectors asked facility personnel if Meggitt has made a waste determination for

the paper flooring. On December 14, 2022, facility personnel provided through email stating “On 5/16/2019, a TCLP was performed on a solid waste sample from building 1. The solid waste sample, KC 135, contains product that are found on the spray booth filter of building 1 as well as the paper flooring. TCLP results included in attachment.” After review of the documents, TCLP results do not appear to be representative to distinguish or identify the waste stream in question.

**Pursuant to Ga. Comp. R. and Regs. 391-3-11-.08(1) [40 C.F.R. § 262.11], a person who generates a solid waste, as defined in Ga. Comp. R. and Regs. 391-3-11-.07(1) [40 C.F.R. § 261.2], must determine if that waste is a hazardous waste following the methods articulated in Ga. Comp. R. and Regs. 391-3-11-.08(1) [40 C.F.R. § 262.11].**
