## NPDES Wastewater Lagoon Inspection Report

| Facility Location Information | |
|---|---|
| Site/Facility Name & Location:<br><b>Town of Oswego Wastewater Lagoons</b><br>Indian Highway<br>48.057576°N; 105.867621°W | Email Report to:<br>Mitchell Youngman<br>Director, Enterprise Tribal Utilities<br><div style="background-color: black; color: red; padding: 2px;">(b) (6)</div> |

## Inspection Narrative and Site Description

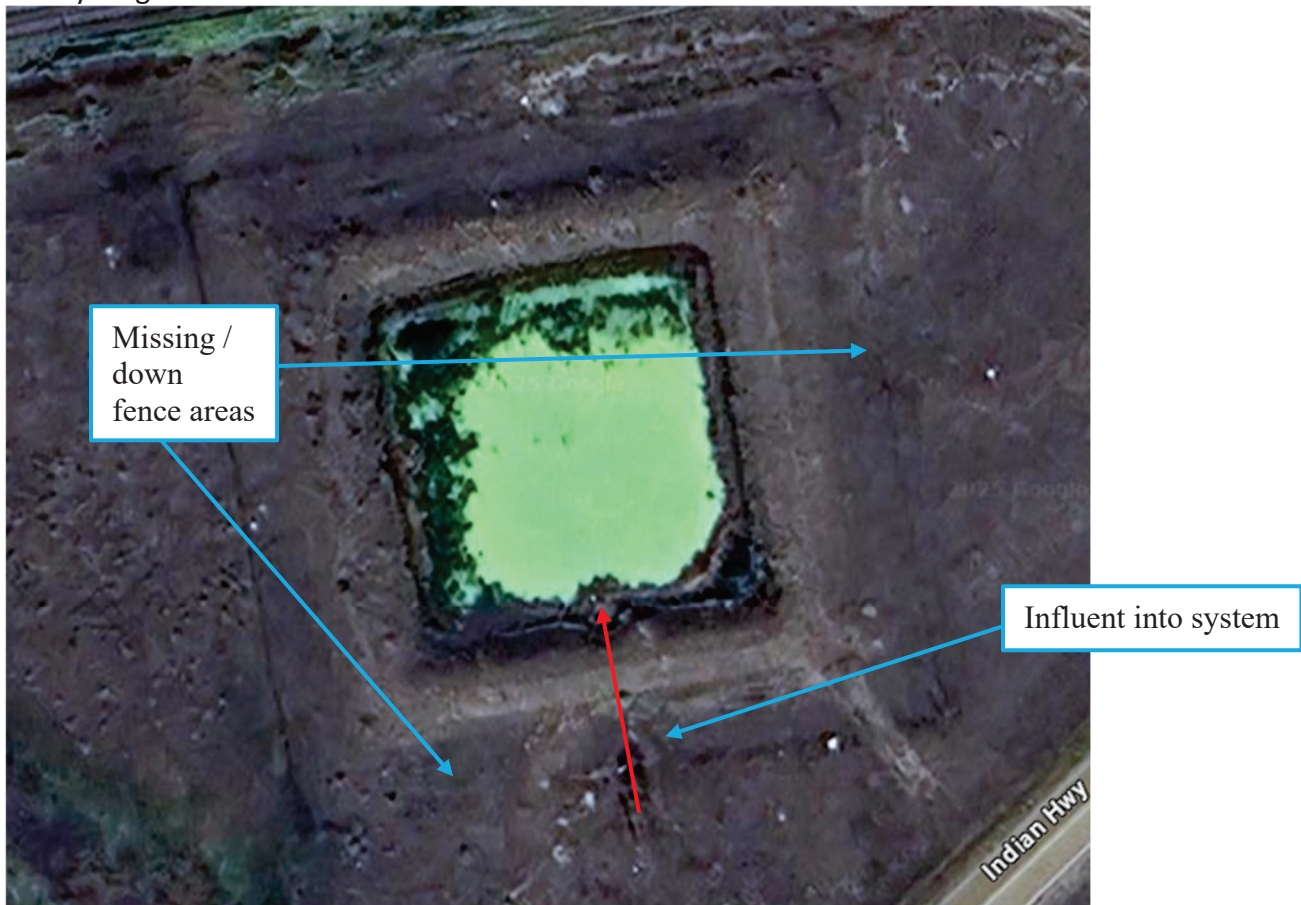
Facility diagram:

We began the site review by walking around lagoon Cell 1 (photos 88, 90, and 91) to evaluate berm integrity and the Facility's discharge status. The inspector observed vegetation and small shrub growth within the slopes inside of the lagoon cell dike walls (noted in the photos). Vegetation on the dike walls were at a height where the health of the dike could not be assessed. The inspector also observed algae creating a mat on the top of most of the cell. During the walk around the cell, it was noted the fencing was not intact in many areas (photos 89 and 93). The inspector also noted on the south side of the lagoon, where the influent pipe enters the lagoon was caved in (photo 92), with no indication if it was the pipe that was collapsed or if it was due to rodent damage. Through conversation with Mr. Bighorn Jr. and the inspector not observing a discharge pipe, the facility appeared to be non-discharging.
