## **Kinross Revisited and the Introduction to SANS 1867**

A.R Nundlall, Senior Inspector of Mines – Department of Minerals and Energy

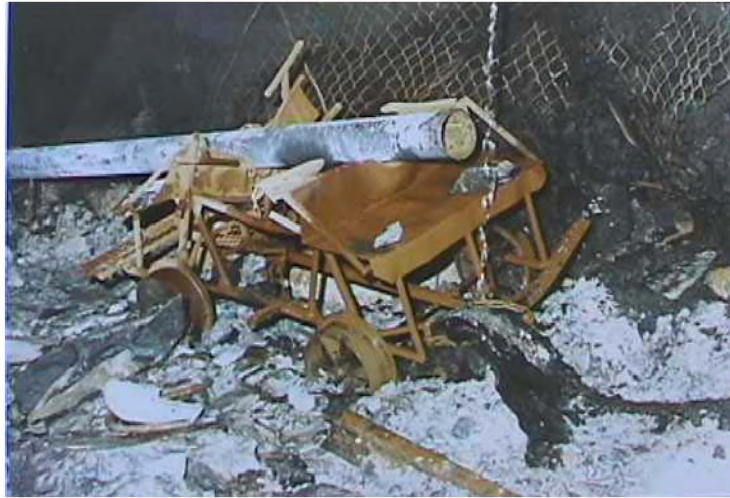
**Physical damage caused by the fire**

The mine overseer, who was in charge of the haulage, testified that the foam was sprayed onto the sidewalls and hanging wall over a distance of 490 metres, about six years previously. The reason for the foam covering was due to the fact that the haulage was covered with wire mesh and rock bolts for support purposes and, to prevent corrosion from affecting the wire mesh, a cement shotcreting was used as a cover. This haulage was a high speed tramming haulage and because of the slow rate at which shotcreting progressed, it was decided to use the foam instead, which was much quicker.

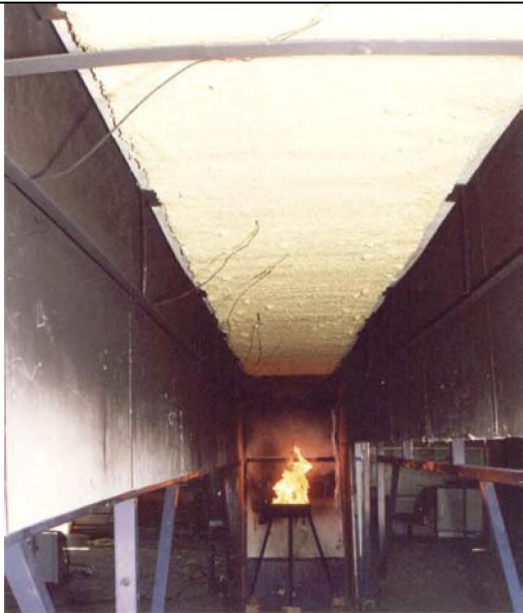
- a. The product shall be non-punking i.e. the product shall not continue to further thermally decompose once the fire source has been removed.
- b. The flame spread, when a large-scale horizontal flame spread test is done, shall not exceed 2,3 metres of the test channel, which is 7,4 metres in length. This test indicates the distance of sustained burning, disregarding surface flashing.
- c. The toxicity index of the combustion gases shall be less than 5, when tested in accordance with Naval Engineering Standard (NES) 713.
- d. The product shall not exceed 200 °C in the exothermic heat generation test.

| <p><b>Large-scale horizontal flame spread test</b></p> | <p><b>Large-scale vertical flame spread test – mine tunnel simulation.</b></p> |
