## **RCRA Inspection Report**

Precoat Mezzanine LLC dba Precoat  
Metals

02/27/2025, 9:00 a.m.

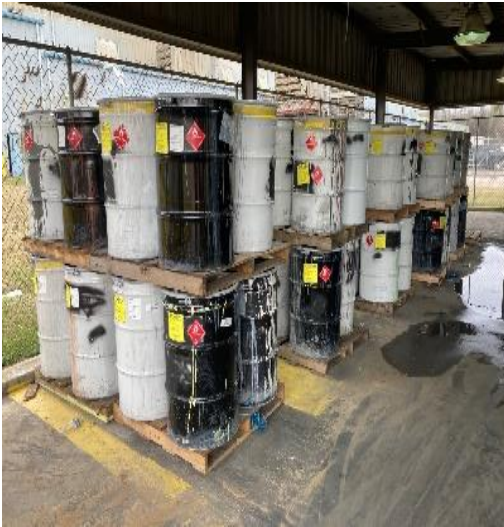
The inspectors observed 96 55-gallon hazardous waste containers in the storage at the time of inspection (Photo-1 and Photo-2)). The inspectors observed four containers on each wooden pallet and the pallets were stacked two high with aisle space. All the containers were closed and labeled with the words “Hazardous Waste” and with an indication of the hazard of the contents (Photo-3). The waste codes on the drums were noted to be D001, D007, F003 and F005. The oldest accumulation start date on the drum was noted to be 01/06/2025. In addition, the inspection team observed two non-regulated waste containers containing used oil absorbents granules and one 220-gallon closed tote of used oil labelled as “Used Oil”. There were no leaks and spills observed in the storage area. The storage area was equipped with a fire extinguisher, eye-wash stations, spill kits and a carbon dioxide (CO<sub>2</sub>) fire suppression system.

Photo-1 CAA Containers

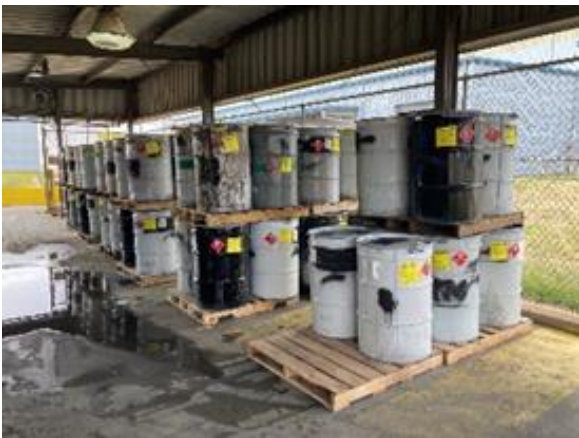
Photo-2 CAA Containers

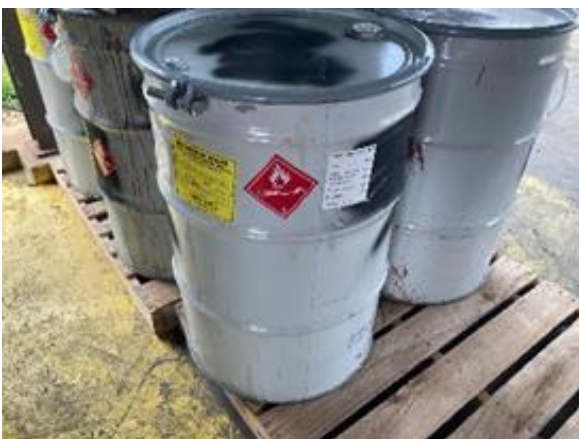
Photo-3 Containers in CAA (Labels and IOH)

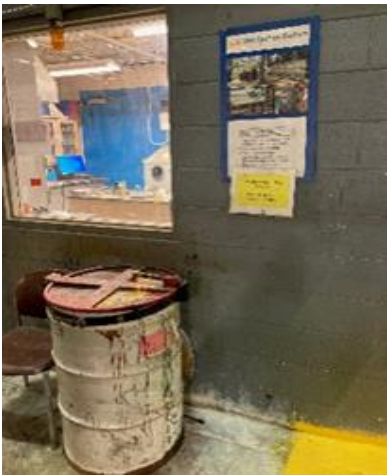
Wet Section: The wet section includes an SAA outside the lab (Photo-4). The SAA container was observed to be closed and labeled with the words “Hazardous Waste” and with an indication of the hazards of the contents (Photo-5). The waste codes on the SAA container were noted to be D002 and D007.

Photo-4 SAA on Wet Side

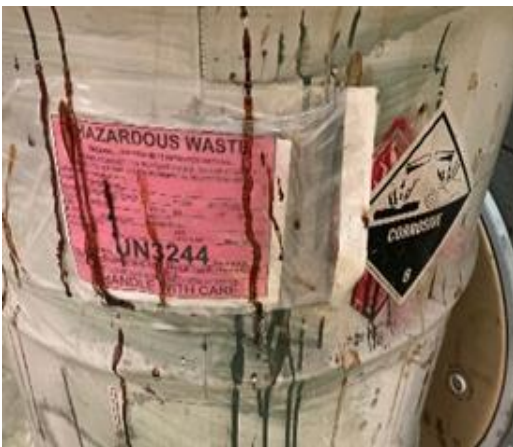
Photo-5 SAA on Wet Side (Labels and IOH)

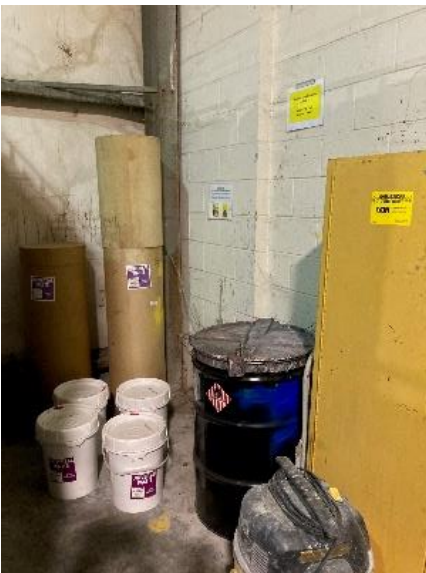
On the other side of the lab, the inspection team observed a universal waste (UW) accumulation area, and a satellite accumulation area (Photo-6). The SAA container was observed to be closed and labeled with the words “Hazardous Waste” with indication of the

hazards of the contents. The UW accumulation area contained used lamps and used batteries. There were two fiber boxes of used lamps and four containers of used batteries. All the universal waste containers were observed to be closed, labeled, and with an accumulation start date. The accumulation start date for the used lamps and the used batteries were 8/14/2024.

Photo-6 SAA and Universal Waste
