Resource Conservation and Recovery Act (RCRA)
 Compliance Evaluation Inspection

Facility Name:	Gov. Juan F. Luis Hospital & Medical Center		
EPA ID Number:	VIN008015919		
Date of Inspection:	September 6, 2023		
Generator Status in Record:	VSQG (Non-Notifier)		
Generator Status at the time of inspection:	VSQG		
RCRA Permitted:	No		
Basis for Inspection:	Core Program		
Corrective Action:	No		
Project ID	CEPD-RCRA-08-0101		
Facility Physical Location: (Municipality, VI, zip code)	4007 Estate Diamond Ruby, Christiansted, St. Croix U.S.V.I. 00821		
Geographical Coordinates:	17.733637, - 64.751376		
Facility Owner:	Mr. Douglas E. Koch, Chief Executive Officer	(340) 772-7418 / (340) 474-1812	
	dkoch@jflusvi.org Mailing address: 4007 Estate Diamond Ruby, Christiansted, St. Croix U.S.V.I. 00821		
Facility Operator:	Ms. Hazel Philbert, Chief Operating Officer	(340) 778-6311 ext. 3302	
	hphilbert@jflusvi.org Mailing address: 4007 Estate Diamond Ruby, Christiansted, St. Croix U.S.V.I. 00821

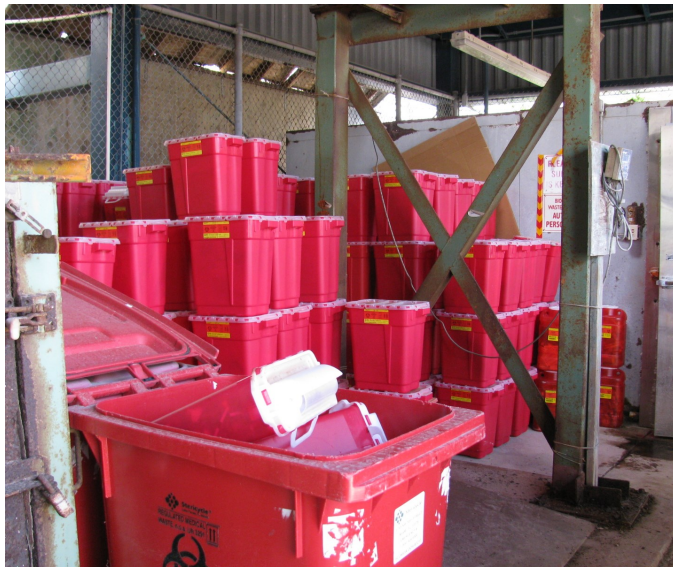
Picture 1 - GOV. JUAN F LUIS HOSPITAL, ST. CROIX- At the Incinerator Building Area, there were two auto sterilization units were out of service and provide a service for collecting, storing, inspecting, packing, and before delivering biomedical waste in red plastic bags and then transferred into DOT boxes.

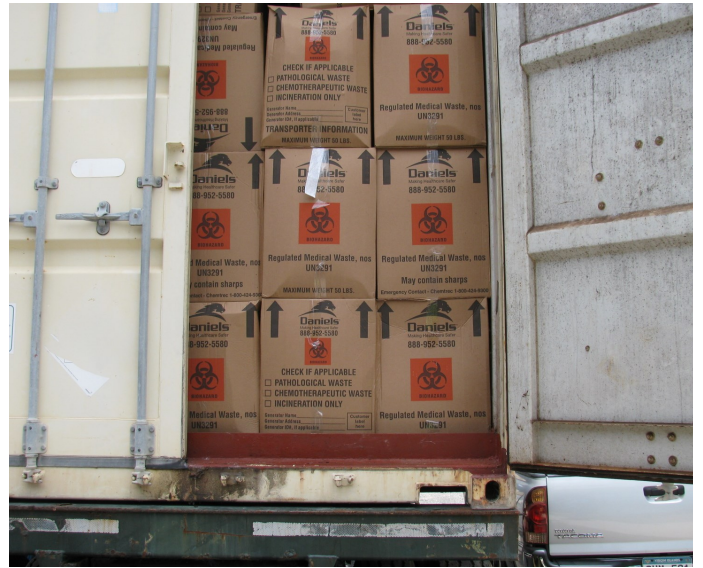
Picture 2 - GOV. JUAN F LUIS HOSPITAL, ST. CROIX- At Incinerator Building Area, biomedical wastes are packed every two weeks into DOT boxes which requires that boxes are arrowed up, no packed on the side before they are picked up by VI Regulated Waste.

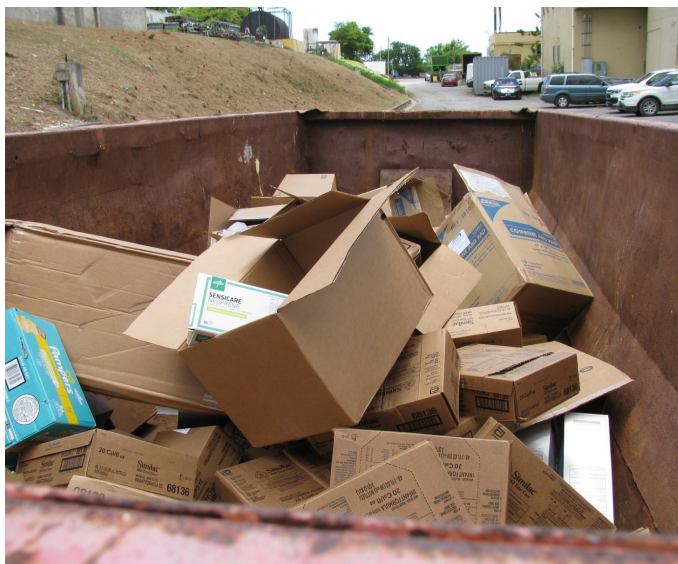
I proceeded to inspect the Backyard Area of the Hospital since most of the domestic waste are accumulated and stored in this area. As observed, there was one (1) 20-cubic yard dumpster containing domestic Hospital wastes (see **Picture 3**). Nearby the dumpster, there was one (1) 330-gallon tote containing hand sanitizer that was donated to the JFL Hospital during the COVID-19 pandemic (see **Picture 4**). According to Ms. Encarnacion-Pascal, the hand sanitizer was in use until three (3) months ago that was decommissioned and moved to this location for disposal. As observed, the tote seemed like being abandoned and identified with its hazard communication pictogram as, “Flammable Liquids.” I explained to Ms. Encarnacion-Pascal, if a VSQG accumulates at any time 1,000 kilograms (2,200 lbs) or greater of non-acute hazardous waste limits, all quantities of that hazardous waste are subject to additional conditions for exemption and independent requirements such labeling with the words,

Picture 3 - GOV. JUAN F LUIS HOSPITAL, ST. CROIX- At the Hospital Backyard Area most of the domestic waste are accumulated and stored in this area. As observed, there was one (1) 20-cubic yard dumpster containing domestic Hospital wastes.

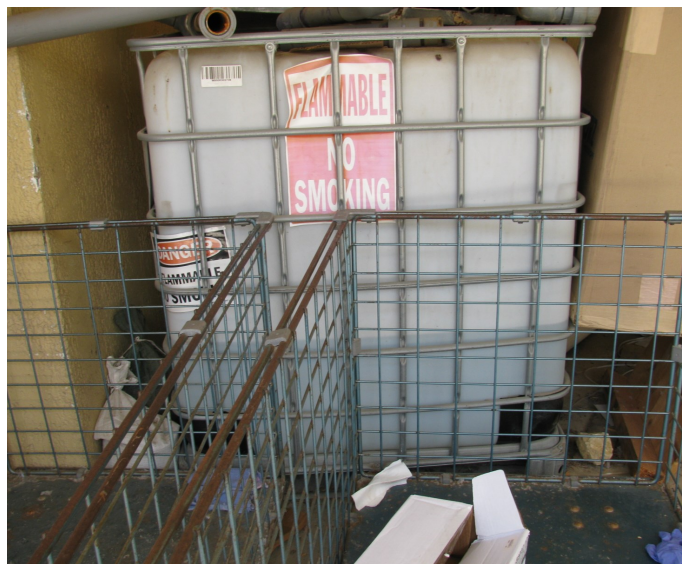
At the time of the Inspection, I observed one (1) 330-gallon tote containing hand sanitizer that was donated to the JFL Hospital during the COVID-19 pandemic and abandoned at the Backyard of the JFL Hospital. As explained, if a VSQG accumulates at any time 1,000 kilograms (2,200 lbs) or greater of non-acute hazardous waste limits, all quantities of that hazardous waste are subject to additional conditions for exemption and independent requirements such labeling with the words, "Hazardous Waste," and dated with its accumulation start date, posting hazard communication pictogram and be held on site for no more than 180 days.

Picture 4 - GOV. JUAN F LUIS HOSPITAL, ST. CROIX- At the Hospital Backyard Area, there was one (1) 330-gallon tote containing hand sanitizer that was donated to the JFL Hospital during the COVID-19 pandemic that was in use until three (3) months ago, decommissioned and moved to this location for disposal.

Gov. Juan F Luis Hospital's Response: On September 8, 2023, the 330-gallon tote containing "Discarded Hand Sanitizer" was clearly labeled with the words, "Hazardous Waste," coded as D001, identified with its hazard communication pictogram as, "Flammable Liquids," and dated with its accumulation start date of May 30, 2023, as required by RCRA program.

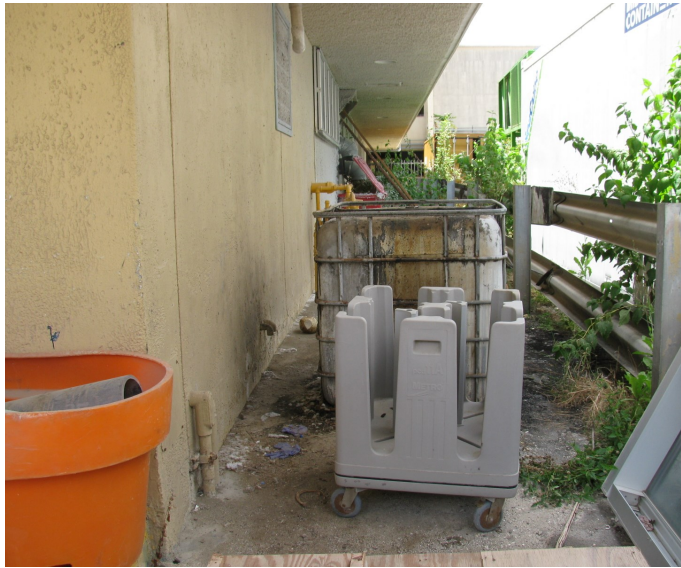
“Hazardous Waste,” and dated with its accumulation start date, and be held on site for no more than 180 days. Nearby the hand sanitizer tote, there was another 275-gallon tote containing discarded cooking oil and grease from JFL Hospital kitchen. I was told that it will be disposed of as non-hazardous waste with VI Regulated Waste (see **Picture 5**).

Picture 5 - GOV. JUAN F LUIS HOSPITAL, ST. CROIX- At the Hospital Backyard Area, there was one 275-gallon tote containing discarded cooking oil and grease from JFL Hospital kitchen that will be disposed of as non-hazardous waste with VI Regulated Waste.

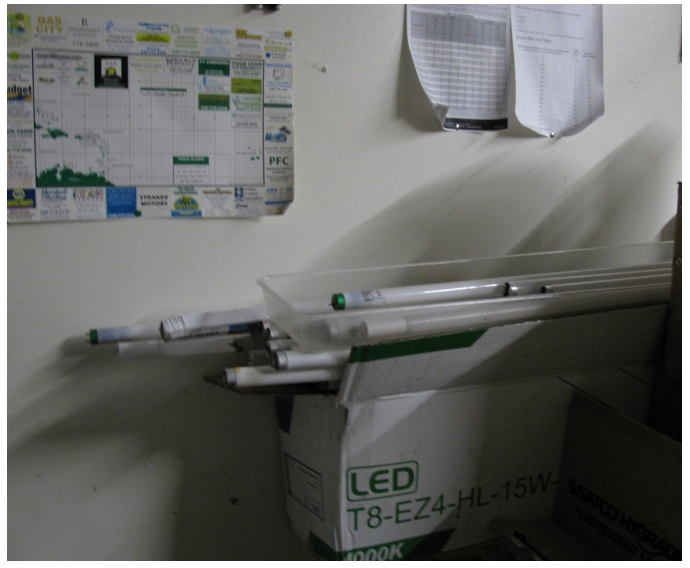
- Forty (40) loose 4-foot spent fluorescent lamps inside a white plastic bin and placed on top of some cardboard boxes, not labeled as “Universal Waste,” or dated (see **Picture 6**).
- One (1) cardboard box with twenty-one (21) 4-foot spent fluorescent lamps, open, not labeled as “Universal Waste,” or dated (see **Picture 7**).

At the time of the Inspection, I observed approximately forty (40) loose 4-foot spent fluorescent lamps inside a white plastic bin and placed on top of some cardboard boxes, not labeled as "Universal Waste," or dated, and one (1) cardboard box with twenty-one (21) 4-foot spent fluorescent lamps, open, not labeled as "Universal Waste," or dated.

Picture 6 - GOV. JUAN F LUIS HOSPITAL, ST. CROIX- At the Universal Waste Storage Area, there were forty (40) lose 4-foot spent fluorescent lamps inside a white plastic bin and placed on top of some cardboard boxes, not labeled as “Universal Waste,” or dated.

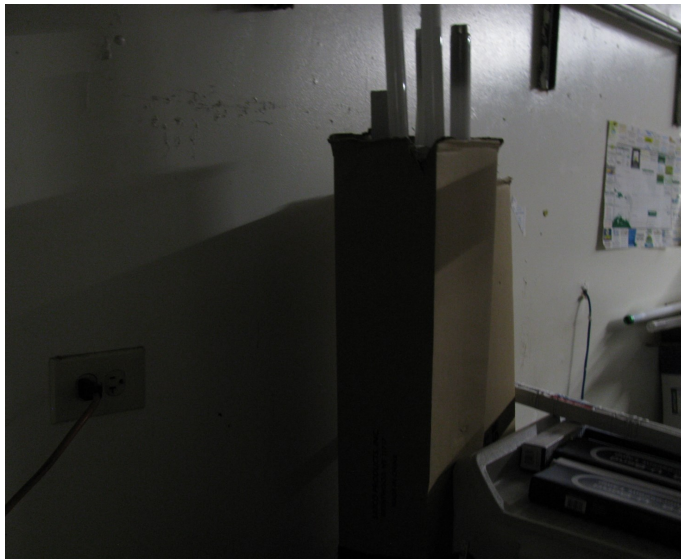
Picture 7 - GOV. JUAN F LUIS HOSPITAL, ST. CROIX- At the Universal Waste Storage Area, there was one (1) cardboard box with twenty-one (21) 4-foot spent fluorescent lamps, open, not labeled as “Universal Waste,” or dated , and no means to that prevents breakage and releases of hazardous constituents.

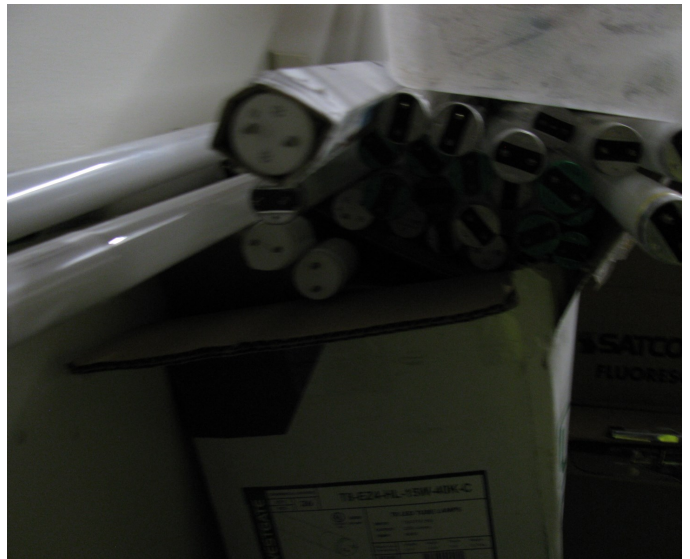
At the time of the Inspection, I observed a white plastic bin (approximate 2 gal) with some spent 4-foot fluorescent lamps, and other lamps placed on top of other cardboard boxes without any kind of protection from breakage (see **Picture 8**). In addition, individually packed and loose spent lamps were observed placed over the floor and on top of other boxes. I expressed the following concerns on the situation, many of these waste lamps could break when moved inside the bin, and the loose ones that were placed over the cardboard boxes, could fit between the gaps of the boxes, fall and break. Ms. Encarnacion-Pascal inquired about EPA recommended/approved method(s) to accumulate “Waste Lamps.” As a result, I indicated, that EPA requires universal waste generators to accumulate waste lamps in a way that prevents breakage and releases of hazardous constituents. Then, she asked if cardboard boxes were more appropriate, and indicated that it is the widely used method. She indicated that spent fluorescent lamps will be packed in appropriate cardboard boxes, labeled with the words, “Waste Lamps” and dated with its accumulation date.

Picture 8 - GOV. JUAN F LUIS HOSPITAL, ST. CROIX— At the Universal Waste Storage Area, it was observed a white plastic bin (approximate 2 gal) with some spent 4-foot florescent lamps, and other lamps placed on top of other cardboard boxes without any kind of protection from breakage .

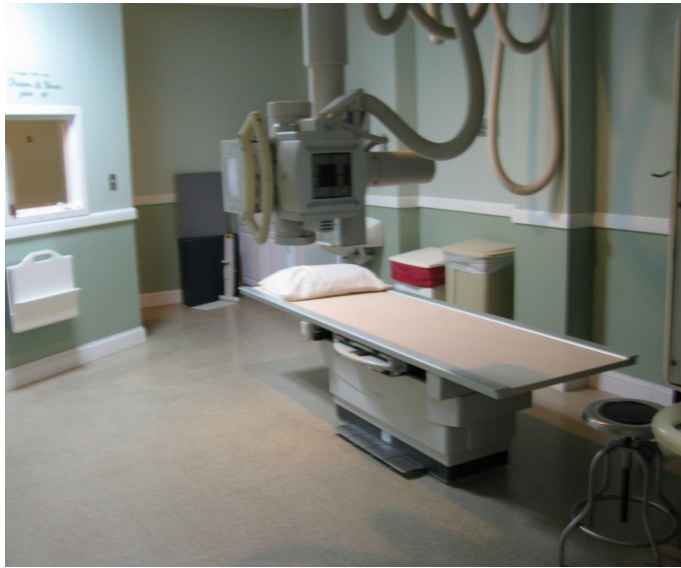
Picture 9 - GOV. JUAN F LUIS HOSPITAL, ST. CROIX- At the Radiology Diagnostic Imaging Area where X-rays negative and silver recovery process used to be performed in the past had being updated and used computer aided X-ray imaging. This area is discontinued and moved to JFL North Building.

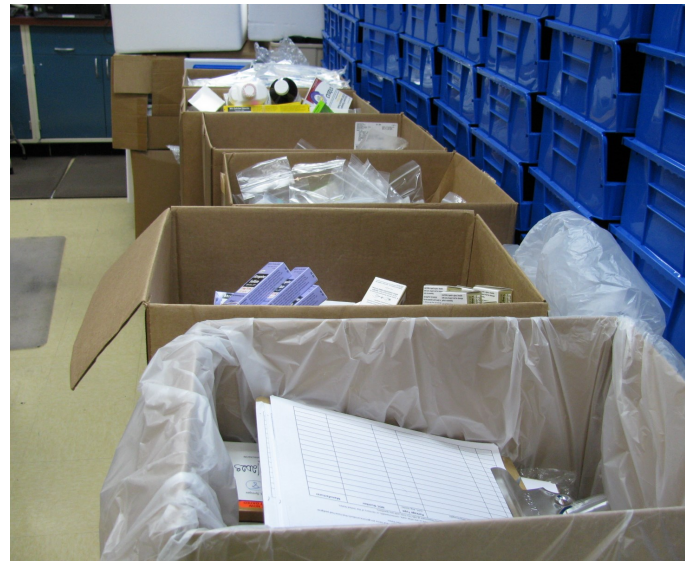
Picture 10 - GOV. JUAN F LUIS HOSPITAL, ST. CROIX- At the Pharmacy Area, off-specification and outdated medicines are managed under a creditable medicine and/or pharmaceutical waste program to receive manufacturer credit and a reverse distribution.

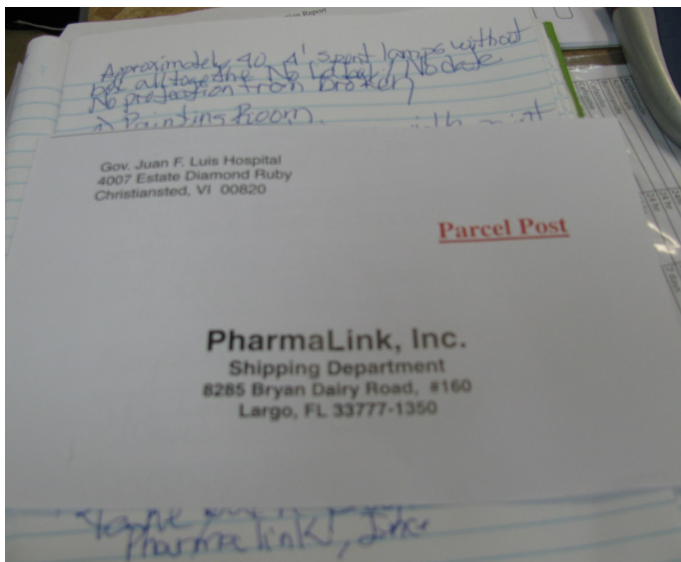
Picture 11 - GOV. JUAN F LUIS HOSPITAL, ST. CROIX- At the Pharmacy Area, off-specification medicines are generated in large amounts and are “lab packed” for final reverse credit as non-hazardous pharmaceutical waste by reverse distributor Pharm Link, Inc.

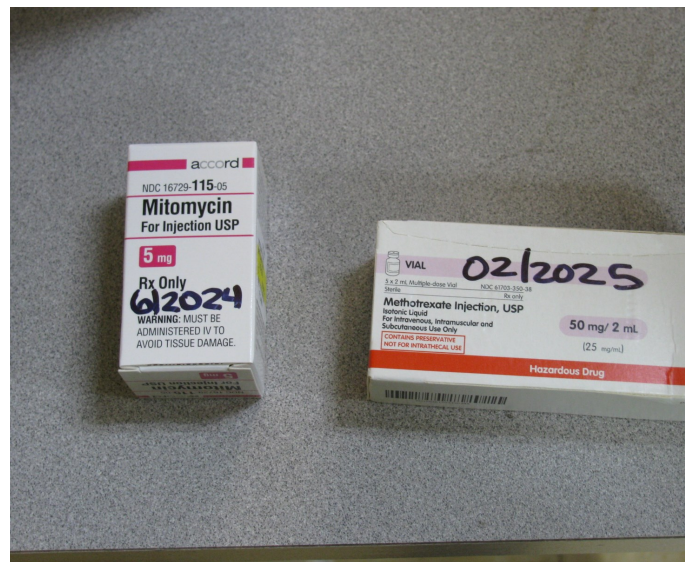
- Mitomycin (CAS# 50-07-7) - is a cytotoxic agent that belongs to the group of medicines known as antineoplastics. It is used to treat some kinds of cancer. The material and its container must be disposed of as hazardous waste (RCRA Hazardous Waste Code U010) (see **Picture 12**).

Picture 12 - GOV. JUAN F LUIS HOSPITAL, ST. CROIX— At the Pharmacy Area, “Mitomycin” is a cytotoxic agent known as antineoplastics which is used to treat some kinds of cancer. The material and its container must be disposed of as hazardous waste (RCRA Hazardous Waste Code U010).

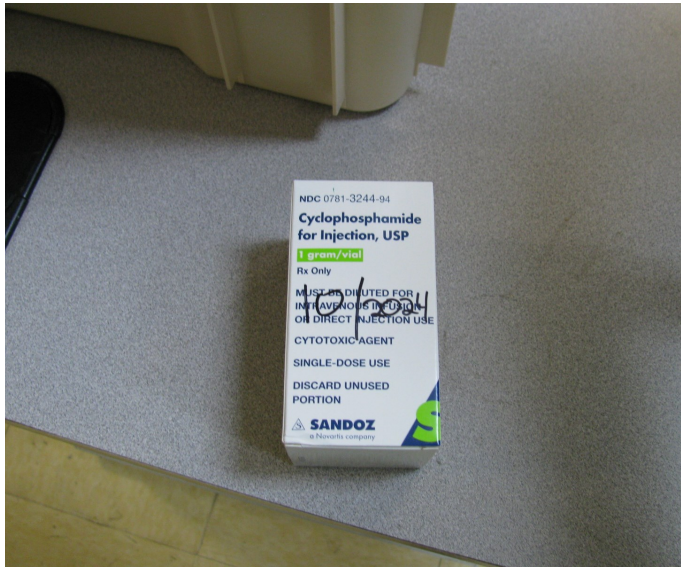
- Cyclophosphamide (CAS# 50-18-0) - is used to treat cancer of the ovaries, breast, blood and lymph system, and nerves (mainly in children). Cyclophosphamide is also used for retinoblastoma (a type of eye cancer mainly in children), multiple myeloma (cancer in the bone marrow), and mycosis fungoides (tumors on the skin). The material and its container must be disposed of as hazardous waste (RCRA Hazardous Waste Code U058) (see **Picture 13**).

Picture 13 - GOV. JUAN F LUIS HOSPITAL, ST. CROIX- At the Pharmacy Area, “Cyclophosphamide” is used to treat cancer of the ovaries, breast, blood and lymph system, and nerves. The material and its container must be disposed of as hazardous waste (RCRA Hazardous Waste Code U058).

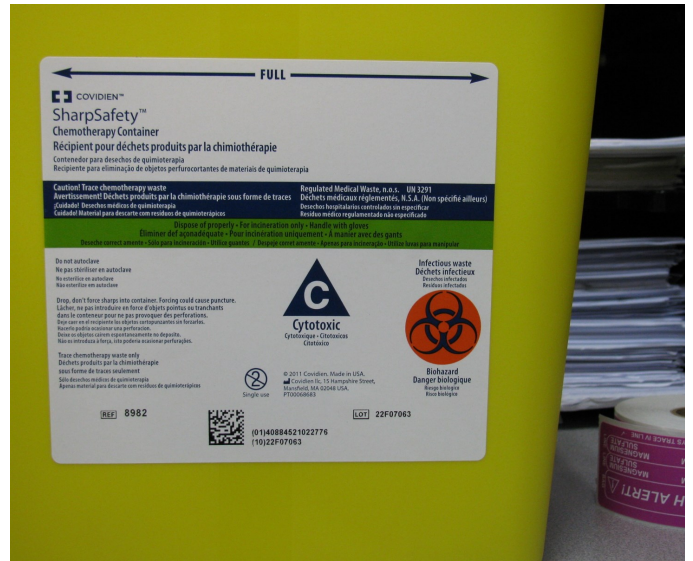
- Chemotherapy Sharp Yellow Container – Used syringes, needles, and chemotherapy agent vials must be thrown away in a “sharps” one (1) 1-gallon yellow container. All syringes, needles, vials, alcohol swabs, and bandages that have come in contact with chemotherapy agents or with blood or body fluid are “Hazardous Pharmaceutical Waste,” Hazardous Wastes,” and/or “Chemotherapy Waste,” (see **Picture 14**).

Picture 14 - GOV. JUAN F LUIS HOSPITAL, ST. CROIX- At the Pharmacy Area, “Chemotherapy Sharp Containers” are used for syringes, needles, and chemotherapy agent vials must be thrown away in a “sharps” one (1) 1-gallon yellow container that have come in contact with chemotherapy agents.

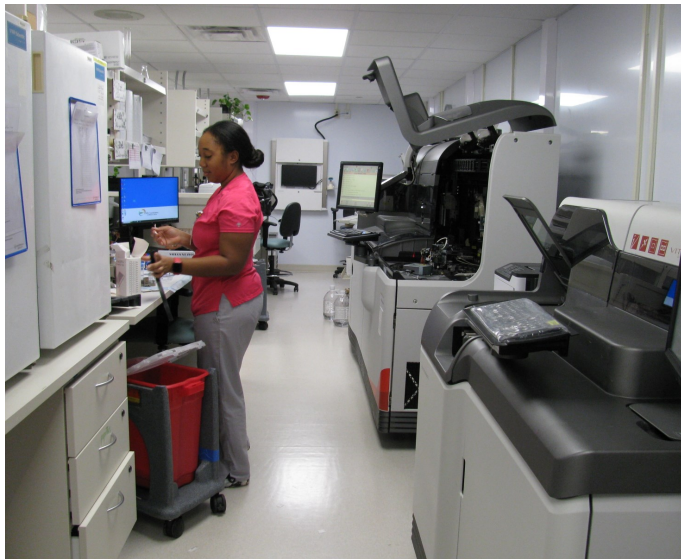
Picture 15 - GOV. JUAN F LUIS HOSPITAL, ST. CROIX- At the Laboratory Health Clinic Area, Biomedical Red Containers are used for solid wastes disposal as Medical Wastes using biohazard plastic bags and red containers for sharp discarded objects (i.e., needles).

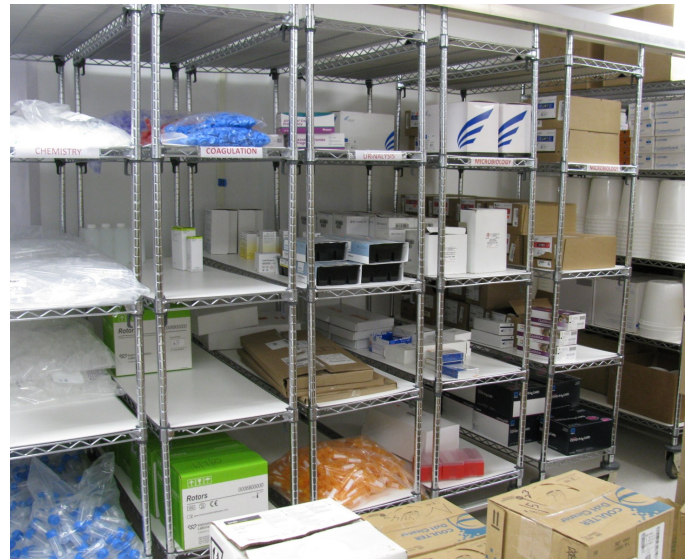
I proceeded to inspect the Laboratory Storage Room located at JFL North Building where all chemical reactants and clinical test are stored in shelves and cabinets. All chemical reactants were clearly identified, and stored, and seemed in good conditions (see **Picture 16**).

Picture 16 - GOV. JUAN F LUIS HOSPITAL, ST. CROIX— At the Laboratory Storage Room located at JFL North Building where all chemical reactants and clinical test are stored in shelves and cabinets. All chemical reactants were clearly identified, and stored, and seemed in good conditions.

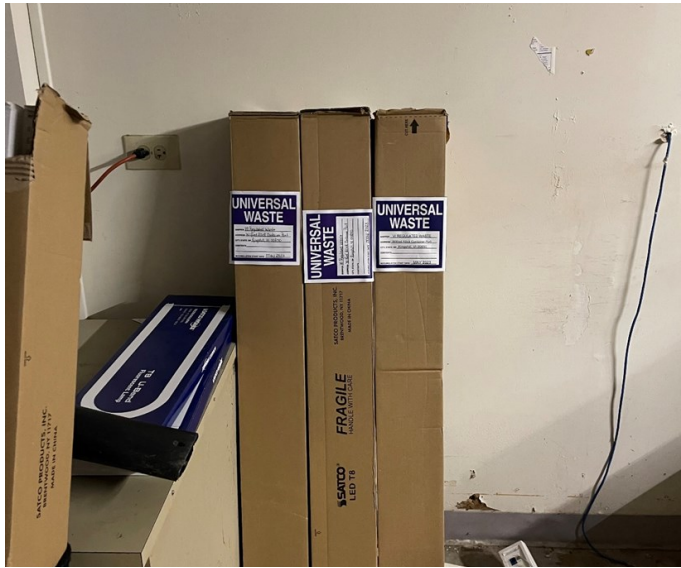
Picture 17 - GOV. JUAN F LUIS HOSPITAL, ST. CROIX- At the Universal Waste Storage Area, three (3) cardboard boxes with 4-foot spent fluorescent lamps were clearly labeled as “Universal Waste,” and all dated on May 1, 2023 after re-inspection on September 8, 2023.

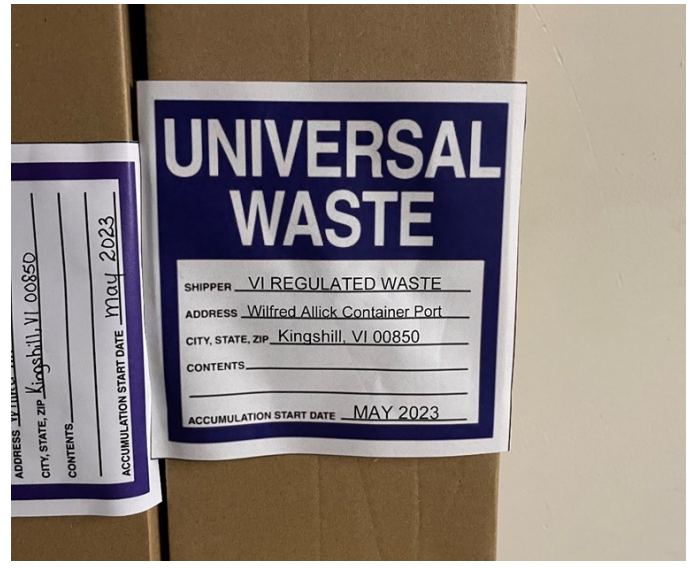
Picture 18 - GOV. JUAN F LUIS HOSPITAL, ST. CROIX- At the Universal Waste Storage Area, all forty (40) spent 4-foot florescent lamps placed on top of other cardboard boxes without any kind of protection from breakage were packed in 4-foot cardboard boxes after re-inspection on September 8, 2023.

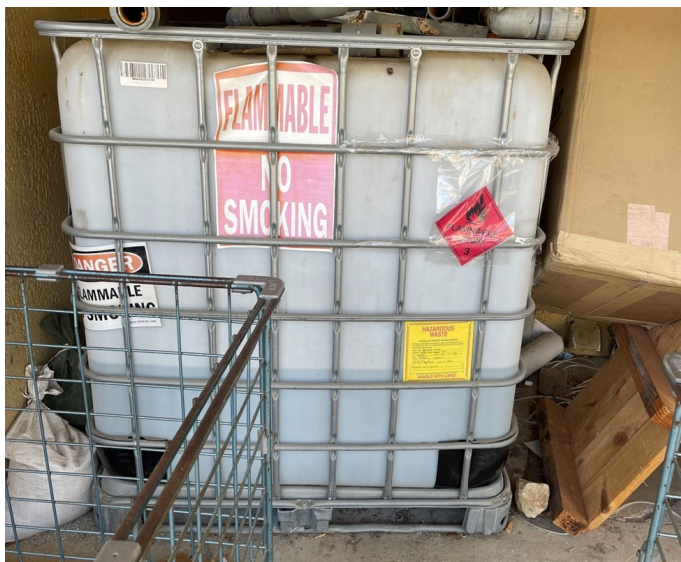
- One (1) 330-gallon tote containing “Discarded Hand Sanitizer” clearly labeled with the words, “Hazardous Waste,” coded as D001, identified with its hazard communication pictogram as, “Flammable Liquids,” and dated with its accumulation start date of May 30, 2023 (see **Pictures 19 and 20**).

Picture 19 - GOV. JUAN F LUIS HOSPITAL, ST. CROIX- At the Hospital Backyard Area, the one (1) 330-gallon tote containing “Discarded Hand Sanitizer” was clearly labeled with the words, “Hazardous Waste,” coded as D001 after the re-inspection on September 8, 2023.

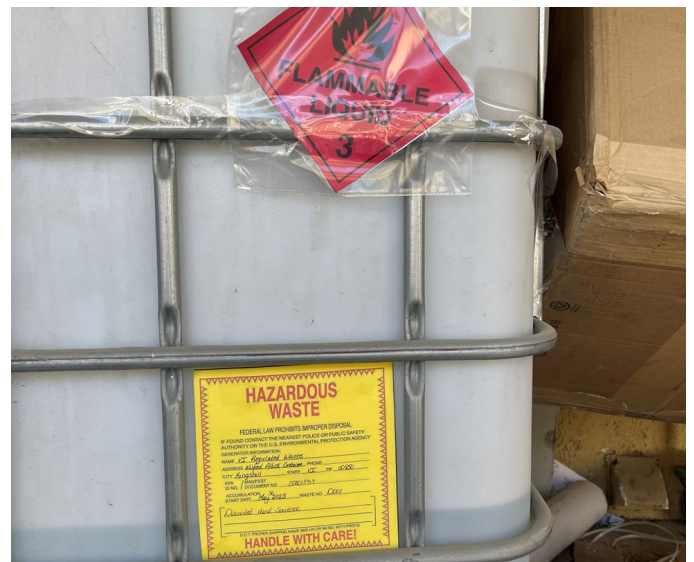
Picture 20 - GOV. JUAN F LUIS HOSPITAL, ST. CROIX— At the Hospital Backyard Area, the one (1) 330-gallon tote containing “Discarded Hand Sanitizer” was also identified with its hazard communication pictogram as, “Flammable Liquids,” and dated with its accumulation start date of May 30, 2023.
