## RCRA Compliance Evaluation Inspection Report

Piper Aircraft Inc.  
2926 Piper Dr.  
Vero Beach, Florida 32960  
Indian River County

March 8, 2023, 10:30 a.m.

Piper Aircraft Inc.  
FLD004054284  
March 8, 2023  
RCRA CEI Photographs  
Photographs by Parvez Mallick, EPA  
Camera: Canon PowerShot

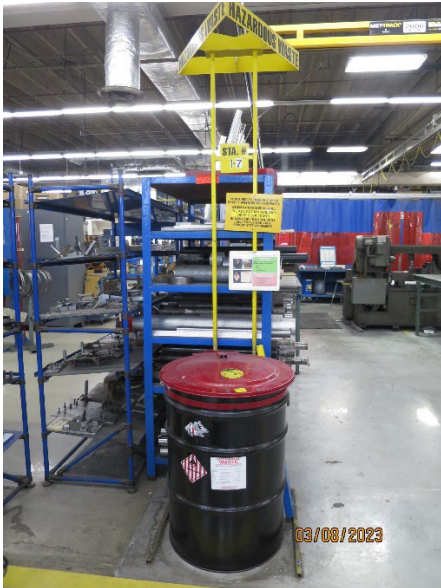
The Fabrication/Tooling area of this building is where the tools to make the parts are fabricated. Waste generated in this area includes waste acetone and spent solvent rags when cleaning the parts. One closed 55-gallon satellite accumulation area (SAA) container of waste acetone and filters, flammable solids (EPA Waste Codes D001, D007, D035, F003, and F005), was marked “Hazardous Waste” and with an indication of the hazards of the contents (Photo #1).

Photo #1 – Building 1- a 55-gallon container of waste acetone and filters, flammable solids.

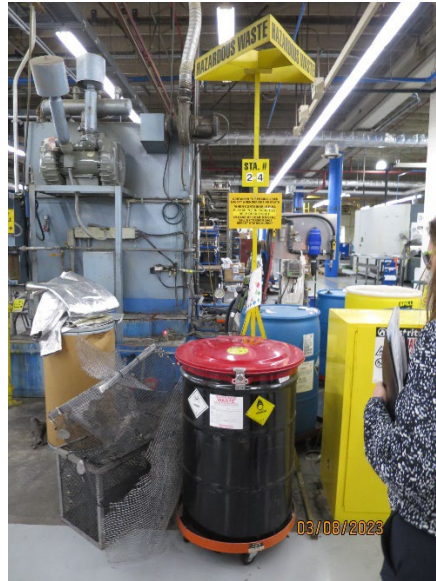
- One open 55-gallon container of non-hazardous “Oil Dry Solids”;
- One closed 55-gallon container of chromium salt and debris (EPA Waste Codes D001 and D007) marked “Hazardous Waste,” “Oxidizer,” and with an indication of the hazards of the contents (Photo #2); and
- One closed 55-gallon container of acetone rags marked “Hazardous Waste” and with an indication of the hazards of the contents in the laser cutting area.

Photo #2 – Building 2- 55-gallon container of hazardous waste chromium salt and debris.

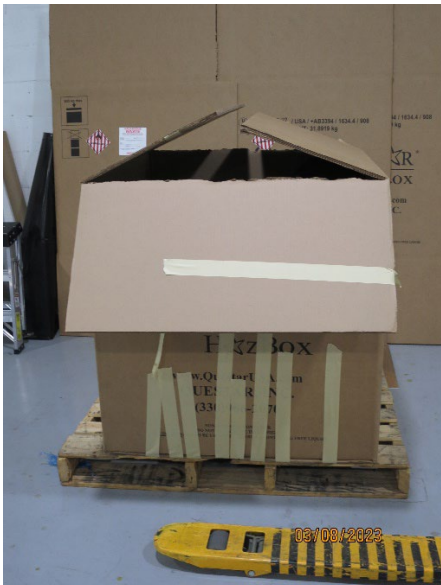
- One open cubic yard cardboard box of hazardous paint booth filters with no markings, indication of the hazards of the contents, and accumulation start date at the time of the inspection (Photo #3). *Since the cubic yard container exceeds the 55-gallon maximum requirement for SAA, the facility shall either move this container to the central accumulation area (CAA) or treat this area as a CAA in accordance with 40 C.F.R. § 262.17. The container also requires an accumulation start date in accordance with 40 C.F.R. § 262.17(a)(5)(i)(A-C). If the facility elects to manage this area as a central accumulation area, the containers in this area will require weekly inspections and documentation as required by 40 C.F.R. § 262.17(a)(1)(v) and Fla. Admin. Code Ann. r. 62-730.160(3), F.A.C.; and*

Photo #3 – Building 3 - cubic yard paint booth filters box not marked or dated.

**Pursuant to Fla. Admin. Code Ann. r. 62-730.160(1) [40 C.F.R. § 262.17(a)(5)(i)(A-C)], which is a condition of the LQG Permit Exemption, a generator must mark or label its containers with the following: (A) The words “Hazardous Waste”; (B) an indication of the hazards of the contents (examples include, but are not limited to, the applicable hazardous waste characteristic(s) (i.e., ignitable, corrosive, reactive, toxic); hazard communication consistent with the Department of Transportation requirements at 49 C.F.R. part 172 subpart E (labeling) or subpart F (placarding); a hazard statement or pictogram consistent with the Occupational Safety and Health Administration Hazard Communication Standard at 29 C.F.R. 1910.1200; or a chemical hazard label consistent with the National Fire Protection Association code 704); and (C) the date upon which each period of accumulation begins clearly visible for inspection on each container.**

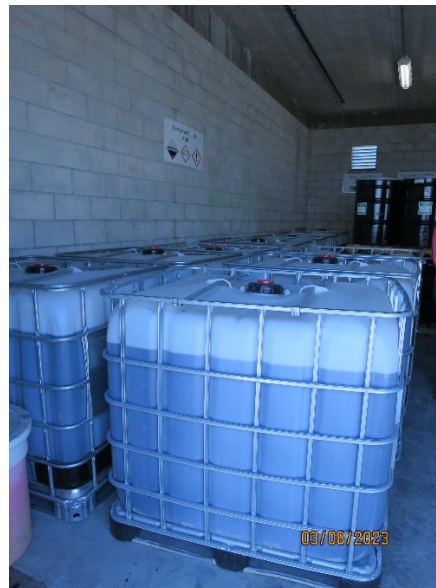
- Ten 250-liter totes marked “Hazardous Waste,” “Corrosive,” marked with an indication of the hazards of the contents, and with an accumulation start date (Photo #4);

Photo #4 – CAA Building – 250-liter totes of corrosive waste marked and dated.

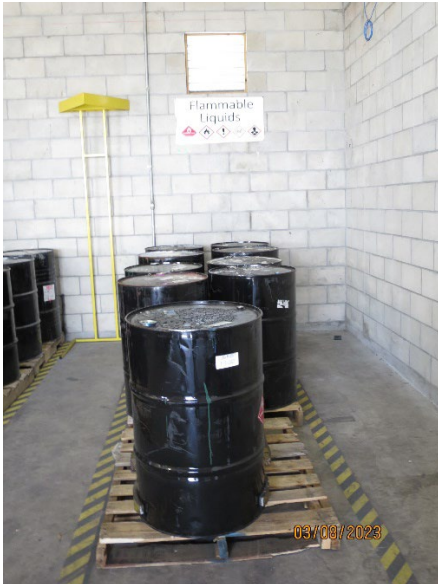
- Nineteen closed 55-gallon containers marked “Hazardous Waste,” “Flammable Liquids,” marked with an indication of the hazards of the contents, and with an accumulation start date (Photo #5);

Photo #5 – CAA Building – containers liquid flammable hazardous waste.

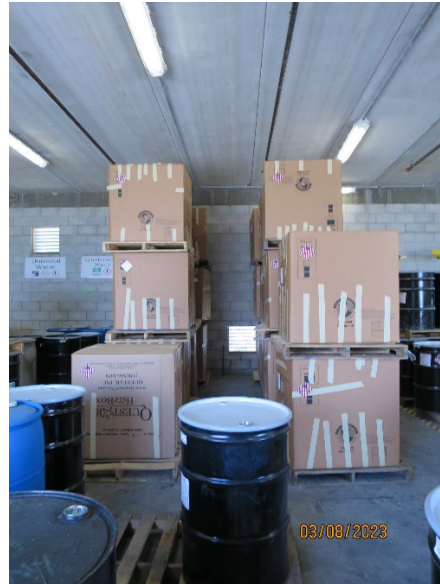
- Twenty-one closed cubic yard boxes of paint waste filters marked “Hazardous waste” marked with an indication of the hazards of the contents, and with an accumulation start date (Photo #6);

Photo #6 – CAA Building – cubic yard boxes of paint waste filters.

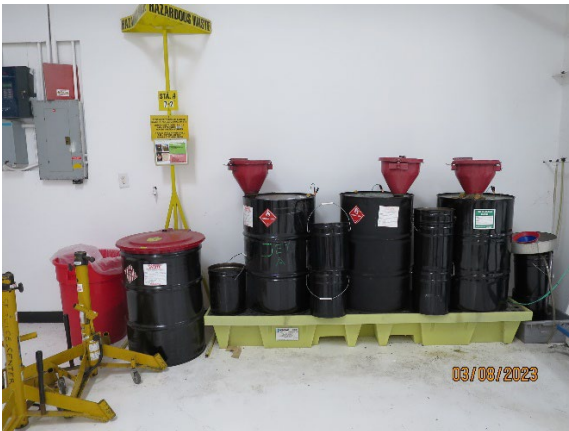
The interiors of all production aircraft including upholstery are put together in Building 7. Building 7 also serves as a service center where maintenance is done on the aircrafts. The inspectors observed two SAAs in separate locations in this building (Photo #7):

Photo #7 – One of the SAA in Building 7.

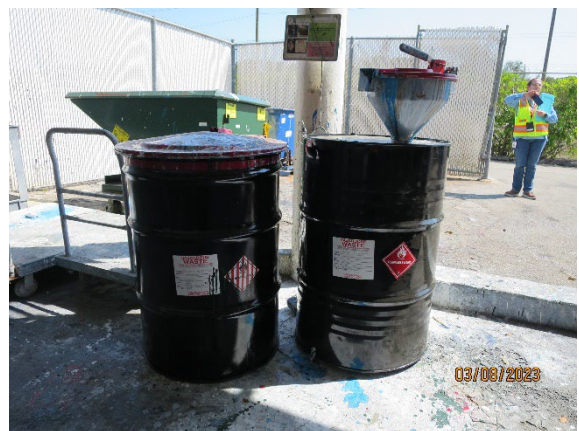
The facility also stores paint waste materials and product acetone in the outside area of Building 9 (Photo #8). There were two parts washers that are used to clean the paint guns and the parts washers are serviced by Crystal Clean. The inspectors observed one closed 55-gallon of waste paint materials marked "Hazardous waste" with an indication of hazards of the contents. One closed 55-gallon container of waste acetone rags marked "Hazardous Waste," "Flammable Solid," and with an indication of the hazards of the contents. The inspectors indicated that SAA container be established "at or near" the point of generation and must be "under the control of the operator." Consolidating or bringing hazardous waste into containers not located at or near the point of generation does not meet the SAA container requirements per 40 C.F.R. § 262.15(a).

Photo #8 – Building 9 – two 55-gallon SAA hazardous waste containers located outside the building.

**Pursuant to Fla. Admin. Code Ann. r. 62-730.160(1) [40 C.F.R. § 262.15(a)], and is a condition of the SAA Permit Exemption, a generator may accumulate as much as 55 gallons of non-acute hazardous waste and/or either one quart of liquid acute hazardous waste listed in § 262.31 or § 262.33(e) of this chapter or 1 kg (2.2 lbs) of solid acute hazardous waste listed § 262.31 or § 262.33(e) of this chapter in containers at or near any point of generation where wastes initially accumulate which is under the control of the operator of the process generating the waste, without a permit or interim status and without complying with the requirements of parts 124, 264 through 267, and 270 of this chapter, provided that all of the conditions for exemption in this section are met.**
