## **RCRA Inspection Report**

T G Kentucky LLC  
633 East Main St.  
Lebanon, Kentucky 40033

EPA ID#: KYR000018572  
NAICS #: 336390 – Other Motor Vehicle Parts  
Manufacturing

August 3, 2023 at 9:00 AM

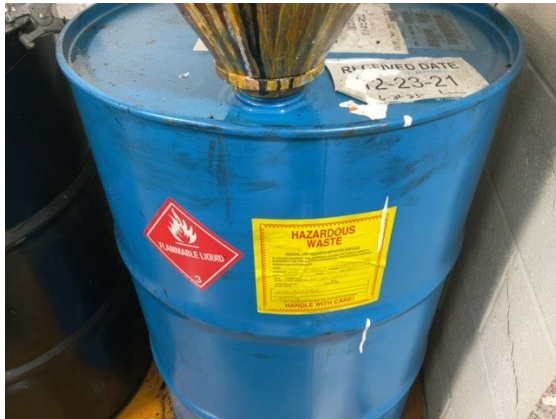
- One (1) 55-gallon container of waste ink (Photo 1). The container was closed, labeled “Hazardous Waste”, and marked with an indication of the hazard of the contents (flammable liquid).
- One (1) 55-gallon container with a puncture device for draining remaining hazardous waste liquid from waste aerosol cans (Photo 2). The container was closed, labeled “Hazardous Waste”, and marked with an indication of the hazard of the contents (flammable liquid).
- Two (2) 4ft cardboard boxes of spent fluorescent bulbs (Photo 3). The containers were closed were both labeled “Universal Waste”. The containers had start accumulation dates of 08/01/2023 and 02/24/2023 respectively.
- One (1) 8ft cardboard box of spent fluorescent bulbs. The container was closed and labeled “Universal Waste” with a start accumulation date of 02/24/2023 (Photo 4).

**Photo 1:** 55-gal container of waste ink. Container was closed, labeled “Hazardous Waste”, and marked with an indication of the hazards of the content.

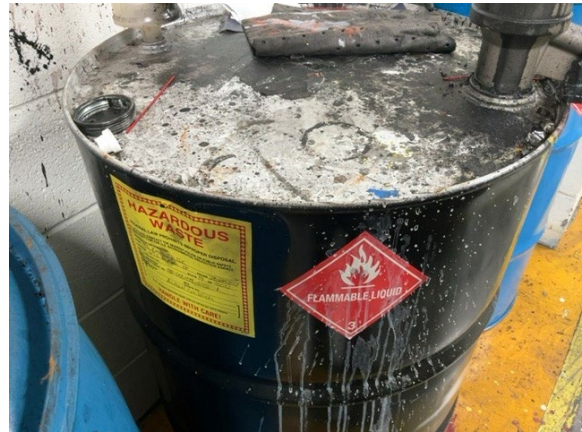
**Photo 2:** 55-gal container of aerosol can liquid with puncture device on top. Container was closed, labeled “Hazardous Waste”, and marked with an indication of the hazards of the content.

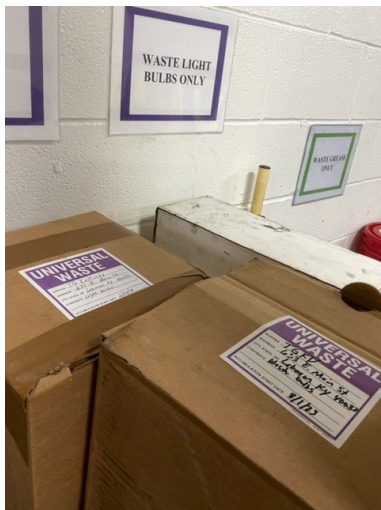
**Photo 3:** 4ft. Universal Waste lamps. Closed, labeled “Universal Waste”, and dated.

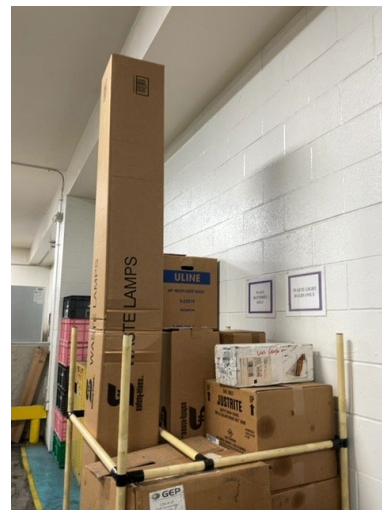
**Photo 4:** 8 ft. Universal Waste lamps. Closed, labeled “Universal Waste”, and dated.

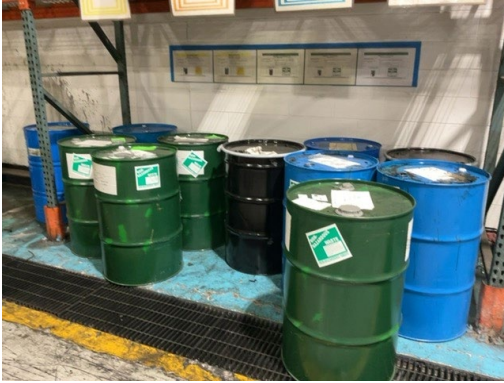
- 10 55-gallon containers labeled “non-hazardous waste” (Photo 5).
- One (1) 250-gallon tote of used oil. The tote was staged under a sign that was labeled “Used Oil” but the container itself was not labeled with the words “Used Oil” (Photo 6).

**Photo 5:** Non-hazardous waste storage area.

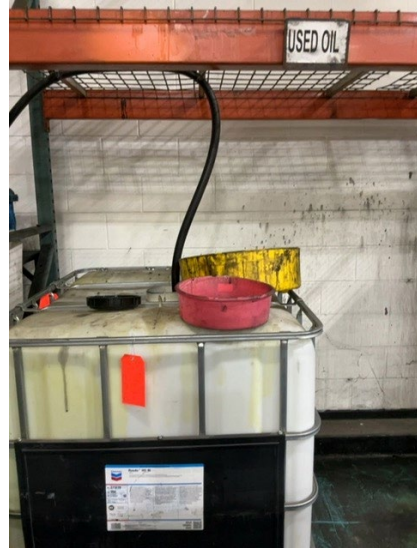
**Photo 6:** 250-gal tote with used oil. Container is not labeled “Used Oil”.

**Pursuant to 401 KAR 39:080, Section 4(1) [40 C.F.R 279.22(c)(1)], containers and aboveground tanks used to store used oil at generator facilities must be labeled or marked clearly with the words “Used Oil”.**

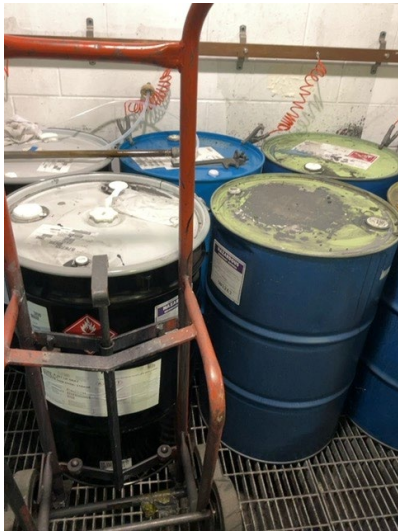
- Two (2) 55-gallon containers of lacquer thinner that were closed and labeled “Hazardous Secondary Material” with a hazard indication for flammable liquid (Photo 7).

**Photo 7:** Two (2) 55-gal containers of HSM—Lacquer Thinner.

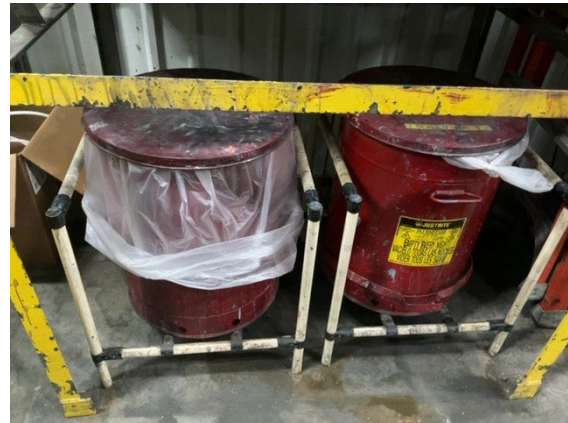
Next to Paint B the inspectors observed two (2) 5-gallon closed containers of solvent-contaminated rags labeled “Soiled Rags” (Photo 8). There was also no accumulation date for the solvent-contaminated rags.

**Photo 8:** Solvent-contaminated rags, labeled “Soiled Rags”.

**Pursuant to 401 K.A.R. 39:060, Section 3(1) [40 C.F.R. § 261.4(b)(18)(i)], the solvent-contaminated wipes, when accumulated, stored, and transported, are contained in non-leaking, closed containers that are labeled “Excluded Solvent-Contaminated Wipes.” The containers must be able to contain free liquids, should free liquids occur. During accumulation, a container is considered closed when there is complete contact between the fitted lid and the rim, except when it is necessary to add or remove solvent-contaminated wipes. When the container is full, or when the solvent-contaminated wipes are no longer being accumulated, or when the container is being transported, the container must be sealed with all lids properly and securely affixed to the container and all openings tightly bound or closed sufficiently to prevent leaks and emissions.**

**Pursuant to 401 K.A.R. 39:060, Section 3(1) [40 C.F.R. § 261.4(b)(18)(ii)], the solvent-contaminated wipes may be accumulated by the generator for up to 180 days from the start date of accumulation for each container prior to being sent for disposal.**

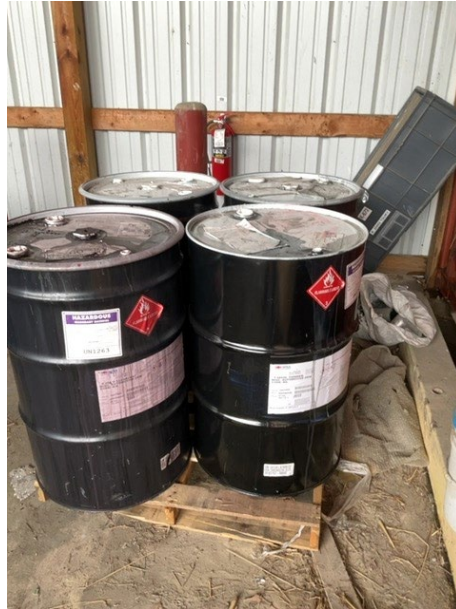
Located outside of the Main Campus Building under a roofed enclosure is the HSM storage area. The inspectors observed one pallet holding four (4) 55-gallon containers of HSM Lacquer Thinner (Photo 8). All of the containers were closed, labeled “Hazardous Secondary Material”, and marked with a hazard indication for flammable liquid.

**Photo 9:** Four (4) 55-gallon containers of HSM in HSM Storage Area.
