# NPDES Compliance Inspection Report

## DTG Recycle - Yakima

**NPDES Permit Tracking Number  
# WAG505030**

**Inspection Date: 01/29/2021**

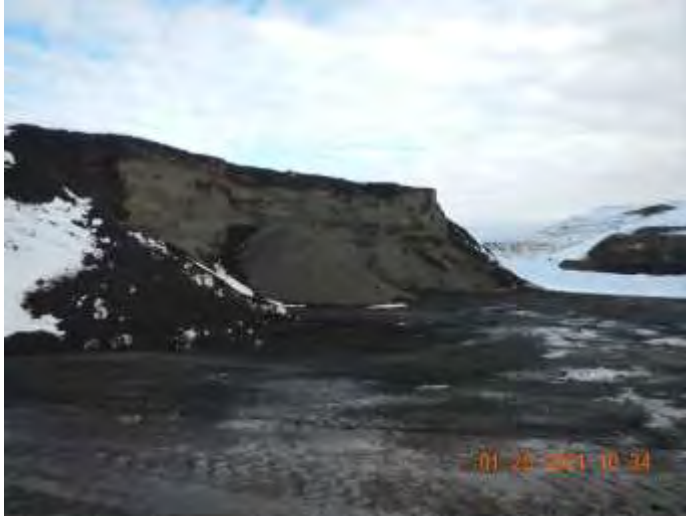
Photo #:01 (DSCN2036)  
Description: Facing northeast, photo of an upper mining area and stockpile within the quarry (east of access road).

To begin the facility tour, we left the main office area and drove separately to the upper mining quarry and associated stockpiles (**Photo 1**), a layer of snow covered the facility from a weather event a few days prior. From the upper quarry we viewed the lower pit (**Photo 2 and Photo 3**). According to Mr. Franklin the groundwater sampling location for S&G permit compliance is within the lower pit, where stormwater occasionally pools and infiltrates. According to Mr. Franklin, the facility has not had a surface water discharge. Best Management Practices (BMPs) for the S&G permitted areas generally include ditching and berming.

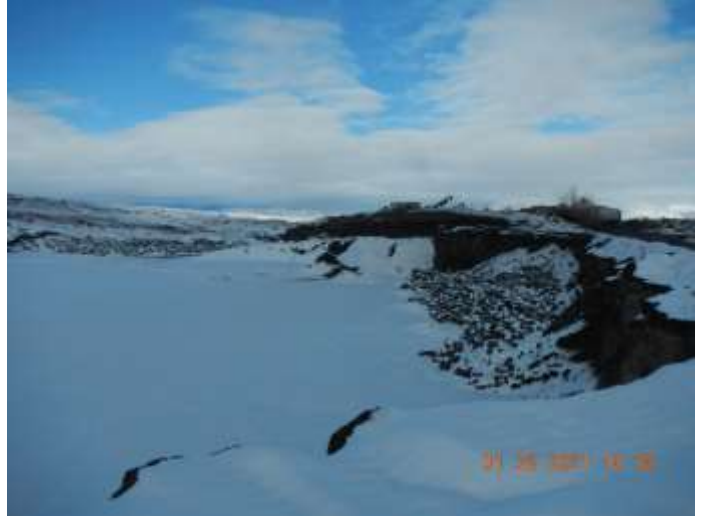
Photo #:02 (DSCN2037)  
Description: Facing northwest, photo of the northern side of lower pit within the quarry.

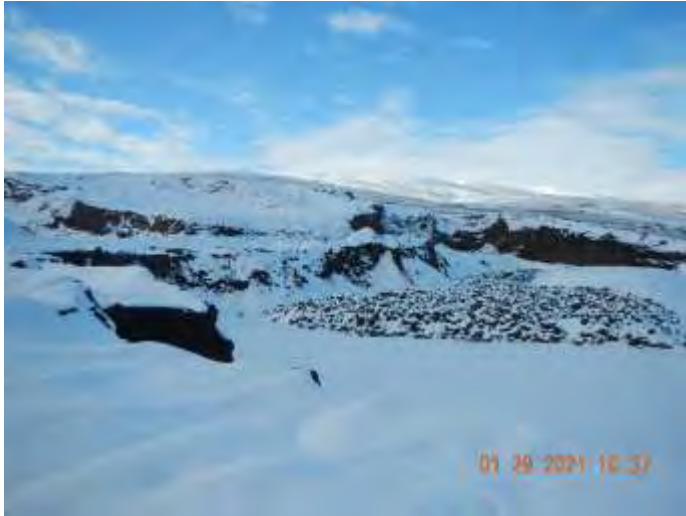
Photo #:03 (DSCN2038)  
Description: Facing southwest, photo of the southern portion of the lower pit within the quarry.

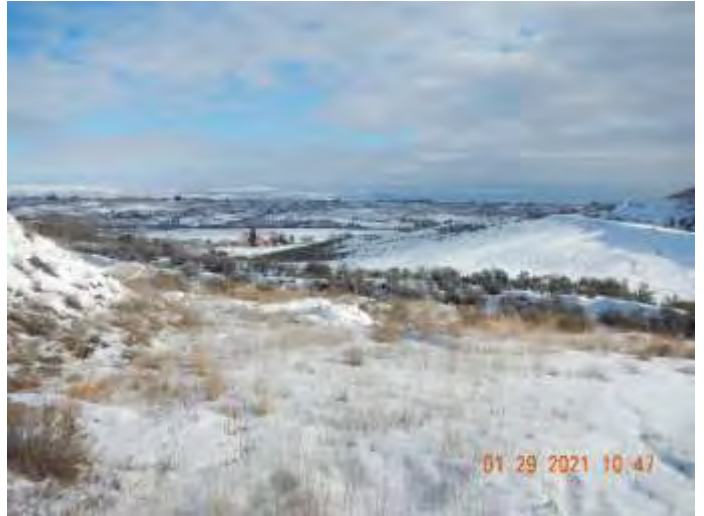
Photo #:04 (DSCN2039)  
Description: Facing east, photo of the area and berm between the upper mining area and the abandoned Yakima Tieton irrigation canal.

After viewing the lower pit, we toured the area to the north and east of the S&G operations including the large vegetative area between facility operations and the abandoned irrigation canal (**Photo 4**), a 3-foot-tall berm borders the canal (**Photo 5 and Photo 6**). We briefly discussed that if the facility ever decided to discharge to a surface water, the permit states that they would need to notify Ecology prior.

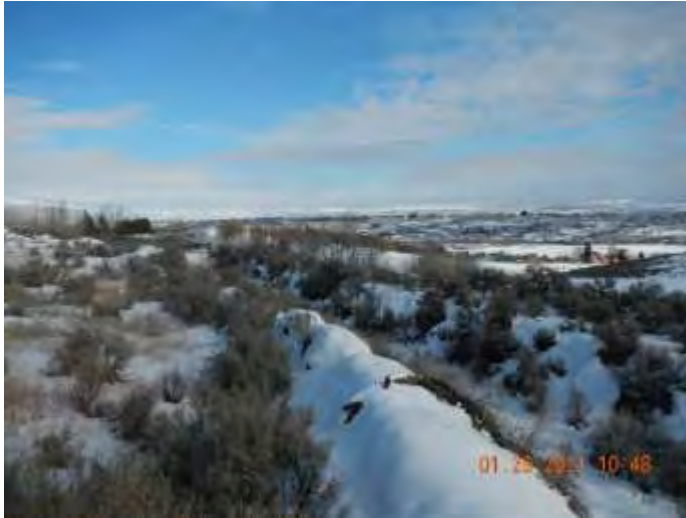
Photo #:05 (DSCN2040)

Description: Facing north, photo of the berm between quarry operations and the abandoned Yakima Tieton irrigation canal.

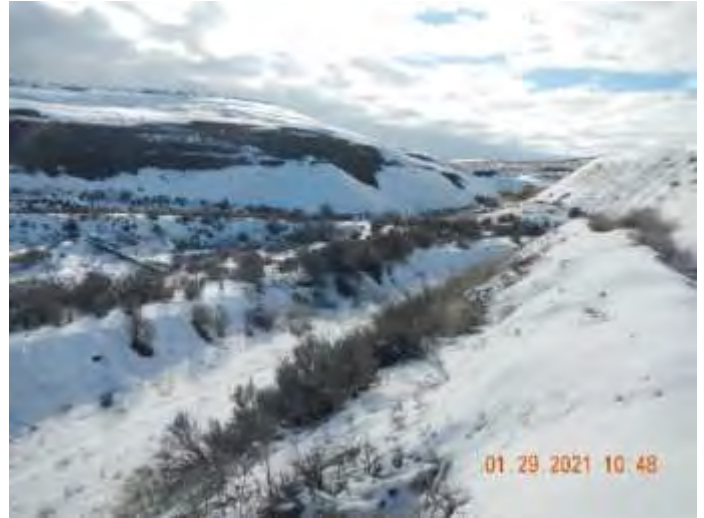
Photo #:06 (DSC2041)

Description: Facing south while standing on top of the berm between quarry operations and the abandoned Yakima Tieton irrigation canal.

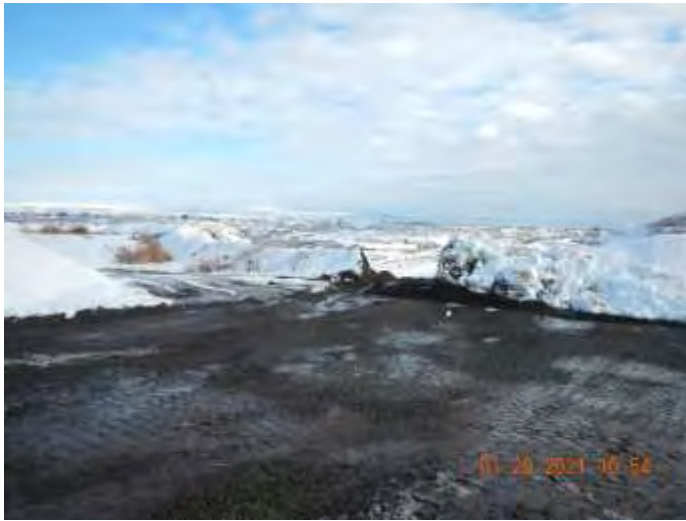
Photo #:07 (DSCN2042)

Description: Facing east, photo near the northeast corner of the upper quarry access road.

There are no paved areas within the S&G areas, stormwater from active areas of the site is either quickly infiltrated or occasionally channels downslope either to the main access road, lower pit, or to vegetated areas where it then infiltrates (**Photo 7 and Photo 8**).

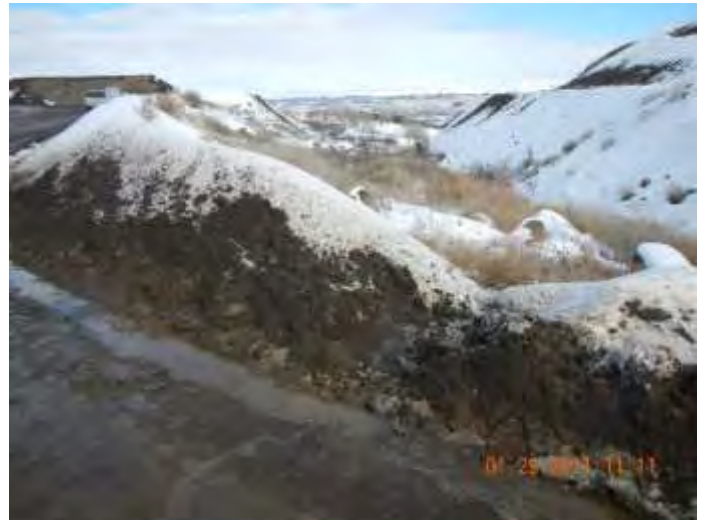
Photo #:08 (DSCN2043)

Description: Facing north, photo near the downslope/southern end of the access road. Snowmelt channeling and infiltrating in area between gravel operations and landfill operations.

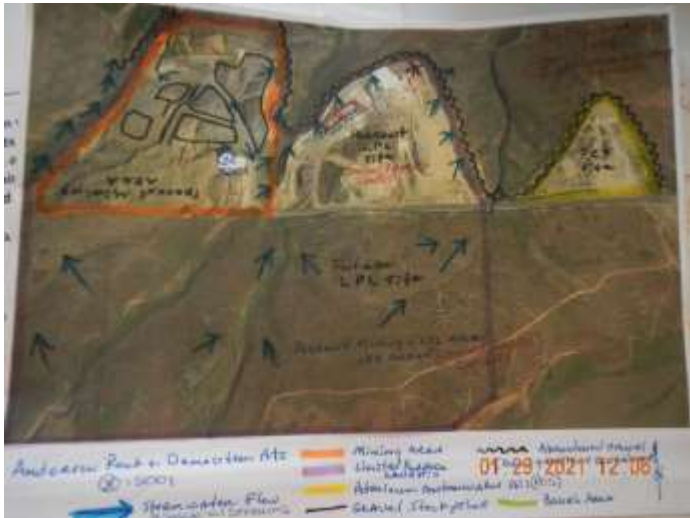
Photo #:09 (DSCN2044)  
Description: Photo of the facilities site map.

- Site Map – the facility's site map used for permit compliance was reviewed on-site (**Photo 9**). The facility had a few iterations of the map available to review, all had been developed under the previous ownership name (Anderson Rock and Demolition Pits). The map reflected the current site operations and features observed during the facility tour.
