Clean Water Act Section 404: Site Visit/Case Development

Site Name: Battaglia Properties

Site Address*: 2 Dikeman Drive (Parcel ID: 122-1-2.1) & 6 Dikeman Drive (Parcle ID: 122-1-2.2)

EPA CWA 404 Inspection Photolog
Battaglia Properties
2 & 6 Dikeman Drive
Goshen, NY

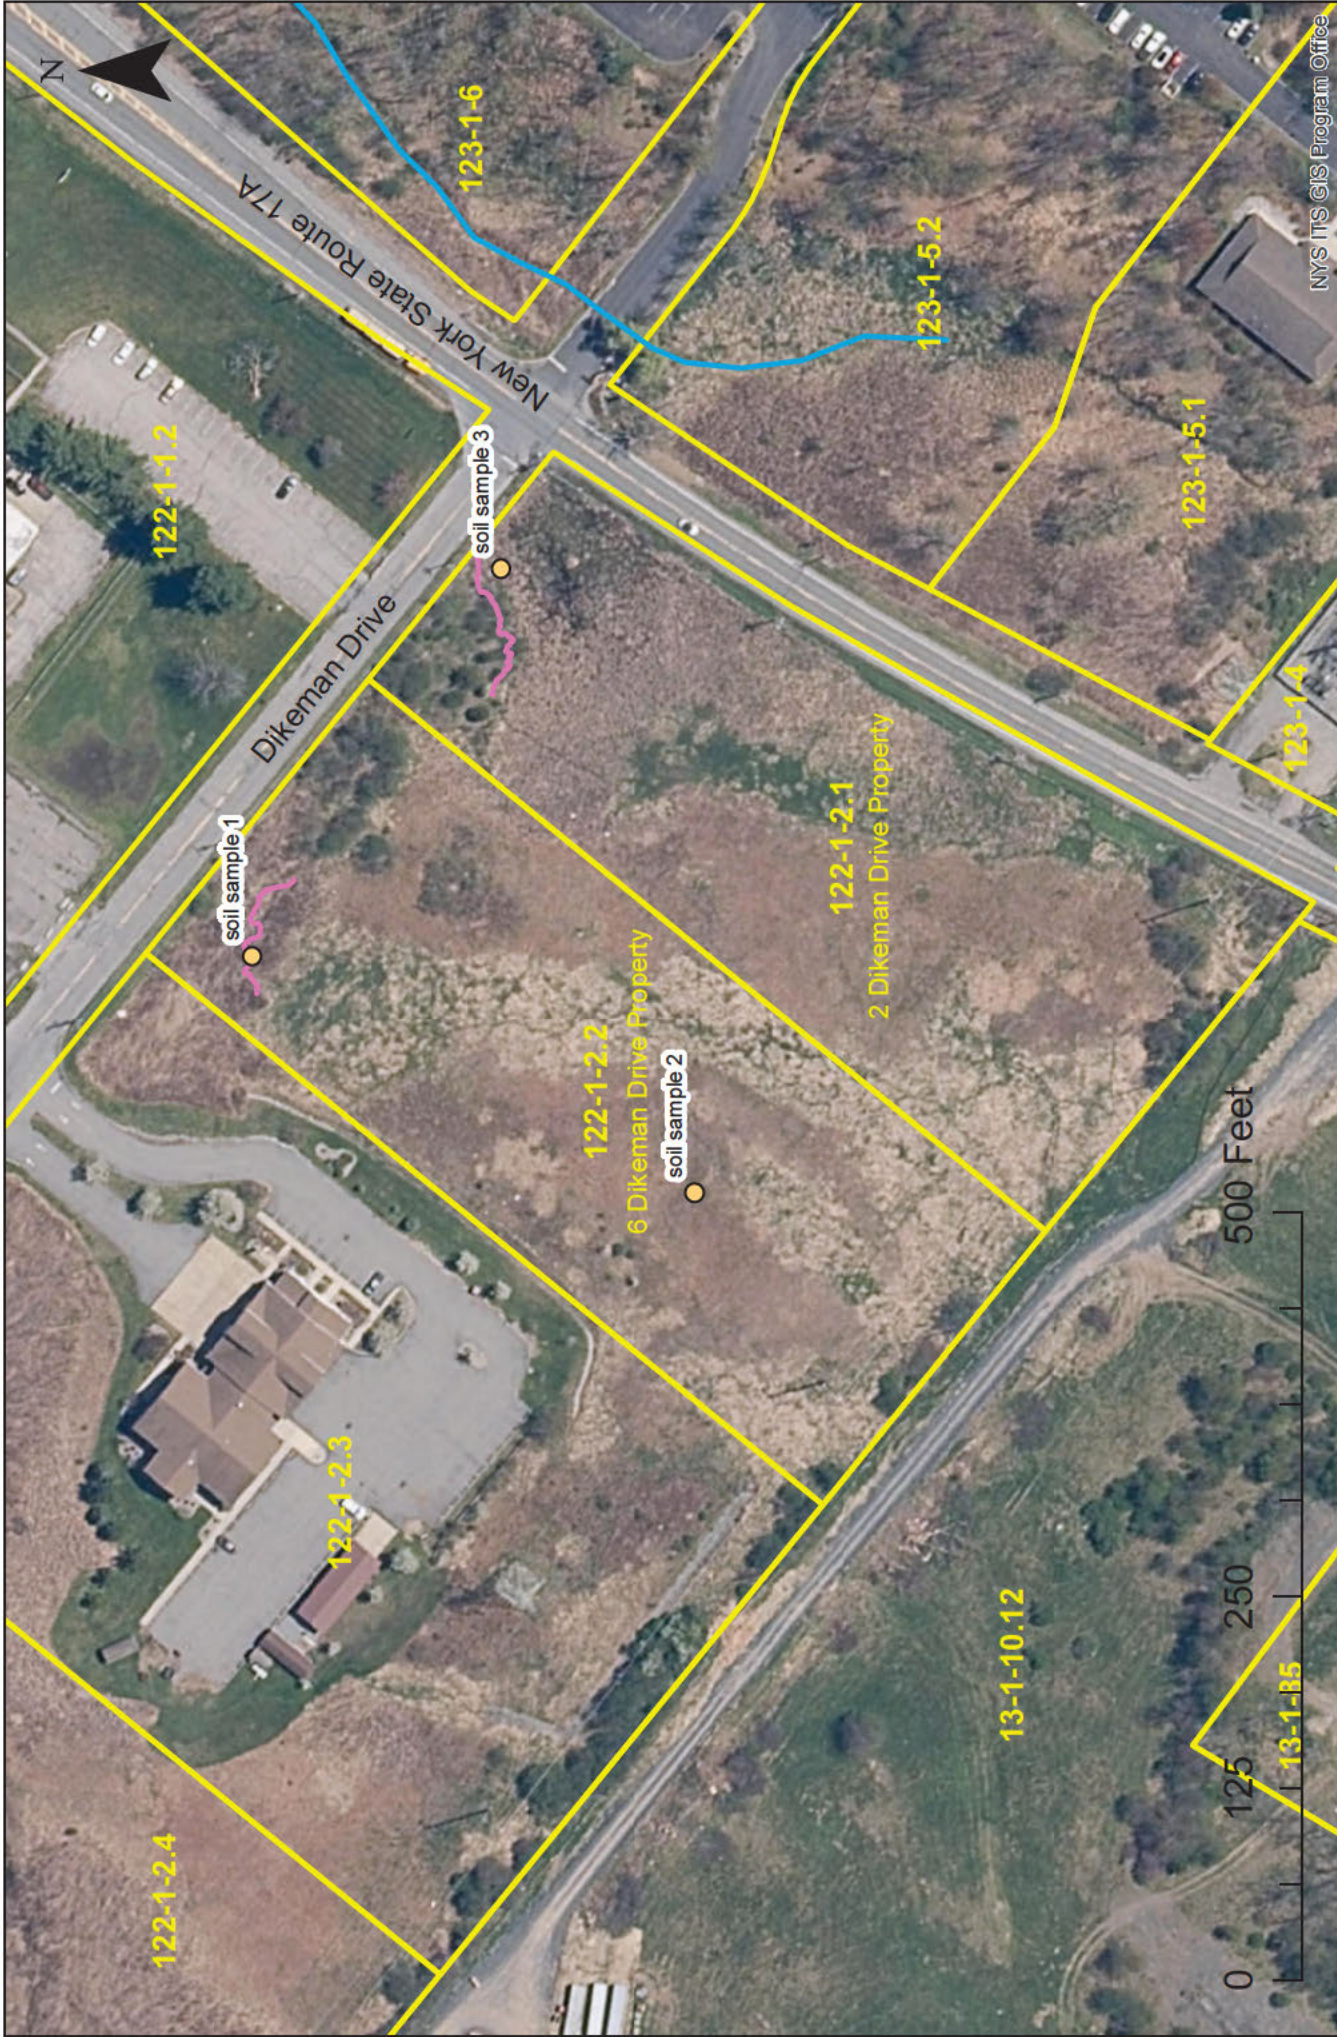
Battaglia Properties
 5/23/2023 CWA Section 404 Inspection
 2 & 6 Dikeman Drive, Orange County, NY
 41.3904, -74.3400

- 5/23/2023 GPS Point
- 5/23/2023 GPS Line
- Orange County Stream
- Approximate Parcel Boundary

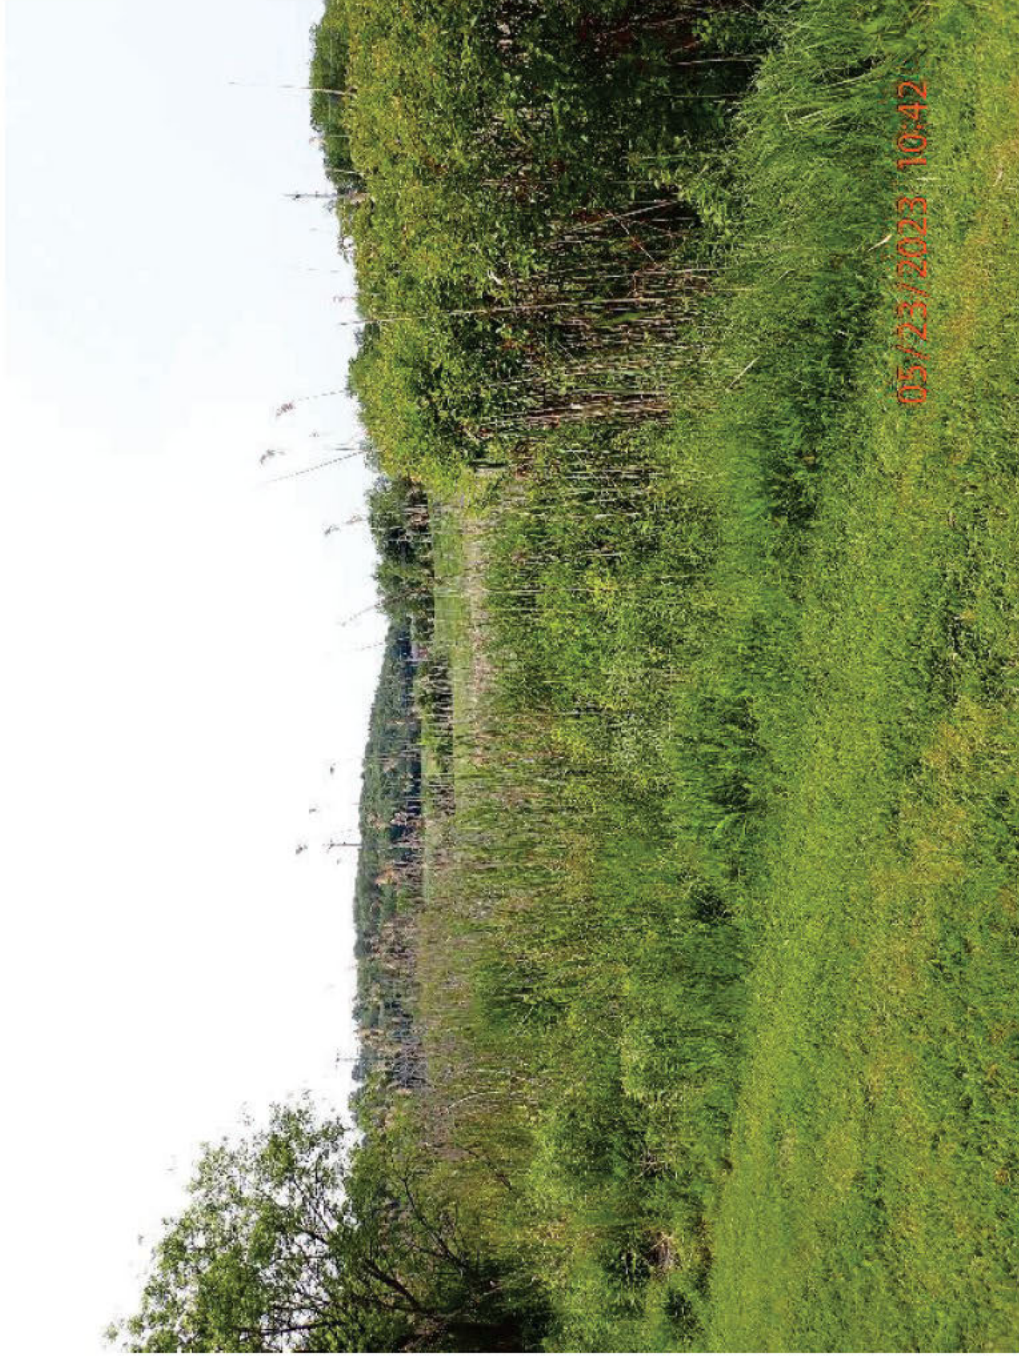
Date: 5/23/2023
Time: 10:42 AM
Photographer: S. Andreescu
Photo ID: 1 – P5230082

Dikeman Drive properties actively being mowed by property owner prior to inspection

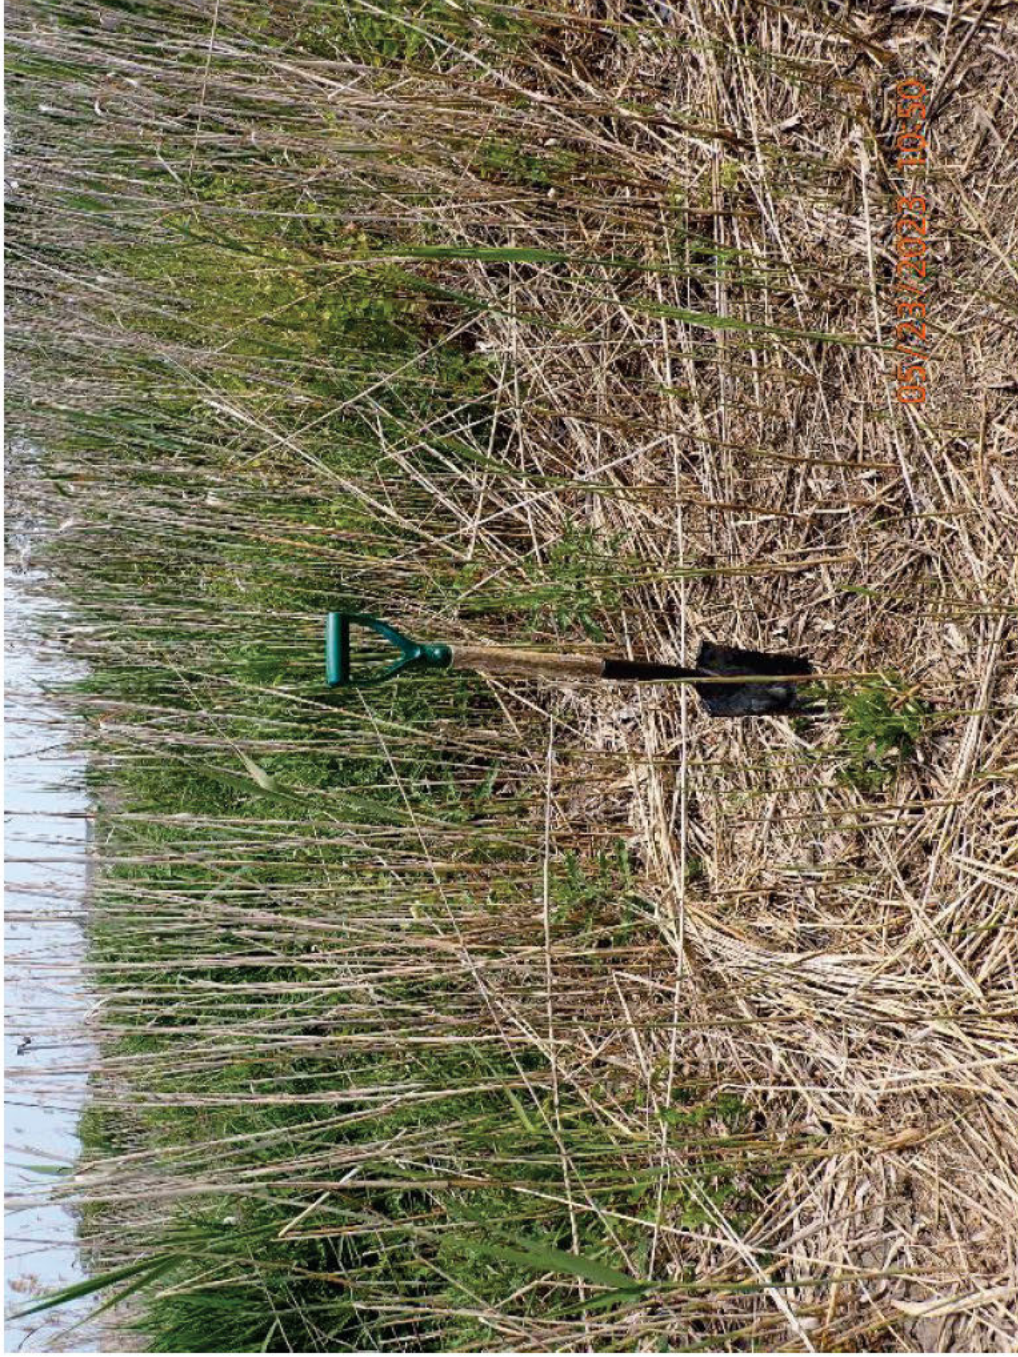
Date: 5/23/2023
Time: 10:50 AM
Photographer: S. Andreescu
Photo ID: 2 – P5230083

Description:
Sampling location (SS1);
recently mowed

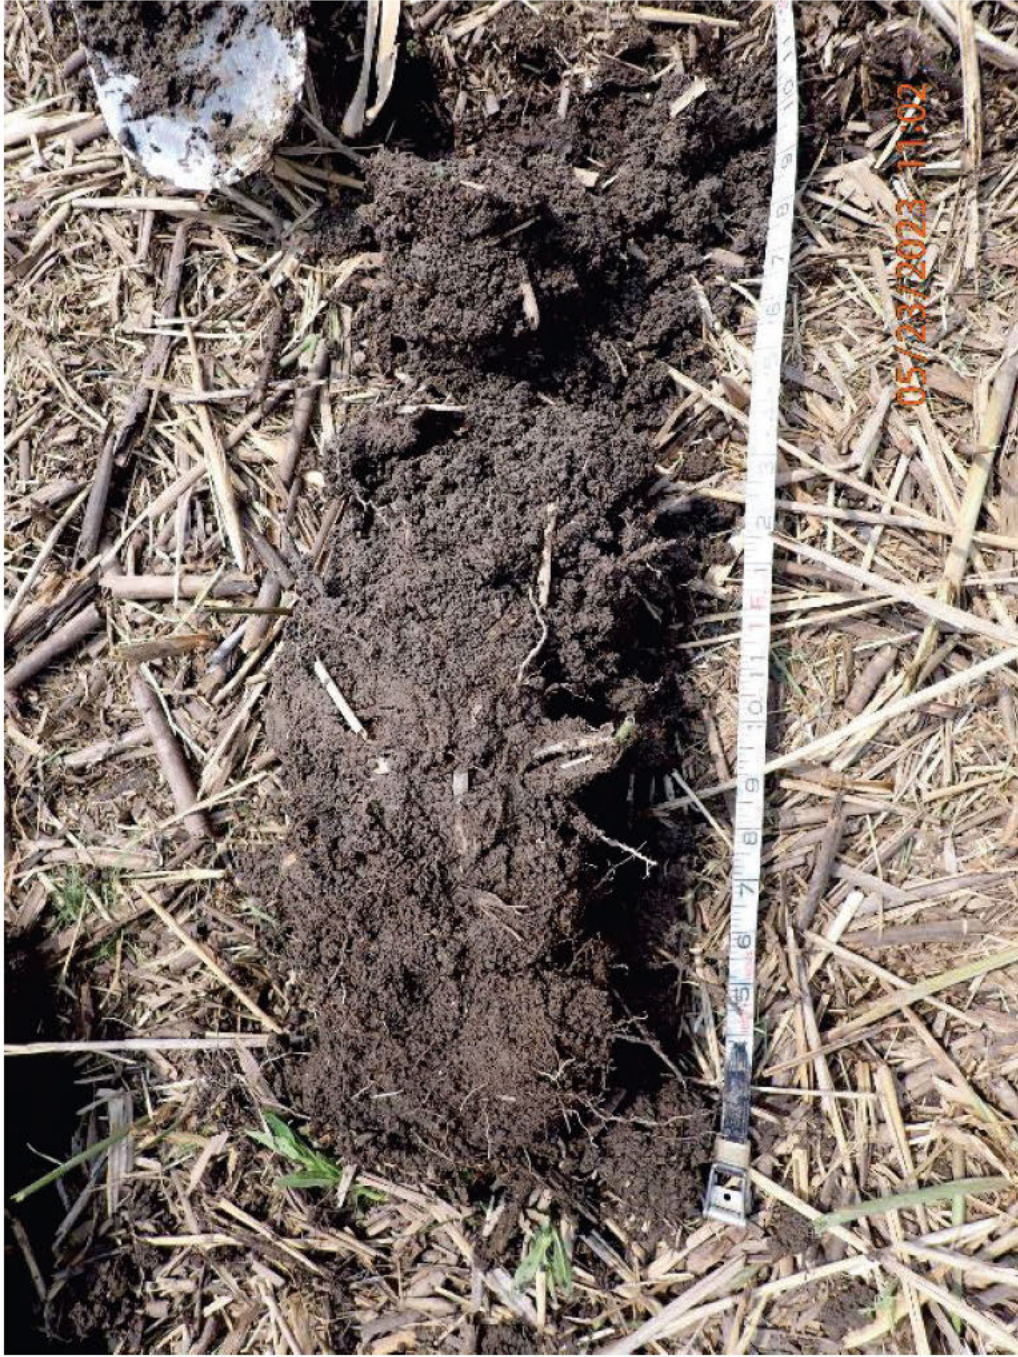
Date: 5/23/2023
Time: 11:02 AM
Photographer: S. Andreescu
Photo ID: 3 – P5230084

Description:
Soil sample 1 (SS1) soil profile

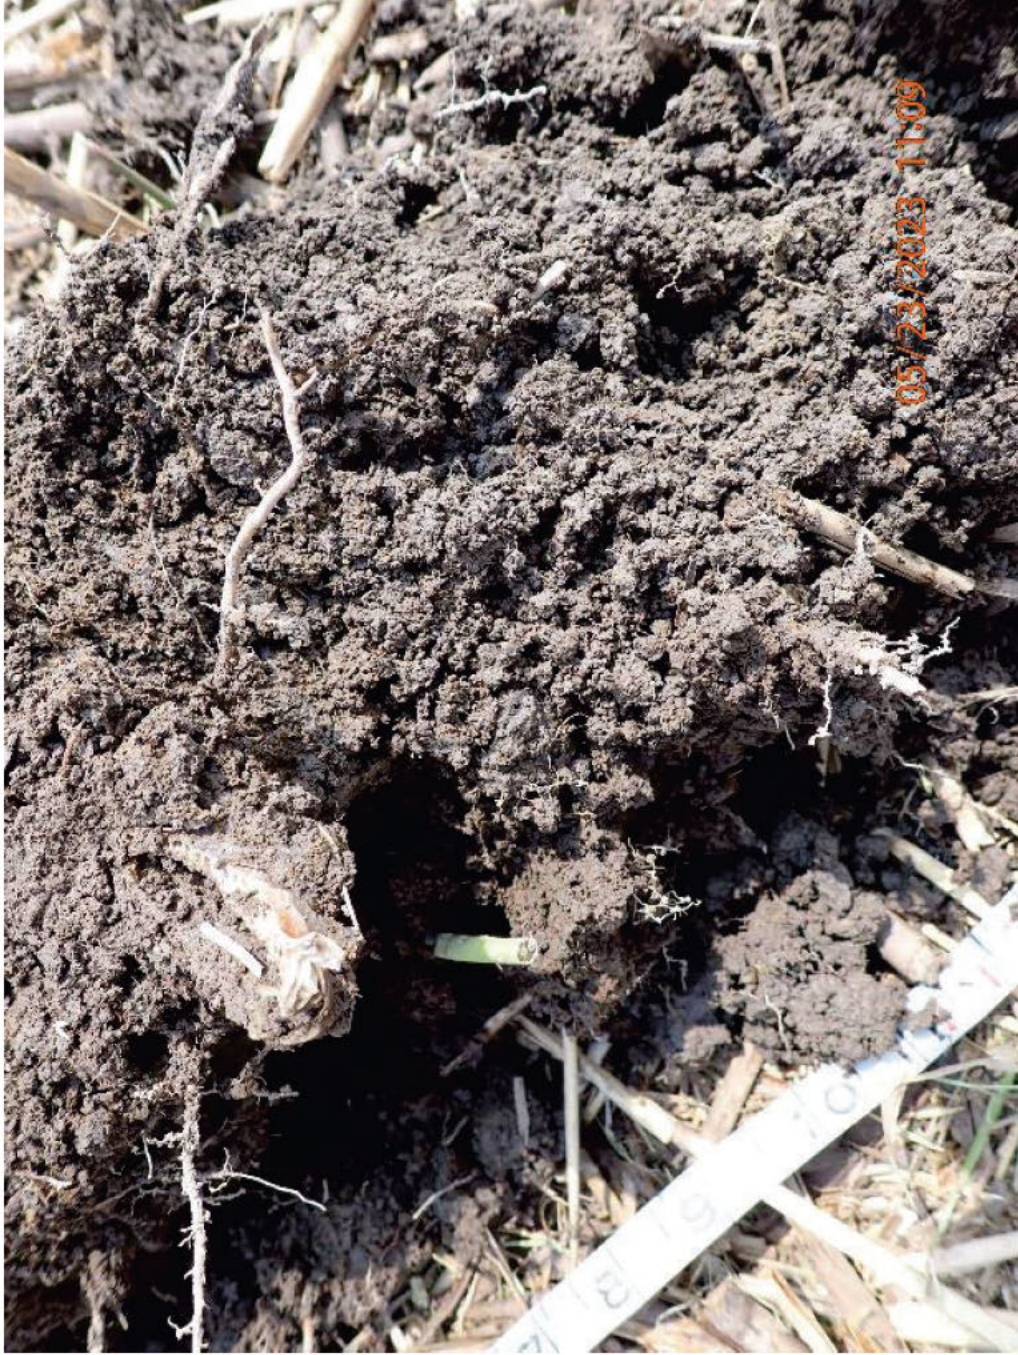
Date: 5/23/2023
Time: 11:09 AM
Photographer: S. Andreescu
Photo ID: 4 – P5230085

Description:
Closeup of redoximorphic
features in soil sample (SS1)

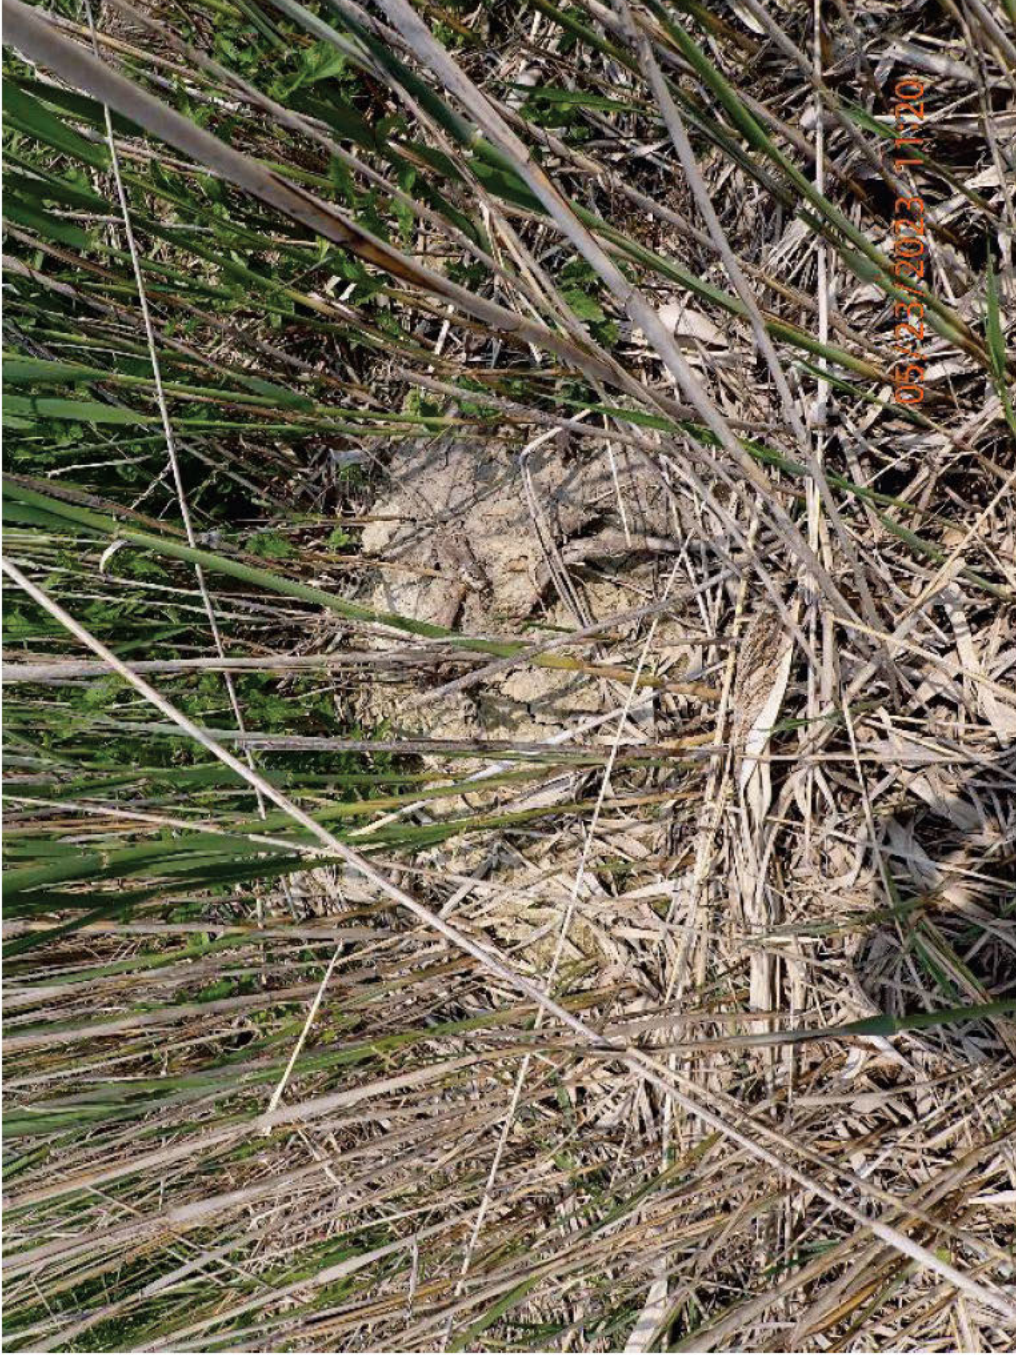
Date: 5/23/2023
Time: 11:20 AM
Photographer: S. Andreescu
Photo ID: 5 – P5230086

Example of sidecasted material
in area dominated by
hydrophytic vegetation

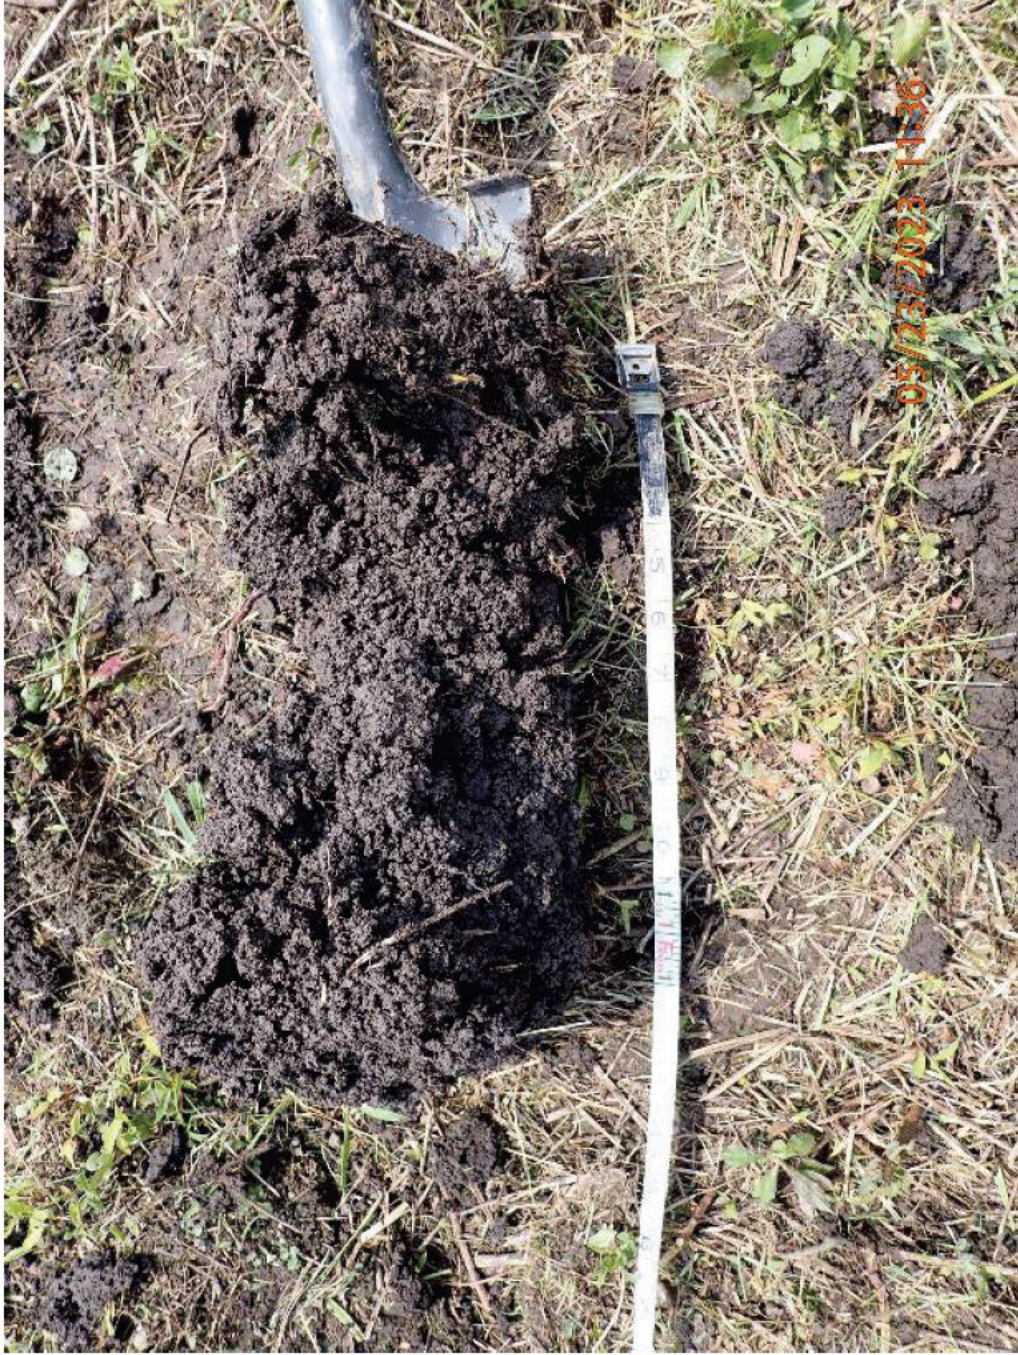
Date: 5/23/2023
Time: 11:36 AM
Photographer: S. Andreescu
Photo ID: 6 – P5230087

Description:
Soil profile 2 (SS2) soil profile

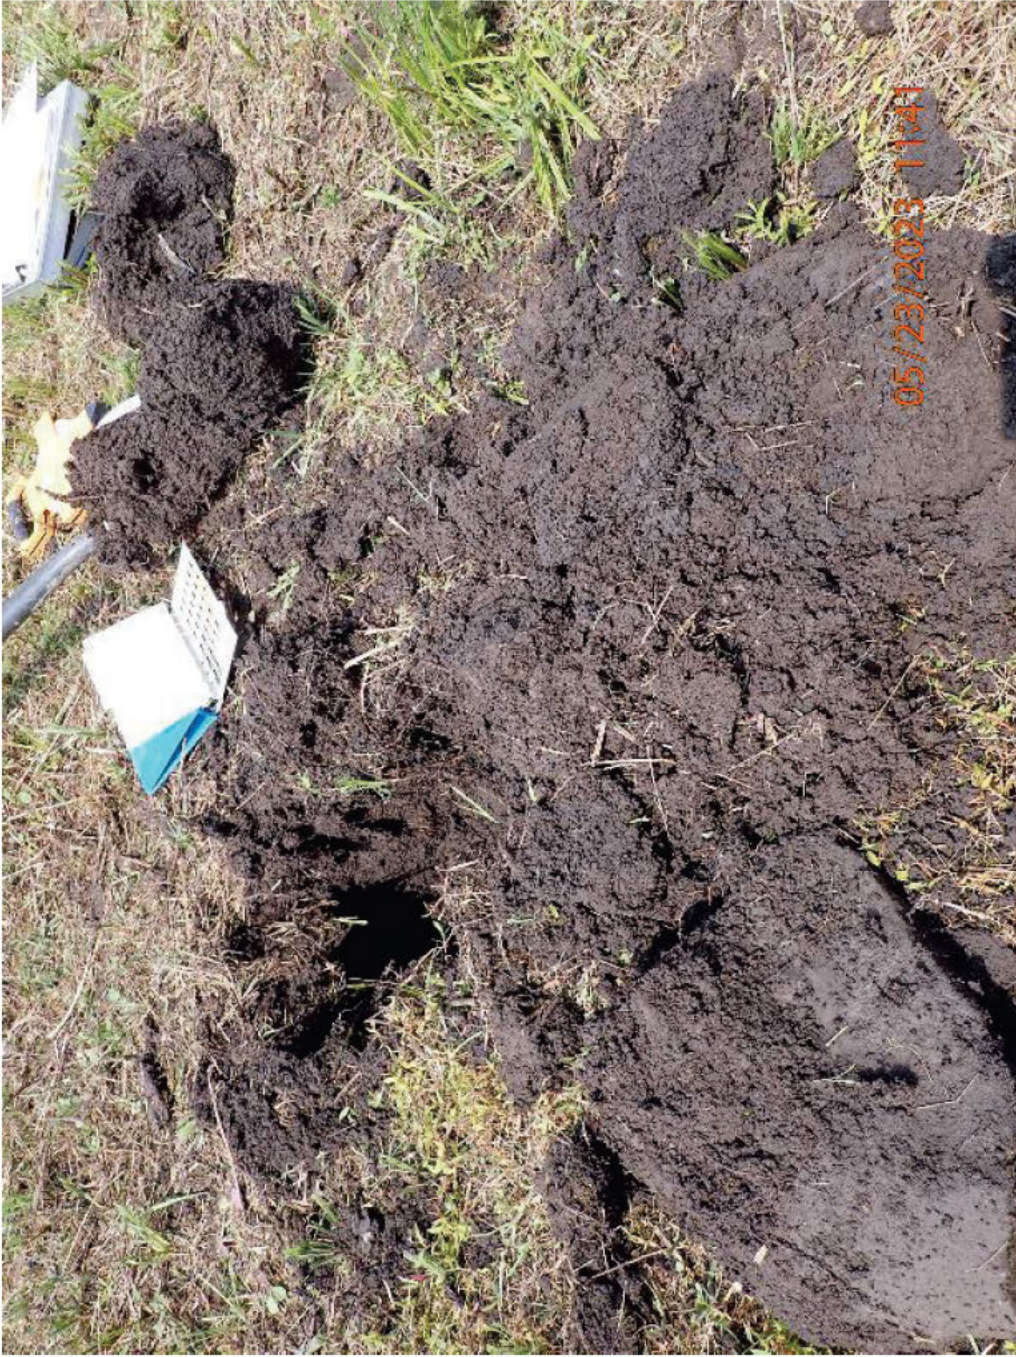
Date: 5/23/2023
Time: 11:41 AM
Photographer: S. Andreescu
Photo ID: 7 – P5230088

Description:
Soil sample 2 (SS2) surrounding
area

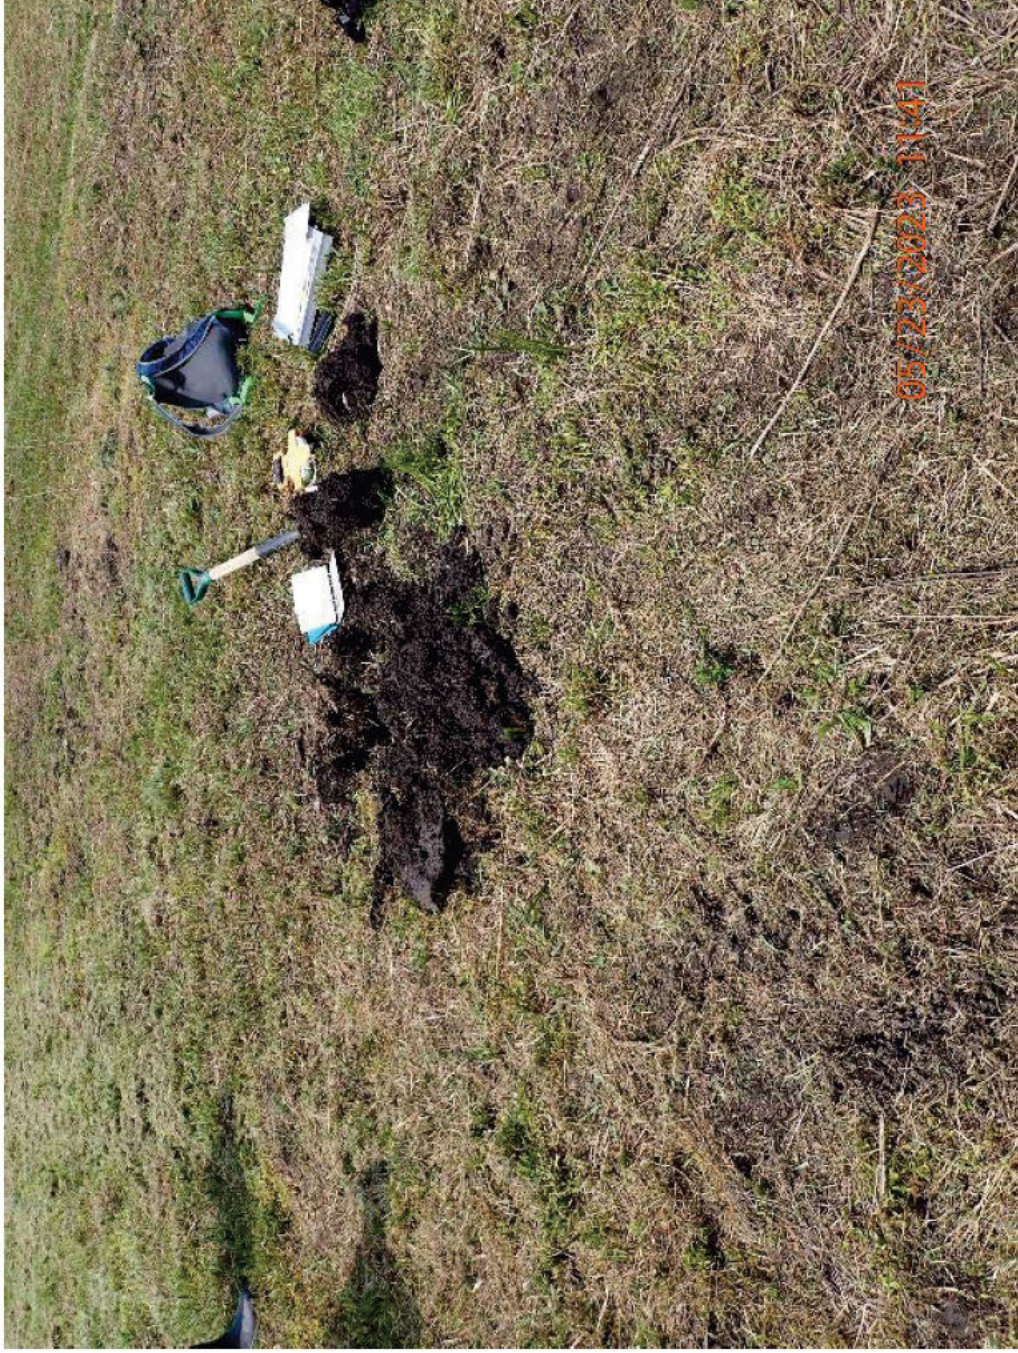
Date: 5/23/2023
Time: 11:41 AM
Photographer: S. Andreescu
Photo ID: 8 – P5230089

Soil sample 2 (SS2) surrounding area; recently mowed

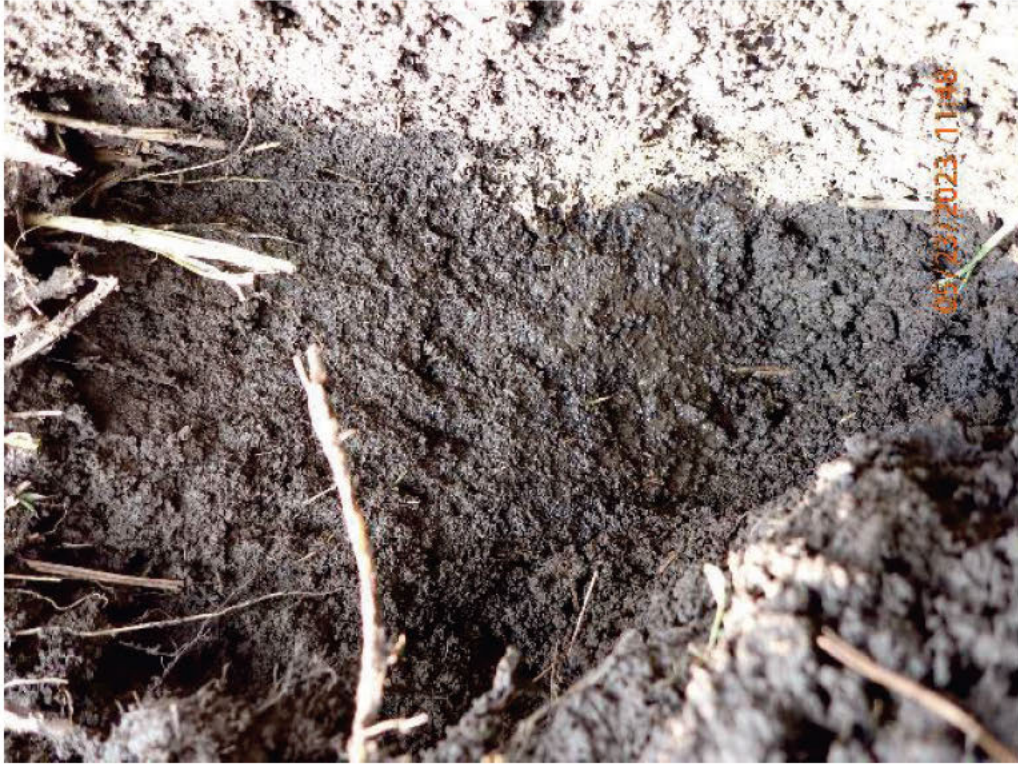
Date: 5/23/2023
Time: 11:48 AM
Photographer: S. Andreescu
Photo ID: 9 – P5230090

Water seeping from side of soil pit

Remarks:
 Water was actively seeping into the soil pit at 8 inches below the surface. Water table was at 14.5 inches and rising.

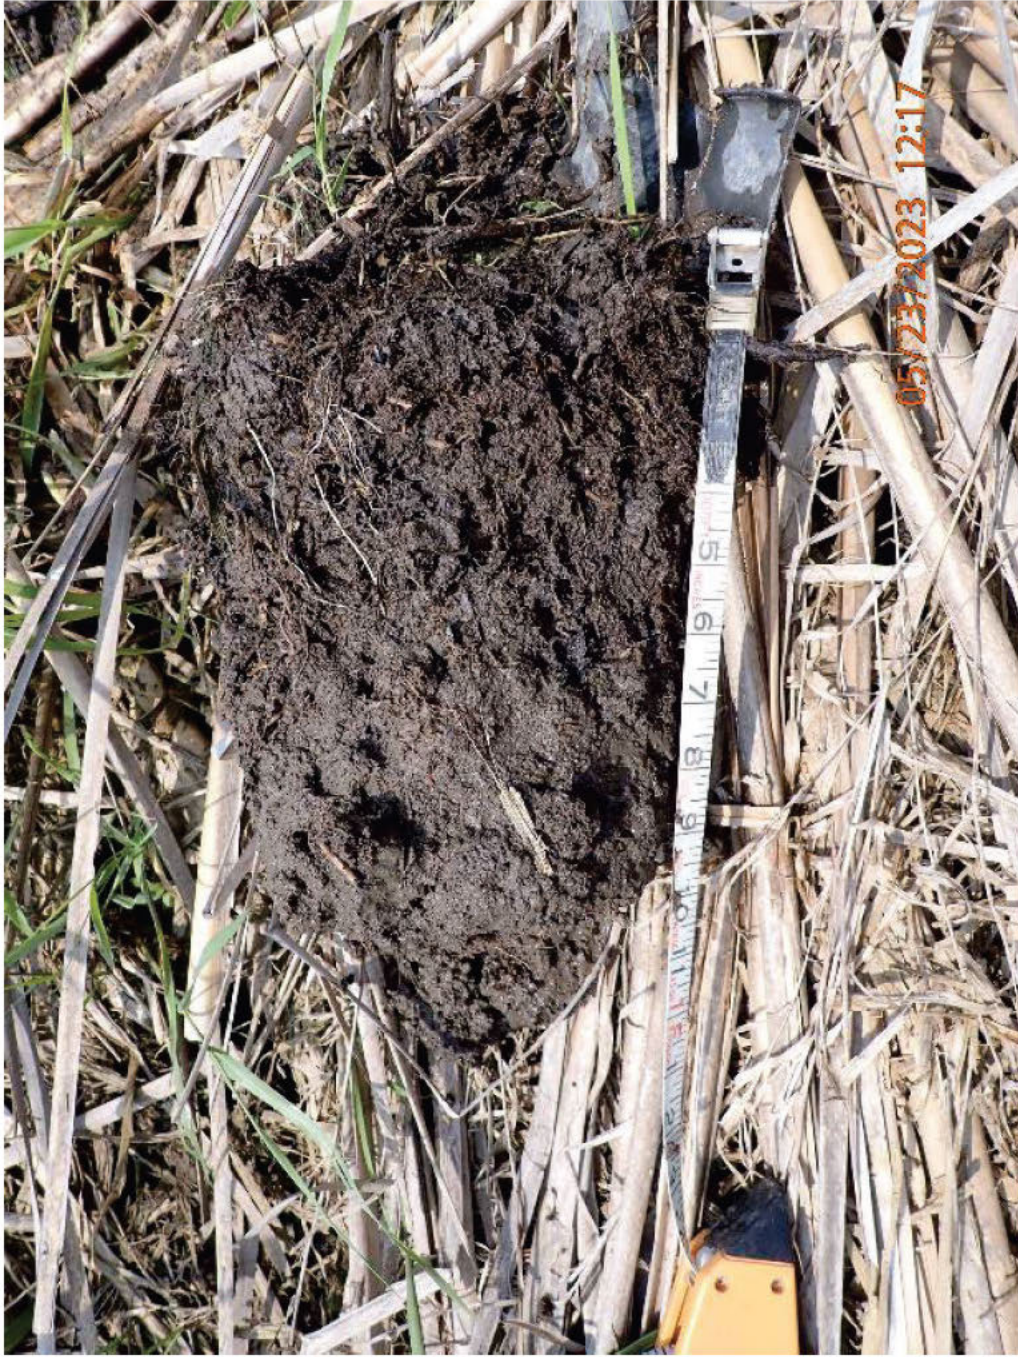
Date: 5/23/2023
Time: 12:17 PM
Photographer: S. Andreescu
Photo ID: 10 – P5230091

Description:
Soil sample 3 (SS3) soil profile

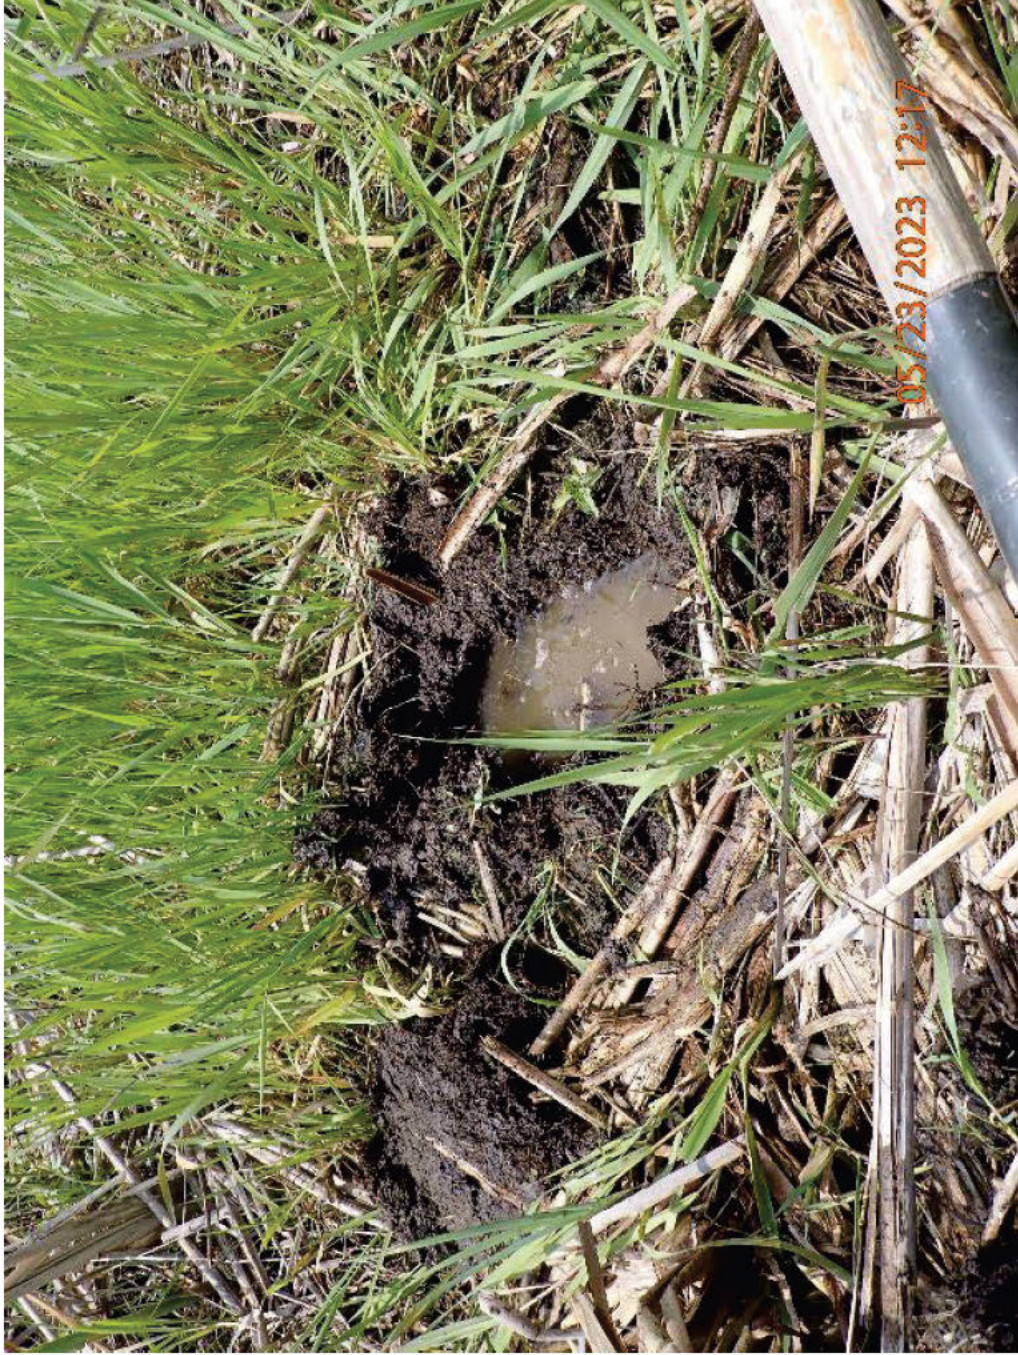
Date: 5/23/2023
Time: 12:17 PM
Photographer: S. Andreescu
Photo ID: 11 – P5230092

Soil pit 3 (SS3) with high water table

Field Observations: Surface Water Present? Yes <u>X</u> No _____ Depth (inches): <u>2</u> Water Table Present? Yes <u>X</u> No _____ Depth (inches): <u>2.5</u> Saturation Present? Yes <u>X</u> No _____ Depth (inches): <u>2.5</u> (includes capillary fringe)	Wetland Hydrology Present? Yes <u>X</u> No _____
---	---

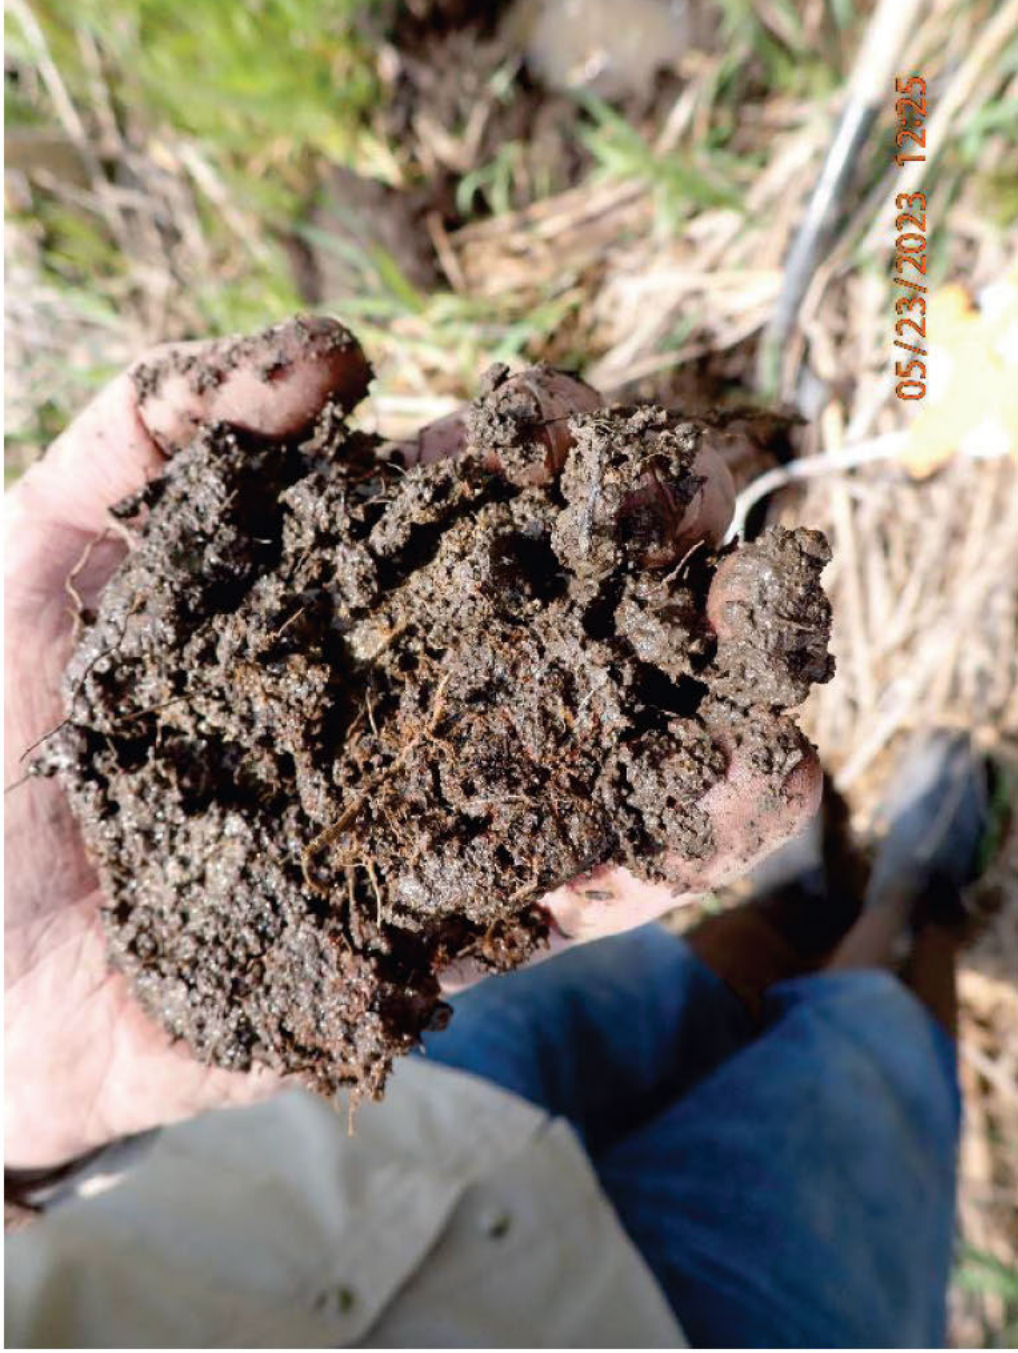
Date: 5/23/2023
Time: 12:25 PM
Photographer: S. Andreescu
Photo ID: 12 – P5230093

Closeup of redoximorphic features in soil sample (SS3); oxidized root channels

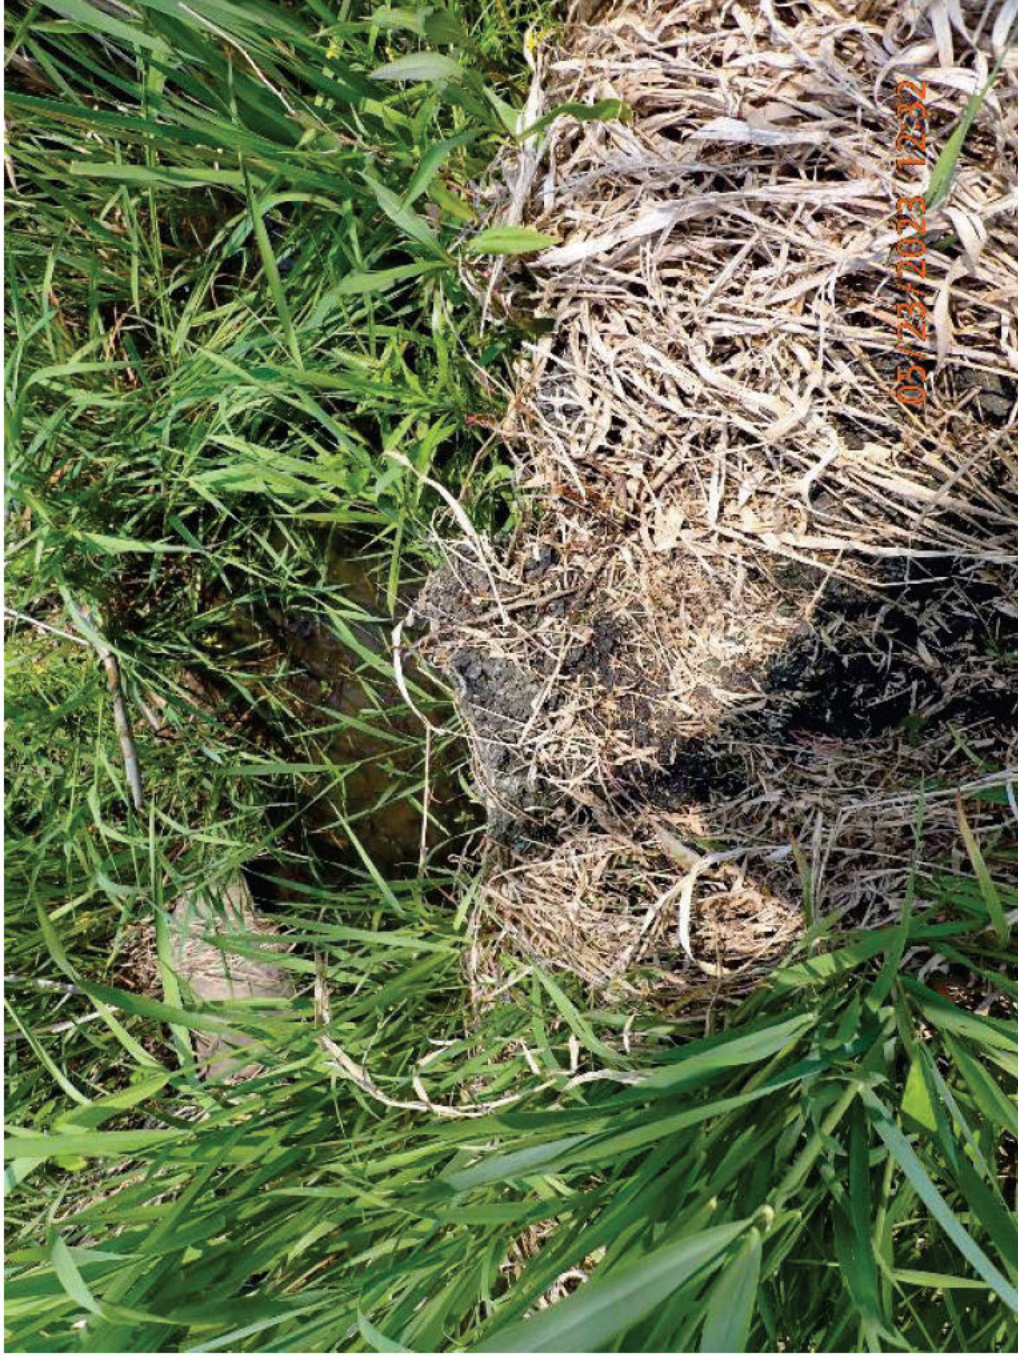
Date: 5/23/2023
Time: 12:32 PM
Photographer: S. Andreescu
Photo ID: 13 – P5230094

Sidcasted material near ditch;
2 Dikeman Drive

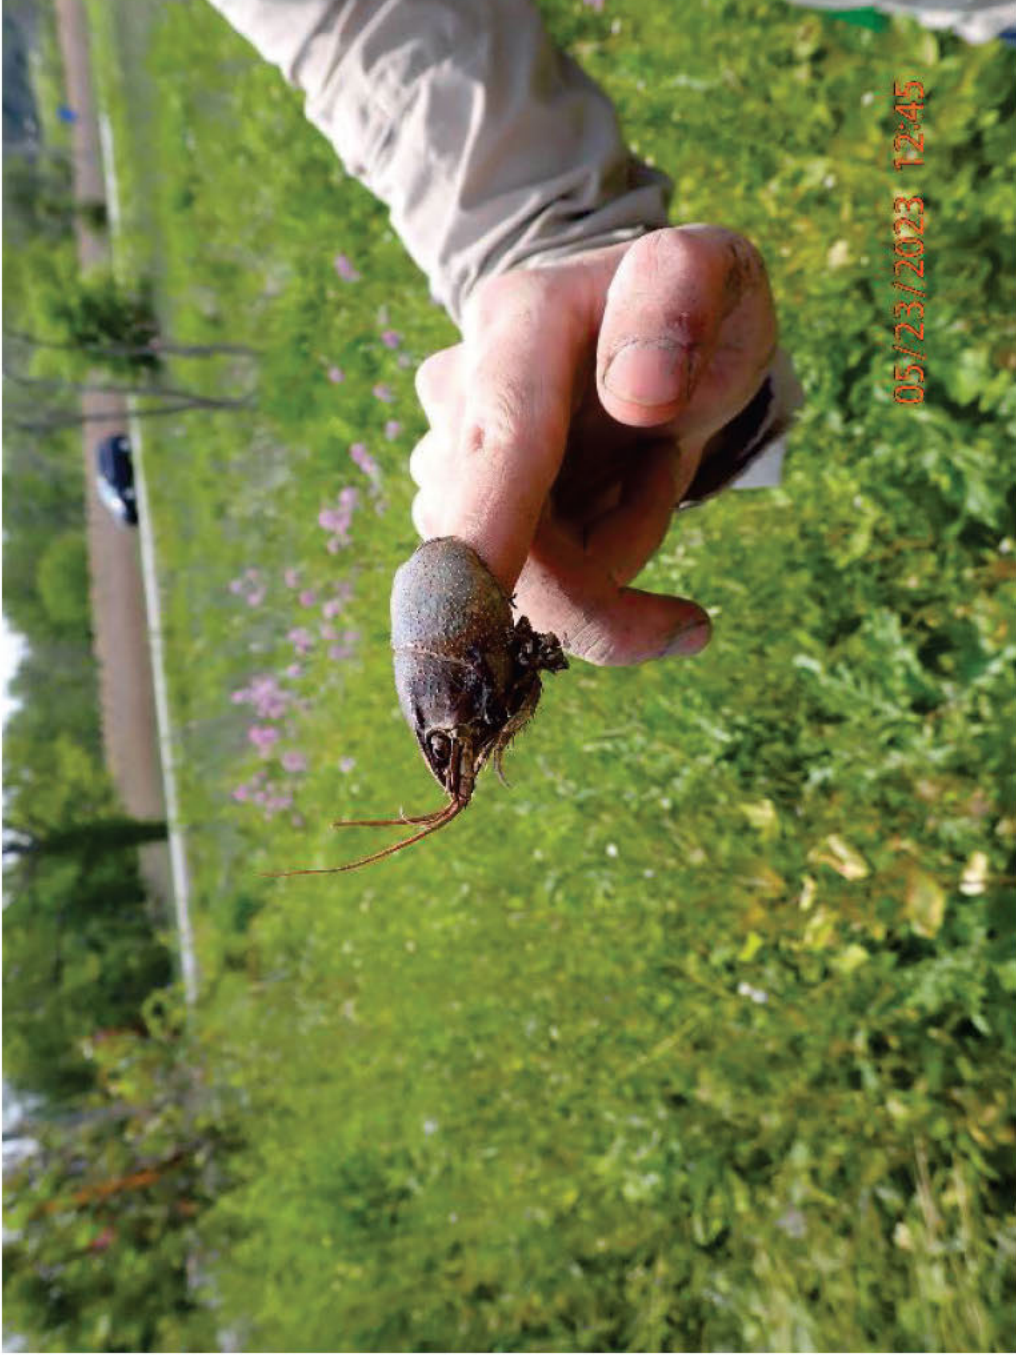
Date: 5/23/2023
Time: 12:45 PM
Photographer: S. Andreescu
Photo ID: 14 – P5230095

Crayfish head found in wetland;
2 Dikeman Drive
