**Region 6 - Enforcement & Compliance Assurance Division**

**INSPECTION REPORT**

| Company Name: | <b>Albuquerque Bernalillo County Water Utility Authority (ABCWUA)</b> | |
| Facility Name: | <b>Southside Water Reclamation Plant (SWRP)</b> | |

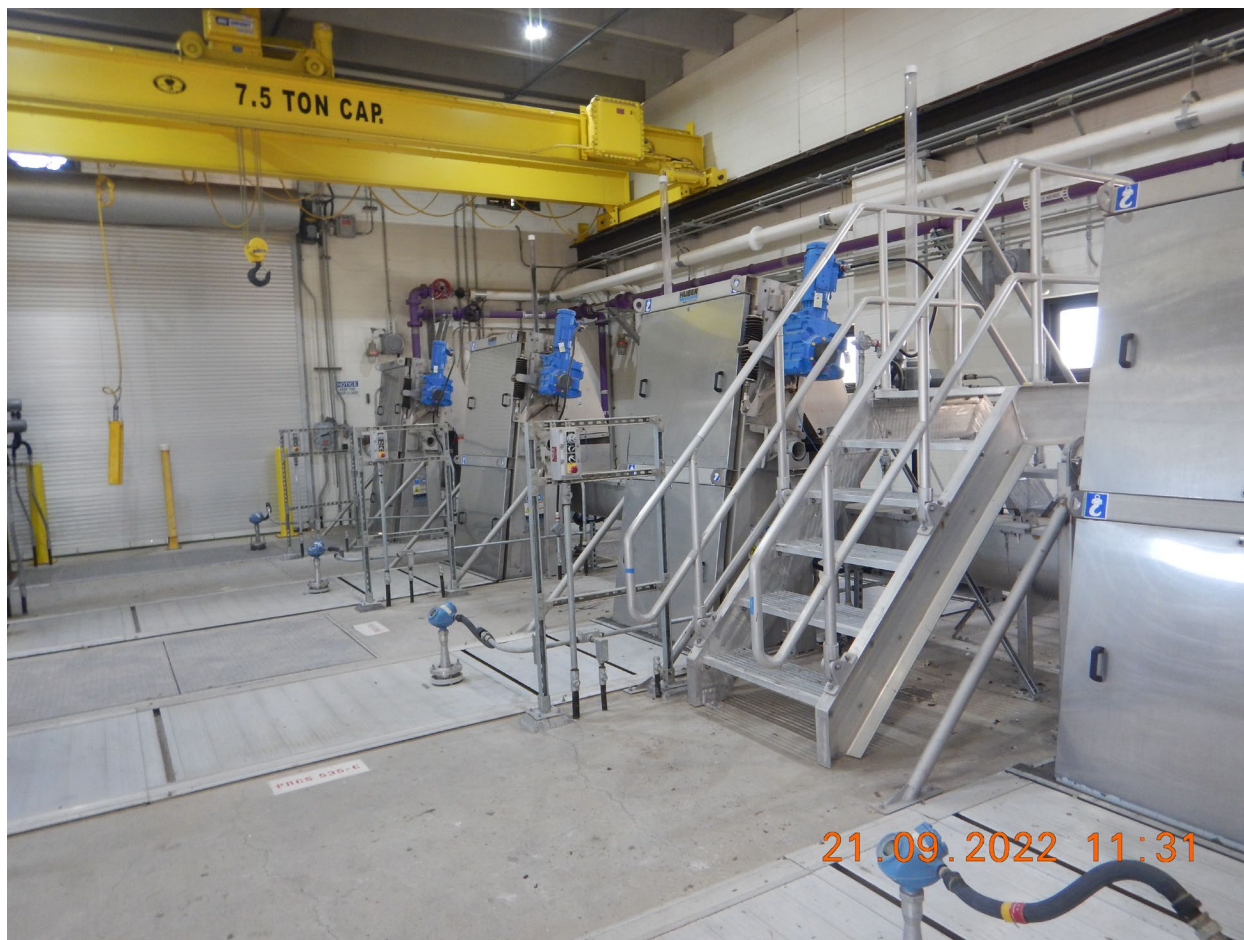
View of process treatment equipment inside the Course Screening Facility (CSF). (DSCN2320)  
Photographed by D. Esparza

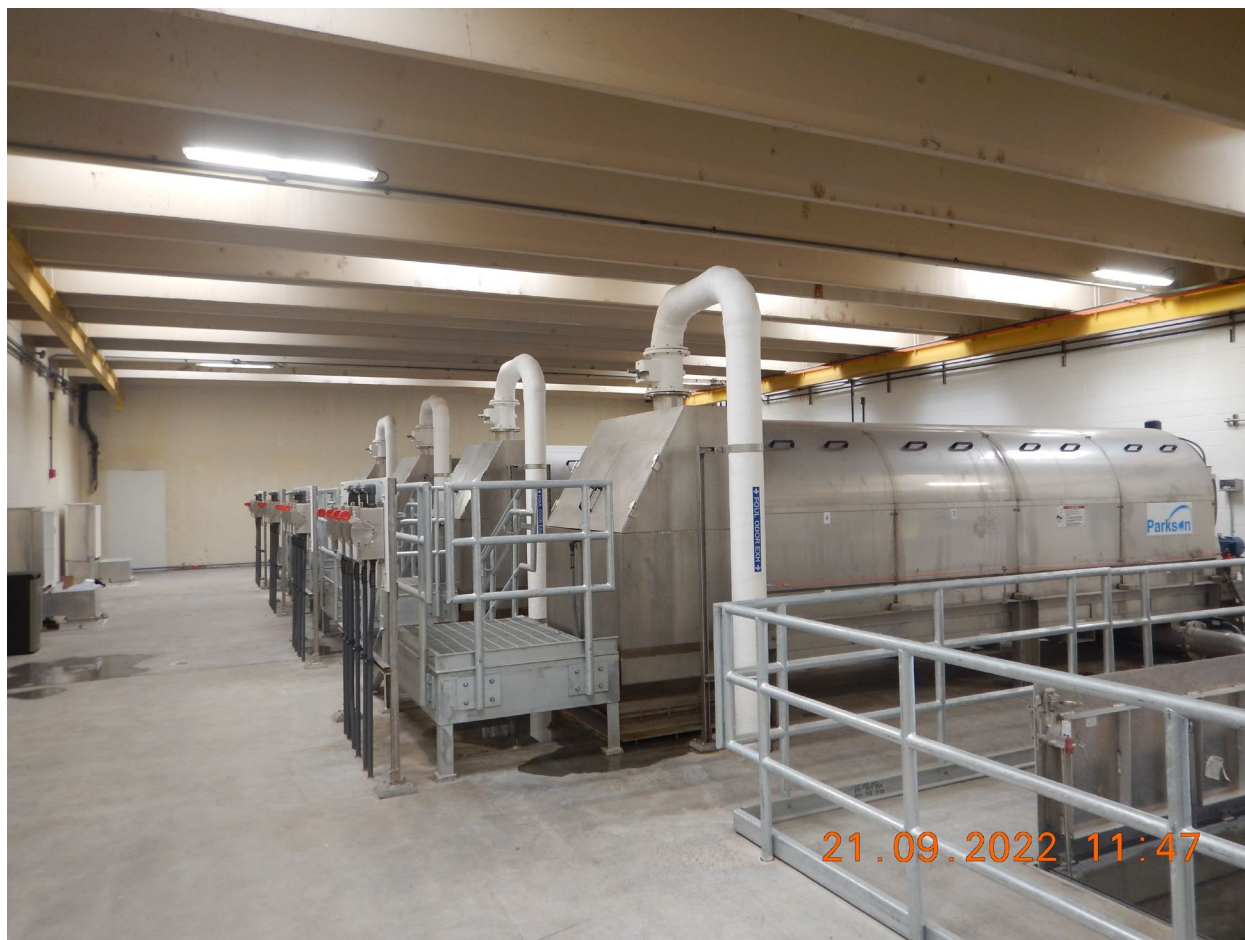
View of process treatment equipment inside the Rotating Drum Thickener Facility (RDT). (DSCN2321)  
Photographed by D. Esparza

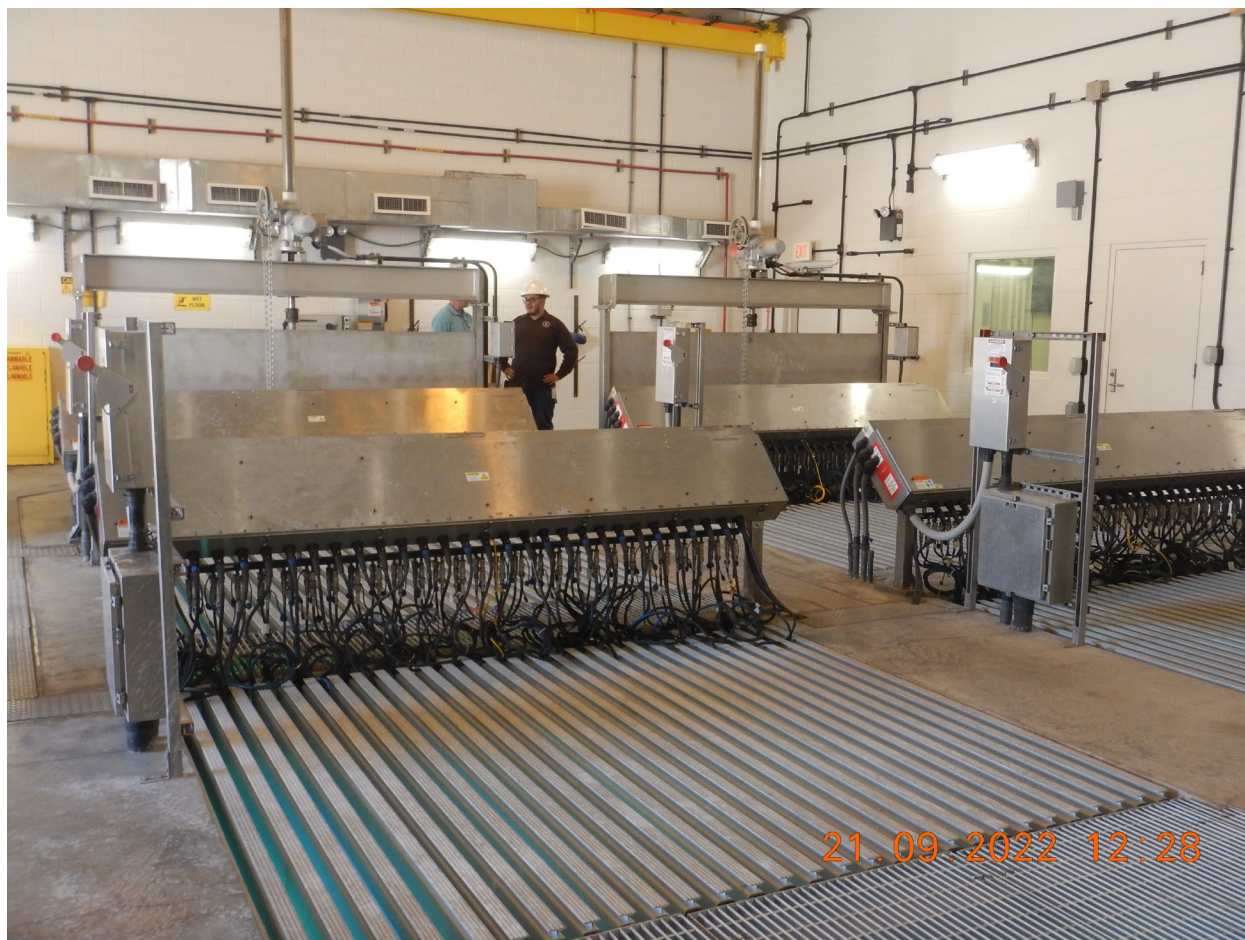
View of ultra-violet (UV) disinfection banks inside the UV Disinfection Building before the Siphon Towers and the eventual discharge to the Rio Grande at Outfall 001. (DSCN2324) Photographed by D. Esparza

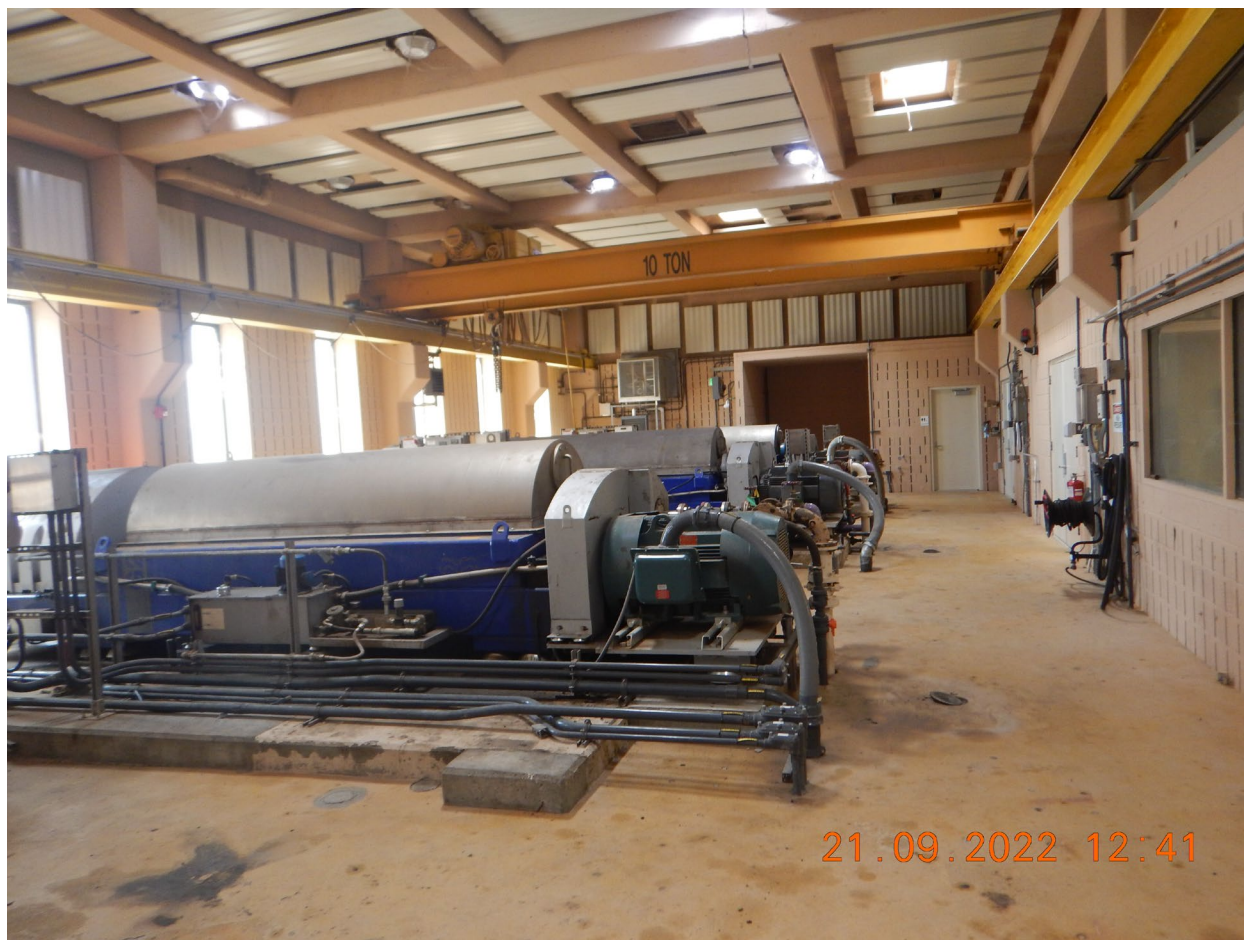
View of several centrifugal drums utilized in the thickening and dewatering of the sludge. (DSCN2326)  
Photographed by D. Esparza

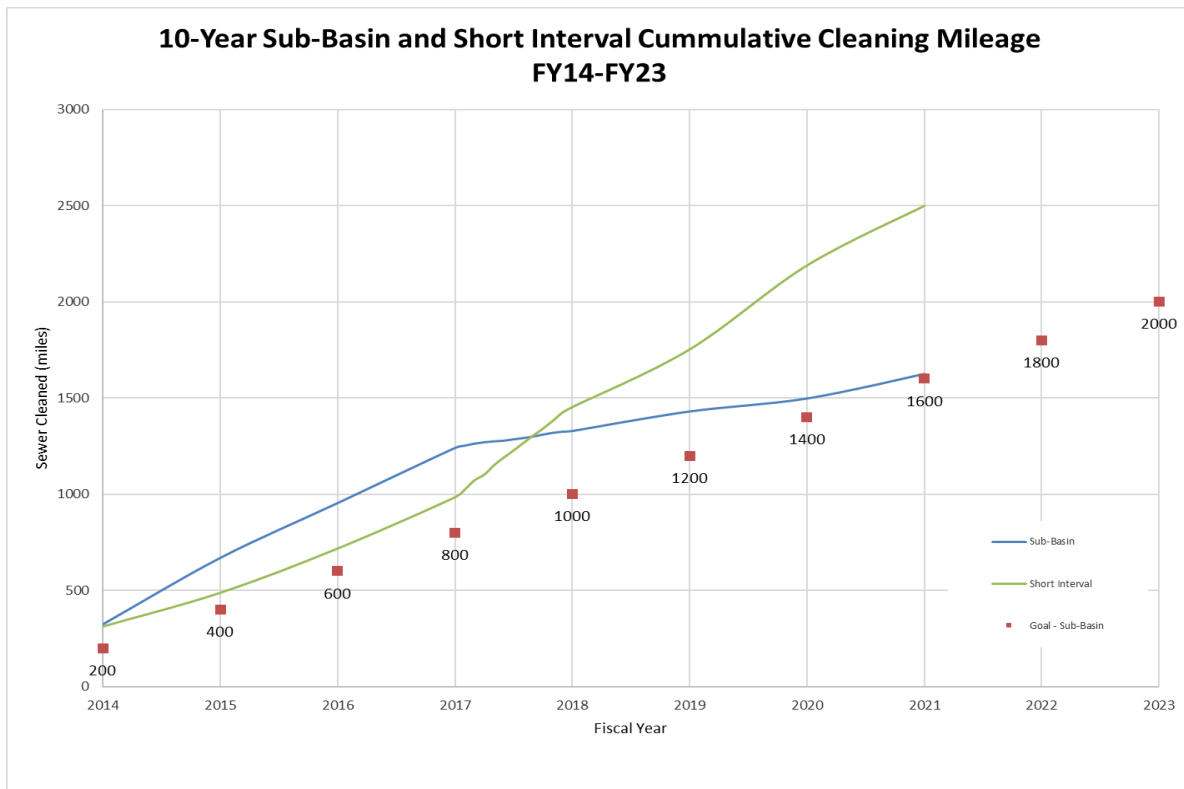
**Figure 4 Small Diameter Sewer Cleaned vs. Ten-Year Goal**

1. The Water Authority will establish and monitor a temporary goal of cleaning all gravity small diameter lines every fifteen years. (This will be accomplished through the existing Sub-Basin program.) The Water Authority will continue the program of high-frequency maintenance of known problem locations within the system. (This will be accomplished through the existing Short Interval program.) The frequency of Short Interval cleaning will vary in accordance with system performance and risk factors, maintenance history, and the latest maintenance findings. This will maintain the Sub-Basin program as currently configured while targeting the Short Interval lines which are more likely to spill.

2. The Water Authority will continue studies with the intent is to validate prior study indicating a significant SSO Rate variation for top versus bottom, and therefore the opportunity to optimize sub-basin cleaning. A possible outcome will be modification of the Sub-Basin program to remove lines shown to be significantly less likely to spill.
