## **RCRA Inspection Report**

Milliken & Company Magnolia Finish Plant  
157 New Milliken RD. and 164 New Milliken RD.  
Blacksburg, South Carolina 29702  
EPA ID# SCD047559570

March 30, 2021

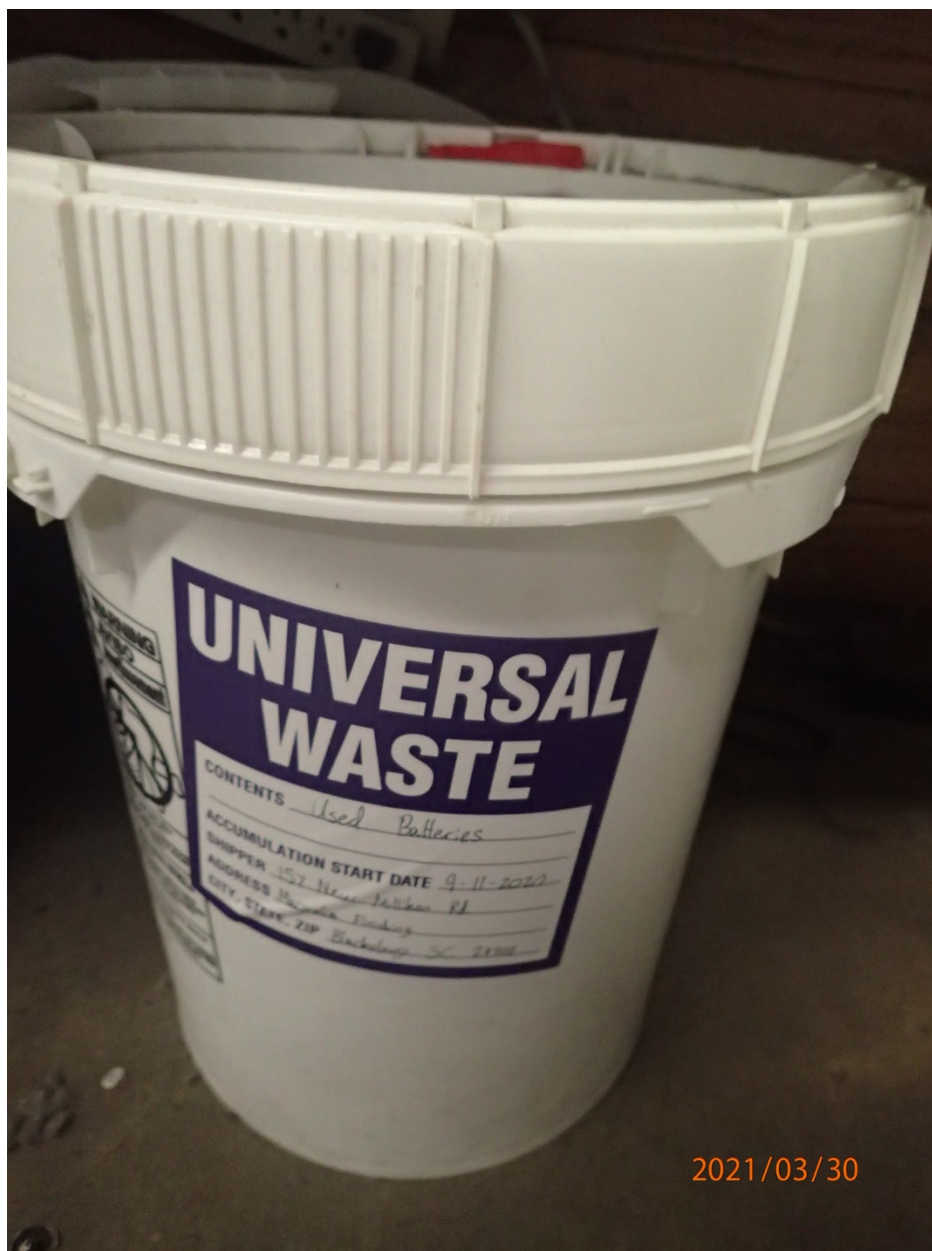
Supply Room: Universal waste (UW) batteries are stored here (Photos 1-4). The following UW was observed:

**Photo 1:** Universal waste – used batteries. Inside Supply Room of Magnolia Plant.

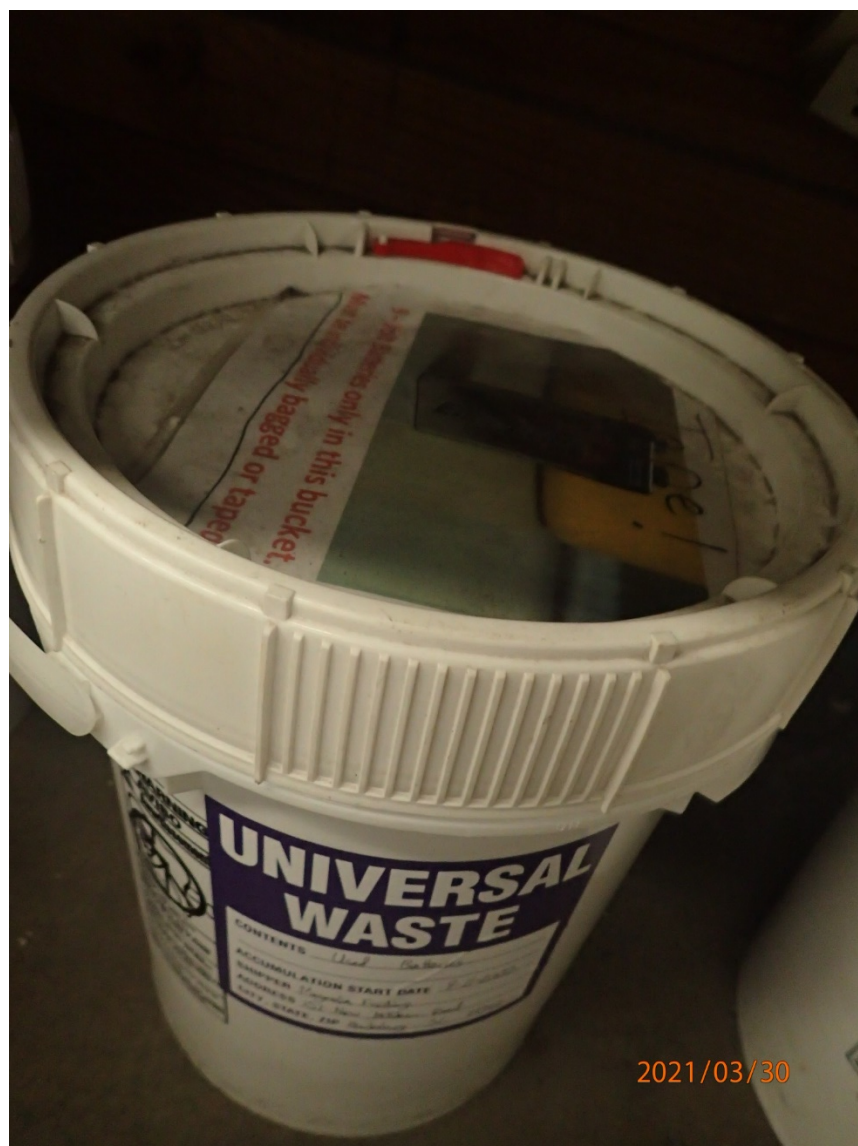
**Photo 2:** Universal waste batteries. Inside Supply Room of Magnolia Plant.

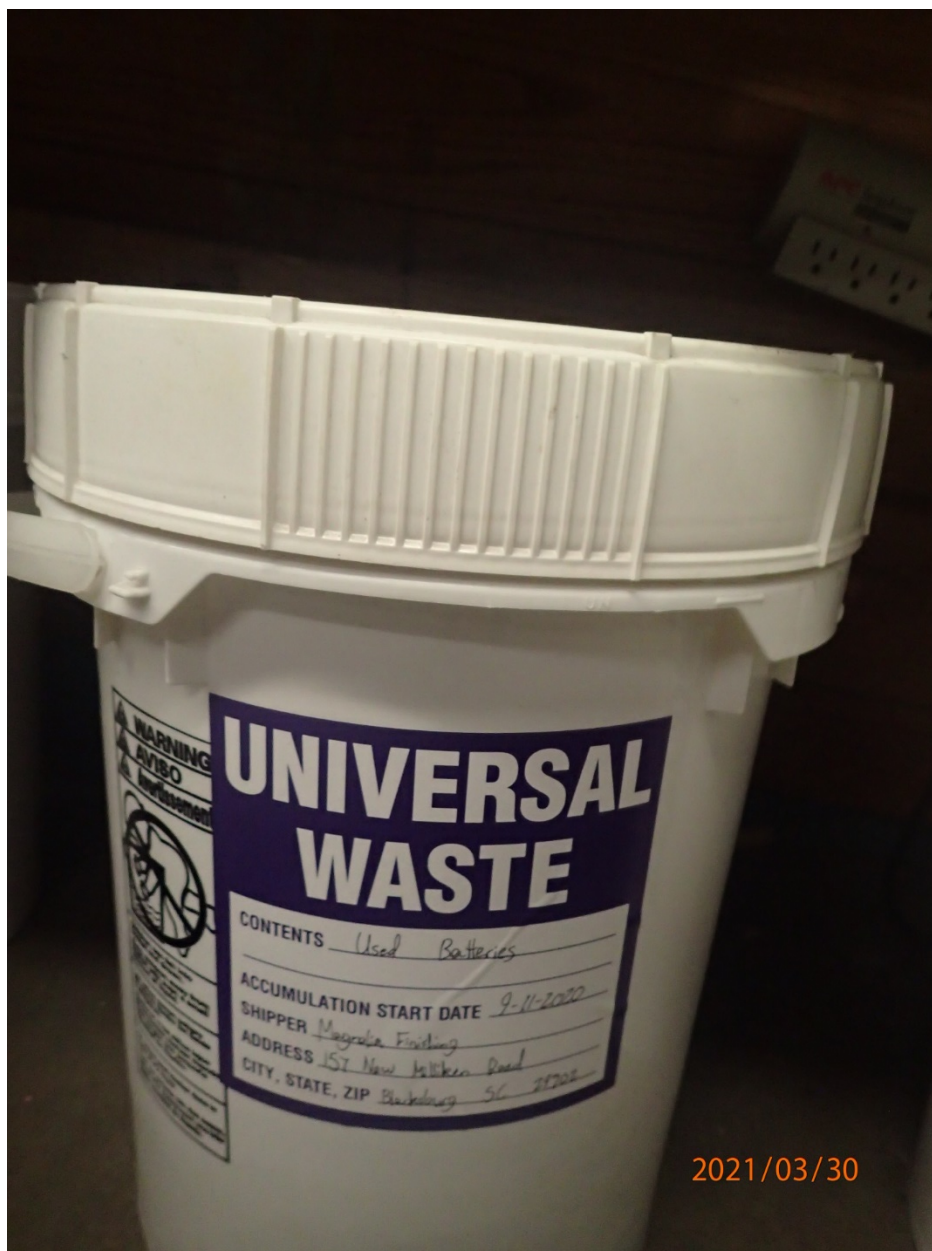
**Photo 3:** Universal waste used batteries, inside Supply Room of Magnolia Plant.

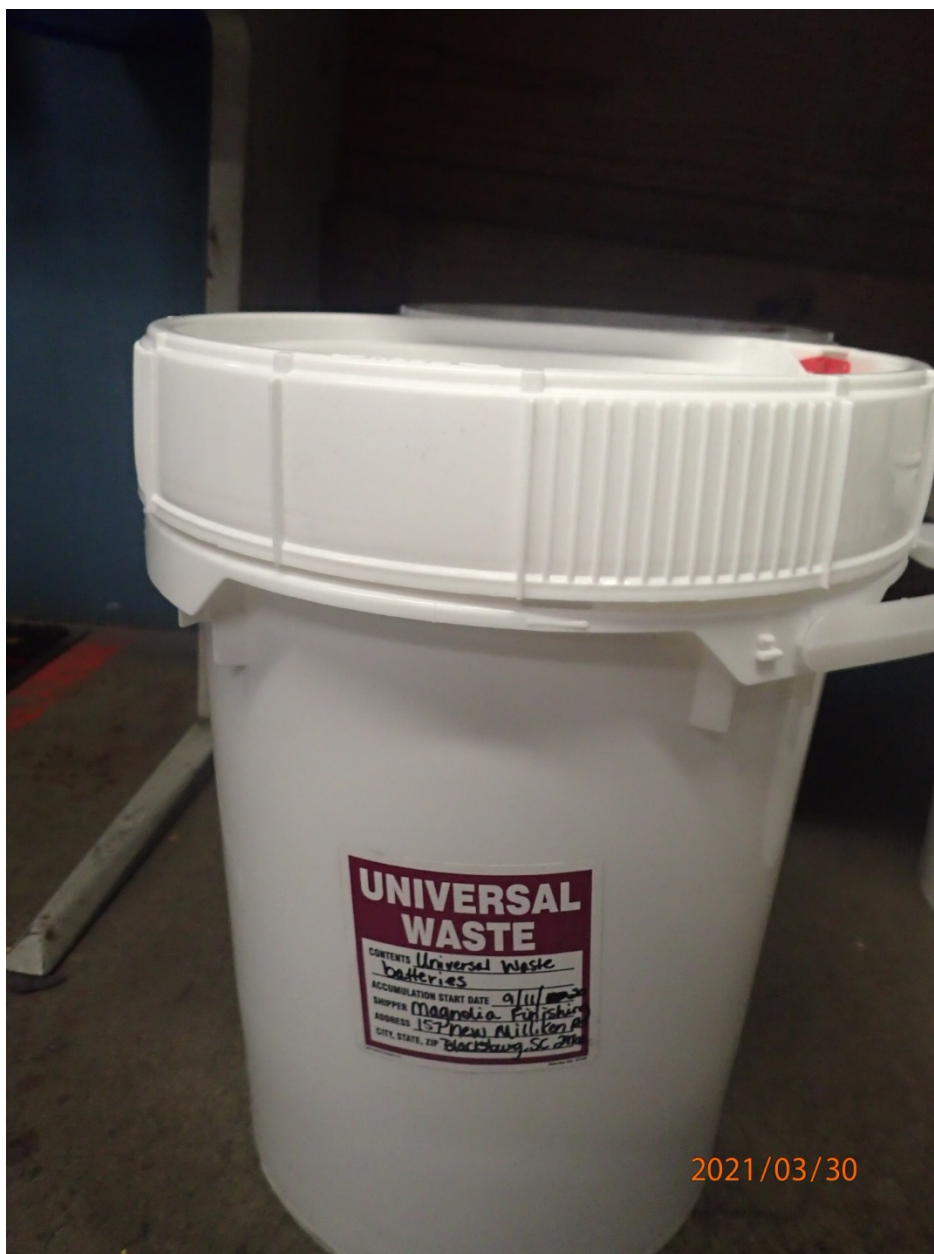
**Photo 4:** Universal waste batteries inside Supply Room of Magnolia Plant.

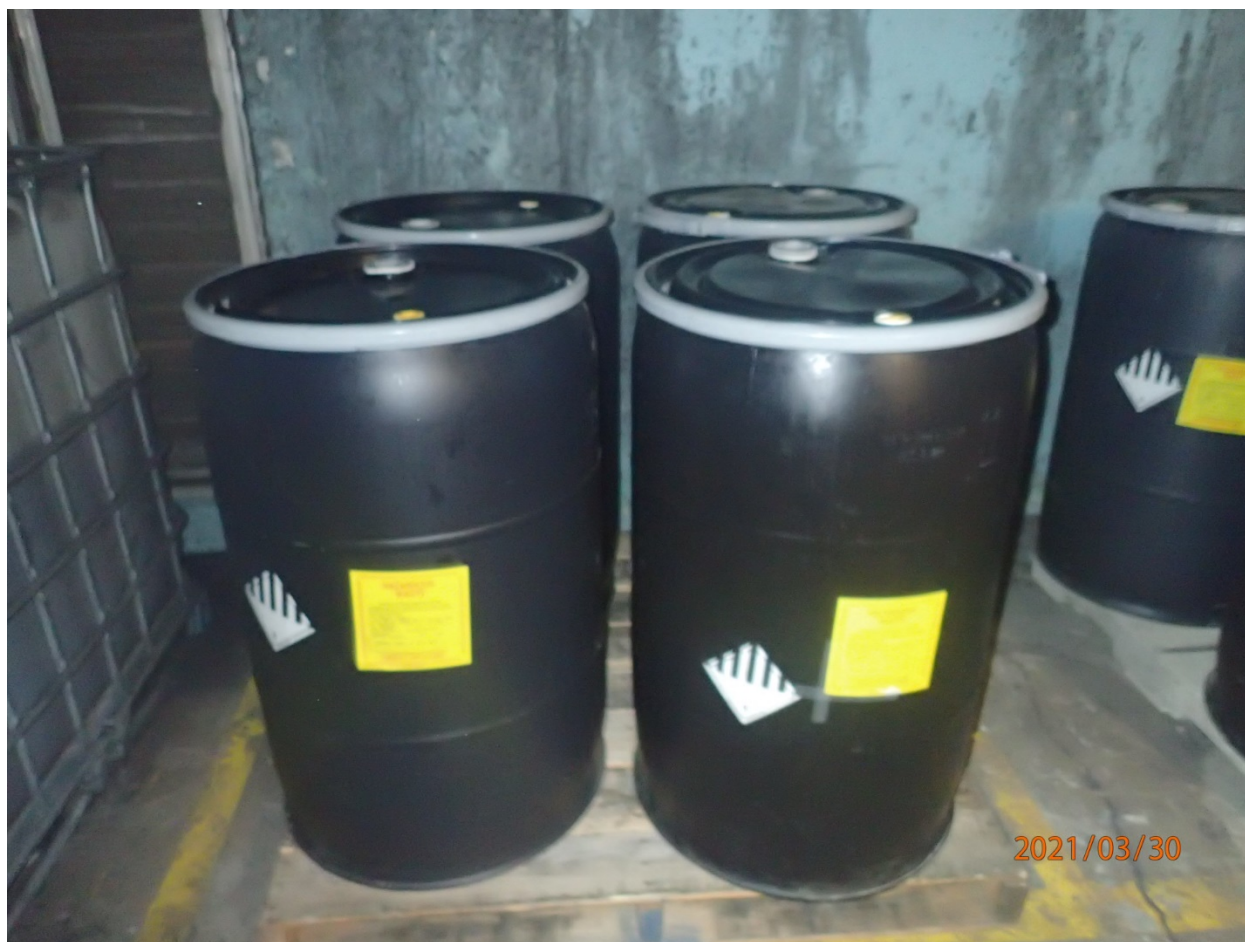
Pen 1 - Just inside Plant 2 Chemical Dock: This area is not a designated Hazardous Waste Central Accumulation Area (CAA); however, Mr. Mills explained that due to the designated CAA being full this area was being used as a hazardous waste storage area. (Photos 5-11). This area was equipped with a fire pull station, fire extinguisher, and spill response equipment. This area did not contain proper secondary containment, or any signage to indicate it is a CAA. The floor also appeared to be cracked. The following hazardous wastes were observed:

- Ten (10) 55-gallon drums labeled “Hazardous Waste Paint - Waste Blasting Media - D008”, closed and all drums dated 3/26/21
- One (1) 250-gallon plastic tote labeled “Hazardous Waste – Blasting Media and Paint Waste – D008”, closed and dated 3/26/21

**Photo 5:** Pen 1 in Magnolia Plant. 55-gallon drums of Hazardous Waste Paint - Waste Blasting Media - D008.

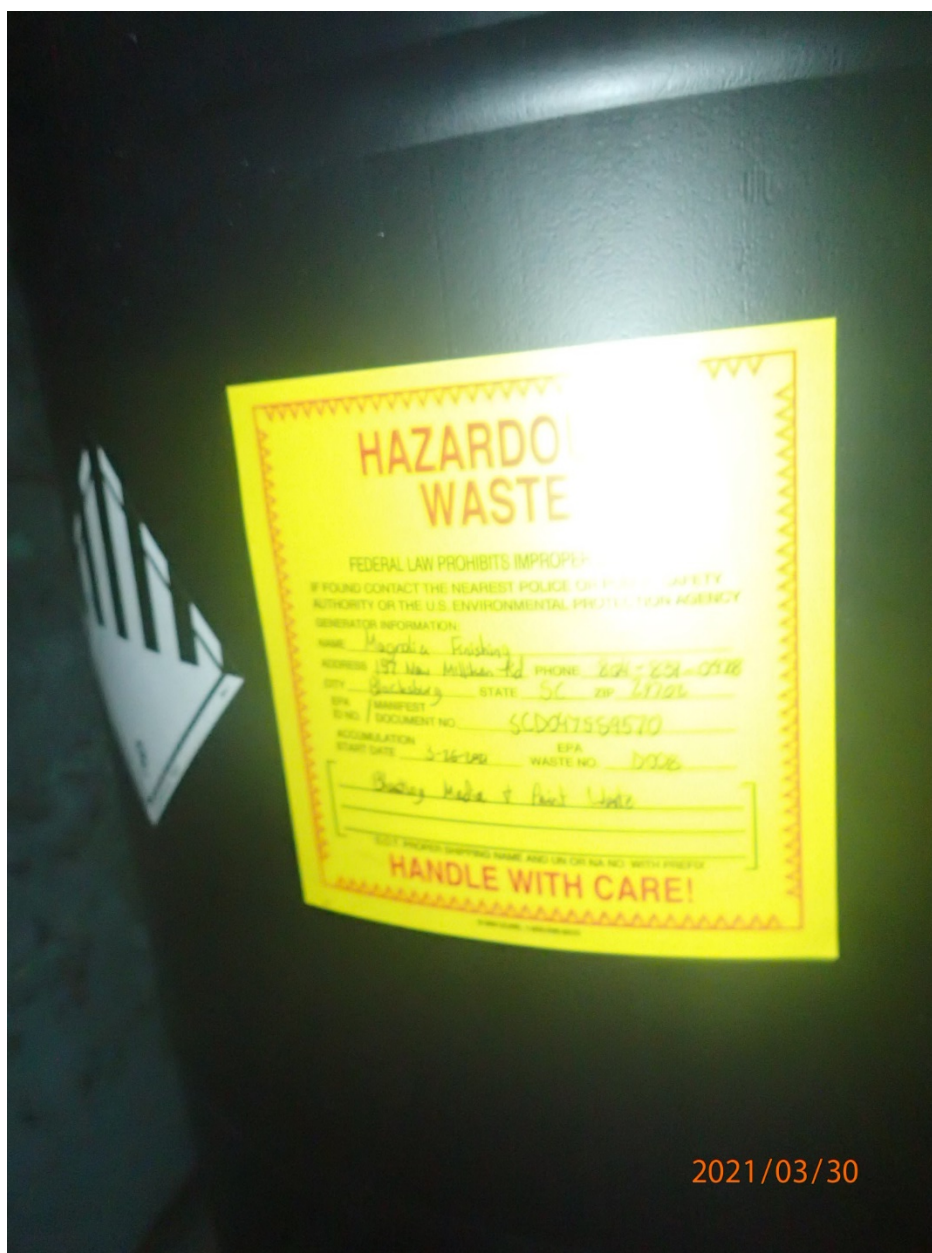
**Photo 7:** 55-gallon drum with label for blasting media and paint waste. Located inside Pen 1 in Magnolia Plant.

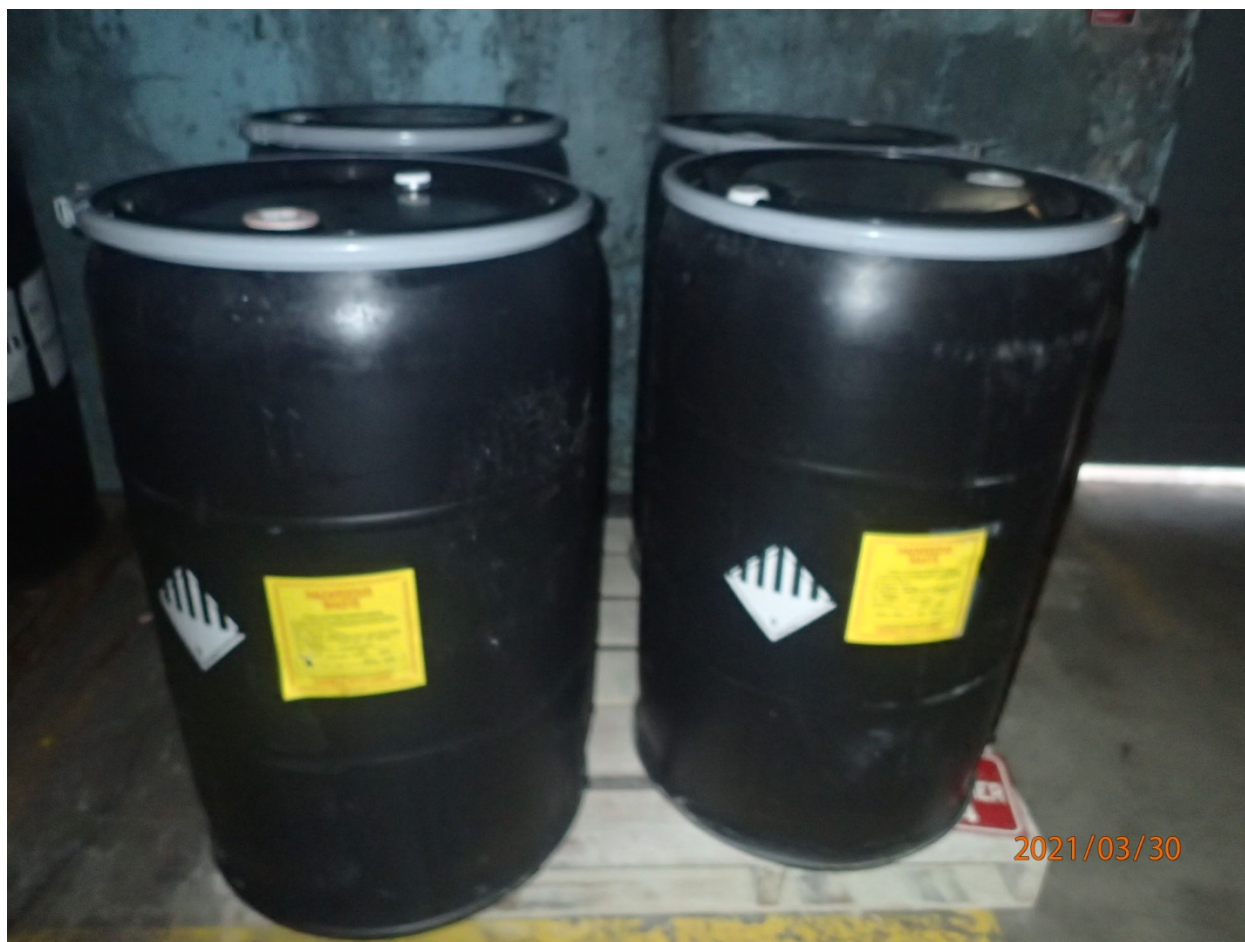
**Photo 8:** Pen 1 in Magnolia Plant. 55-gallon drums of Hazardous Waste Paint - Waste Blasting Media - D008.

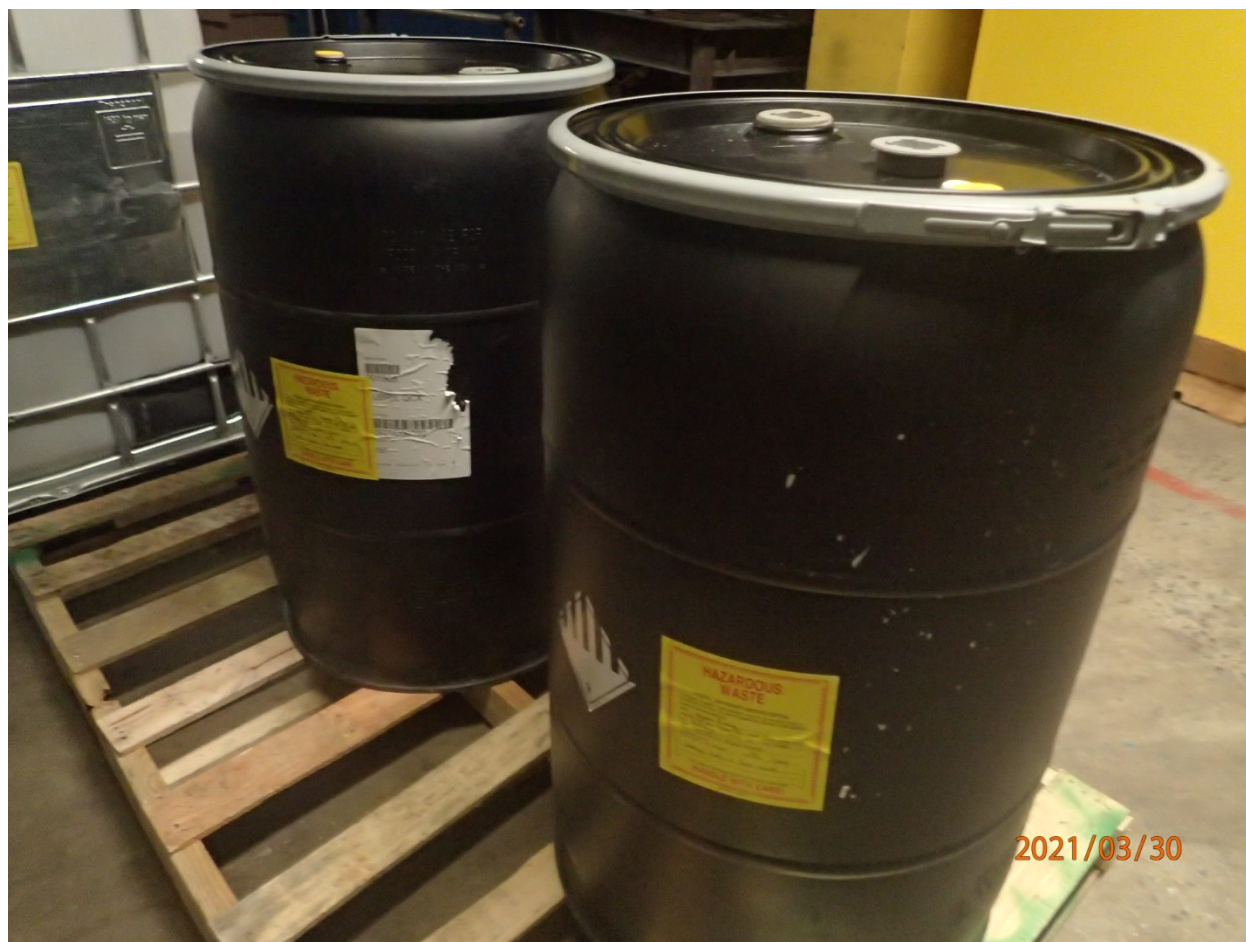
**Photo 10:** 55-gallon drums of “Hazardous Waste Paint - Waste Blasting Media - D008”, located in Pen 1, of Magnolia Plant.

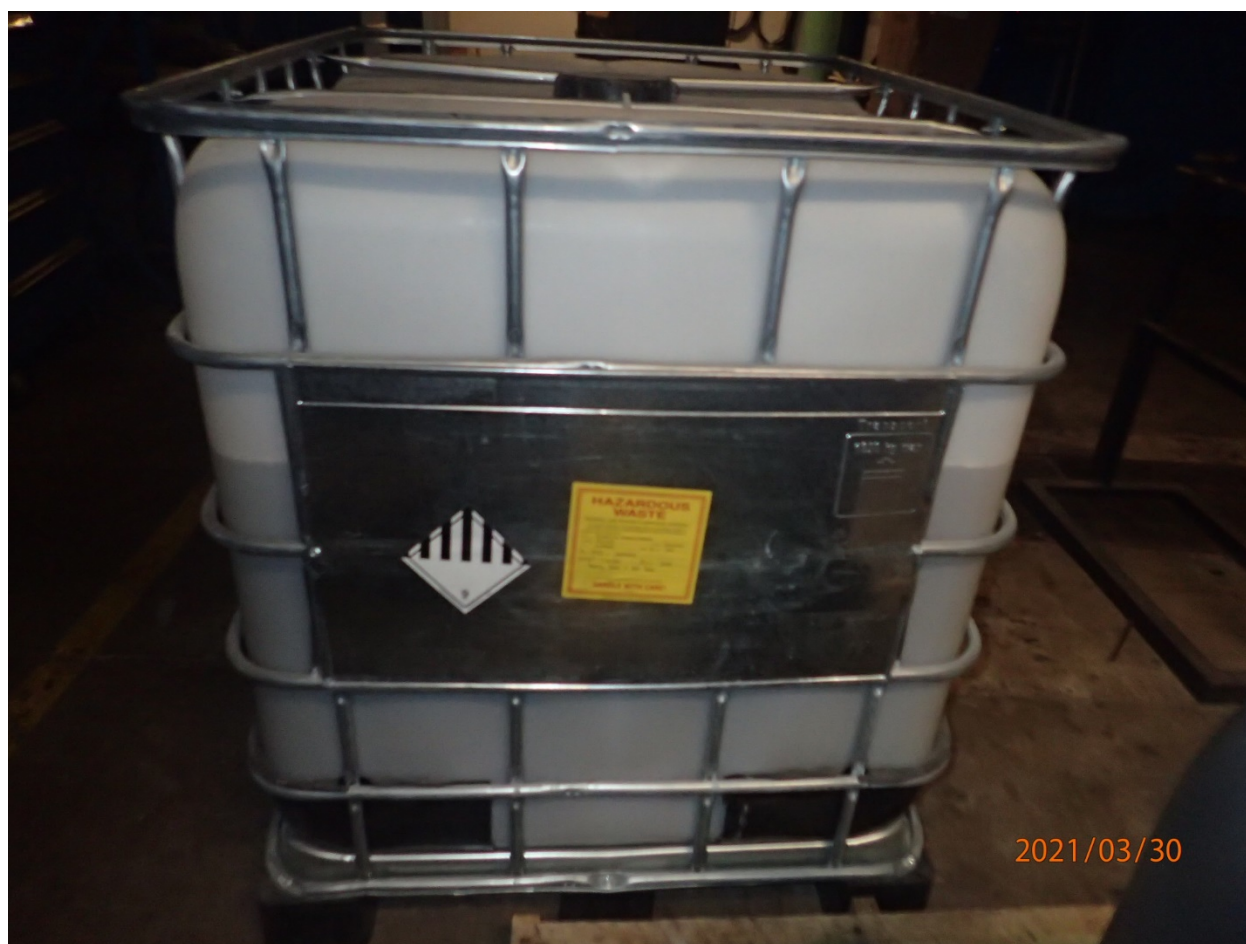
**Photo 11:** 250-gallon tote labeled “Hazardous Waste – Blasting Media and Paint Waste – D008”. Located at Pen 1 inside Magnolia Plant.

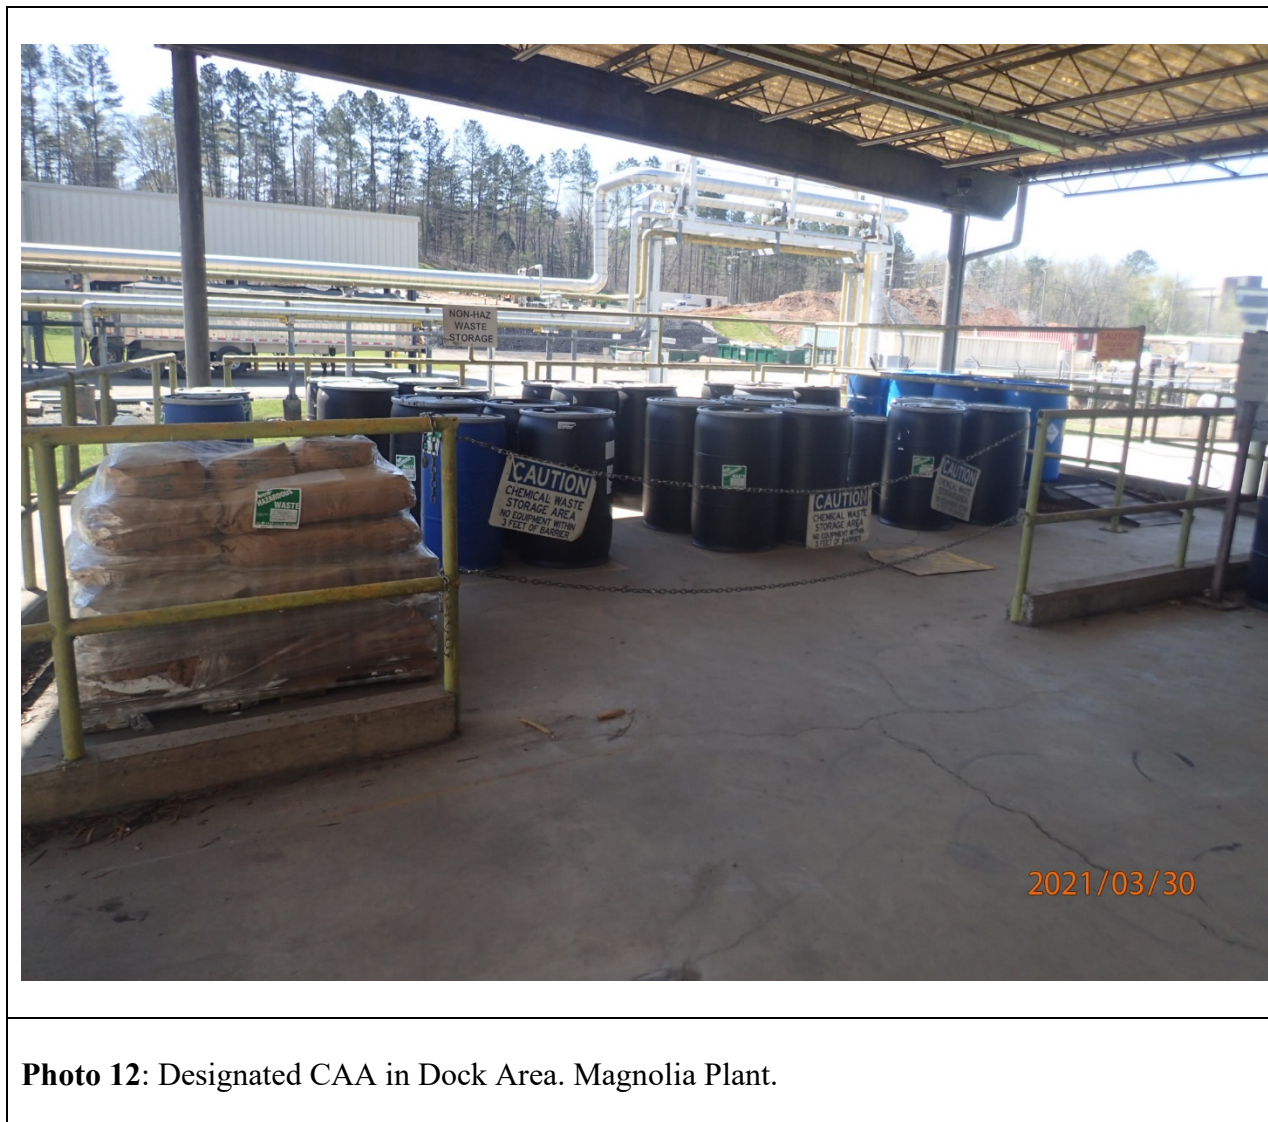
Designated CAA in Dock Area: The CAA is located in a covered area and on a concrete pad. It is divided into nonhazardous and hazardous waste storage (Photos 12-18). The CAA is equipped with a spill kit. Hazardous waste containers are stored on top of portable secondary containment units. The following containers were observed in front of the CAA:

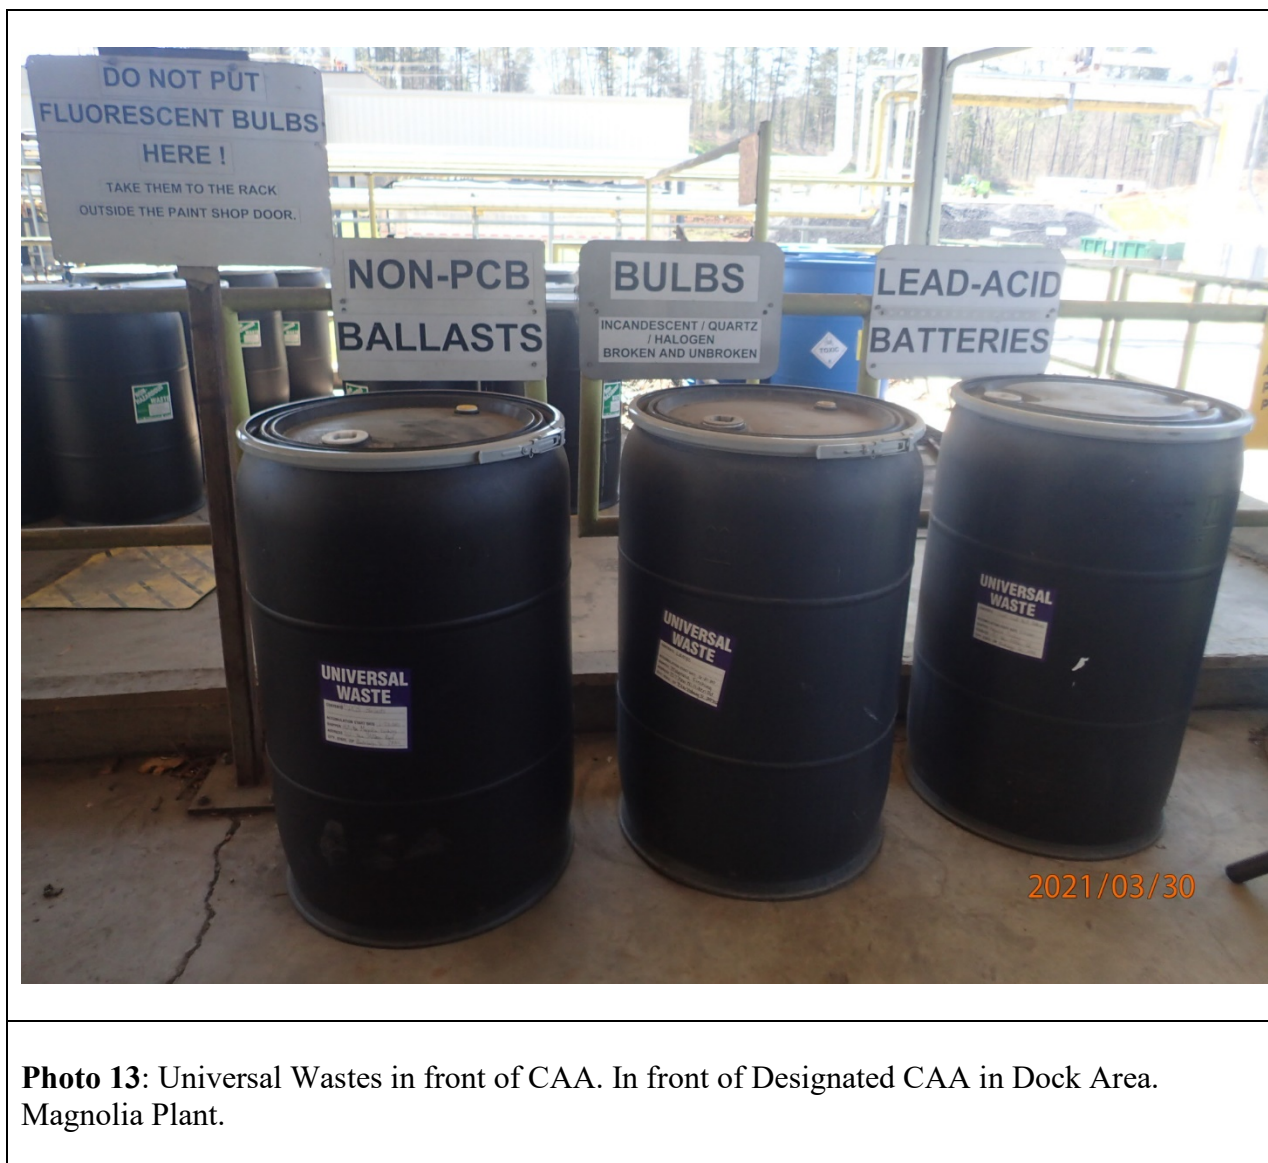
- One (1) 55-gallon drum labeled “Universal Waste Non-PCB Ballasts” closed and dated 1/28/21
- One (1) 55-gallon drum labeled “Universal Waste Lamps” closed and dated 6/21/20
- One (1) 55-gallon drum labeled “Universal Waste Lead Acid Batteries” closed and dated 9/22/20
- One designated hazardous waste satellite accumulation area (SAA) with one (1) 55-gallon drum labeled “Hazardous Waste Broken Bulbs – Mercury” closed and elevated with a locked latched lid.

**Photo 13:** Universal Wastes in front of CAA. In front of Designated CAA in Dock Area. Magnolia Plant.

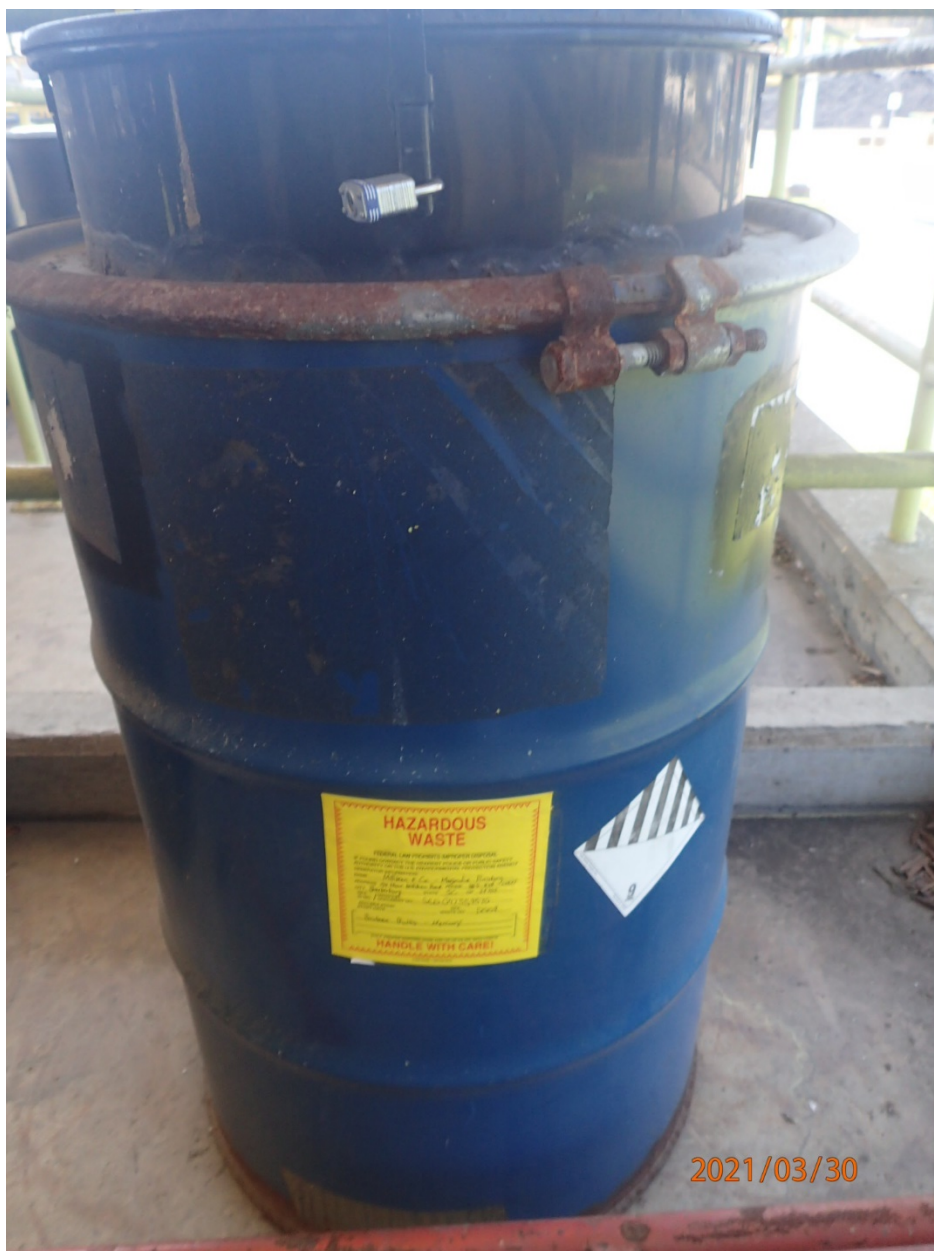
**Photo 14:** 55-gal drum of Hazardous Waste Broken Bulbs – Mercury D009. In front of designated CAA in Dock Area. Magnolia Plant.

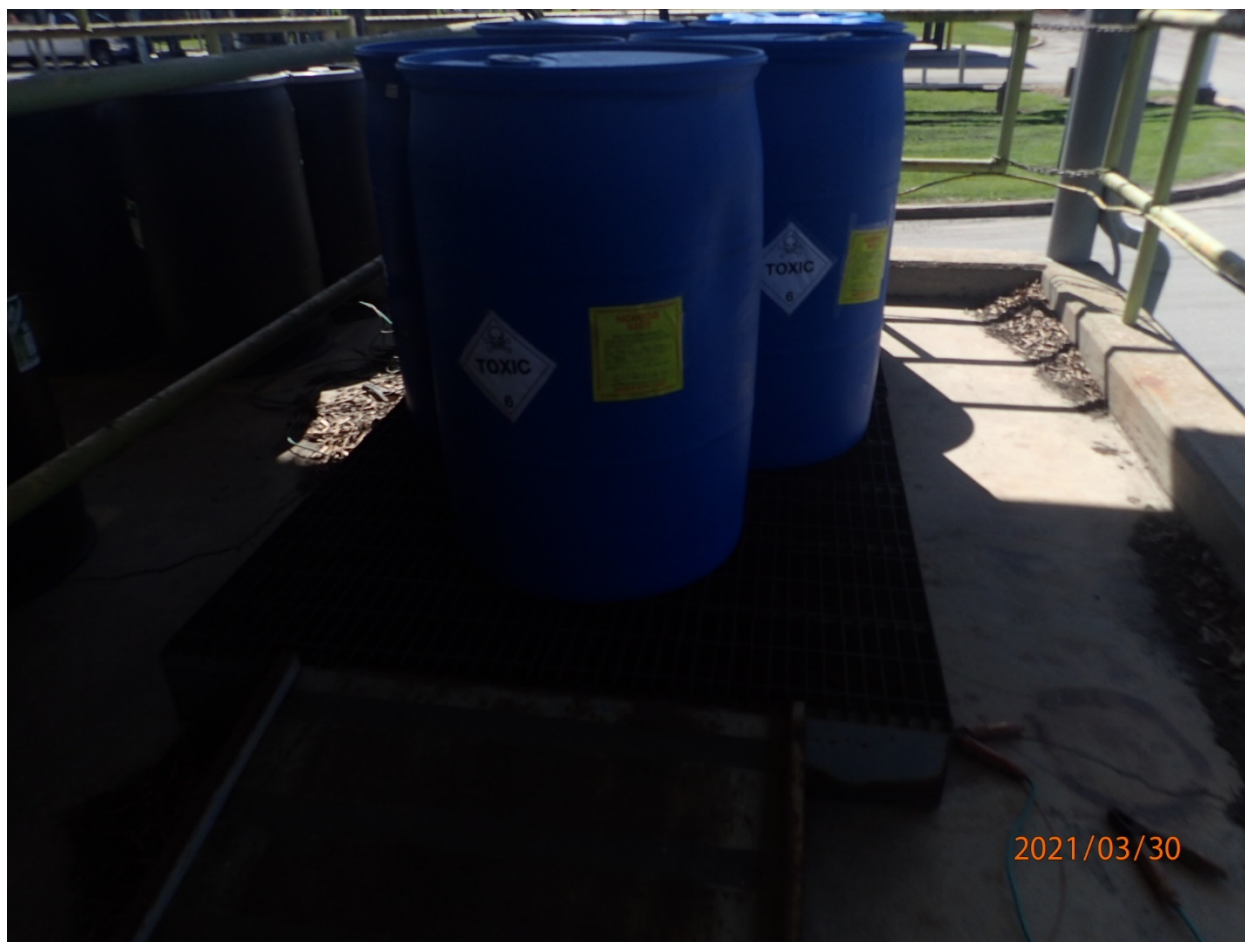
- Six (6) 55-gallon drums labeled “Hazardous Waste Toxic FR Mix - D004, D007”, closed, all contained DOT toxic hazard placard, and all dated 3/1/21
- One (1) 55-gallon drum labeled “Hazardous Waste Aerosol – D001” closed, contained DOT flammable hazard placard, and dated 2/11/21

**Photo 15:** 55-Gal drums of Hazardous Waste Toxic FR Mix - D004, D007. Designated CAA in Dock Area. Magnolia Plant.

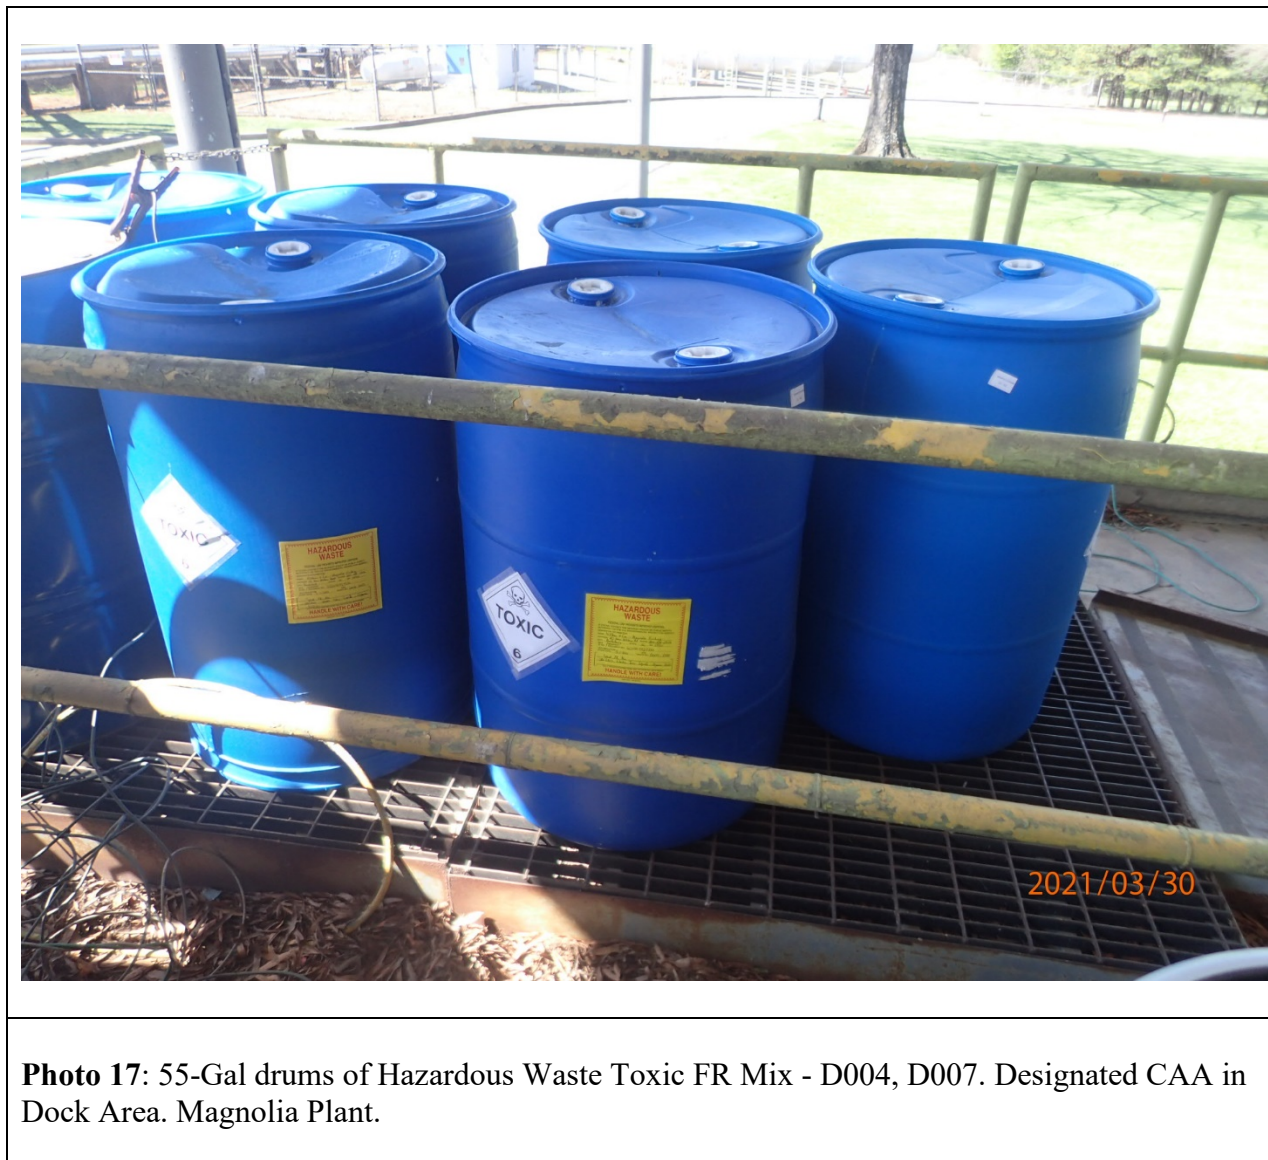
**Photo 17:** 55-Gal drums of Hazardous Waste Toxic FR Mix - D004, D007. Designated CAA in Dock Area. Magnolia Plant.

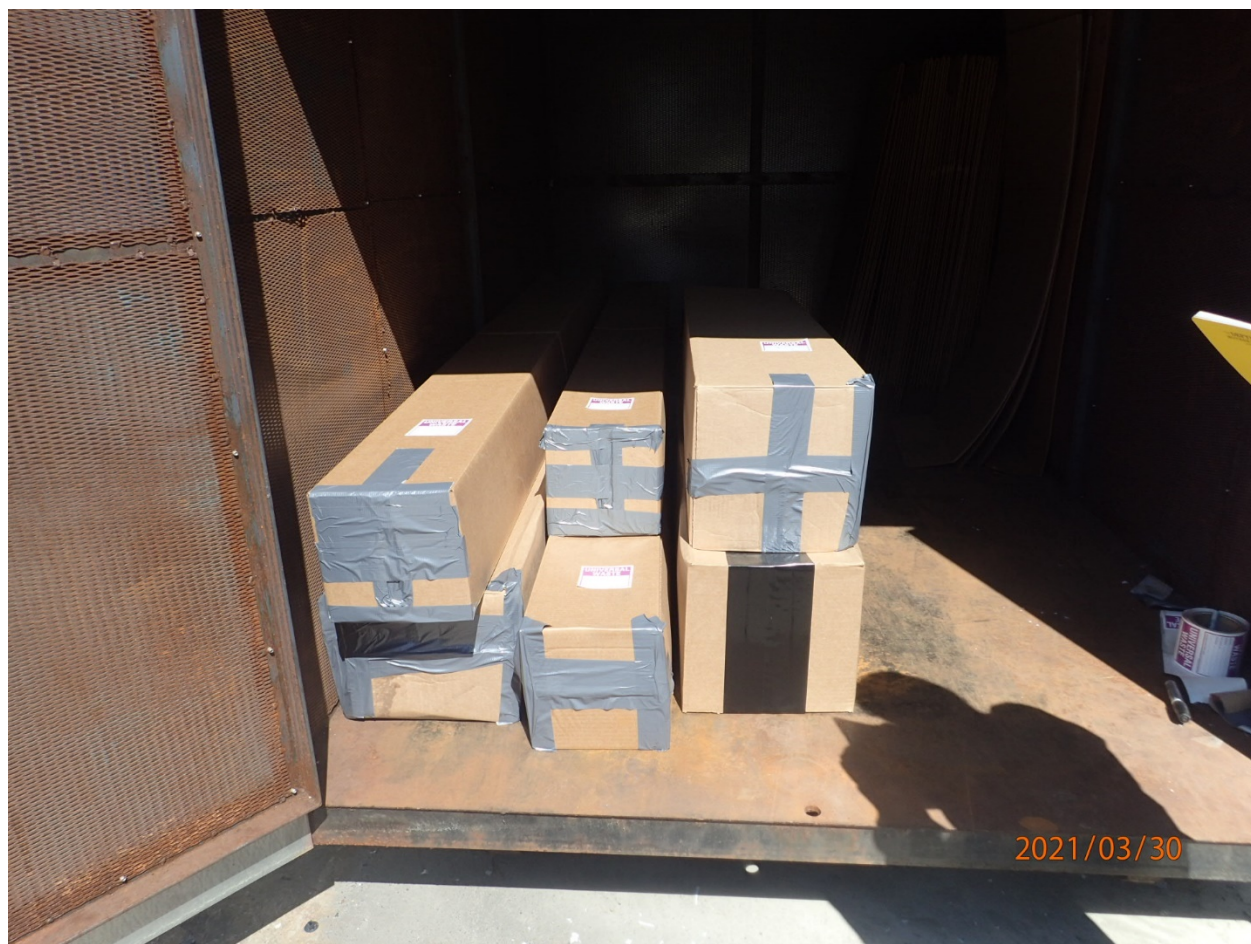
Storage Area for Fluorescent Bulbs: Storage shed was labeled used “fluorescent bulbs”. Six (6) boxes of fluorescent bulbs were observed inside the storage shed. All boxes were labeled Universal Waste lamps (Photo 19). The inspectors observed four (4) 8-ft boxes and two (2) 4-ft boxes. All boxes were closed. The oldest accumulation start date was 10/20/20.

**Photo 19:** Storage area for Universal Waste Spent Fluorescent Bulbs. Four 8-ft boxes and two 4-ft boxes. Magnolia Plant.

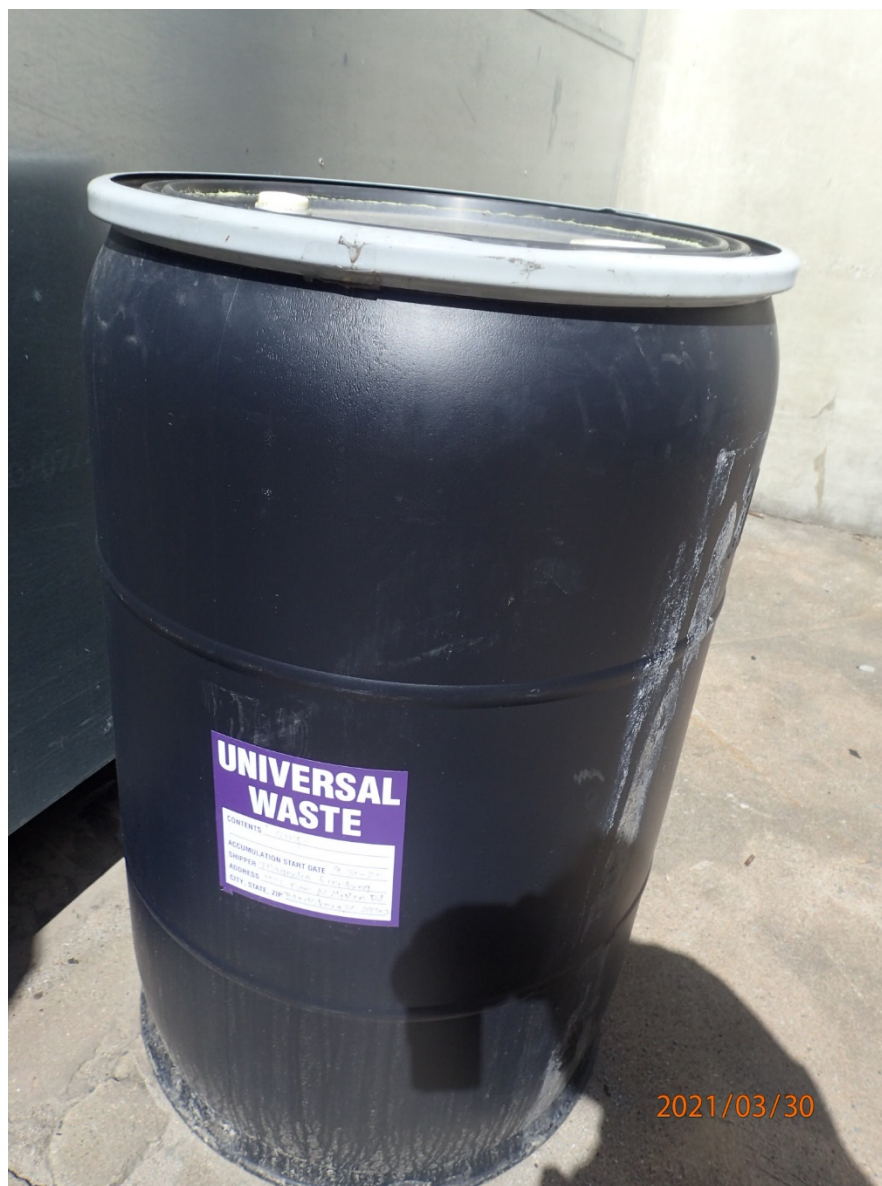
**Photo 20:** Universal waste lamps in 55-gal drum next to Universal Waste Spent Fluorescent Bulbs storage shed. Magnolia Plant.

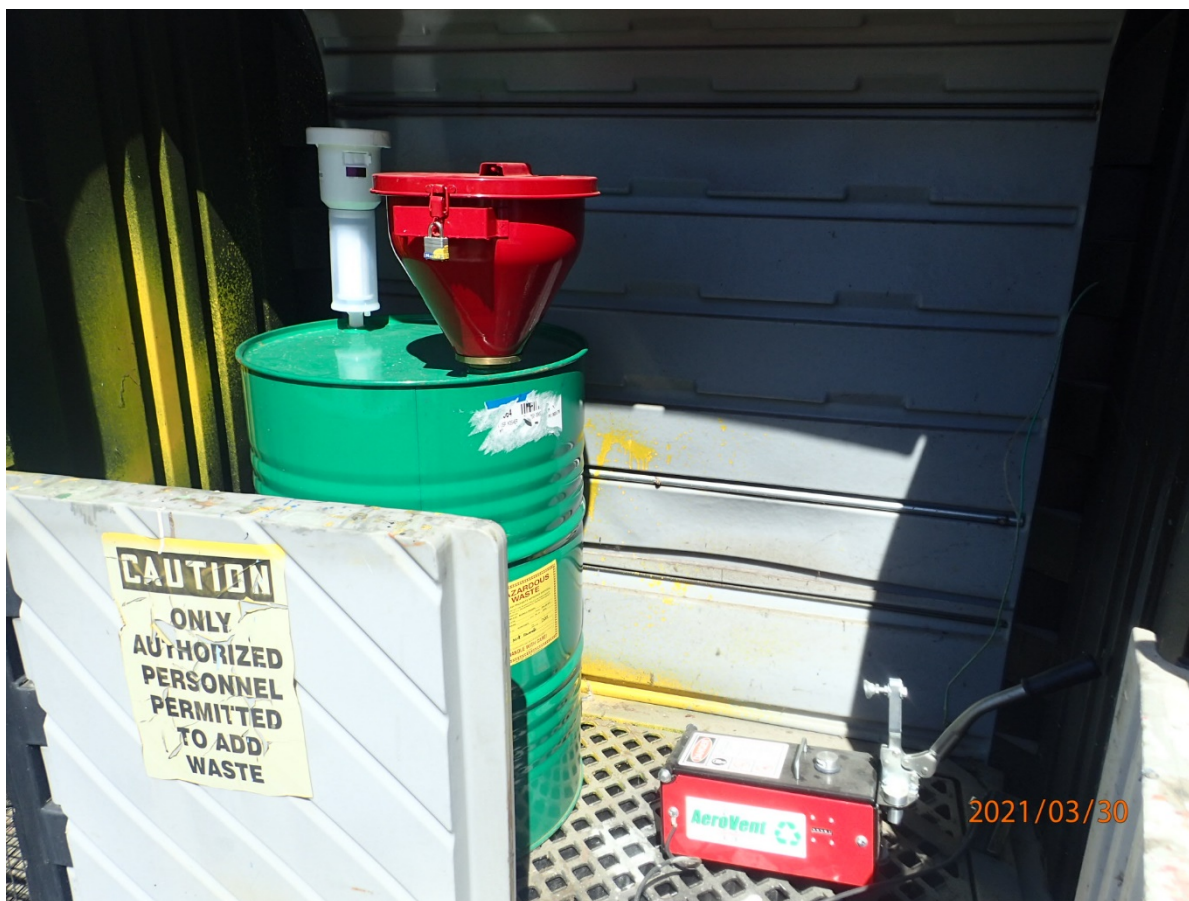
- One (1) 55-gallon drum with a locked, latched funnel lid, and on secondary containment. Labeled “D001 Hazardous Waste Used Paint” with flammable liquid DOT hazard placard (Photos 21 and 22).

**Photo 21:** SAA – 55-gal drum labeled D001 Hazardous Waste Used Paint. Magnolia Plant.

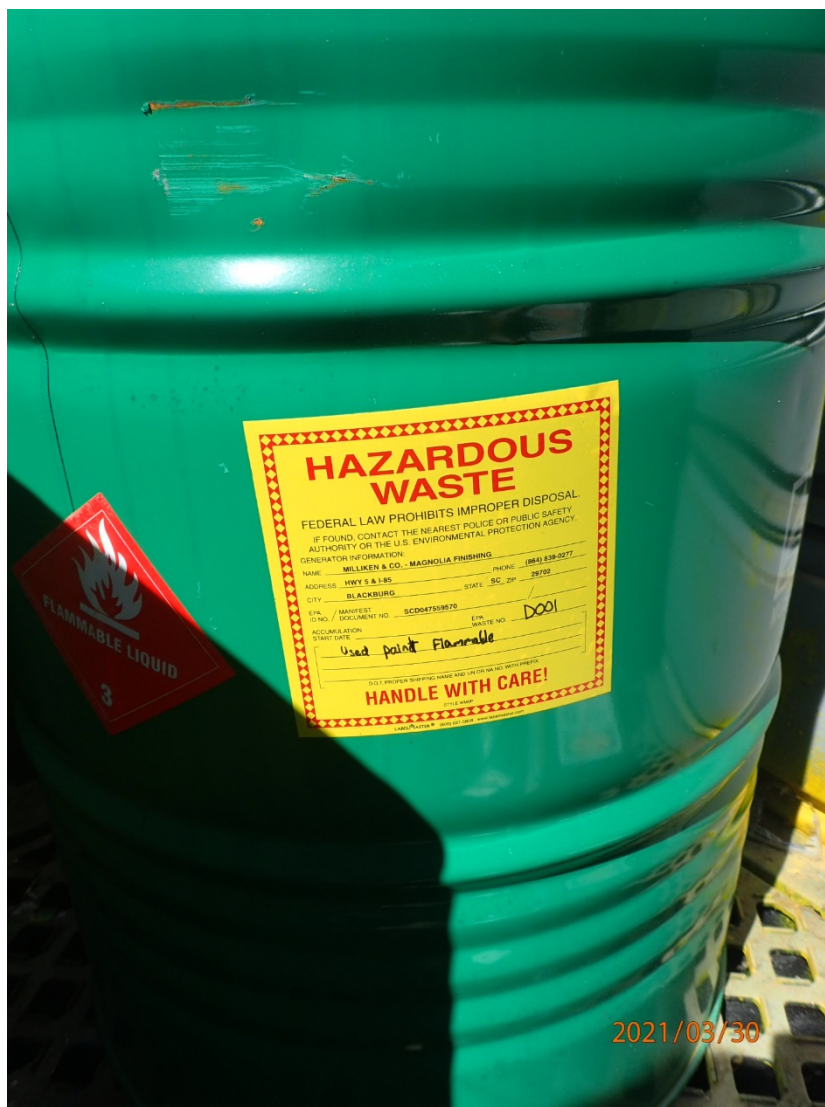
**Photo 22:** Close up of hazardous waste label of 55-gal drum labeled D001 Hazardous Waste Used Paint. Magnolia Plant.
