## **RCRA Inspection Report**

Milliken & Company Magnolia Finish Plant  
157 New Milliken RD. and 164 New Milliken RD.  
Blacksburg, South Carolina 29702  
EPA ID# SCD047559570

March 30, 2021

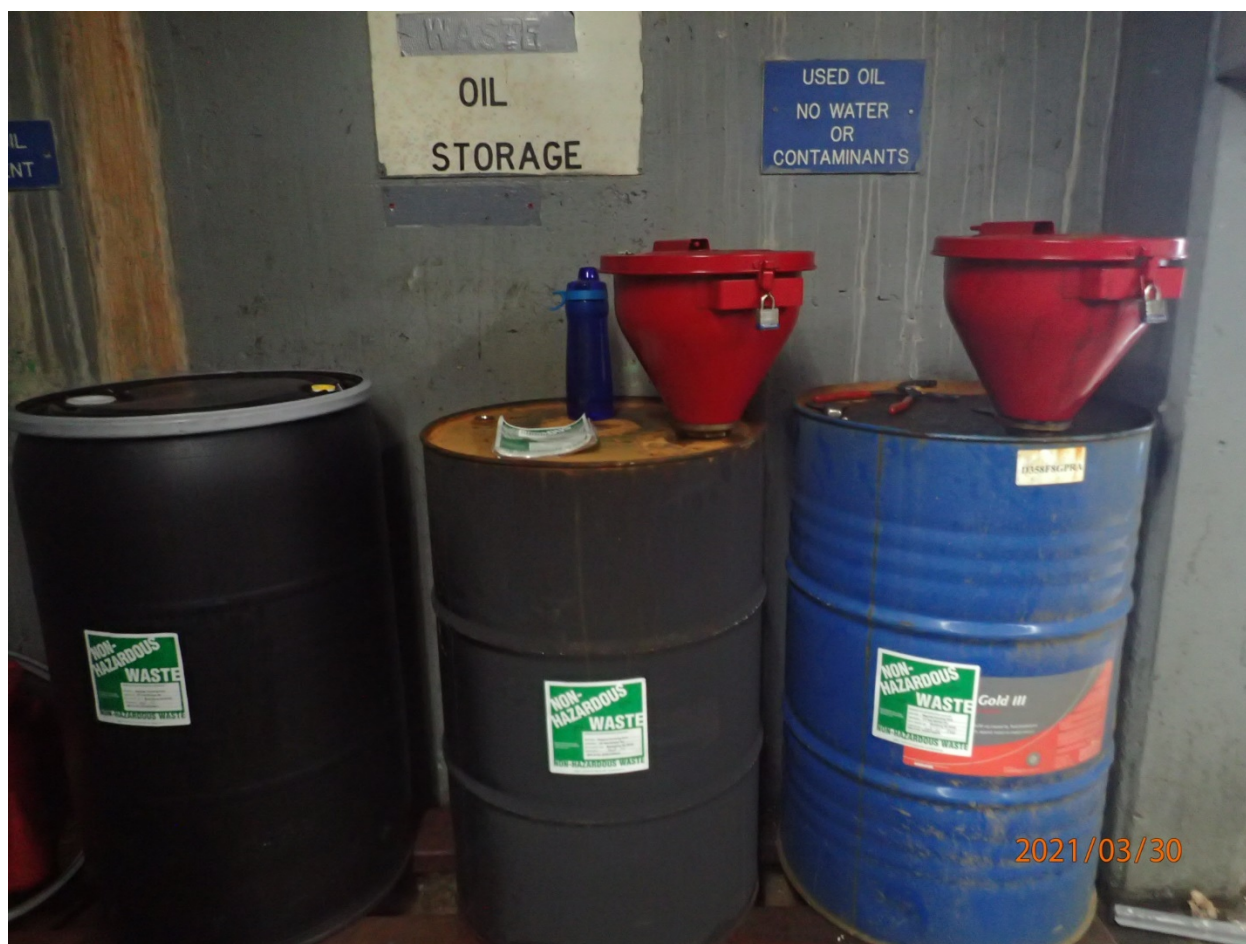
**Photo 23:** Three 55-gallon drums of used oil with locked funnel lid. Small bung open on one used oil drum (middle). Inside Oil Room in Magnolia Plant.

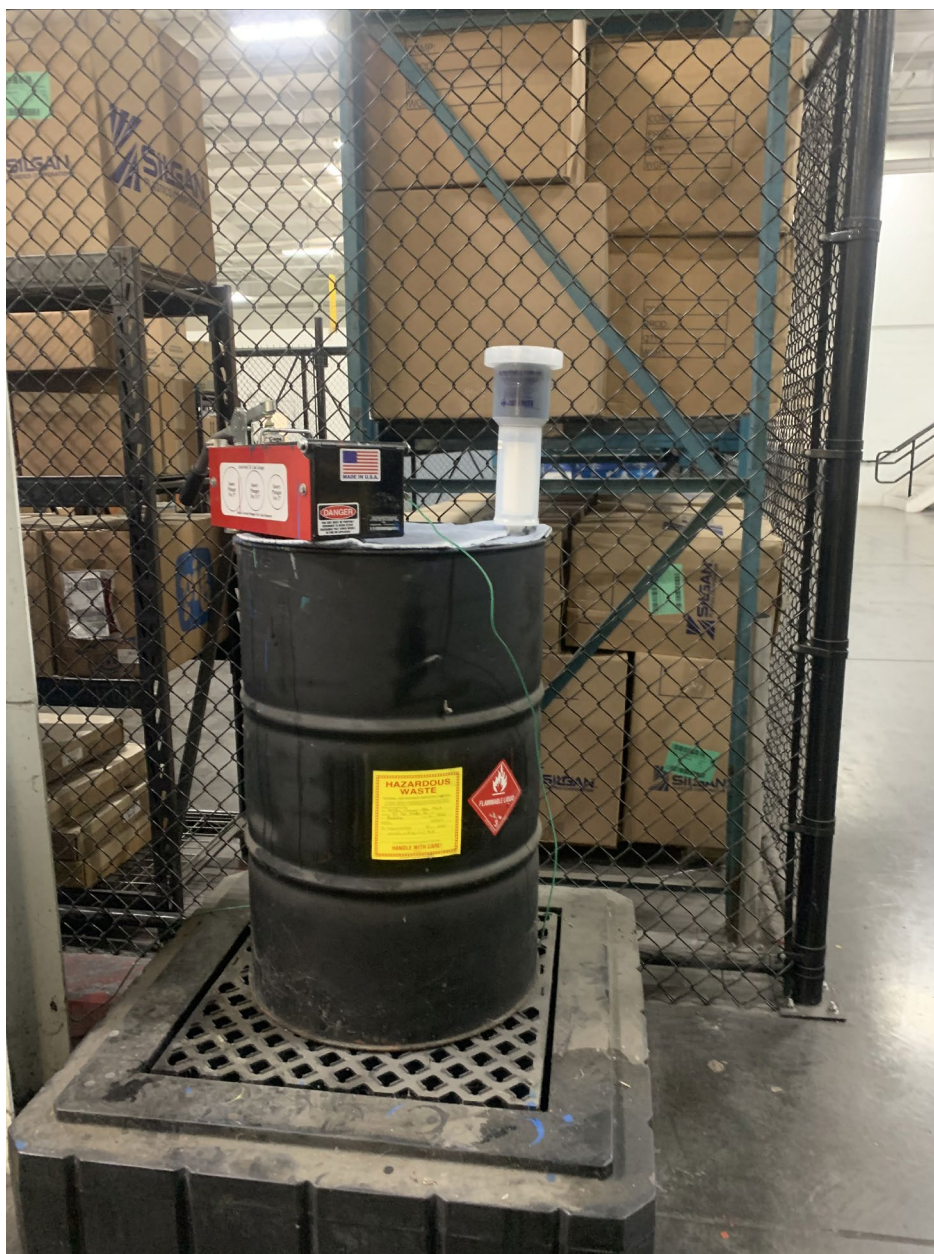
An aerosol can puncture device was observed with a 55-gallon drum labeled Hazardous Waste - Paint with a flammable liquid DOT hazard placard (Photo 24). Emergency shower / eyewash and fire extinguisher were observed nearby.

**Photo 24:** Photo taken by Rob Wallace, Environmental Manager at Allen Plant. 55-gal drum of Hazardous Waste – Paint with aerosol can puncture device.

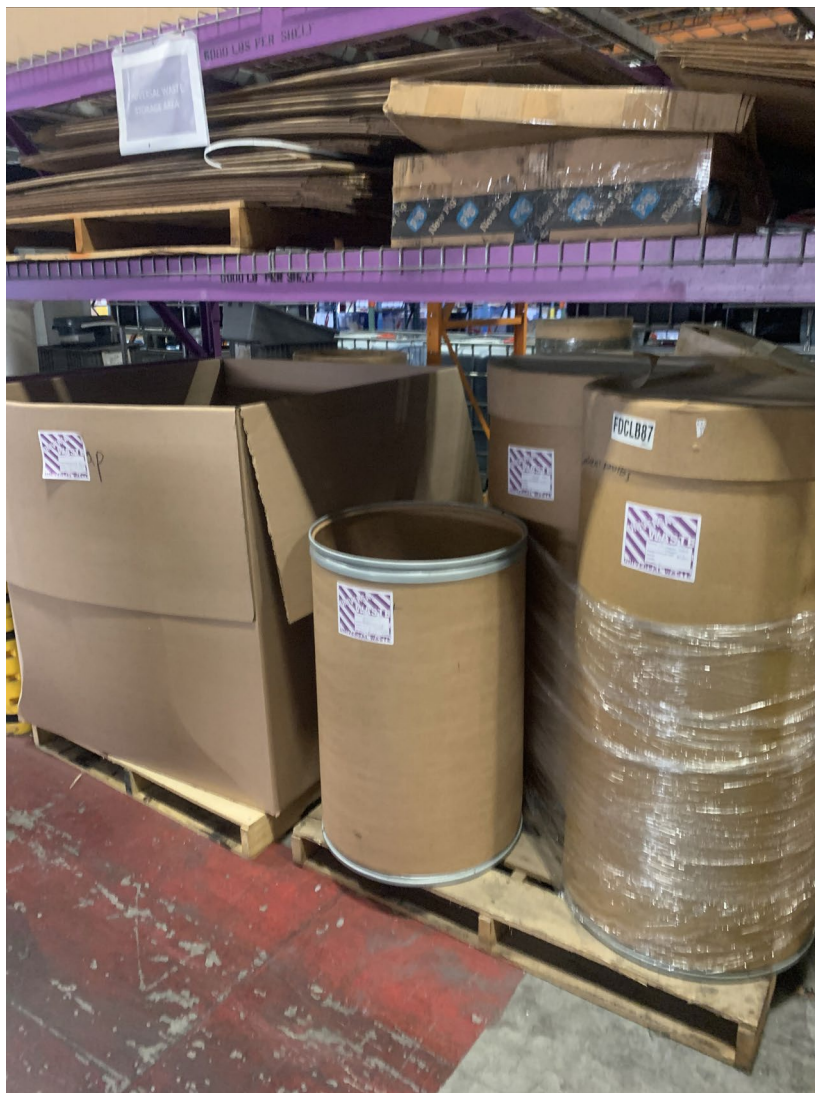
Secondary CAA/UW Storage Area: The secondary Central Accumulation Area (CAA) is located inside the warehouse and identified with signage. It is equipped with a fire extinguisher and a spill kit at the end of the row of shelves. Employees carry radios on them and have cell phones for communication. There is portable secondary containment for hazardous waste storage. At the time of the inspection, there was no hazardous waste being stored in the secondary CAA. The following universal wastes were observed (Photo 25):

**Photo 25:** Photo taken by Rob Wallace, Environmental Manager at Allen Plant. Secondary CAA/ Universal Waste storage area.

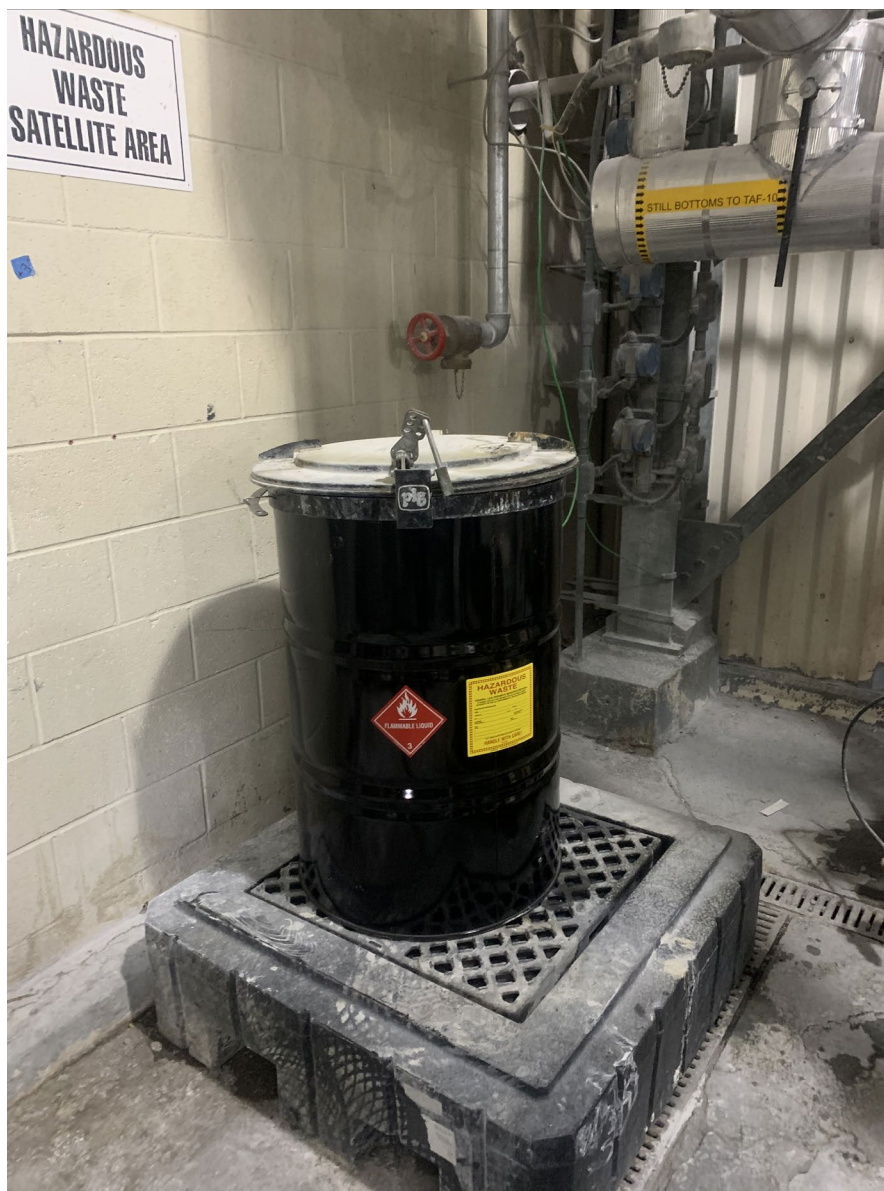
- One (1) 55-gallon drum for filter bags from the recirculation line, labeled “Hazardous Waste Flammable Liquid D001”, closed and on secondary containment (Photo 26).

**Photo 26:** Photo taken by Rob Wallace, Environmental Manager at Allen Plant. AF Building. 55-gallon drum for filter bags from the recirculation line, labeled “Hazardous Waste Flammable Liquid D001”.

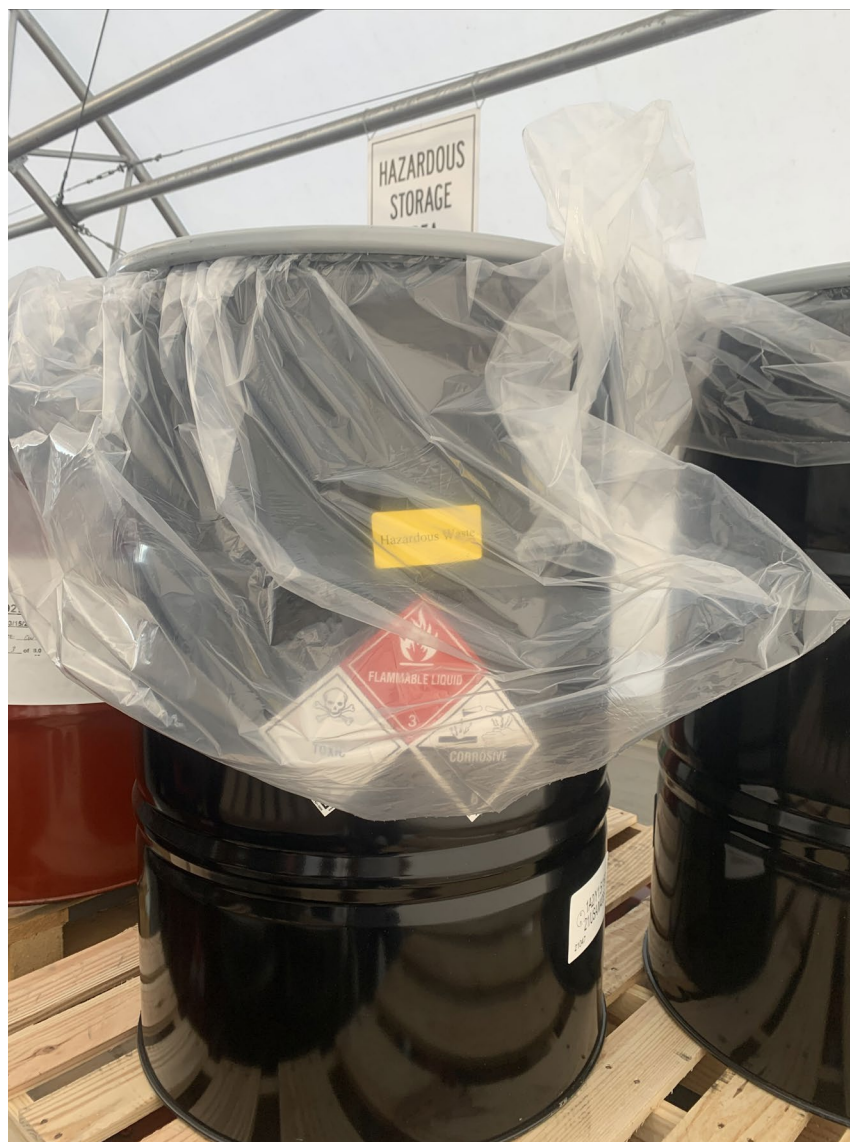
carry radios. The inspectors observed were four rows of hazardous waste containers double stacked. Approximately (198) 55-gallon hazardous waste drums with flammable liquid, toxic and corrosive DOT hazard placards and the majority labeled “Hazardous Waste” with an accumulation start date (Photo 27). The earliest start accumulation date was 3/6/21. Approximately seven (7) 55-gallon drums were missing a Hazardous Waste label. Milliken personnel immediately added Hazardous Waste labels to those drums during the inspection.

**Photo 27:** Photo taken by Rob Wallace, Environmental Manager at Allen Plant. 55-gal Hazardous waste drum in Primary CAA.
