U.S. Environmental Protection Agency, Region 4  
61 Forsyth Street SW, Atlanta, GA 30303  
**Water Compliance Inspection Report**

**Facility Name:** Concrete Supply Company, LLC (CSC) – South Plant (Charlotte)      **SIC Code:** 3273 / E / E2

This was a joint EPA and NC DEQ stormwater Compliance Evaluation Inspection (CEI) focusing on the requirements of the North Carolina General Permit for Storm Water Discharges Associated with Industrial Activities (General Permit No. NCG140000).

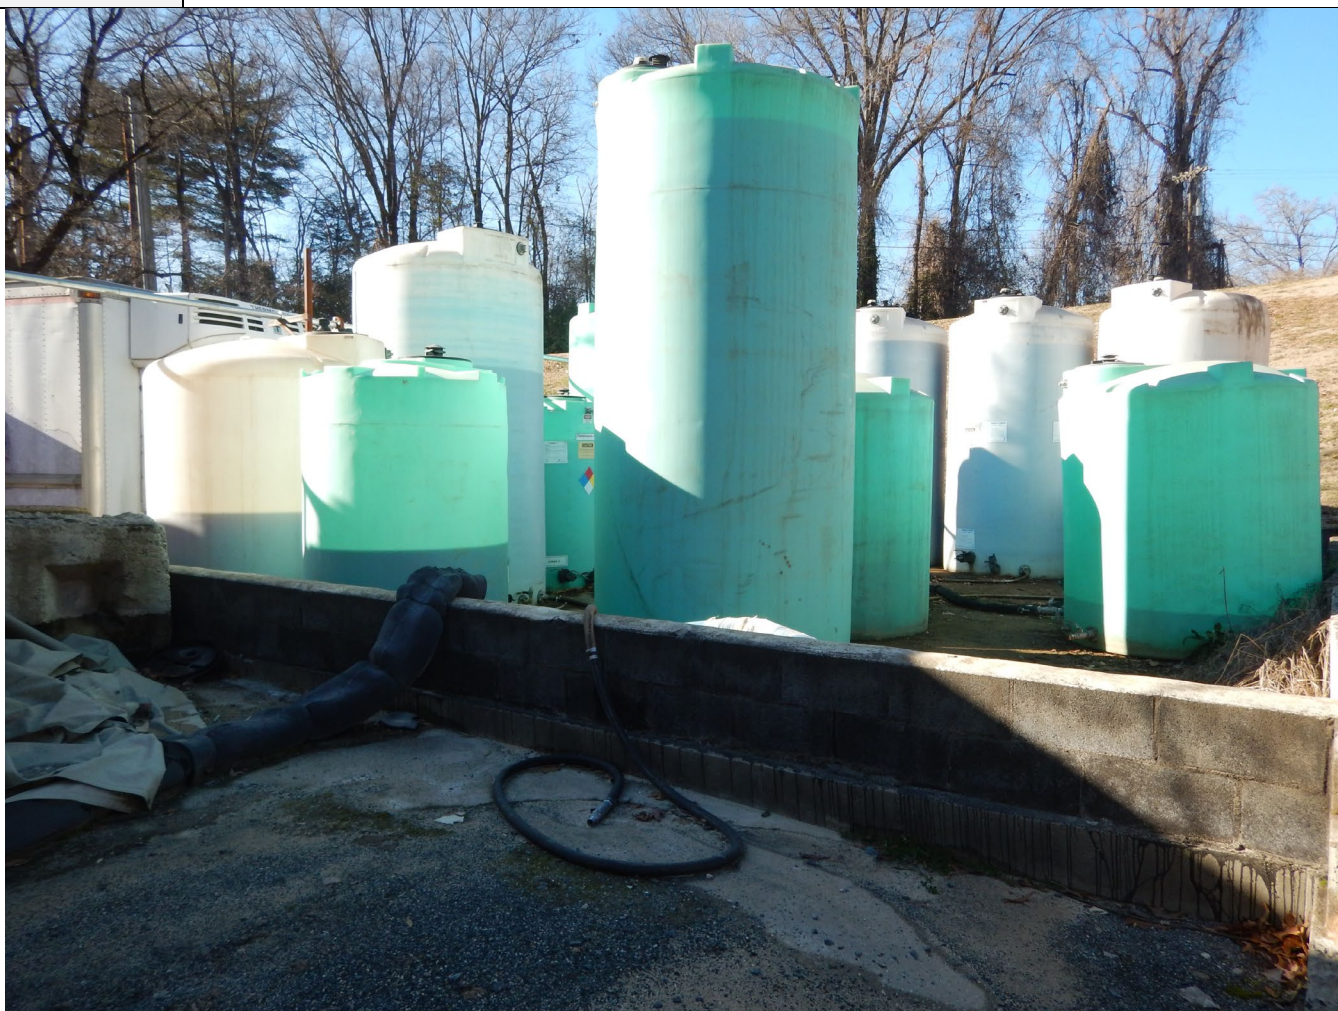
| <b>Photo ID:</b> | DSCN 1558 |

| <b>Description:</b> | Designated area for Aug Mixture containers located within secondary concrete berm |

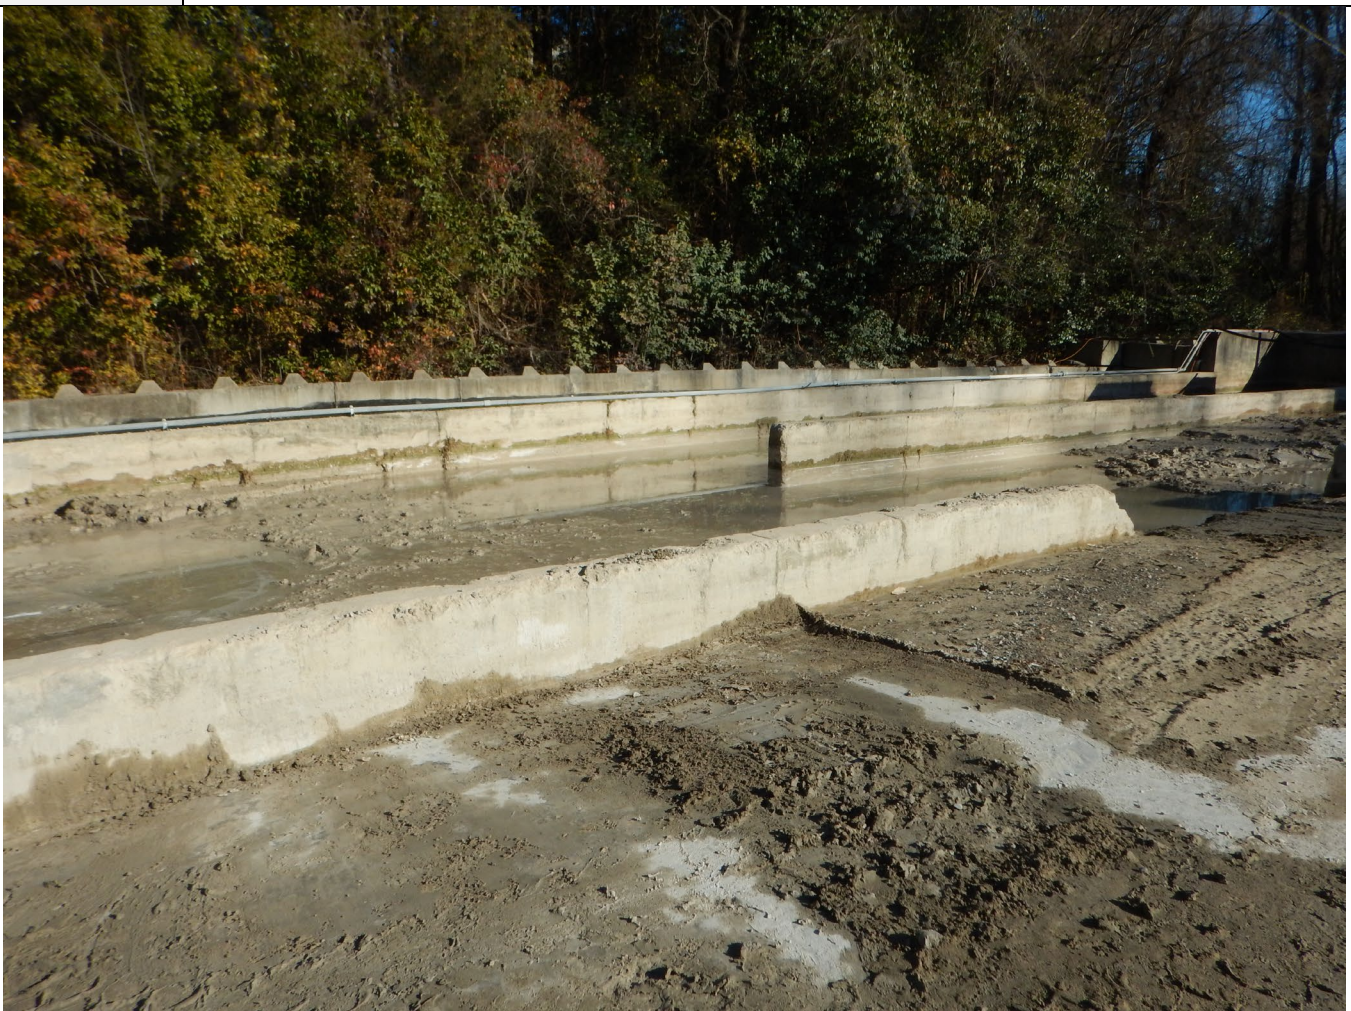
| <b>Photo ID:</b> | DSCN 1559 |

| <b>Description:</b> | Designated area for collection pits for process wastewater, stormwater, and comingle |

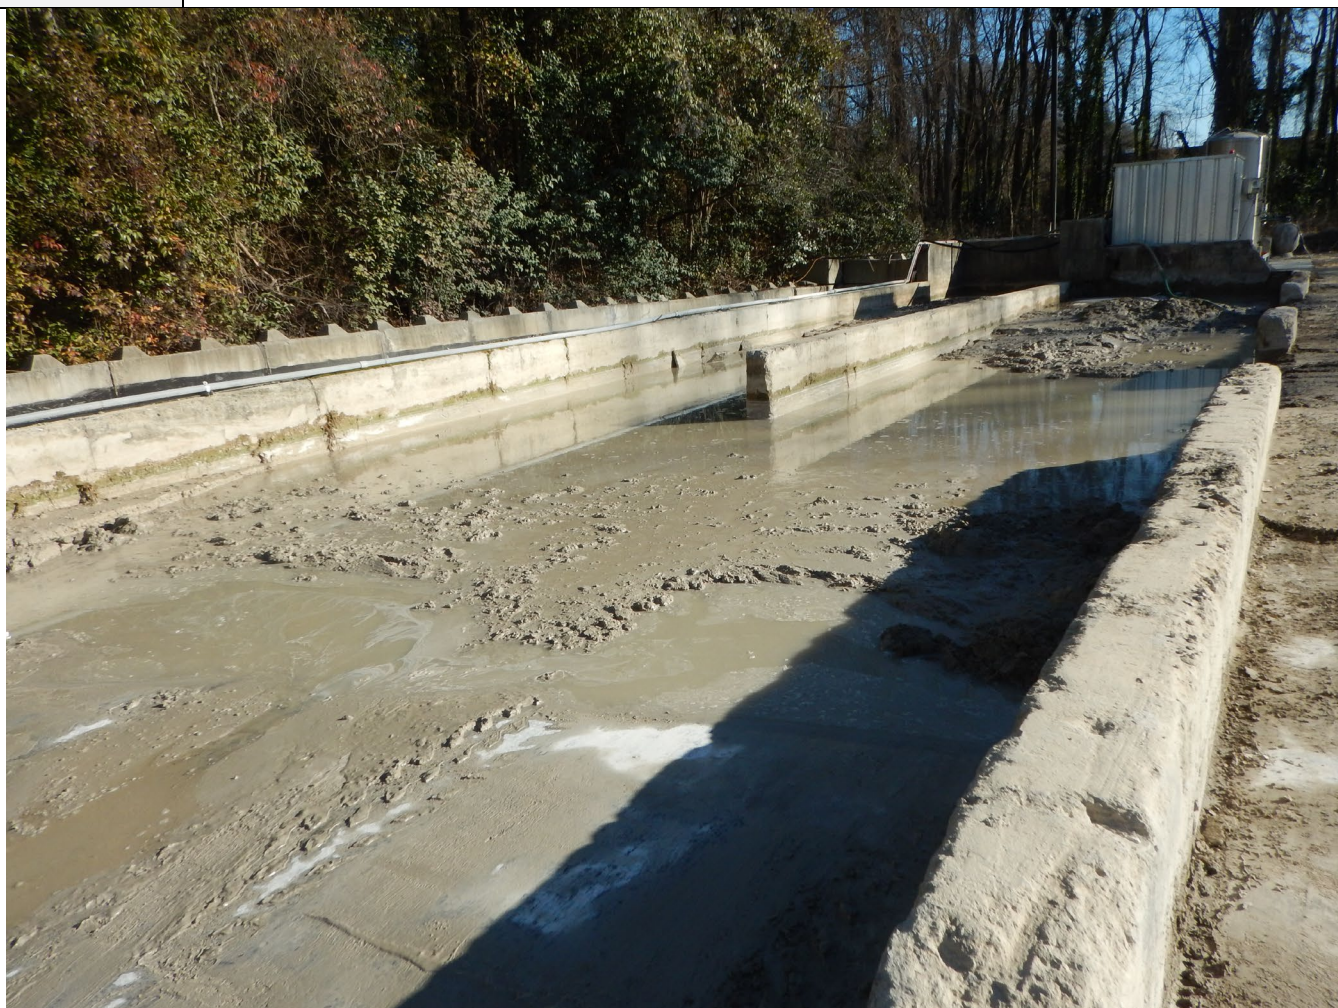
| <b>Photo ID:</b> | DSCN 1560 |

| <b>Description:</b> | Designated area for collection pits for process wastewater, stormwater, and comingle |

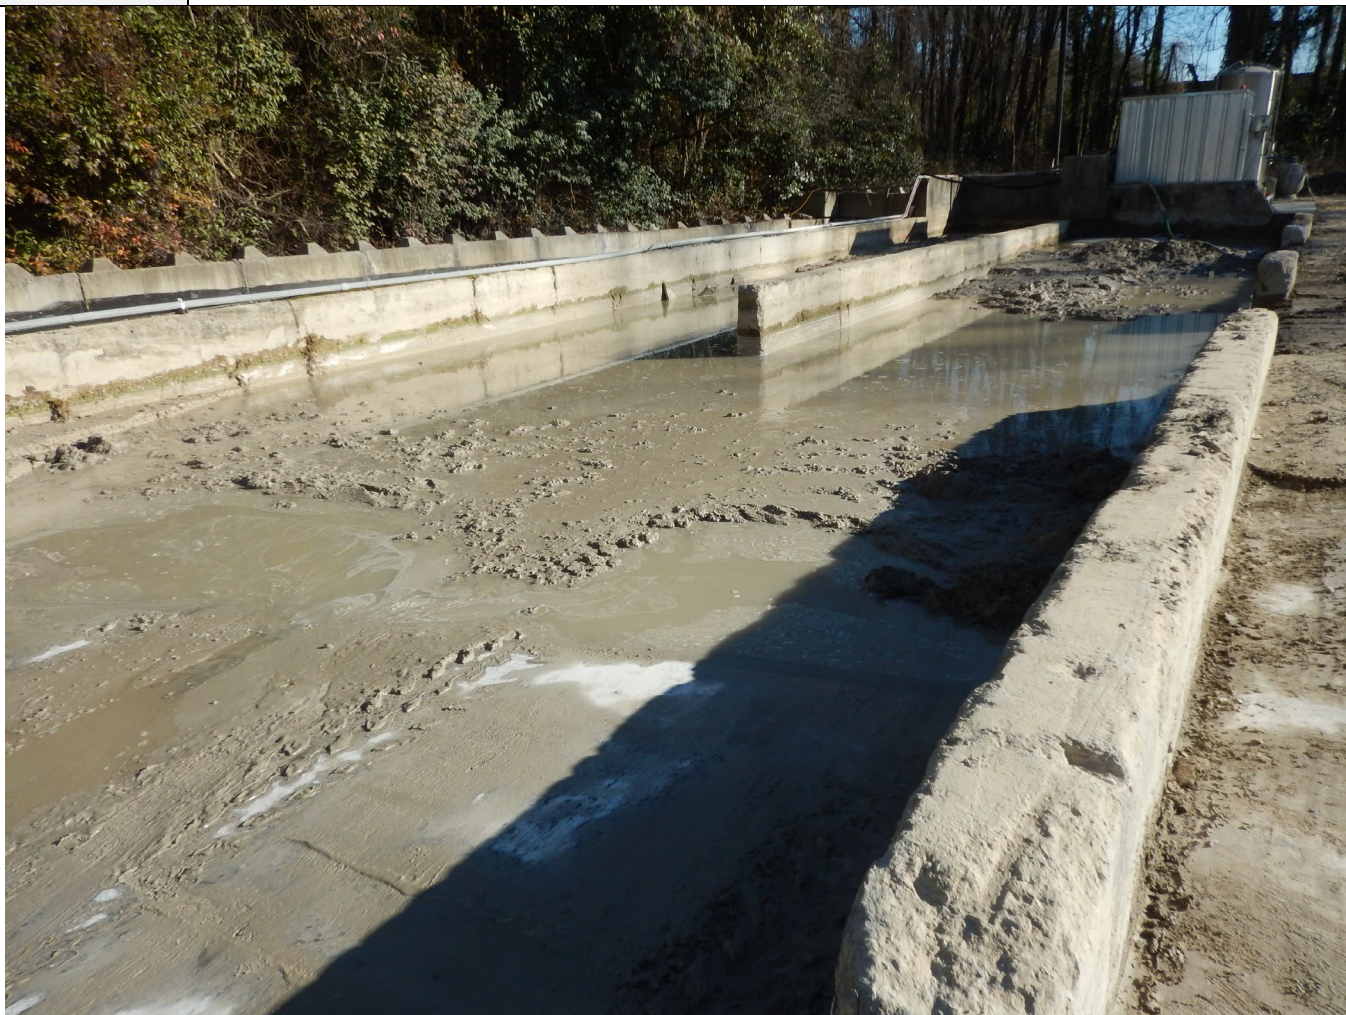
| <b>Photo ID:</b> | DSCN 1561 |

| <b>Description:</b> | Designated area for collection pits for process wastewater, stormwater, and comingle |

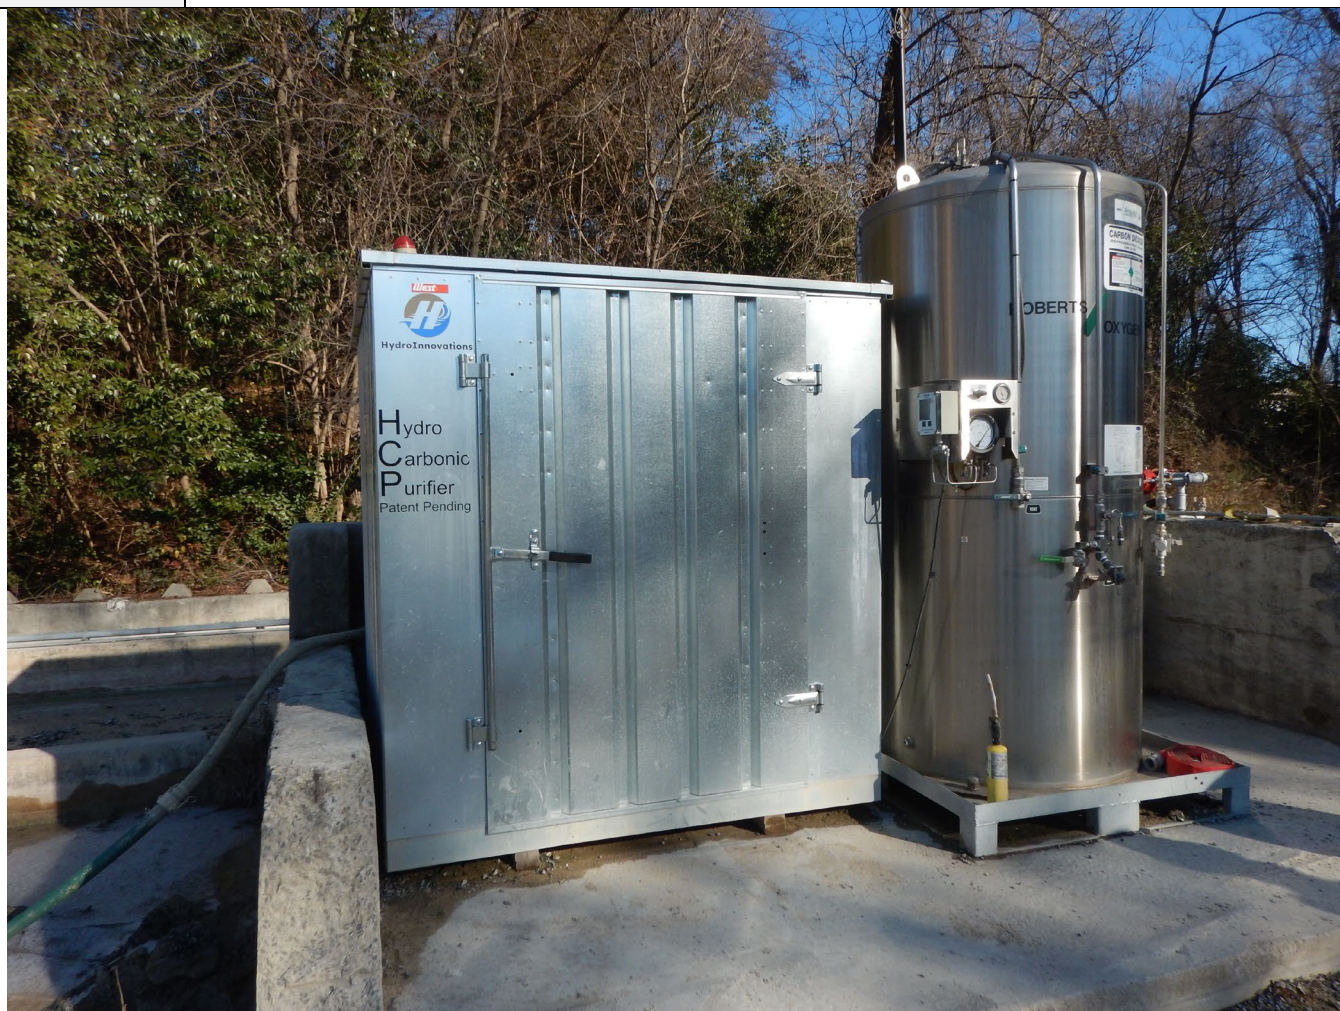
| <b>Photo ID:</b> | DSCN 1562 |

All the runoff from the production area drains toward the east side of the facility and collects in a concrete ditch. Wastewater and stormwater from the ditch are pumped through a CO<sub>2</sub> treatment system for pH adjustment prior to discharge via outfall #1.

| <b>Description:</b> | pH Adjusting system with CO2 tank and sand filter |

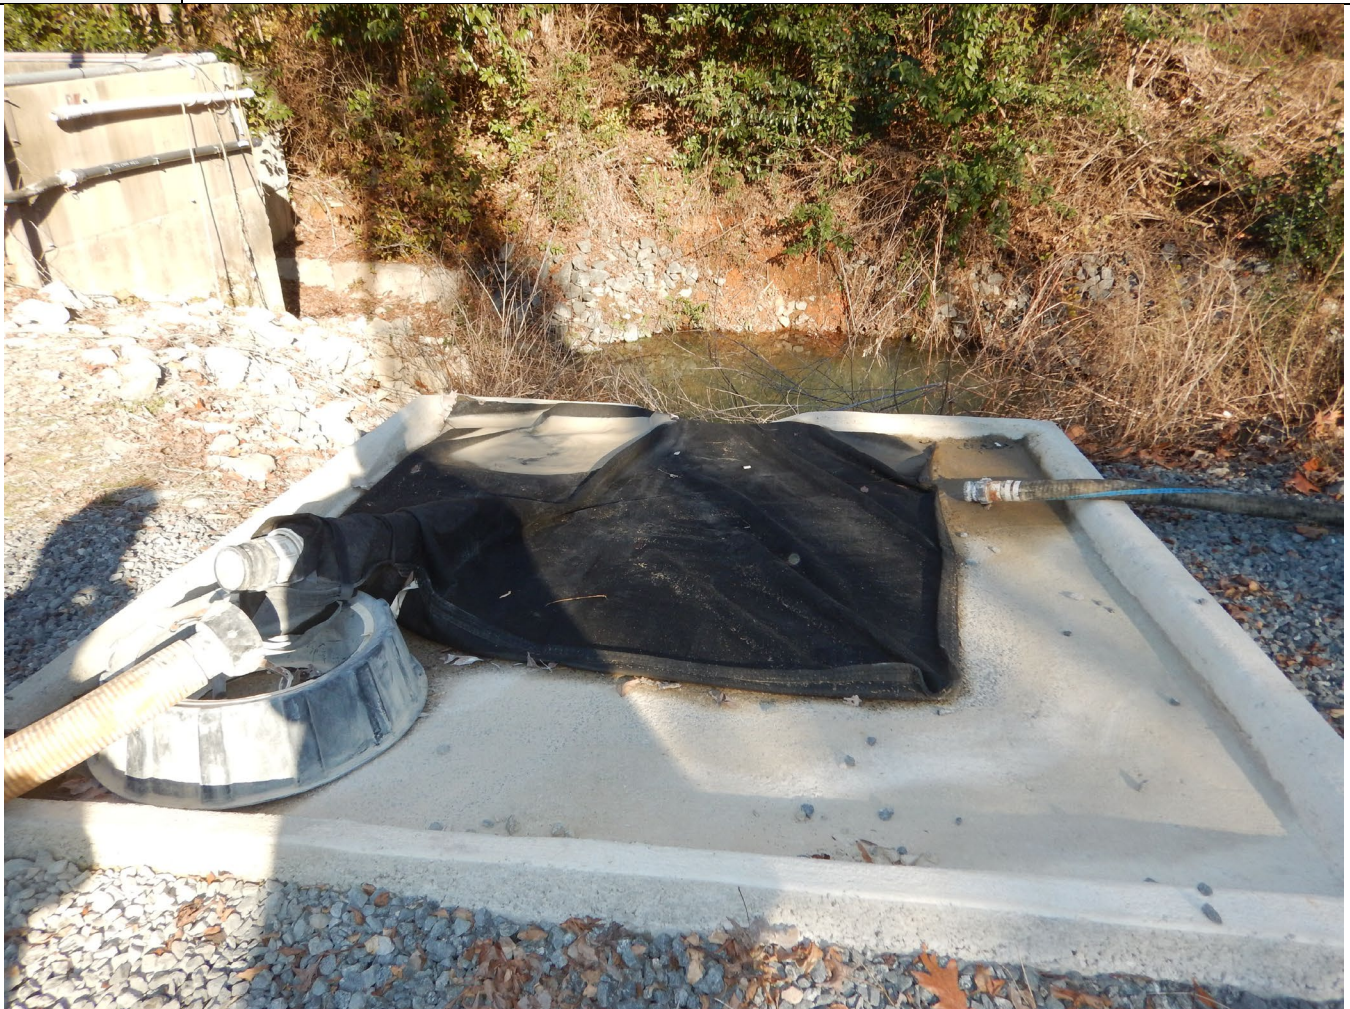
| <b>Photo ID:</b> | DSCN 1563 |

| <b>Description:</b> | Usage of filtration bag as a structural BMP |

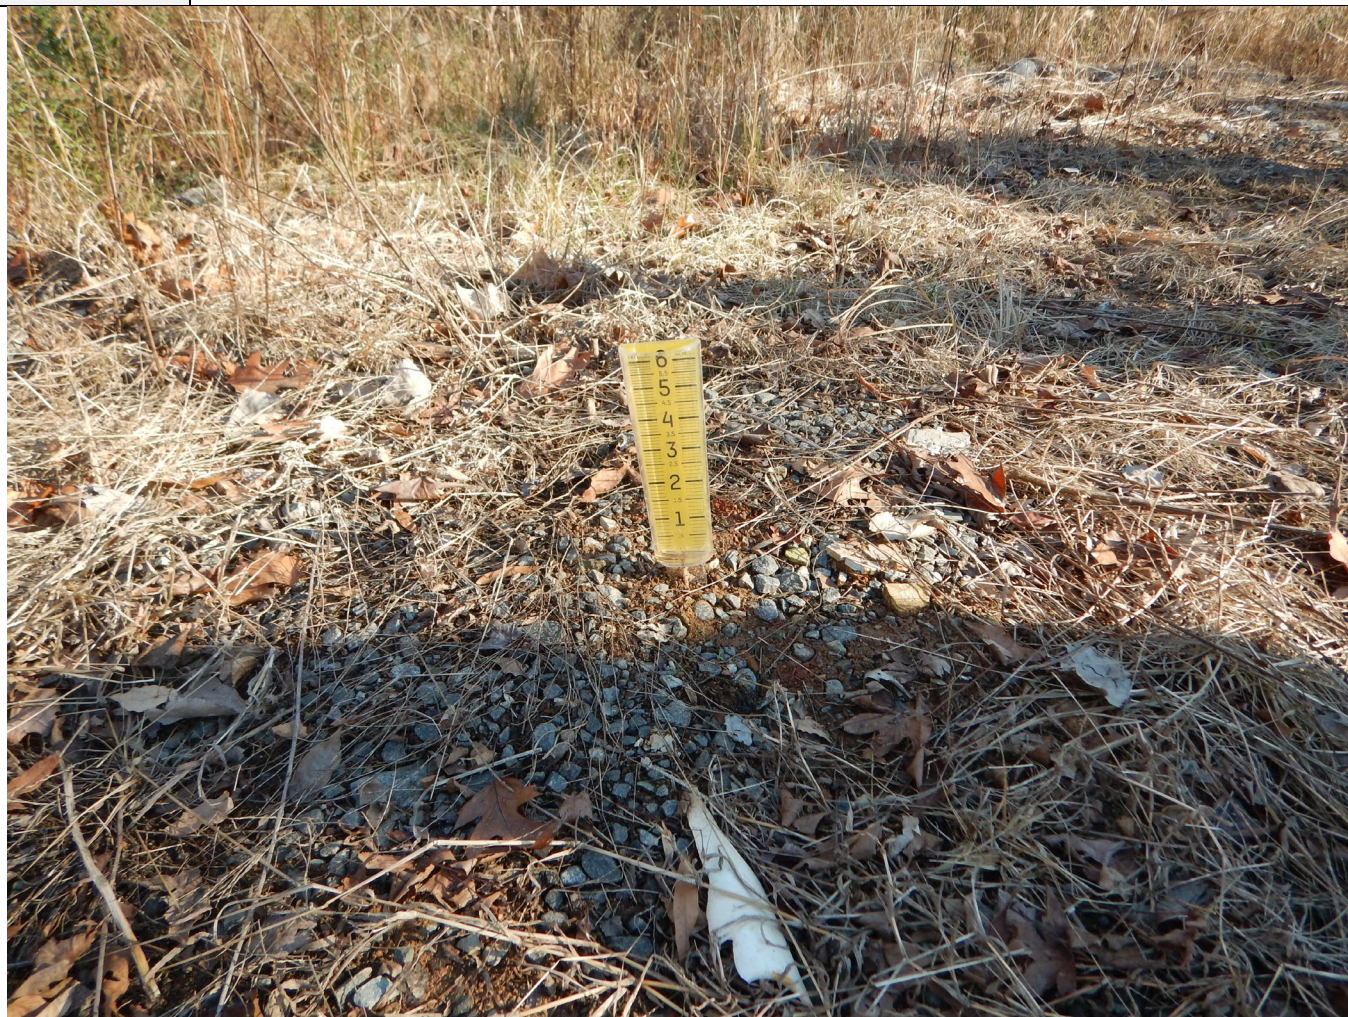
| <b>Photo ID:</b> | DSCN 1564 |

| <b>Description:</b> | Rain gauge located near collection pit |

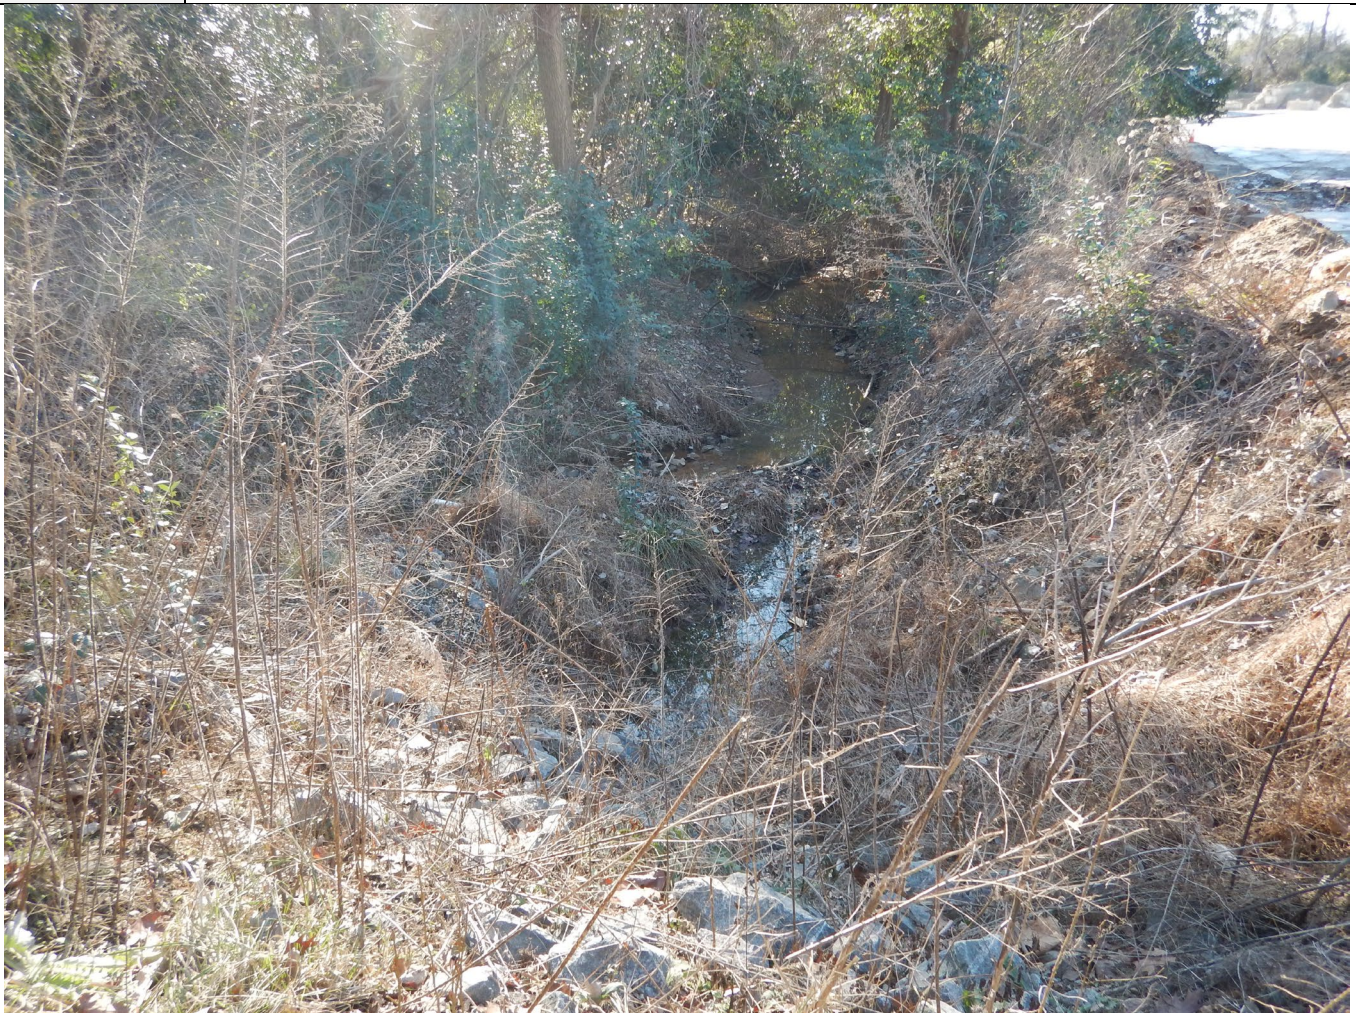
| <b>Photo ID:</b> | DSCN 1565 |

| OUTFALL, STORMWATER, DISCHARGE, & RECEIVING WATER | YES | NO | DESCRIPTION |
|---|---|---|---|
| Number & location of stormwater discharge(s)/outfall(s) consistent with SWP3 | X | | One outfall was observed, as reflected in the SPPP. |

| <b>Description:</b> | Location of outfall – no discharge during the stormwater inspection |

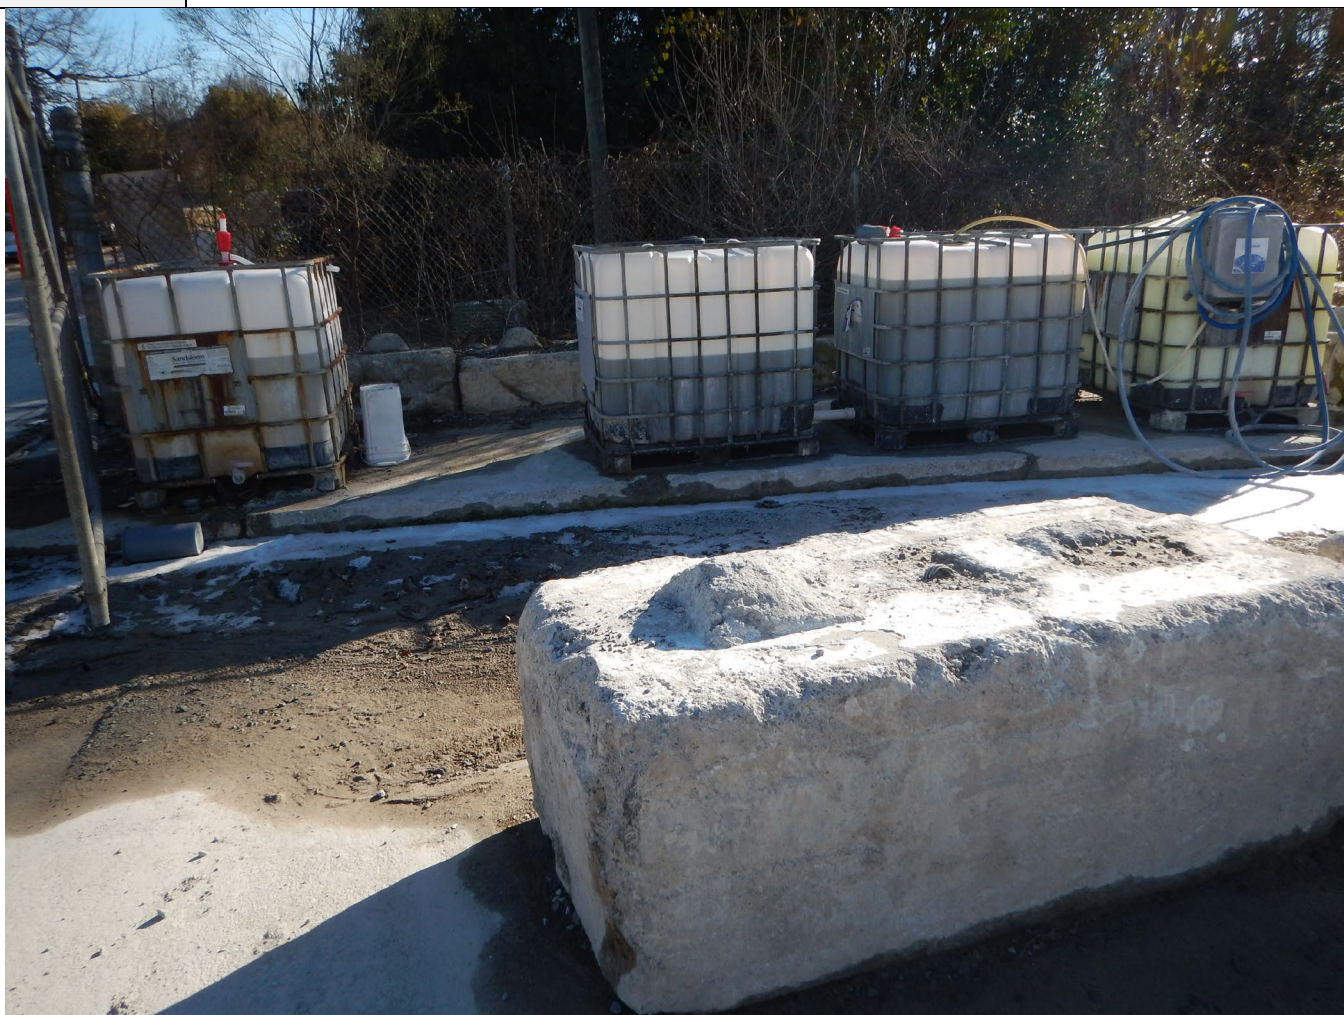
| <b>Photo ID:</b> | DSCN 1566 |

| <b>Description:</b> | Designated area for truck wash material containers |

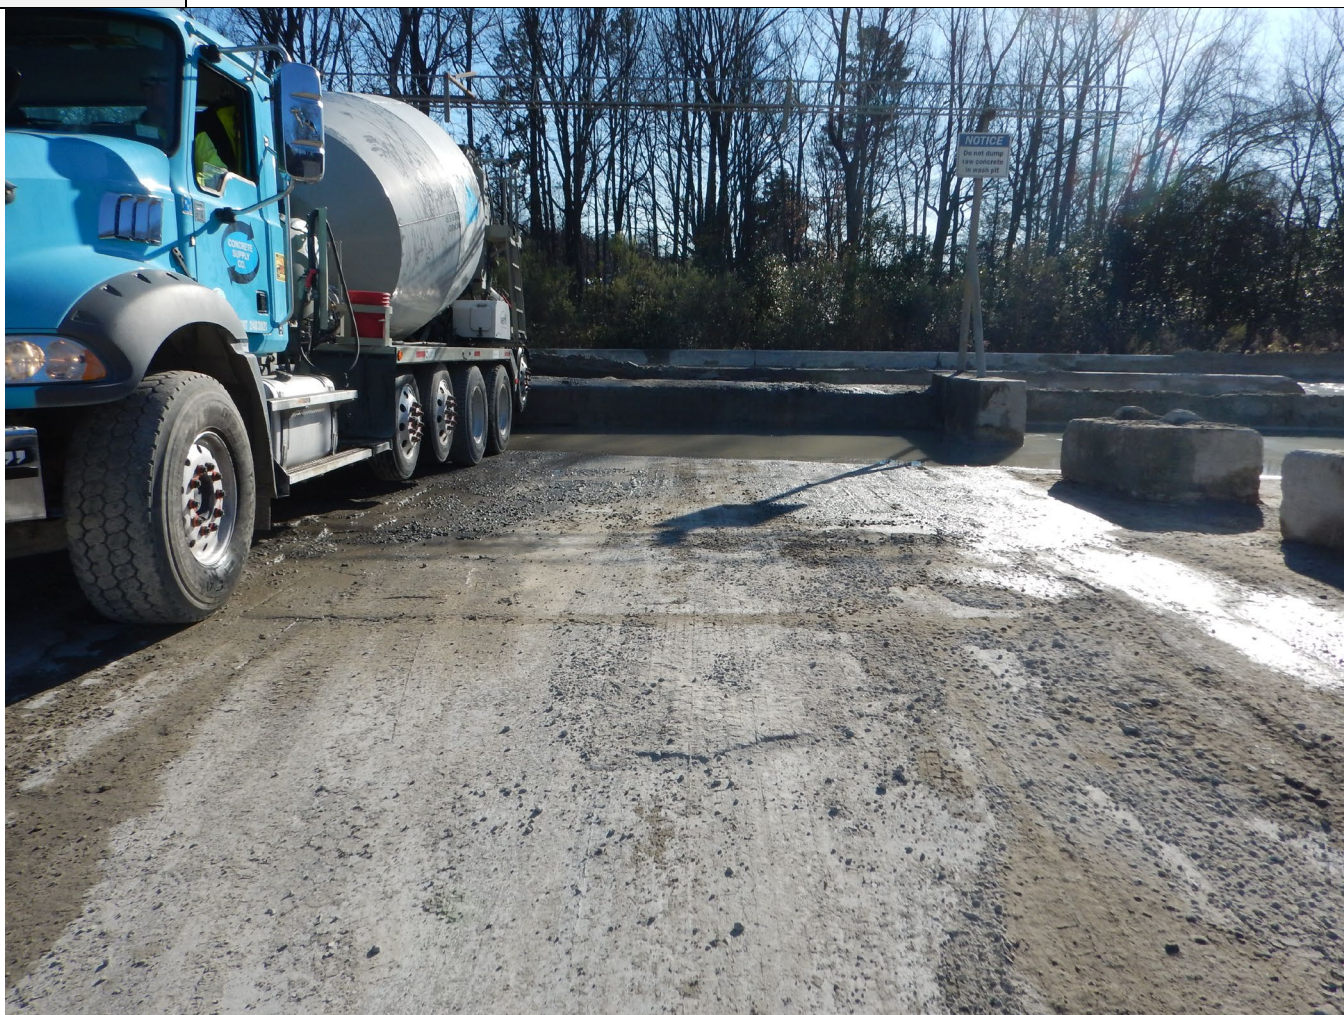
| <b>Photo ID:</b> | DSCN 1567 |

| <b>Description:</b> | Designated area for truck washout |

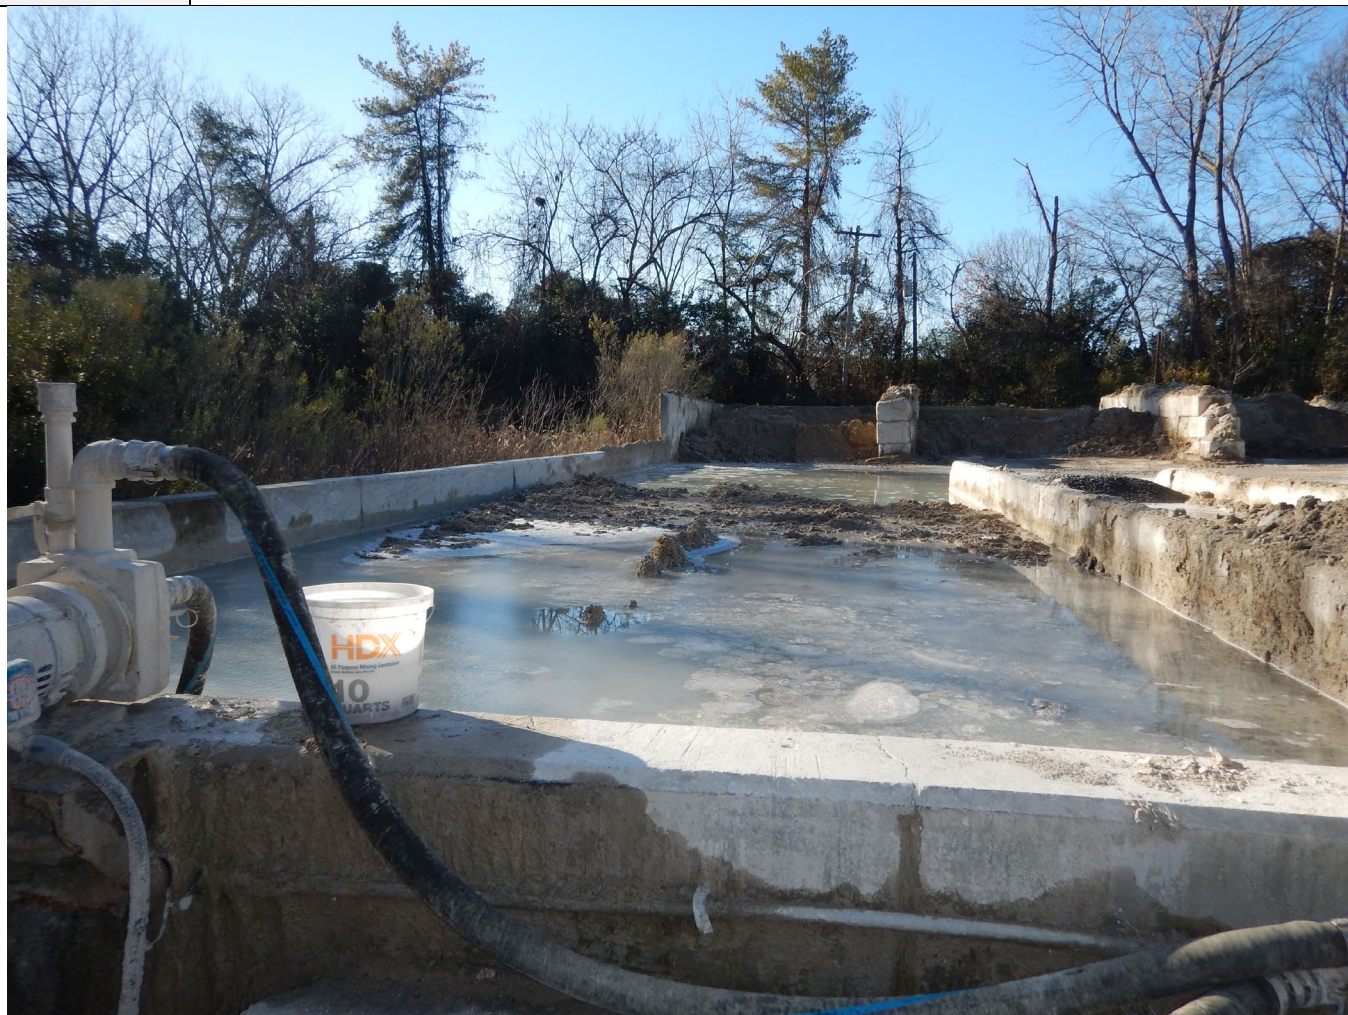
| <b>Photo ID:</b> | DSCN 1568 |

| <b>Description:</b> | Designated area for truck wash out collection |

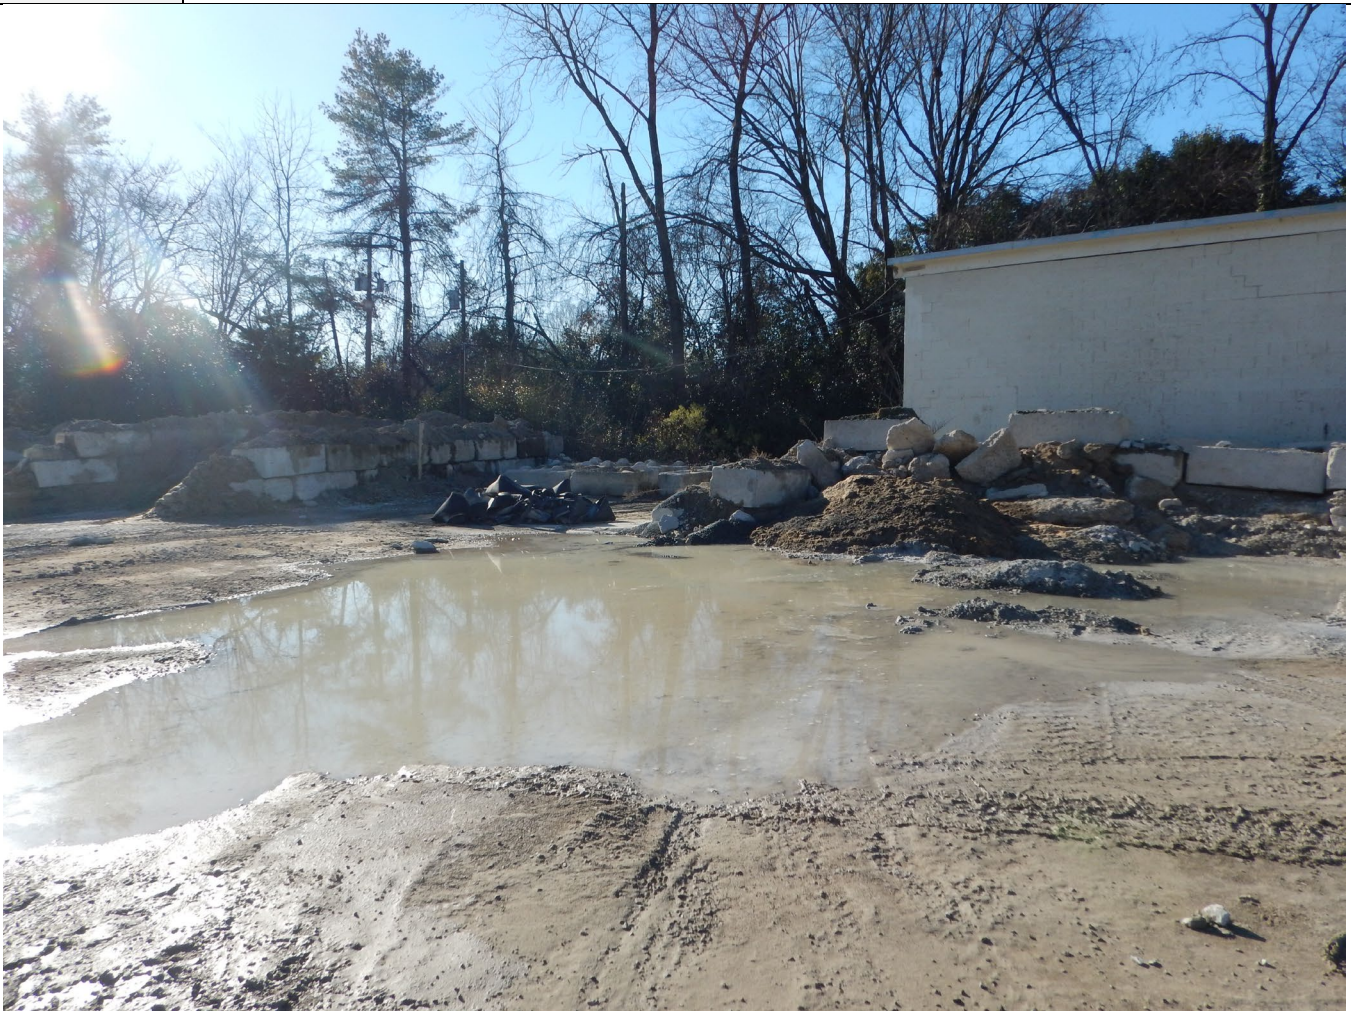
| <b>Photo ID:</b> | DSCN 1569 |

| <b>Description:</b> | Designated area for used concrete placement/storage |

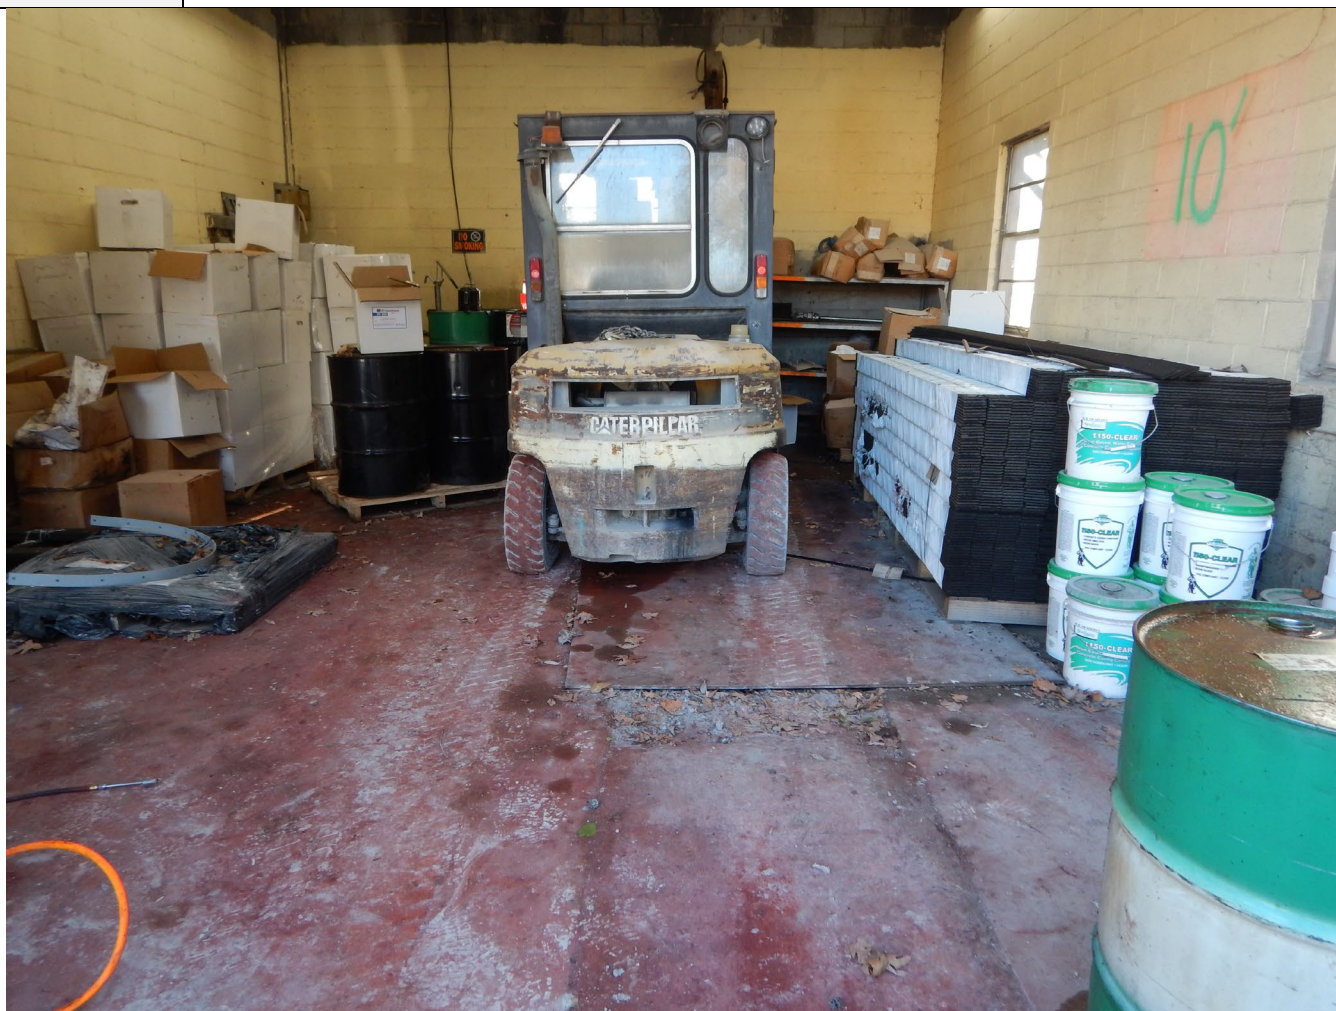
| <b>Photo ID:</b> | DSCN 1570 |

| <b>Description:</b> | Material Storage area with cover |

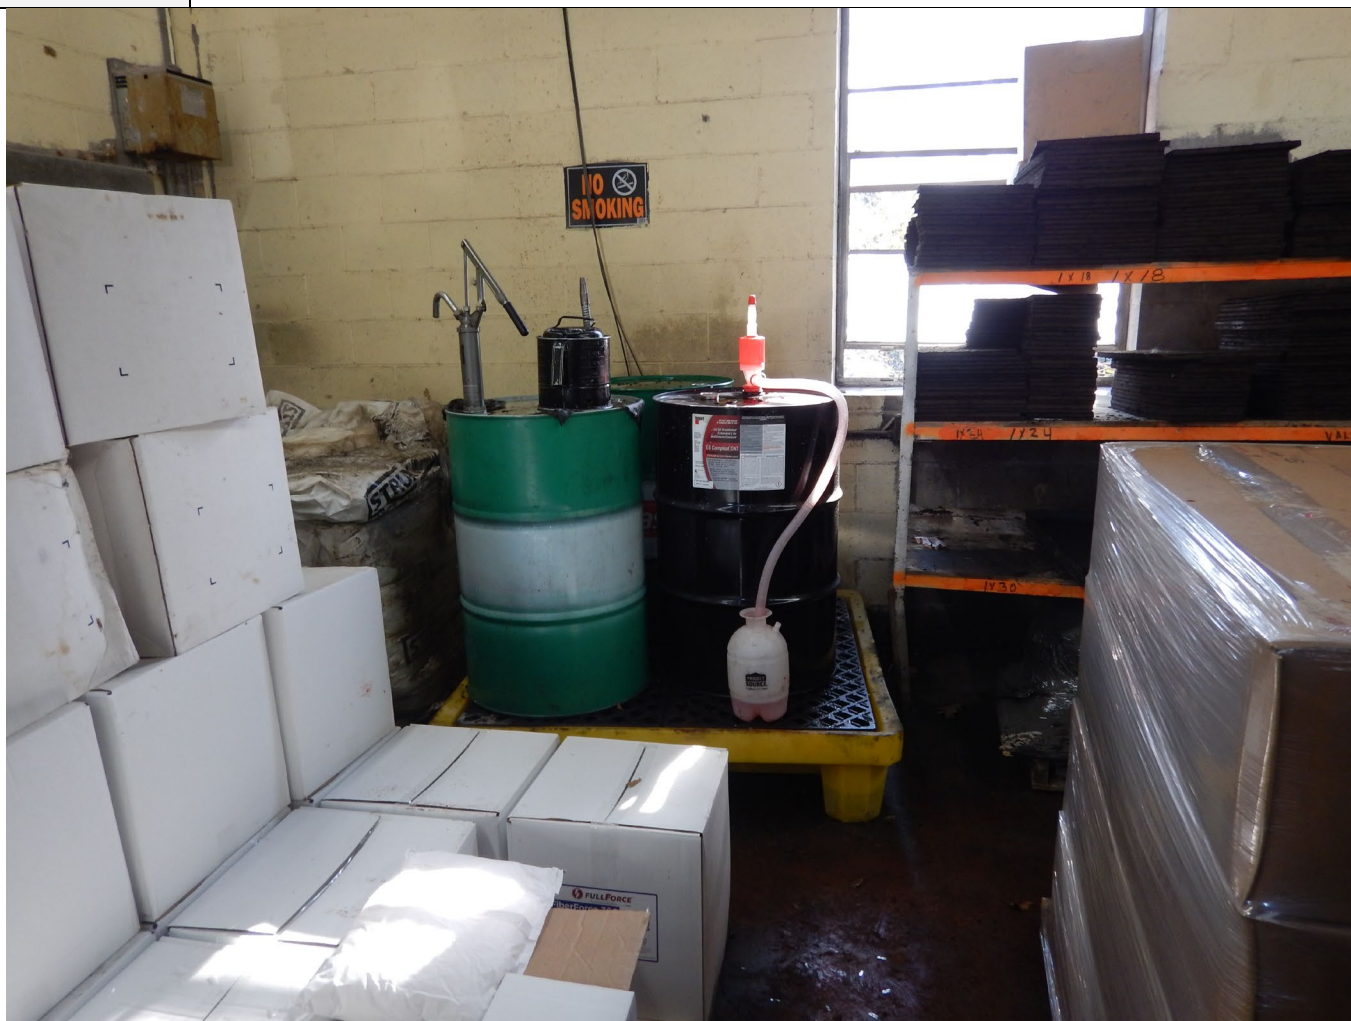
| <b>Photo ID:</b> | DSCN 1571 |

| <b>Description:</b> | 55-gallon drums located on spill pad within the material storage area with cover |

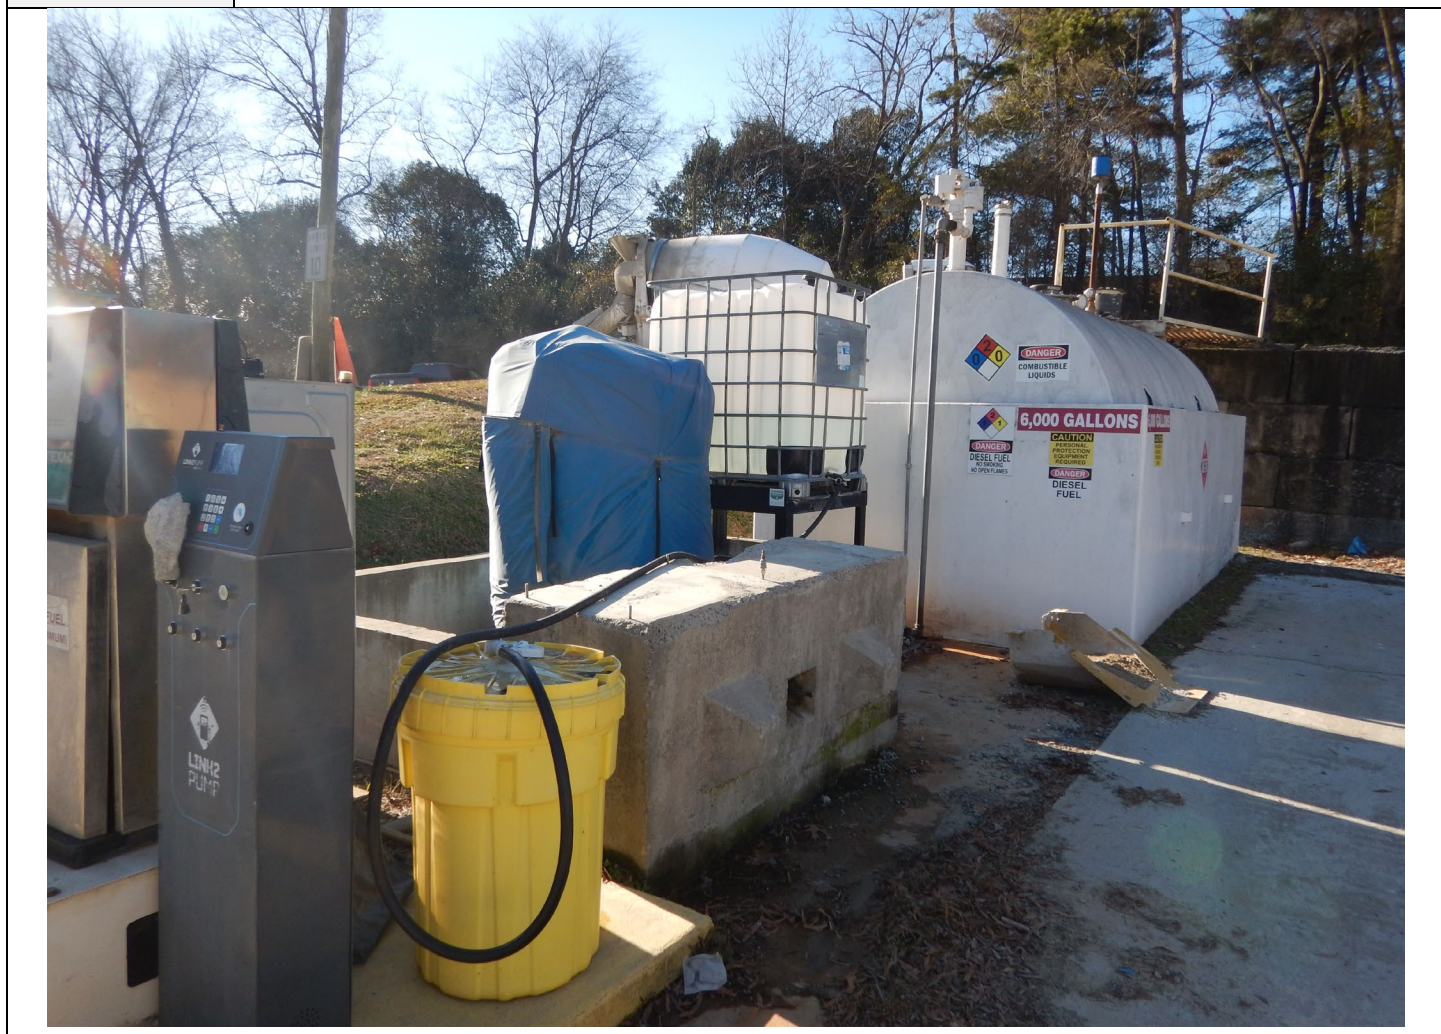
| <b>Photo ID:</b> | DSCN 1572 |

| PLAN TOPICS – Section B of Permit | YES | NO | N/E |
|---|---|---|---|
| <b>Secondary Containment Plan</b> Part B.8<br>The facility provided a plan document for review by email on April 15, 2025 (after the inspection)<br>The facility does have a 6,000 gallon AST and a few 55-gallon drums stored onsite. | X | | |

| <b>Description:</b> | 6,000 gallon above ground storage tank (AST) with secondary and tertiary containment |

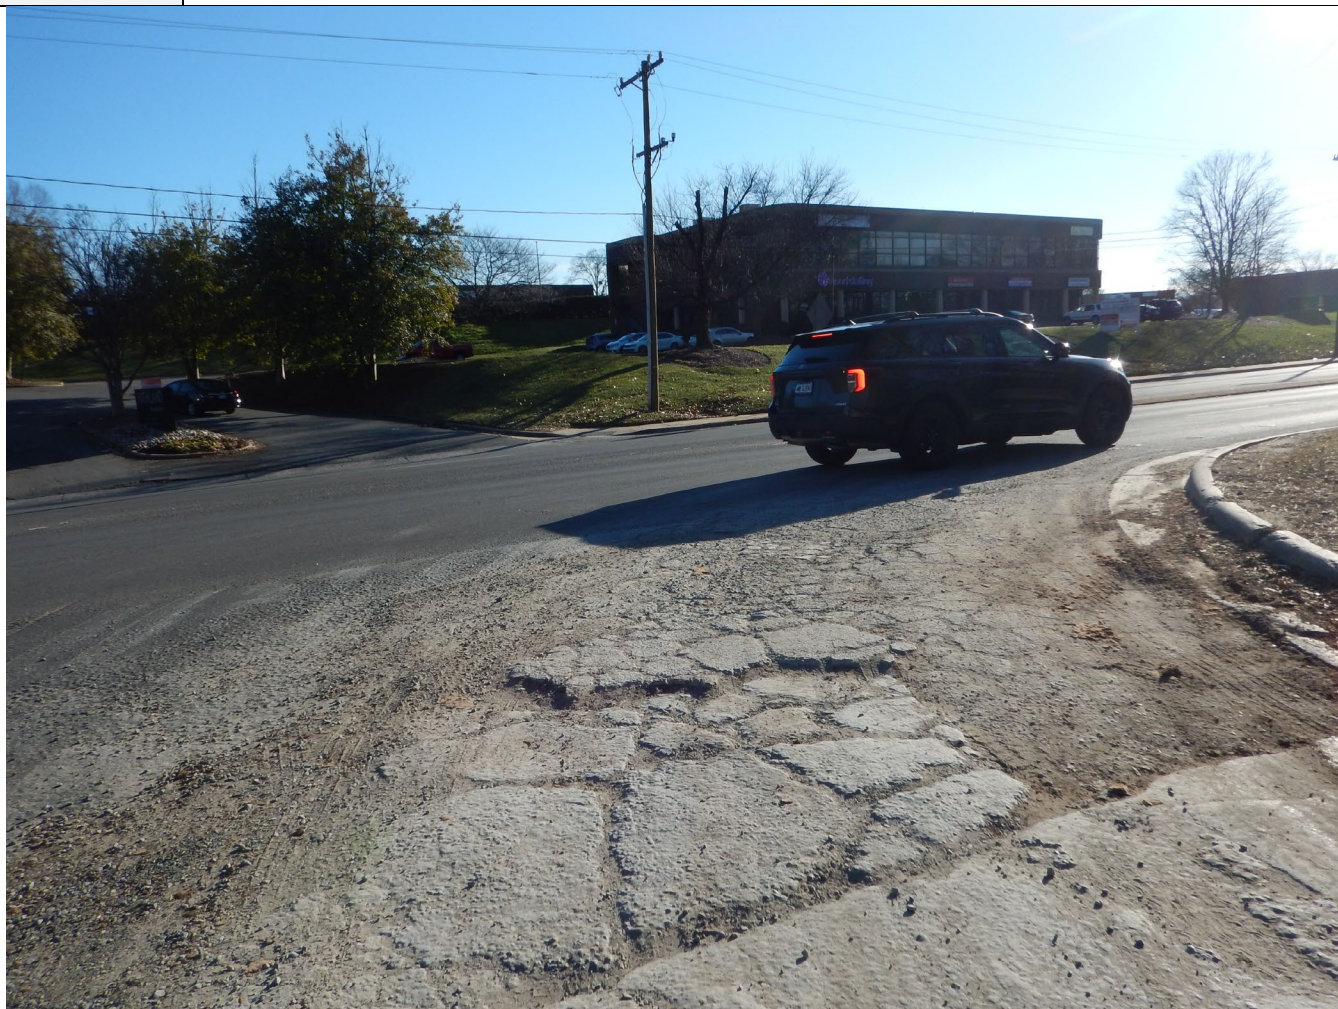
| <b>Photo ID:</b> | DSCN 1573 |

| Pollutant Sources | Note location, quantitative description, design issue, O&M deficiencies, and pollutants offsite |
|---|---|
| Sediment & Erosion Controls (BMPs) | Observed minor dust control concerns/issues at the site.<br>Observed minor sediment track out at the entrance / exit. |

| <b>Description:</b> | View of entrance / exit to the industrial facility – observations of some sediment/dirt track out |

1. Observed minor dust control concerns/issues at the site.
2. Observed minor sediment track out at entrance / exit
