U.S. Environmental Protection Agency, Region 4  
61 Forsyth Street SW, Atlanta, GA 30303  
**Water Compliance Inspection Report**

**Facility Name:** Concrete Supply Company, LLC (CSC) – South Plant (Charlotte)      **SIC Code:** 3273 / E / E2

This was a joint EPA and NC DEQ stormwater Compliance Evaluation Inspection (CEI) focusing on the requirements of the North Carolina General Permit for Storm Water Discharges Associated with Industrial Activities (General Permit No. NCG140000).

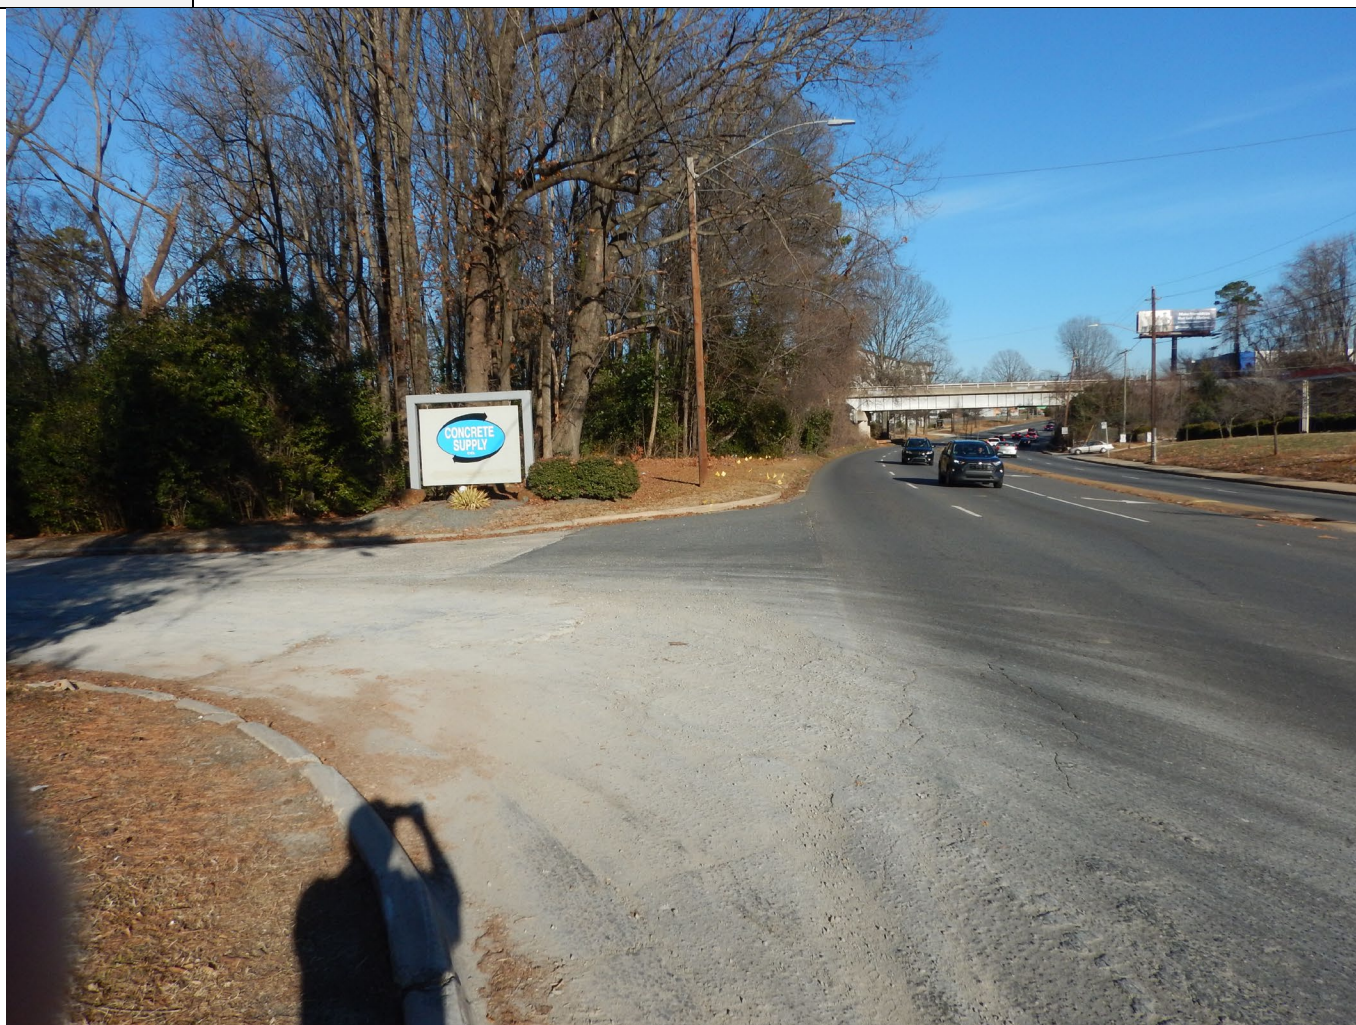
| <b>Photo ID:</b> | DSCN 1574 |

| Pollutant Sources | Note location, quantitative description, design issue, O&M deficiencies, and pollutants offsite |
|---|---|
| Sediment & Erosion Controls (BMPs) | Observed minor dust control concerns/issues at the site.<br>Observed minor sediment track out at the entrance / exit. |

| <b>Description:</b> | View of entrance / exit to the industrial facility – observations of some sediment/dirt track out |

1. Observed minor dust control concerns/issues at the site.
2. Observed minor sediment track out at entrance / exit

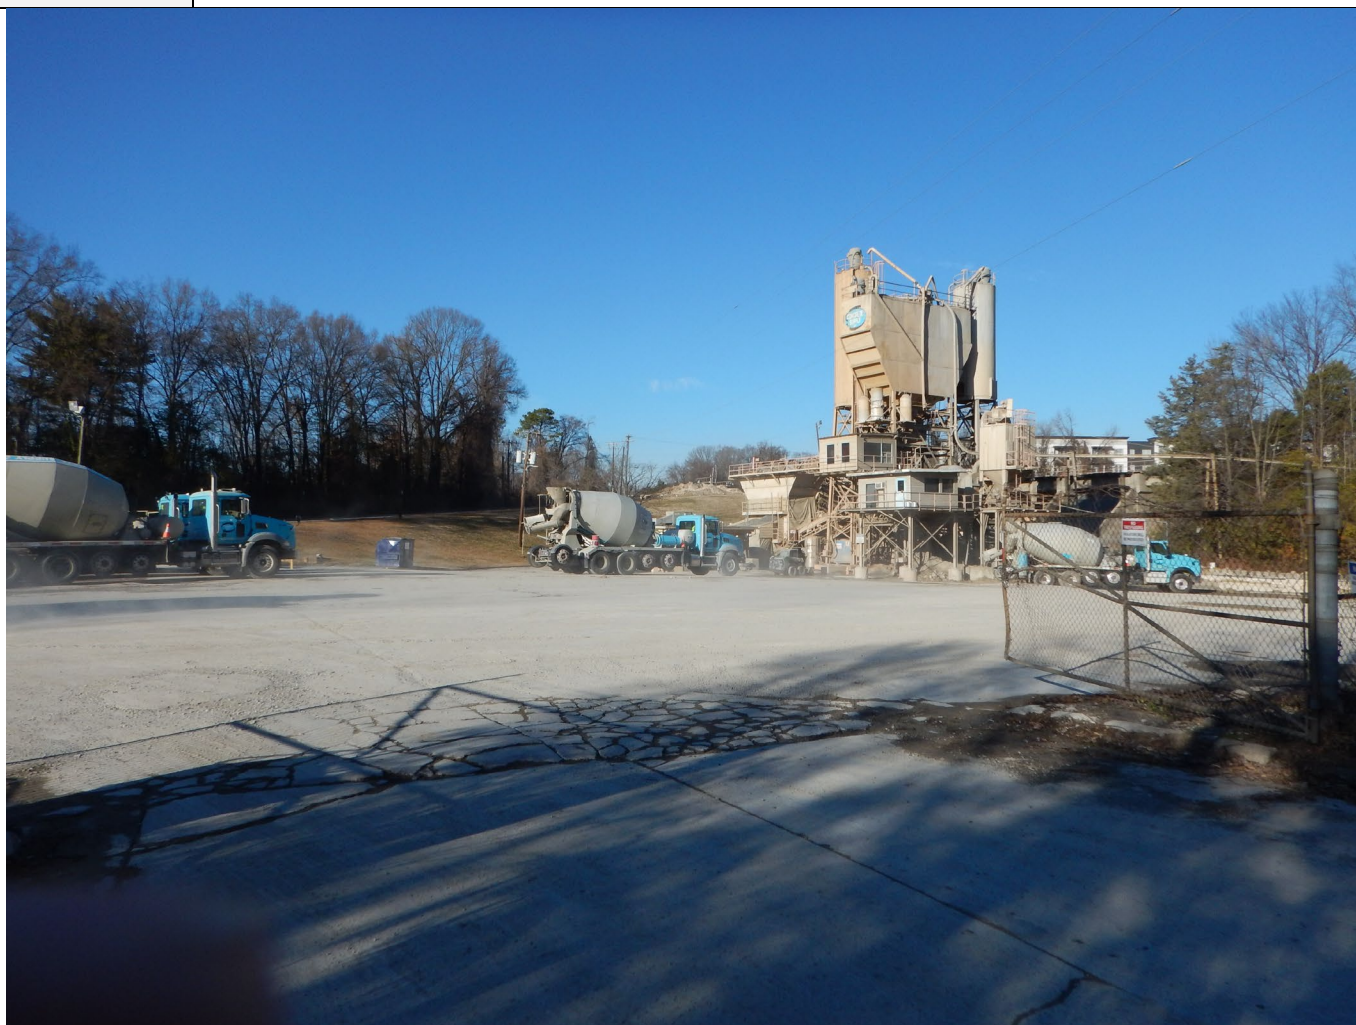
| <b>Photo ID:</b> | DSCN 1575 |

| <b>Description:</b> | View of the industrial facility – observations of need for dust control |

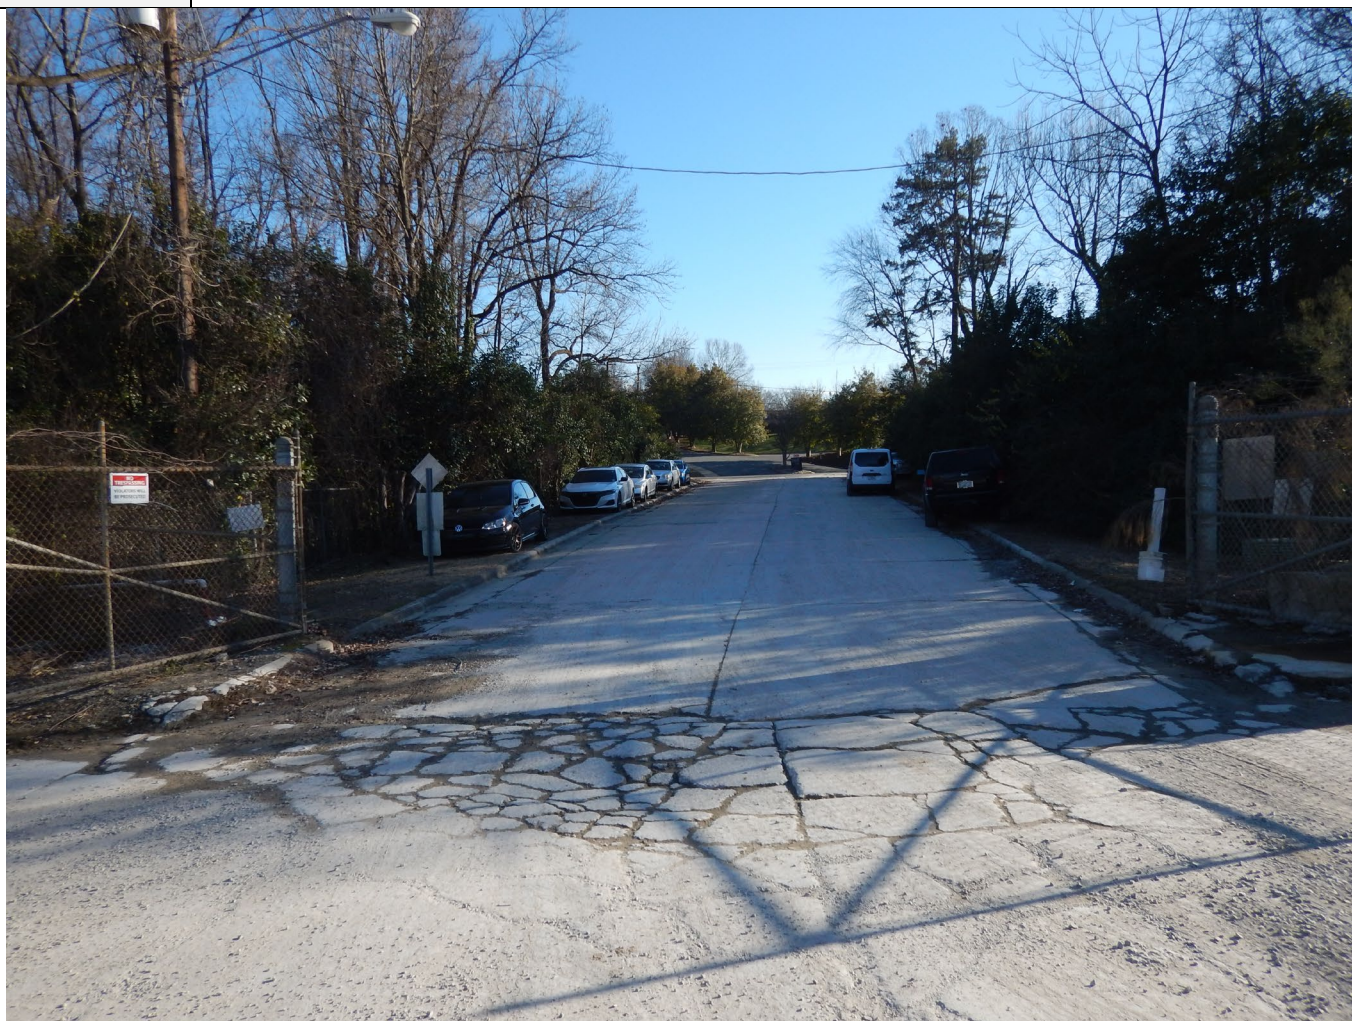
| <b>Photo ID:</b> | DSCN 1576 |

| <b>Description:</b> | View of entrance / exit to the industrial facility |
