Purpose: NPDES SSO Inspection Trip Report

Facility: City of Cahokia Heights, Illinois

Dates of Inspection: March 8, 2022 – March 9, 2022

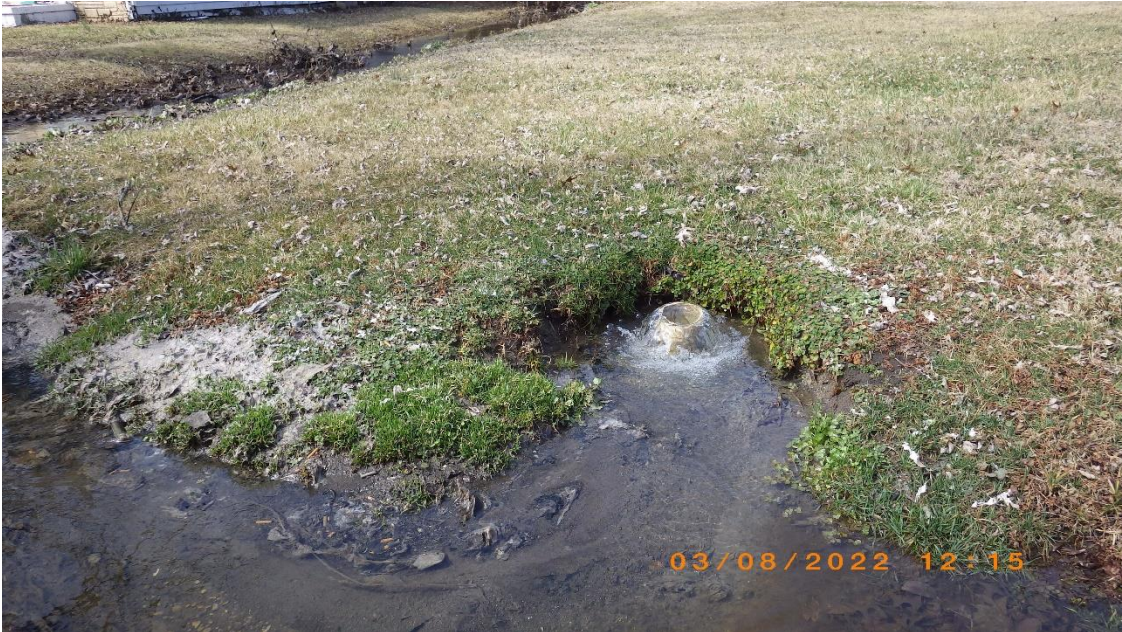
1: RIMG0041

EPA inspectors arrived at the cleanout overflow location on North 82nd Street at 12:15PM. The cleanout was discharging at the time of observation. According to City of Cahokia Heights Sewer Department representative Dennis Traiteur, this cleanout had been discharging continuously since February 17, 2022. See Photo 1.

Description: Active discharge of sanitary waste from cleanout.

Location: North 82nd Street.

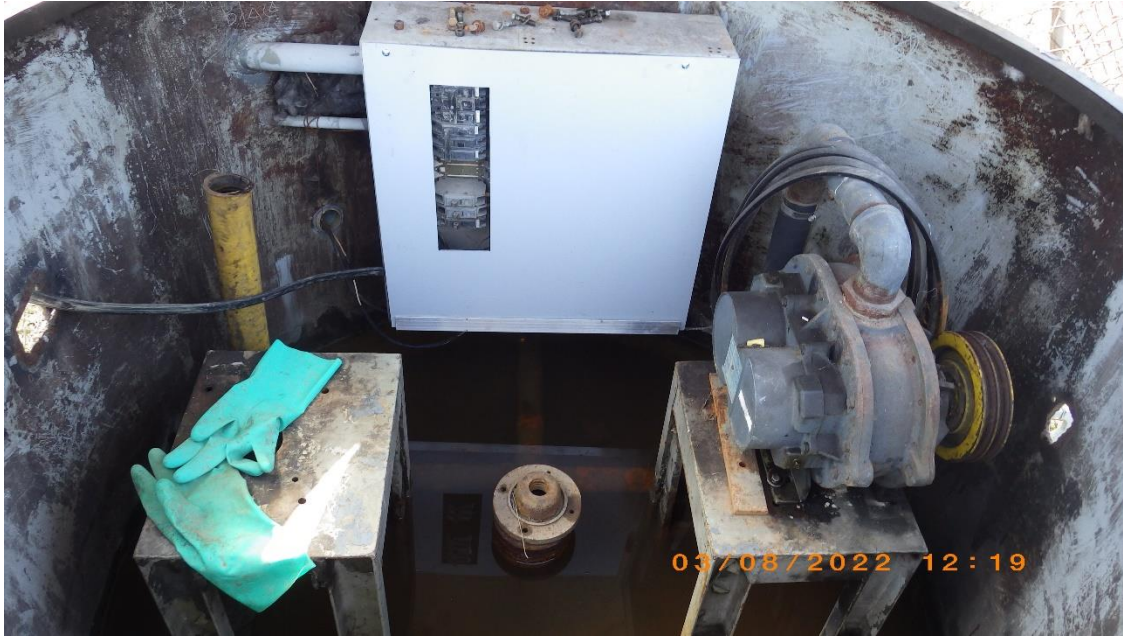
2: RIMG0042

EPA inspectors arrived at the lift station at the intersection of North 82nd Street and Bluff Street at 12:20PM. The lift station structure fencing was not secured and the lid to the structure was not locked. The above ground structure was holding water. The pump in this structure did not have belts attached to it, although it is no longer in use due to the installation of submersible pumps. See Photo 2.

Description: Above ground lift station structure. Note belts are off the pump and structure is holding stagnant water.

Location: Intersection of North 82nd Street and Bluff Street.

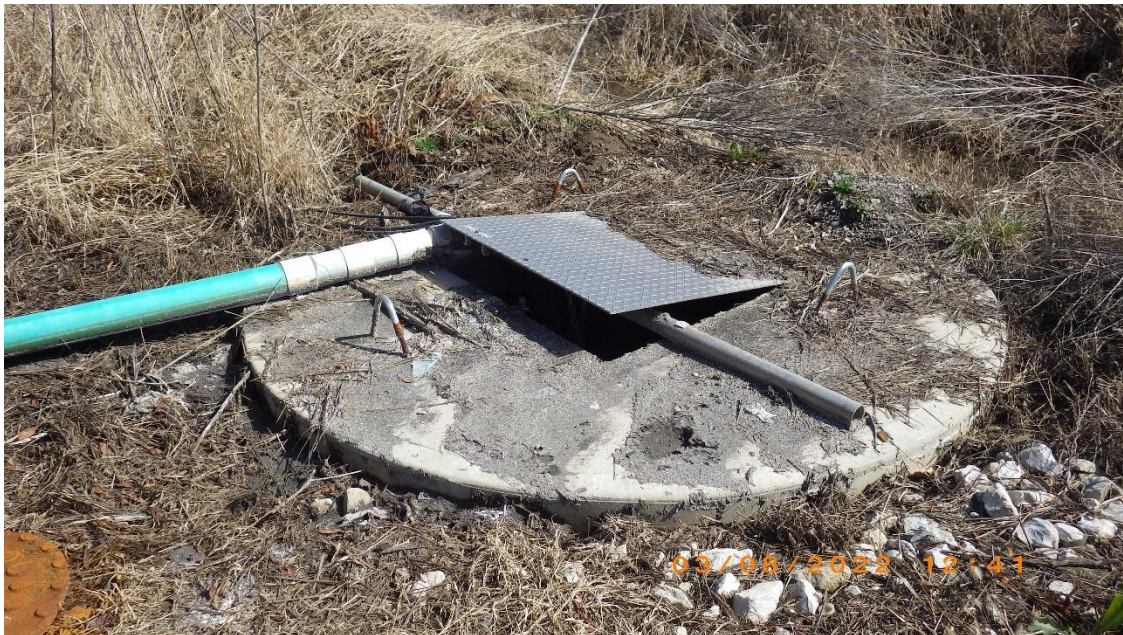
3: RIMG0043

EPA inspectors arrived at the Lady of the Snows lift station located near the intersection of Illinois Route 157 and Missouri Avenue at 12:38PM. The submersible pumps were running at the time of observation and were pumping water through a temporary above ground pipe and discharging it to a manhole adjacent to Missouri Avenue. There was dried material around the top of the wet well. See Photo 3.

Description: Lady of the Snows lift station wet well. Note dried debris on concrete wet well cover and temporary above ground piping.

Location: Near the intersection of Illinois Route 157 and Missouri Avenue.

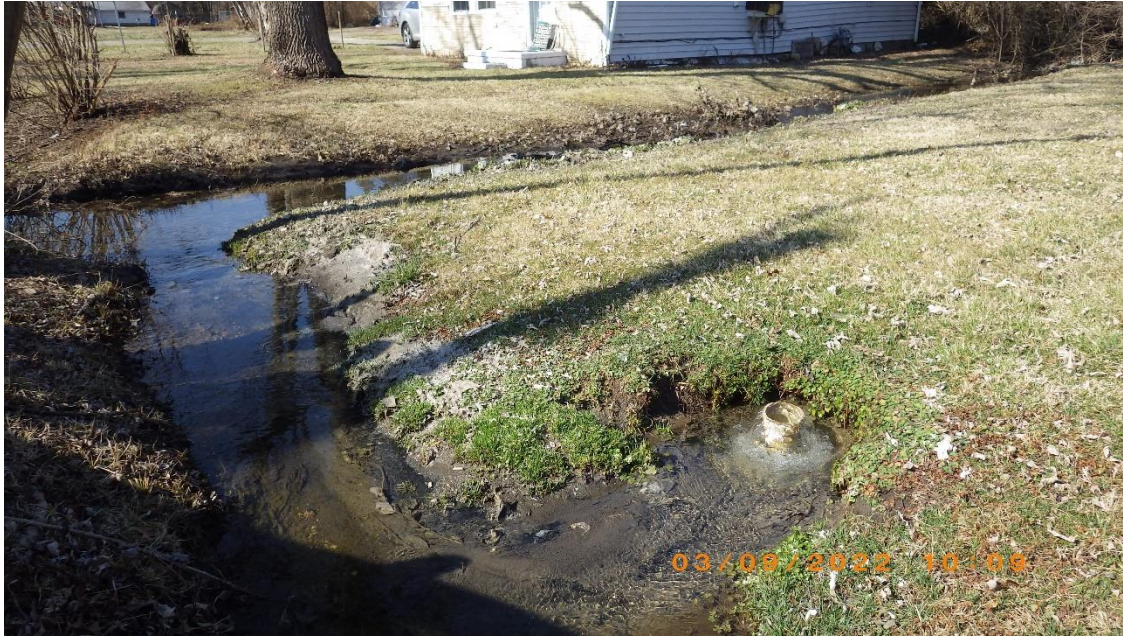
4: RIMG0044

EPA inspectors arrived at the cleanout overflow location on North 82nd Street at 10:10AM. The cleanout was discharging at the time of observation. The condition of the cleanout and surrounding area were the same as observed on March 8, 2022. See Photo 4.

Description: Active discharge of sanitary waste from cleanout.

Location: North 82nd Street.

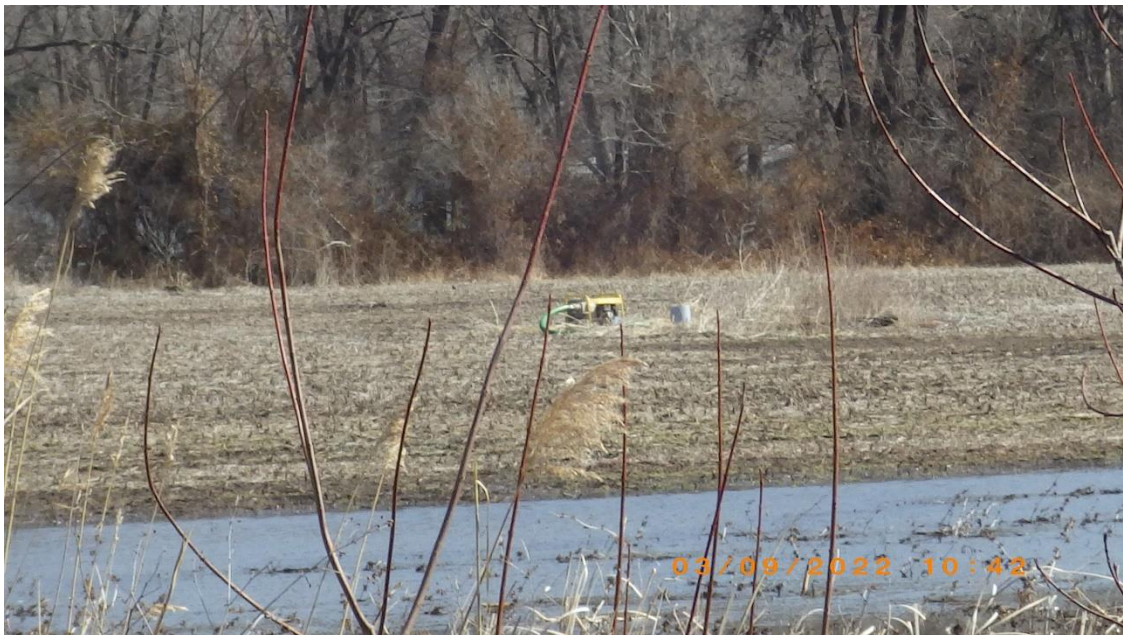
5: RIMG0045

EPA inspectors arrived at the lift station near the intersection of Lauralee Drive and Violet Drive at 10:41AM. The lift station was not overflowing. The lift station was not secured. An abandoned lift station wet well is located next to the current lift station. The top of that wet well was also not secured. Inspectors observed a portable pump located in a field approximately 200 feet northeast of the lift station. Portions of this field were flooded and holding stagnant water at the time of observation. It was unclear if this pump was pumping water into the sanitary sewer system. See Photo 5.

Description: Pump in an agricultural field. Note field is flooded and holding stagnant water.

Location: Approximately 200 feet northeast of the intersection of Lauralee Drive and Violet Drive.

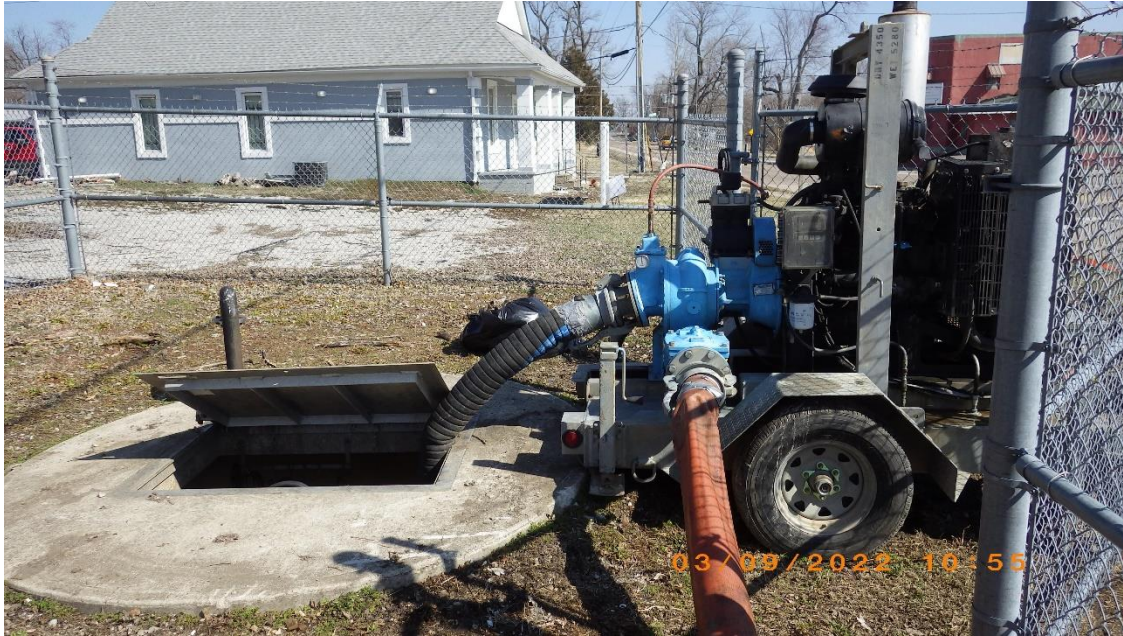
6: RIMG0046

EPA inspectors arrived at the lift station located near the intersection of Illinois Route 157 and Church Road at 10:56AM. This is also called the Railroad lift station by the City of Cahokia Heights. This lift station had a tow-behind pump parked in front of it with hoses going into the

wet well and an adjacent manhole. The pump was not running at the time of observation. See Photos 6 and 7.

Description: Tow-behind pump with hose going into lift station wet well.

Location: Near the intersection of Illinois Route 157 and Church Road.

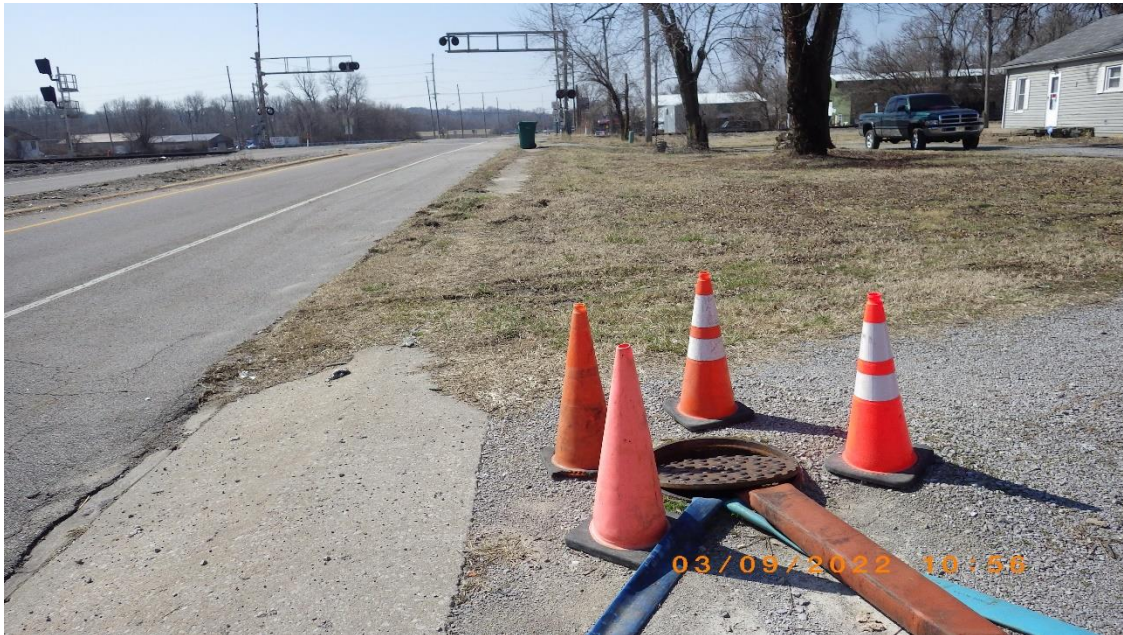
7: RIMG0047

Description: Hose from tow-behind pump going into adjacent manhole.

Location: Near the intersection of Illinois Route 157 and Church Road.

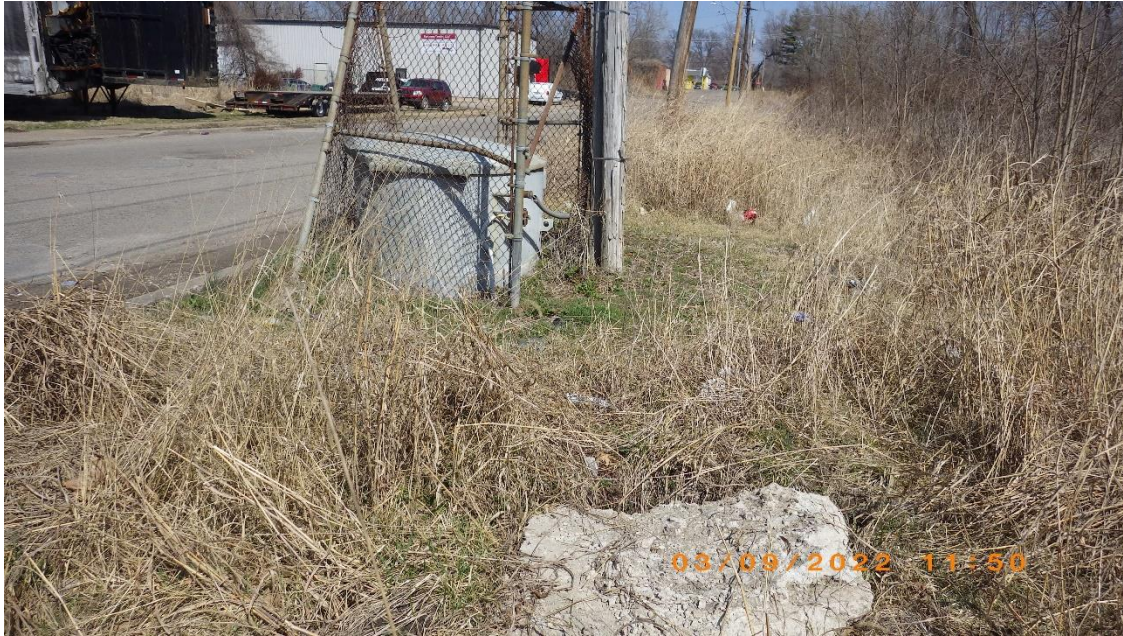
8: RIMG0048

EPA inspectors arrived at a manhole on North 73rd Street south of the intersection with State Street at 11:50AM. This manhole is adjacent to a lift station and had been previously identified as a safety concern because it did not have a manhole cover and was holding stagnant water. The city placed a large concrete block on the open manhole. See Photo 8.

Description: Concrete block covering open manhole.

Location: On North 73rd Street, just south of the intersection with State Street.
