**Region 6 - Enforcement & Compliance Assurance Division**  
**INSPECTION REPORT**

| Company Name: | <b>Village of Angel Fire</b> | |
| Facility Name: | <b>Angel Fire WWTF</b> | |

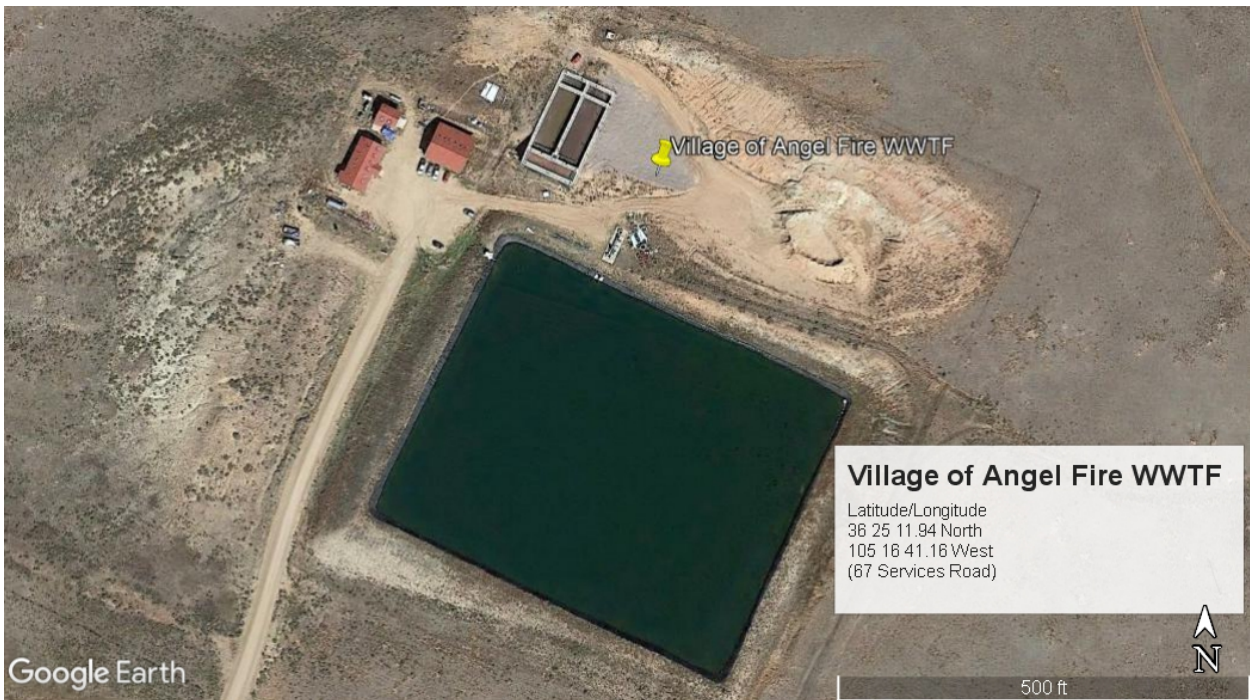
**Aerial Image #1:** Overall view of the Village of Angel Fire’s Wastewater Treatment Facility. Aerial from Google Earth maps.

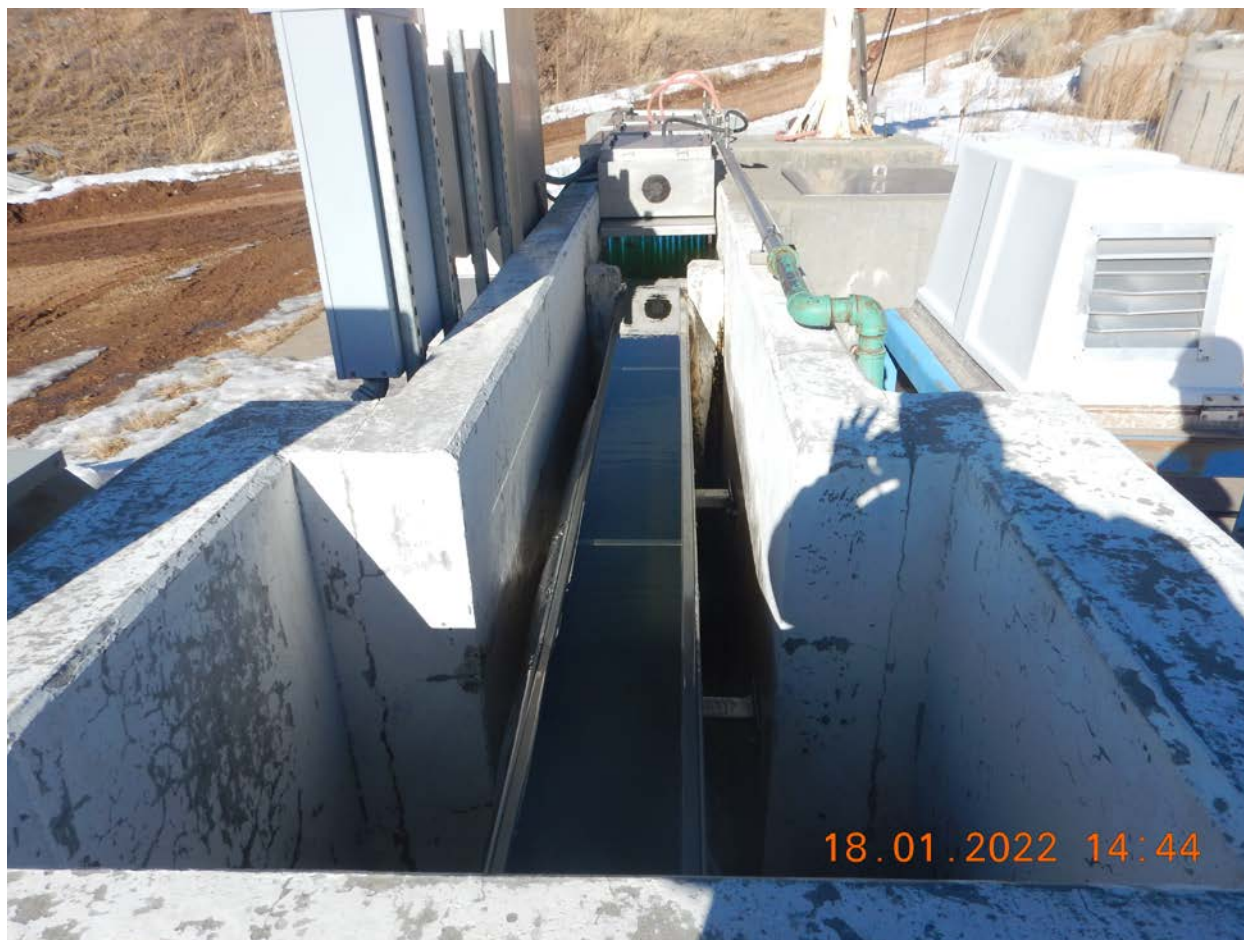
Photo No. 1

The UV system an Aqua Ray 40 HO vertical lamp system (manufactured by Degremont Technologies) consists of five (5) banks of lights situated over a concrete channel. According to a December 2020, HDR Preliminary Engineering Report (PER), “the existing UV disinfection needs replacement due to age”. The disinfected effluent is stored in a pond prior to being discharged to the La Cieneguilla

View of the Ultraviolet (UV) disinfection system situated over the concrete channels. (DSCN2087)  
Photographed by D. Esparza

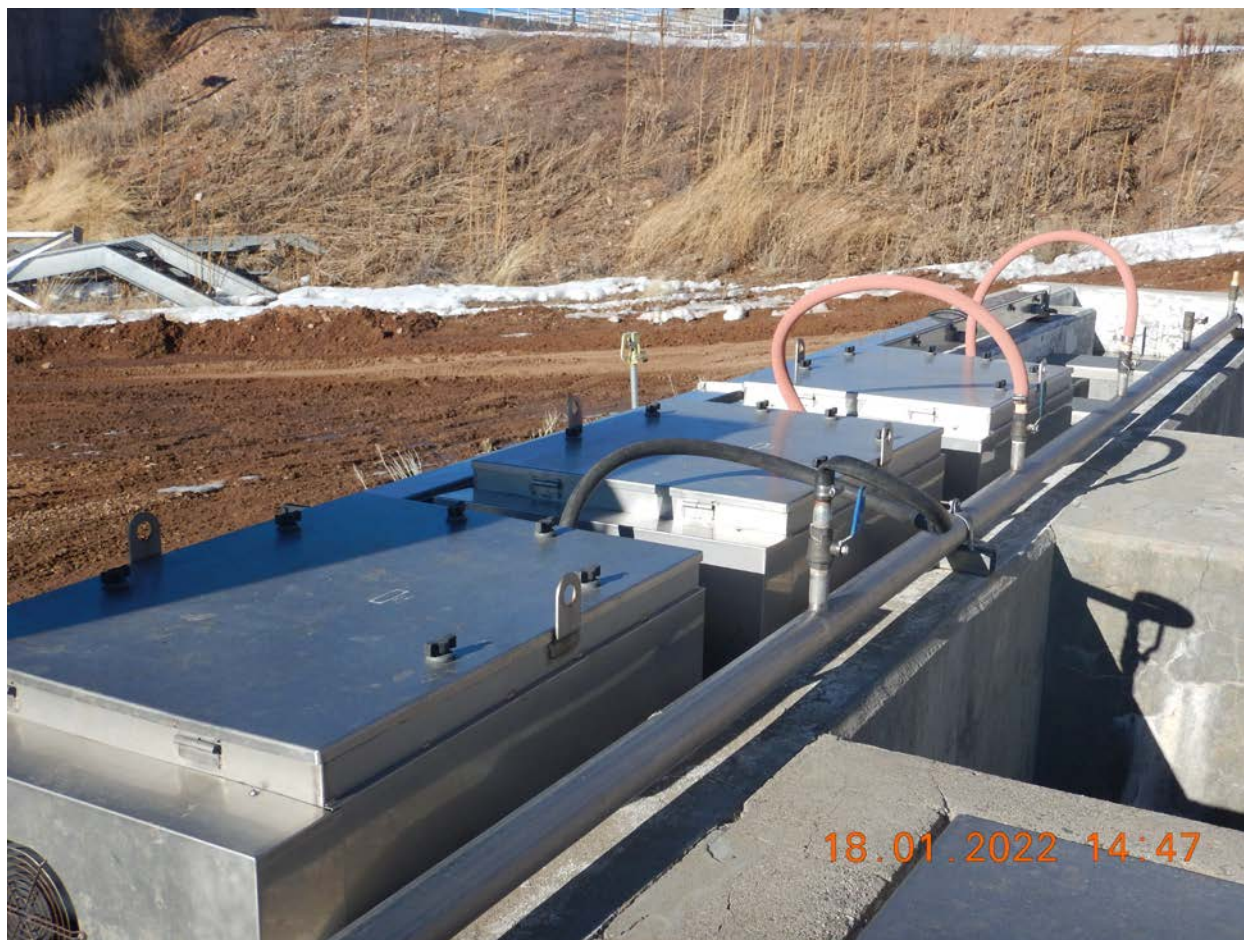
Photo No. 2

Another view of the UV disinfection system. (DSCN2089). Photographed by D. Esparza

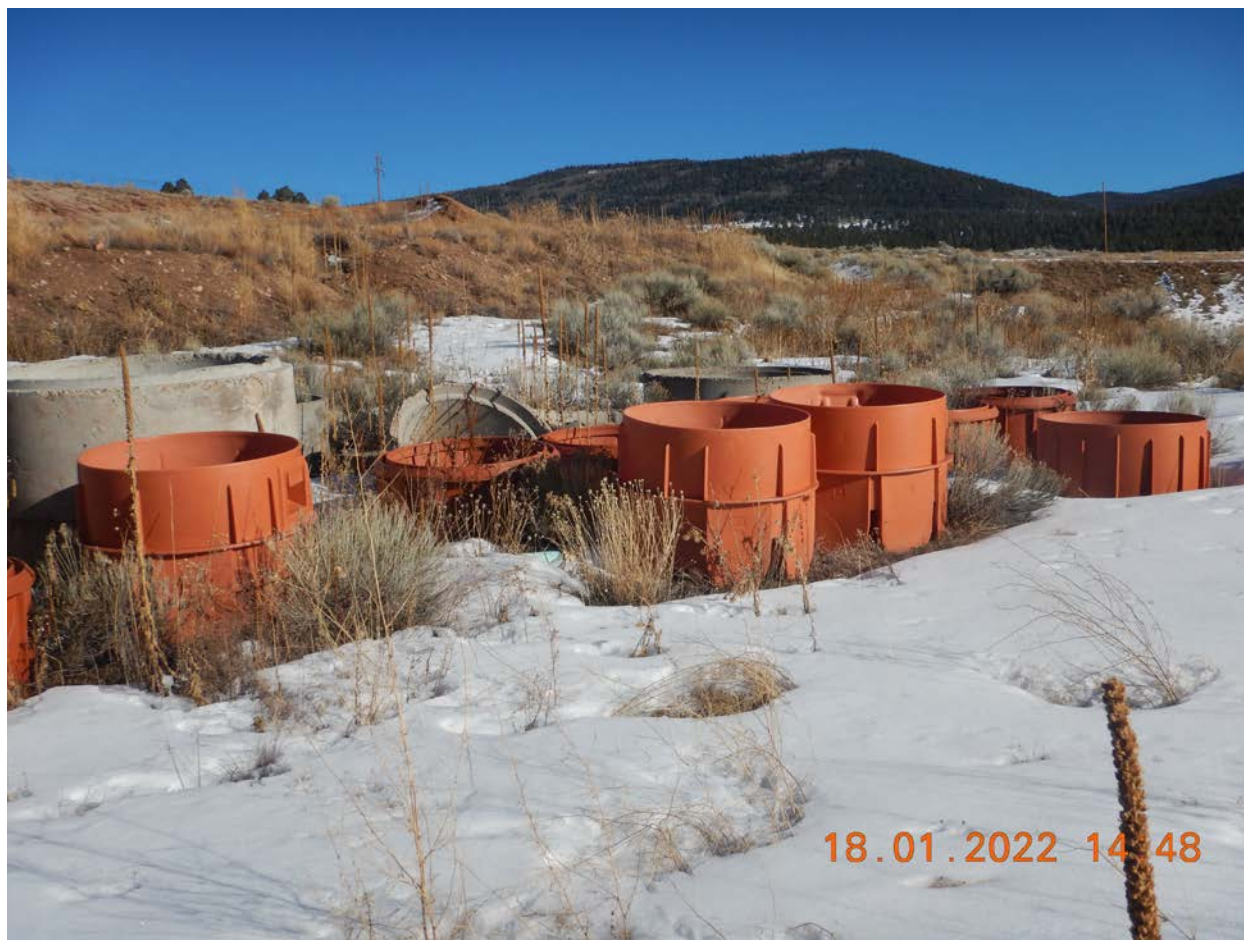
Photo No. 3

View of the location of the proposed new influent equalization (EQ) basin adjacent to the SBR basins. This location is approximately on the northside of the SBR basins. (DSCN2090). Photographed by D. Esparza

- Overall maintenance and operation of the WWTF appeared to be satisfactory. All equipment looked to be running properly and effectively.
- The WWTF is scheduled to upgrade the exiting headworks building and install new isolation valves. Additional upgrades or improvement include, new mixers are planned for installation within the existing SBR basins, replacement of the existing UV disinfection system and construction of a new influent equalization (EQ) basin adjacent to the SBR basins.

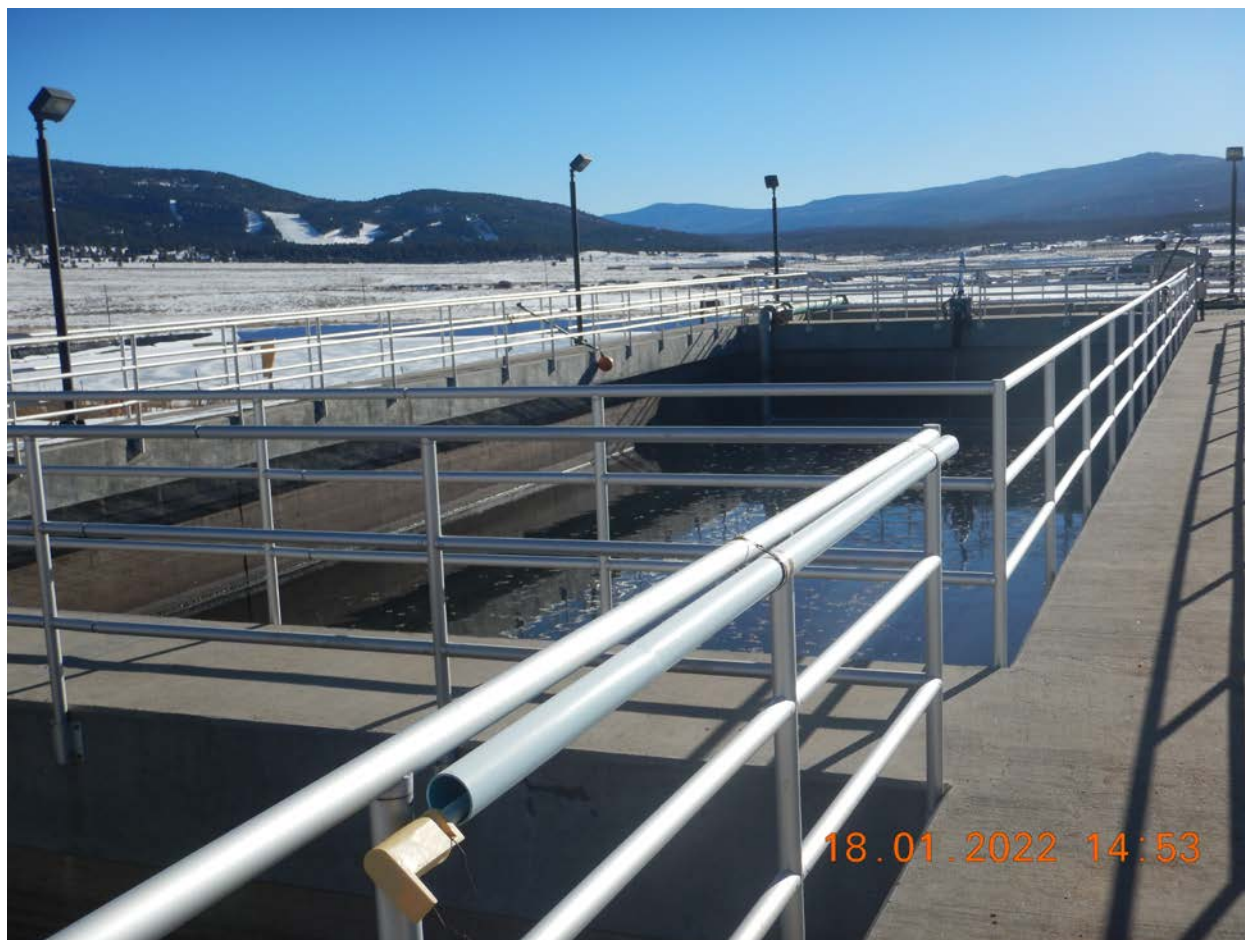
Photo No. 4

View of the approximate northside SBE basin. (DSCN 2091). Photographed by D. Esparza

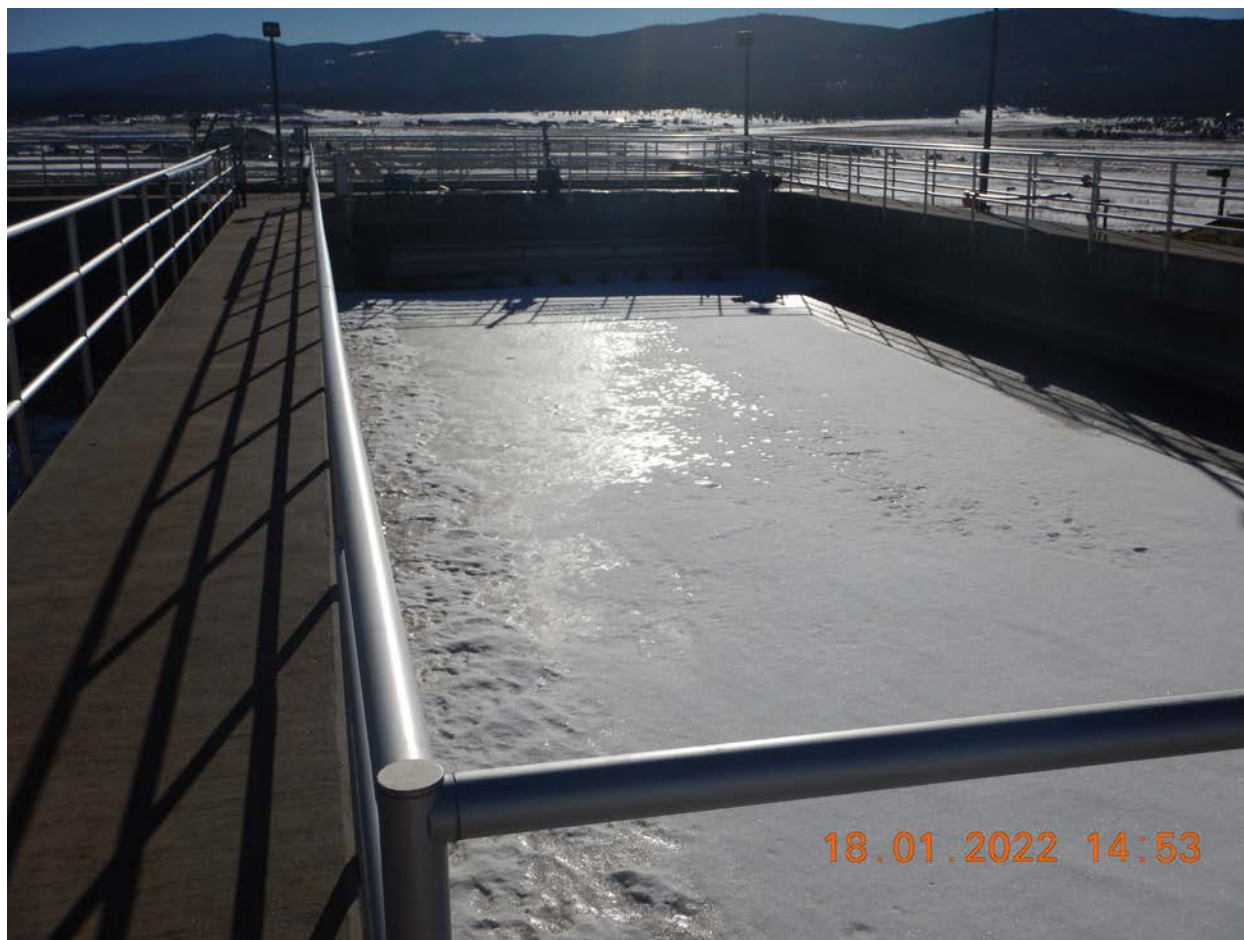
Photo No. 5

View of the approximate southside SBR currently used for treatment and storage of sludge. (DSCN 2093). Photographed by D. Esparza

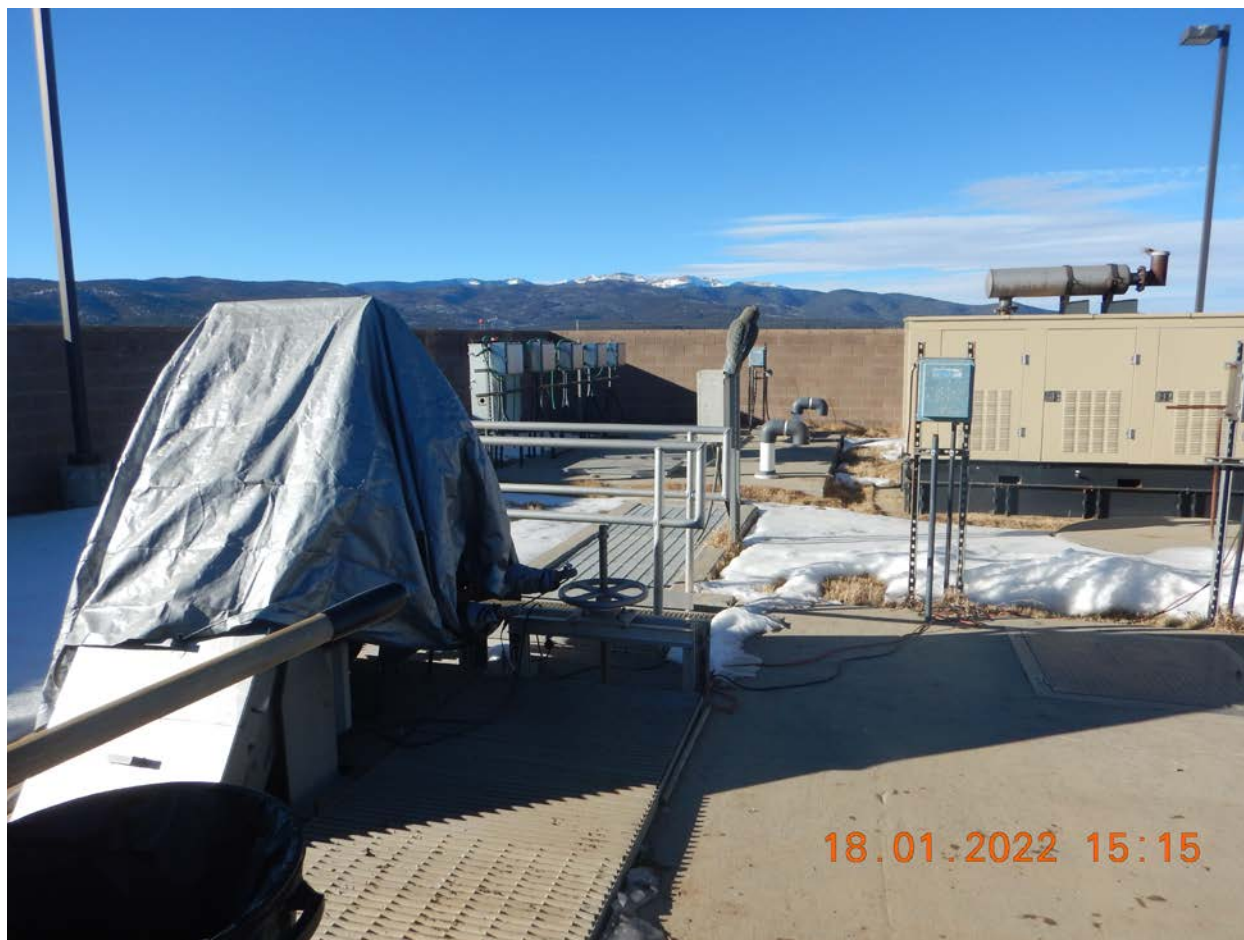
Photo No. 6

- It was also stated the electrical controls for the SBR's, and headworks are outdated, and WWTF staff has difficulty with manufacturer service and obtaining replacement parts.

View of the headwork at the Main Lift Station. Note: The WWTF is scheduled to upgrade the exiting headworks building and install new isolation valves. (DSCN 2096). Photographed by D. Esparza
