## RCRA Compliance Branch INSPECTION REPORT

| <b>Facility or Site Name:</b> | Utrecht Manufacturing Corp | |
| <b>Facility/Site Physical Location:</b> | 4014 1 <sup>st</sup> Avenue Building 26 Space 26-5 North | |

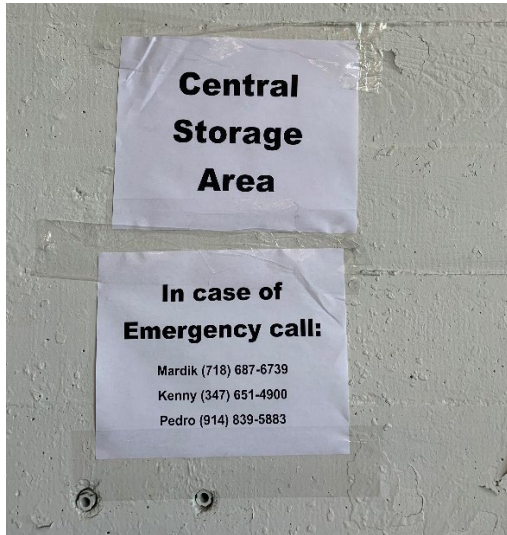
(Figure 1: Picture of emergency phone number list)

3. Pursuant to 6 NYCRR § 372.2(a)(8)(iii)(e)(2)(i), The name and phone number of the emergency coordinator must be posted next to the telephone.

At the time of the inspection, there was no phone number of the emergency coordinator posted next to the telephone in the central storage area.

On September 14, 2023, Mr. Sarkissian followed up in an email regarding the area of concerns. Mr. Sarkissian stated: “We put the sign for Central Storage Area with emergency contact list see the attachment (see figure 1 below).”
