## RCRA COMPLIANCE EVALUATION INSPECTION REPORT

Plaskolite South LLC (Plaskolite)  
10500 High Point Road  
Olive Branch, Mississippi 38654  
EPA ID: MSD980799480

October 25, 2022      9:00 a.m.

**COMPLIANCE EVALUATION INSPECTION**

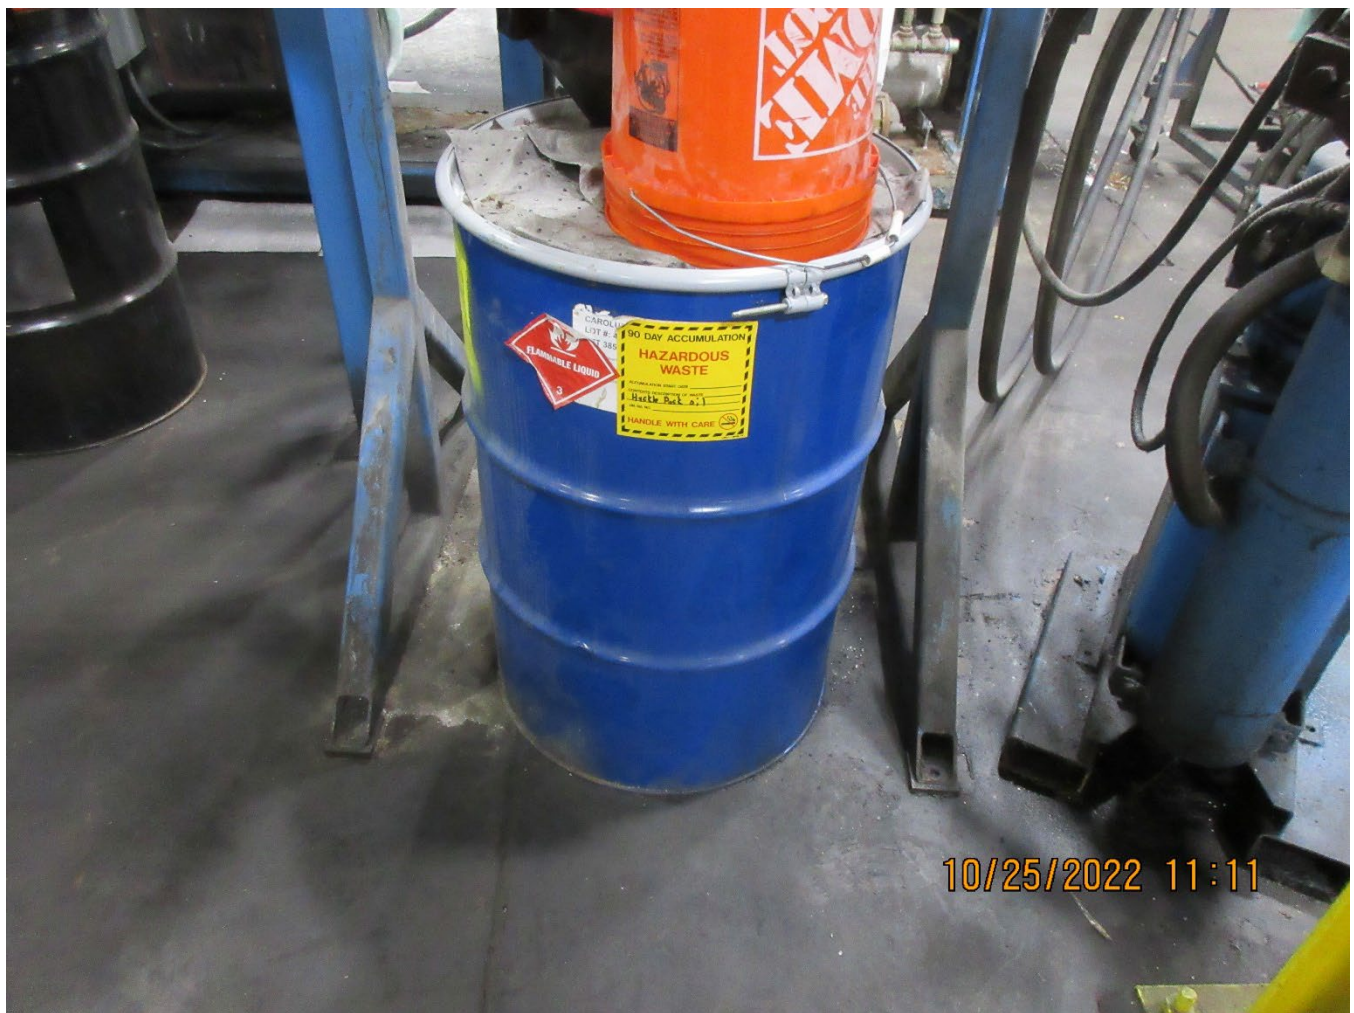
One 55-gallon container of a hazardous waste referred to as "Huckle Pack Oil" was observed within a SAA in this area (Photo 1). The "Huckle Pack Oil" is composed partially of butyl stearate and has a flash point of less than 140 degrees Fahrenheit. A second 55-gallon container observed within a separate SAA in this area was used for the collection of hazardous waste cleanup materials (Photo 2).

**Photo 1 – Drum of Hazardous Waste “Huckle Pack Oil” in South Extrusion Area SAA**

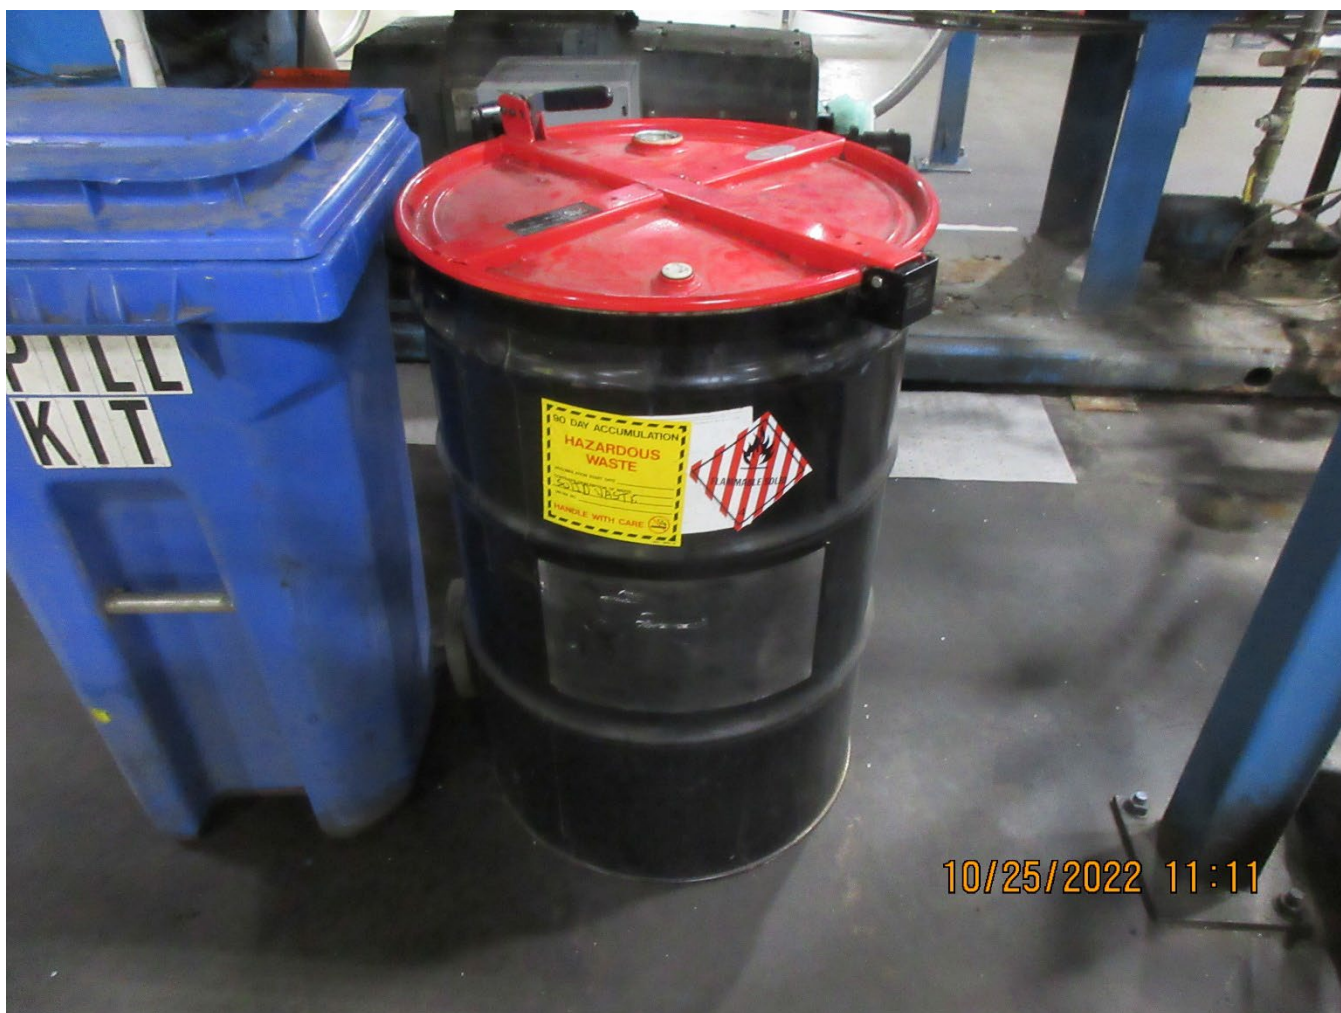
**Photo 2 – Drum of Hazardous Waste Cleanup materials in South Extrusion Area**

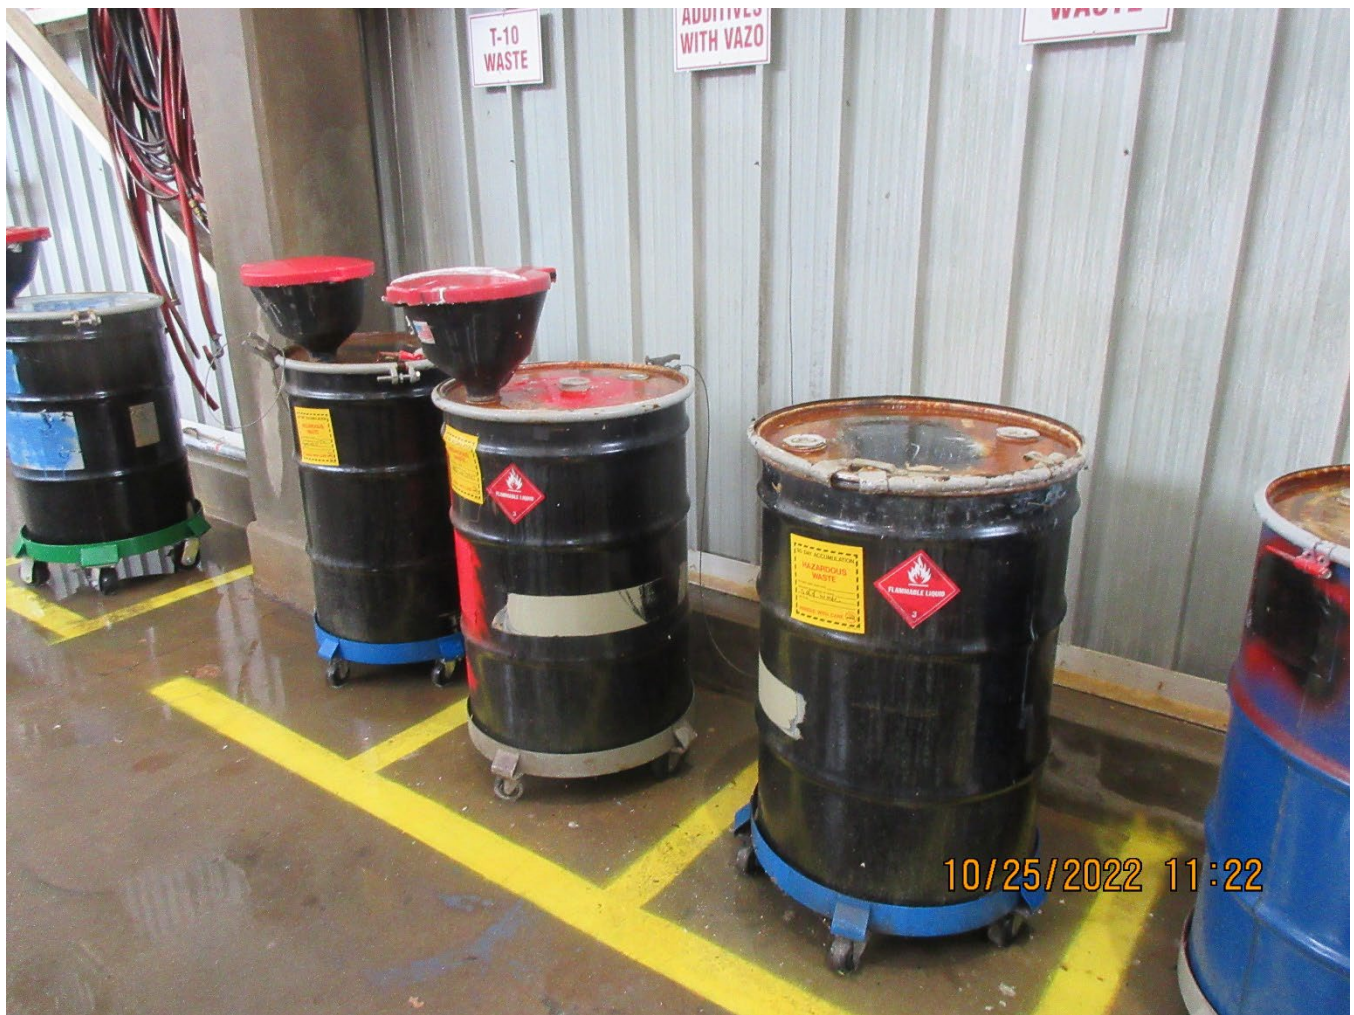
Three individual SAAs were observed in this area for the collection of three separate hazardous waste streams. The individual waste streams were referred to as T-10 waste, Additive W/T2 waste and one drum for the collection of hazardous waste rags and filters (Photo 3).

**Photo 3 – Three SAs in Reactor 2 Area**

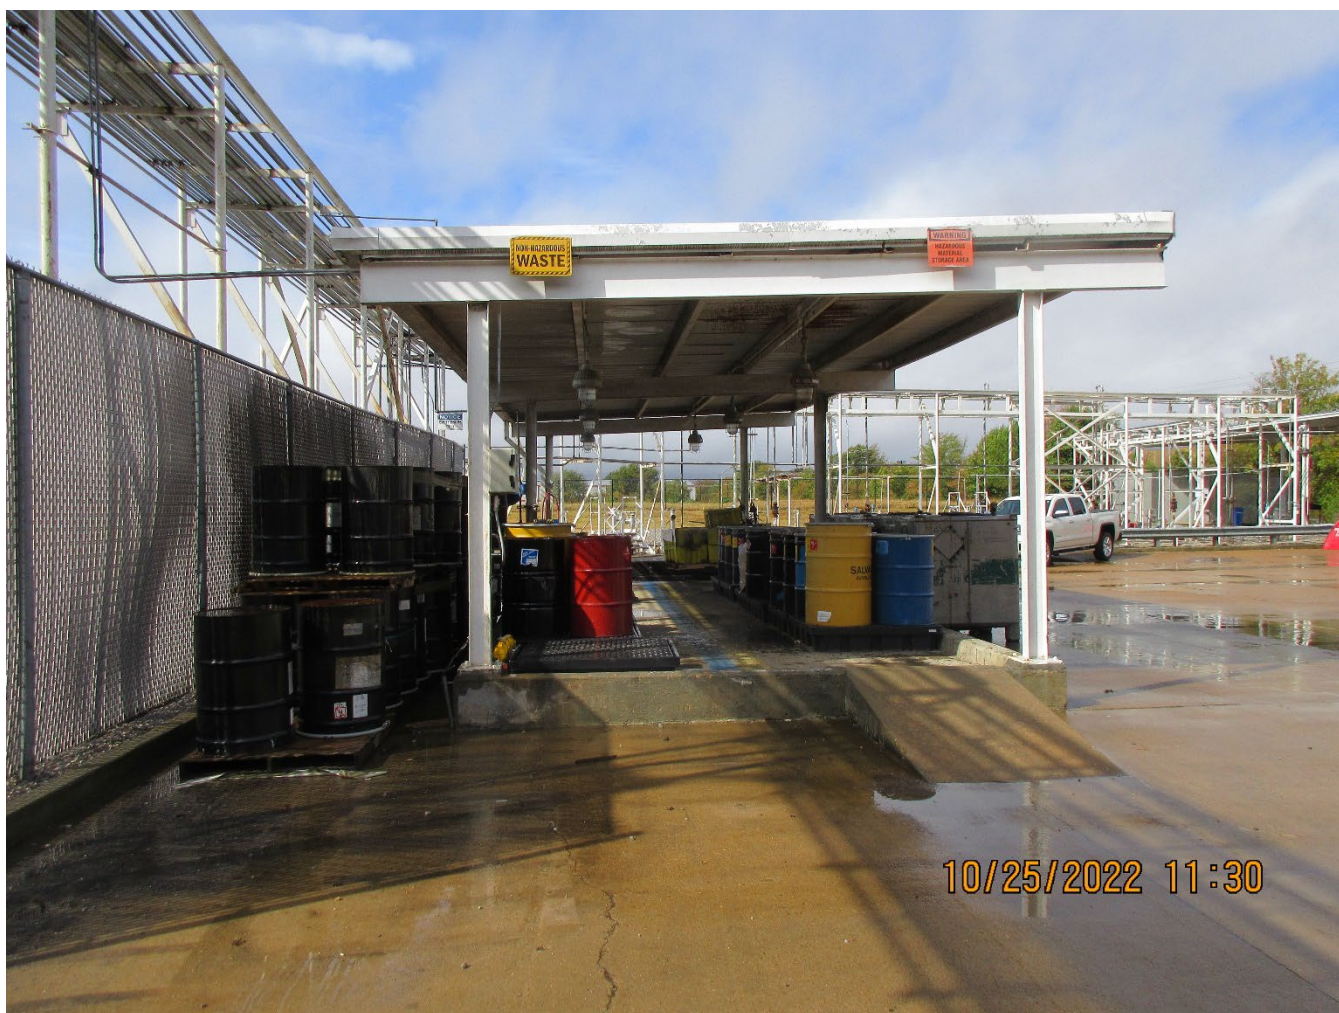
This area is used for the collection of containerized hazardous waste generated by the facility. The area consisted of a raised and bermed concrete pad covered by a metal roof (Photo 4). Containers observed in the area were placed on pallets at the time of the inspection. Twenty-two 55-gallon containers of hazardous waste were observed on the pad at the time of the inspection

**Photo 4 – Container Collection Area**

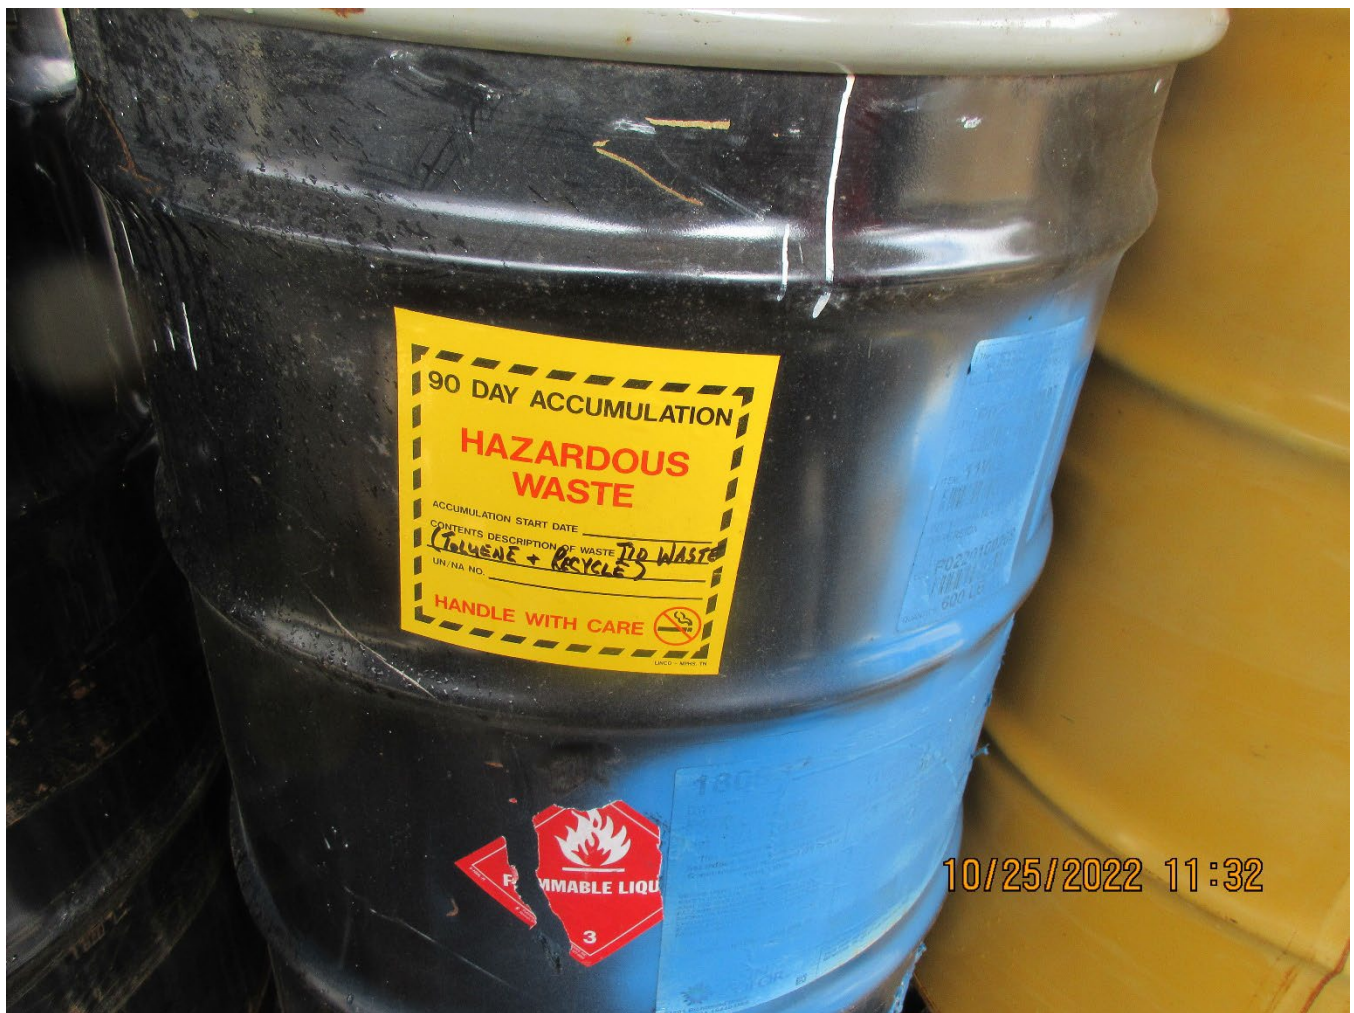
(Photos 5 & 9). One of the containers was not marked with an accumulation start date at the time of the inspection (Photo 6).

**Photo 5 – Missing Accumulation Start Date on Drum in CAA**

**Pursuant to 11 Miss. Admin. Code Pt. 3, R. 1.3 [40 C.F.R. § 262.34(a)(2)], which is a condition of the LQG Permit Exemption, a generator is required to ensure that the date upon which each period of accumulation begins is clearly marked and visible on each container. I**

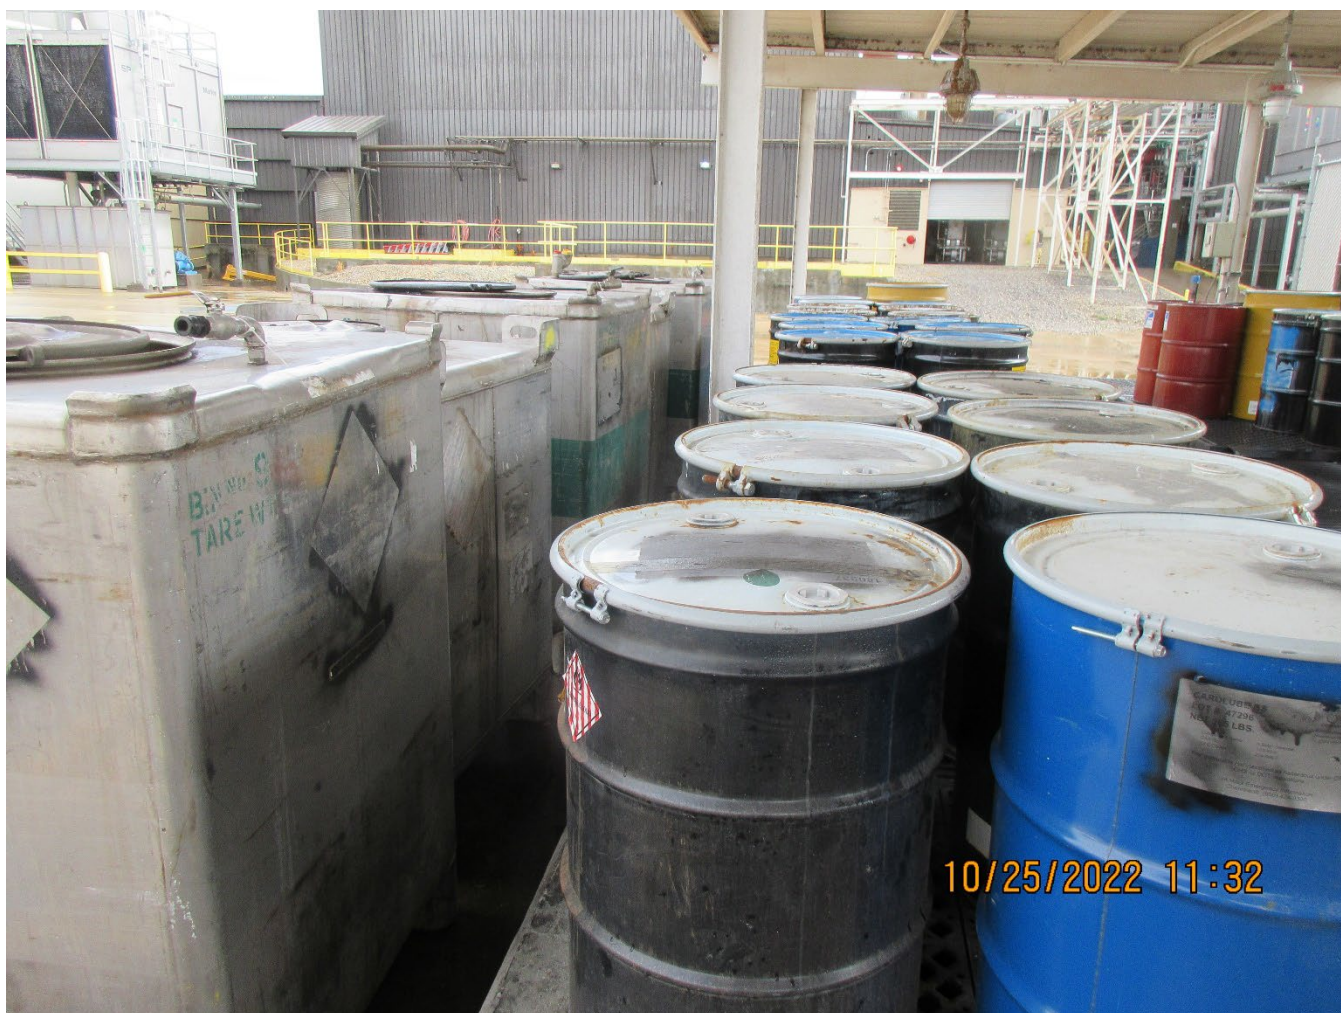
**Photo 6 - Container Collection Area**

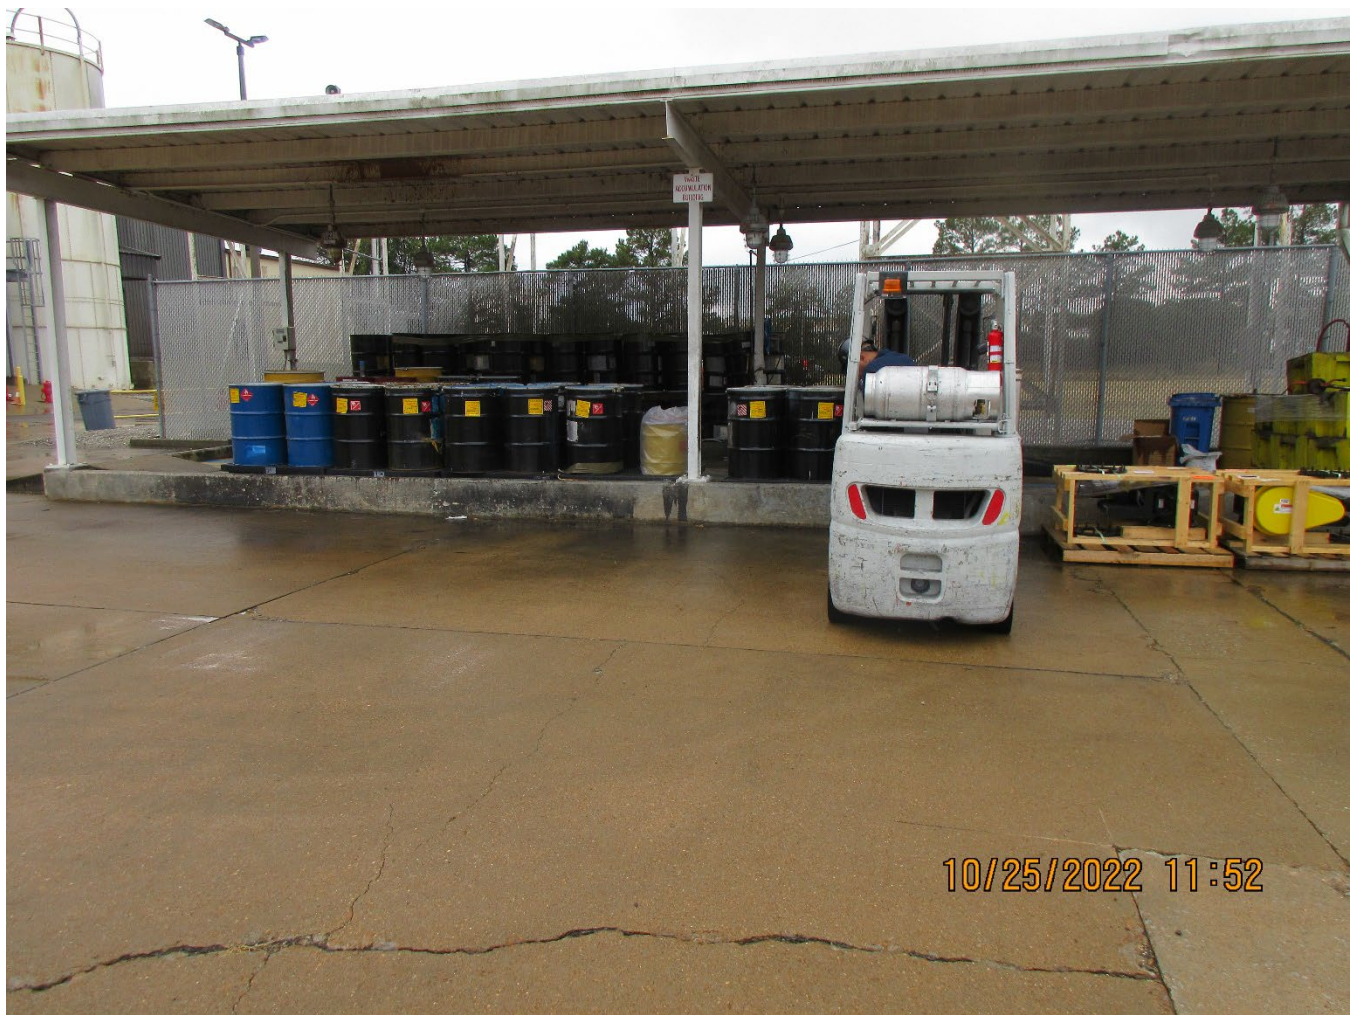
**Photo 9 – Central Accumulation Area**

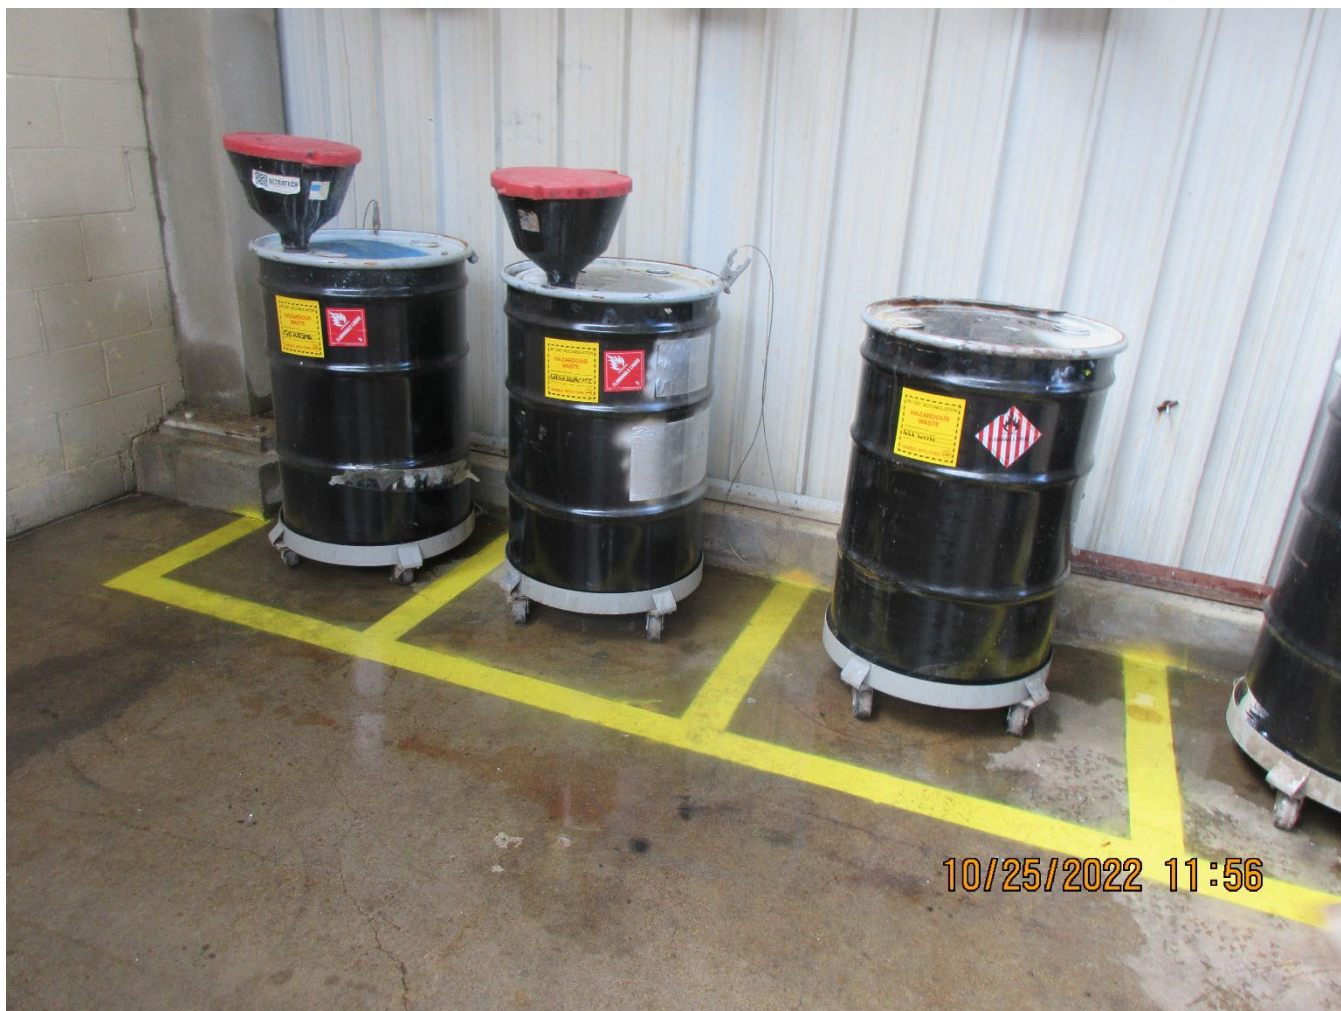
Similar to Reactor Area 2, three individual SAAs were observed in this area for the collection of three separate hazardous waste streams. The individual waste streams were referred to as T-10 waste, Additive W/T2 waste and one drum for the collection of hazardous waste rags and filters (Photo 10).

**Photo 10 – SAAs in Production Area 2**

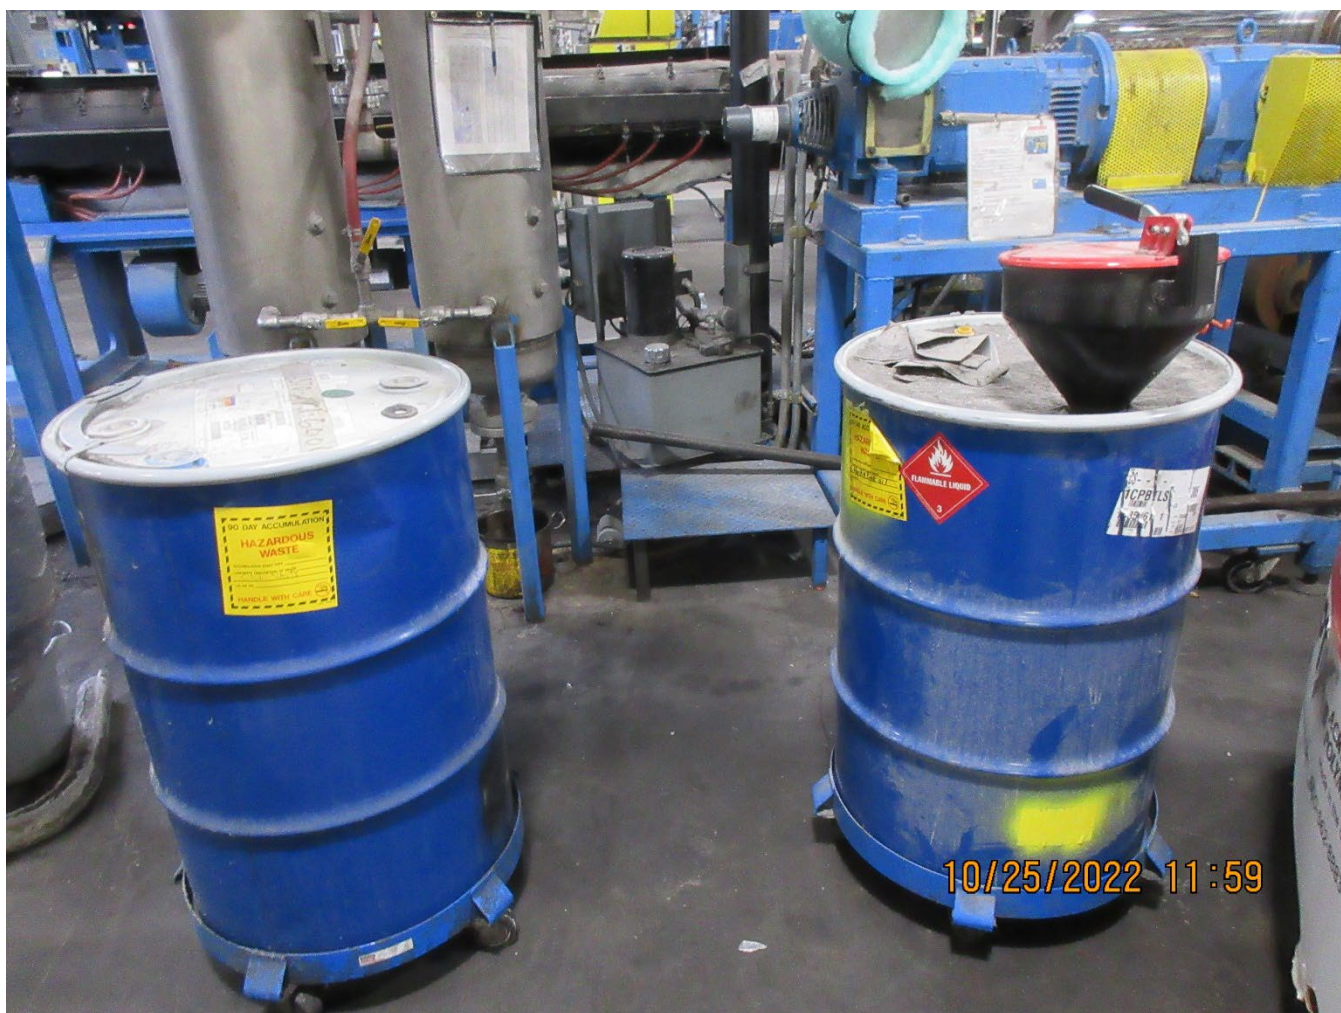
In addition, two 55-gallon containers were observed in SAAs in this production area for the collection of spent solvents (Photo 11).

**Photo 11 – Two additional SAAs in Production Area 2**
