## RCRA Compliance Branch INSPECTION REPORT

| <b>Facility or Site Name:</b> | Starfire Systems Inc. | |

#### Purpose of the Inspection Objective

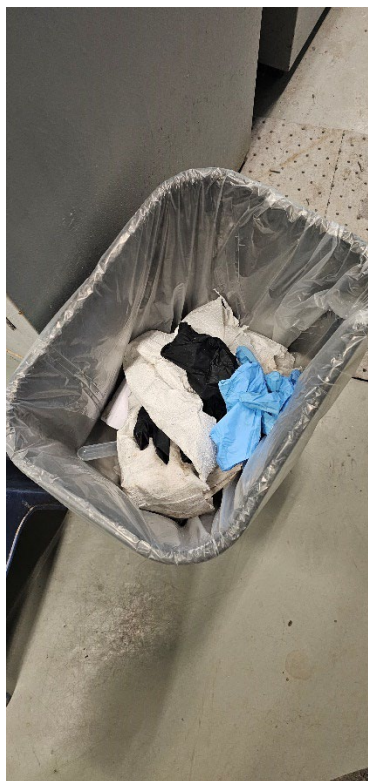
The fine chemicals laboratory is a small-scale chemistry lab, that conducts both research and development as well as final product production. The fine chemicals laboratory had one 1-gallon satellite accumulation container that was not labeled or closed. Additionally, four approximately 5-gallon municipal waste garbage cans were observed with hazardous waste PPE, hazardous waste lab equipment (pipettes, etc.), and hazardous waste chemical-stained rags stored within them (figures 1-4). The facility representative stated the hazardous waste observed within the municipal waste garbage cans are disposed of within the facility's municipal waste dumpster located in the Back Pad Area.

Figure 1: Hazardous waste lab PPE, hazardous waste lab equipment, and hazardous waste chemical-stained rags observed stored in municipal waste garbage can.

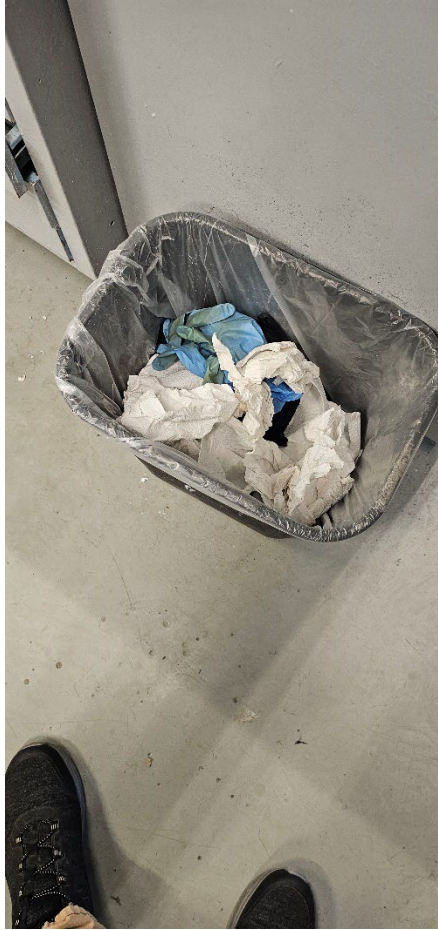
Figure 2: Hazardous waste lab PPE, hazardous waste lab equipment, and hazardous waste chemical-stained rags observed stored in municipal waste garbage can.

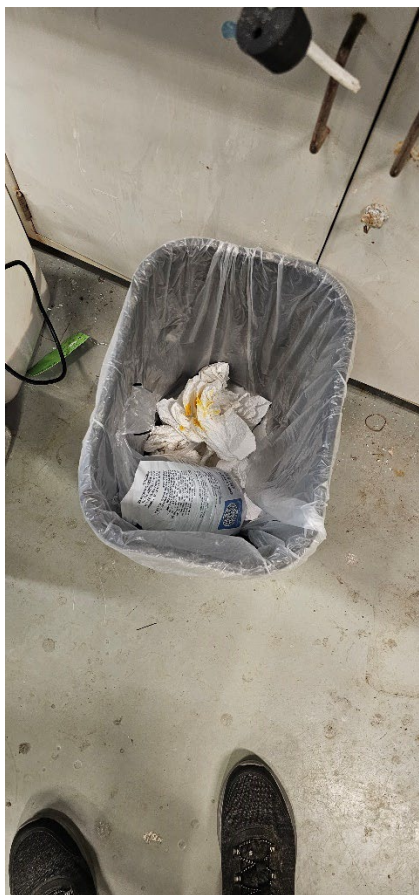
Figure 3: Hazardous waste lab PPE, hazardous waste lab equipment, and hazardous waste chemical-stained rags observed stored in municipal waste garbage can.

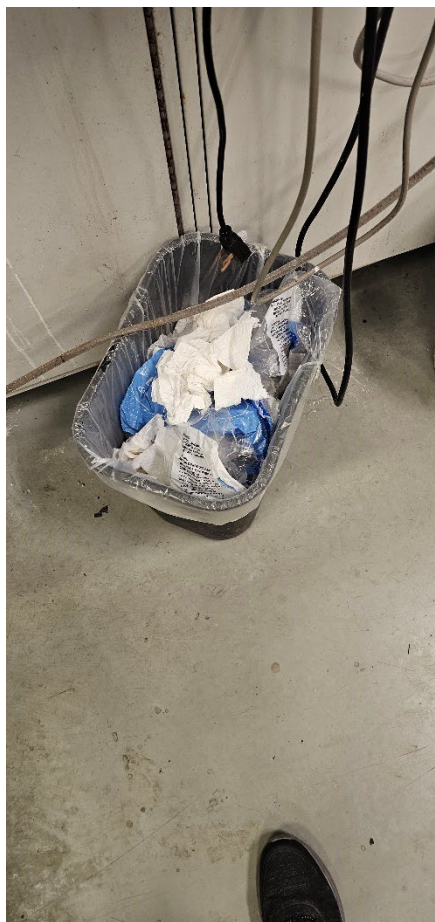
Figure 4: Hazardous waste lab PPE, hazardous waste lab equipment, and hazardous waste chemical-stained rags observed stored in municipal waste garbage can.

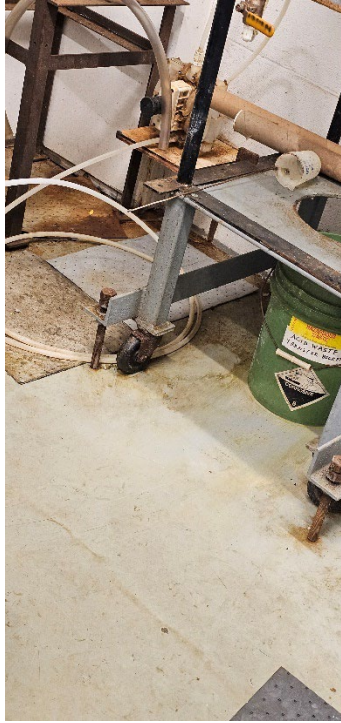
The polyramics laboratory had one 55-gallon satellite accumulation container and one 5-gallon satellite accumulation container at the time of the inspection. The 55-gallon satellite accumulation container was not labeled “Hazardous Waste” and was not labeled with words identifying its contents. Additionally, the 5-gallon satellite accumulation container was not closed (figure 5). There was a 2.5-gallon container of glycol located in this area as well. Several hazardous waste saturated and unusable absorbent pads were observed in this area at the time of the inspection. The absorbent pads were stated to be used to collect spilled hazardous wastes; the pads were severely stained and saturated and no longer sufficient to properly contain hazardous waste spills. (figures 6 and 7). The facility representative stated the hazardous waste containing absorbent pads are disposed of within the municipal waste stream (municipal waste dumpster).

- a. At the time of the inspection, the fine chemicals laboratory had one 1-gallon satellite accumulation container that was not closed.
  - b. At the time of the inspection, one 5-gallon satellite accumulation container located in the polyramics lab was not closed.

Figure 5: The 5-gallon satellite accumulation container located in the polyramics lab was not closed. Additionally, hazardous waste containing absorbant pads were observed in this figure. The absorbant pads were saturated and no longer sufficient to collect hazardous wastes.

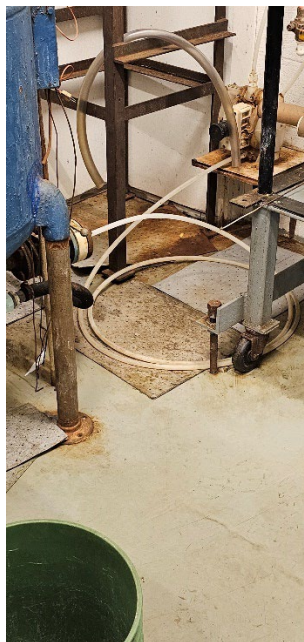
Figure 6: Absorbant pads observed in the polyramics lab were severely stained and saturated and no longer sufficient to properly contain hazardous waste spills.

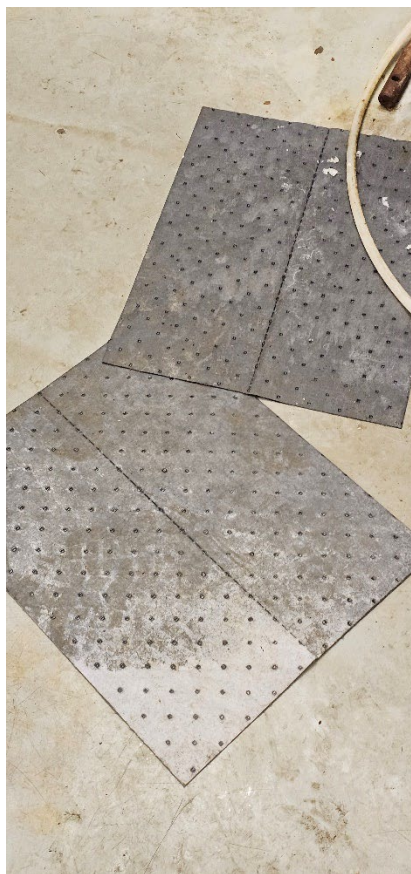
Figure 7: Absorbant pads observed in the polyramics lab were severely stained and saturated and no longer sufficient to properly contain hazardous waste spills.

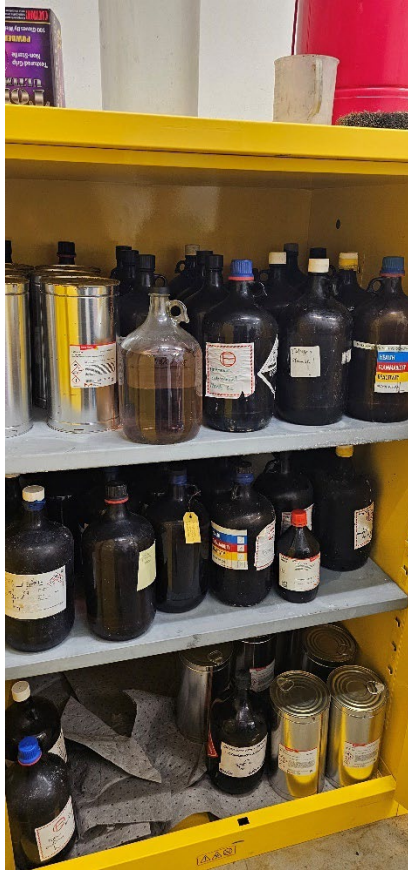
- Flammable Cabinet 1 – One container labeled as “unknown substance - needs GC,” the container was unidentified at the time of the inspection and a hazardous waste determination was not done. The container had a corrosives placard on it and was incompatibly stored with ignitable materials (figure 8).
- Flammables Cabinet 2 – Corrosive and ignitable materials were incompatibly stored in this area. Many of the stored chemical containers showed signs of corrosion and degradation. One 35-gallon drum of magnesium powder was observed to be severely degraded and had flammable liquid stored on top of the drum. The magnesium powder was labeled “dangerous when wet” and “spontaneously combustible” (figures 9 and 10).
- Flammables cabinet 3: Lithium aluminum hydride was stored in this cabinet.

- e. At the time of the inspection, the facility failed to make a hazardous waste determination for a container labeled as “unknown substance - needs GC,” located in the mixing room flammables cabinet 1. The container was unidentified at the time of the inspection and a hazardous waste determination was not done. The container had a corrosives placard on it and was incompatibly stored with ignitable materials.

Figure 8: In the mixing room flammables cabinet 1, one container labeled as “unknown substance - needs GC,” the container was unidentified at the time of the inspection and a hazardous waste determination was not done. The container had a corrosives placard on it and was incompatibly stored with ignitable materials.

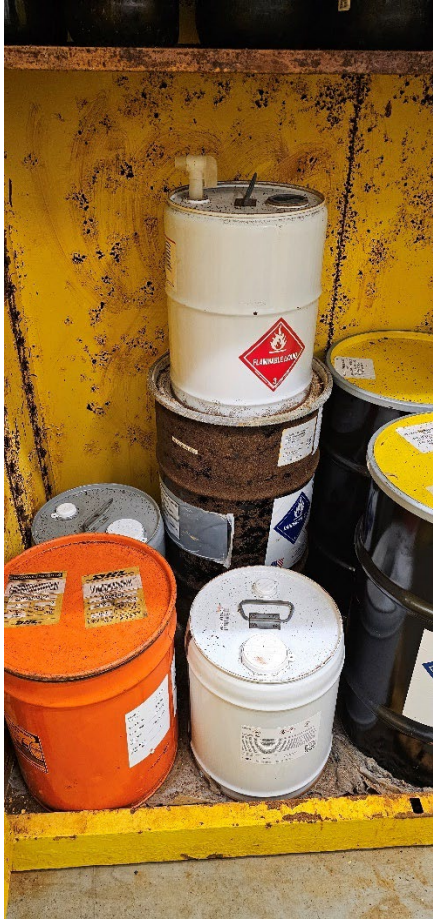
- b. At the time of the inspection, one 35-gallon drum of magnesium powder located in the mixing room flammables cabinet 2 was observed to be severely degraded and had flammable liquid stored on top of the drum. The magnesium powder was labeled “dangerous when wet” and “spontaneously combustible.” Due to the reactive nature of the magnesium powder and the conditions of its storage, the risk of a fire or explosion significantly increases. This substantially impacts the safety of employees and visitors at the facility.

Figure 9: In the mixing room flammables cabinet 2, one 35-gallon drum of magnesium powder was observed to be severely degraded and had flammable liquid stored on top of the drum. The magnesium powder was labeled “dangerous when wet” and “spontaneously combustible.”

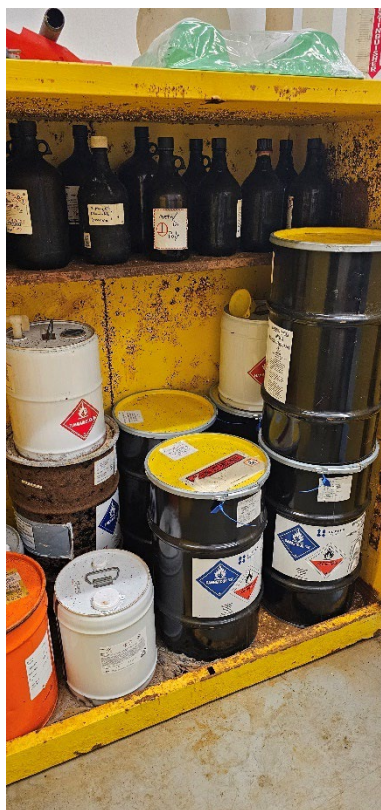
Figure 10: In the mixing room flammables cabinet 2, many of the stored chemical containers showed signs of corrosion and degradation. The corroded magnesium powder drum can also be seen in the figure.

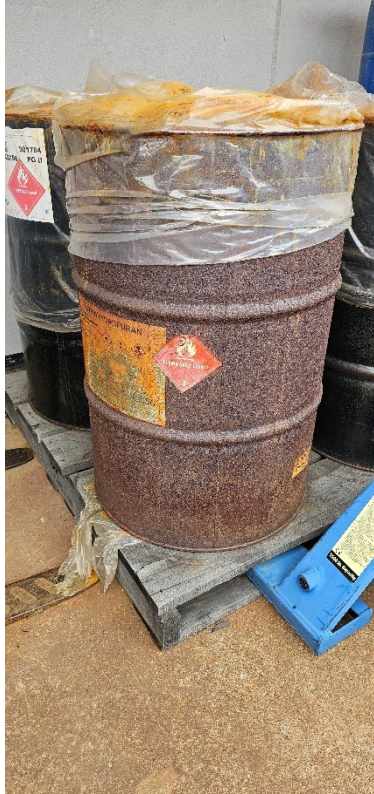
- Four 55-gallon drums were observed on a pallet, the facility representative stated the facility was determining if these chemicals were still usable. One 55-gallon drum of Tetrahydrofuran was observed to be extremely corroded and potentially unusable in the condition observed (figure 11).
- Four full 275-gallon hazardous waste totes (not in the filling pad area) were closed and labeled but were not dated.

- f. At the time of the inspection, the facility had failed to make a hazardous waste determination for a 55-gallon drum of Tetrahydrofuran that was located in the back pad area. The drum was observed to be extremely corroded and inherently waste like.

Figure 11: In the back pad area, one 55-gallon drum of Tetrahydrofuran was observed to be extremely corroded and potentially unusable in the condition observed.

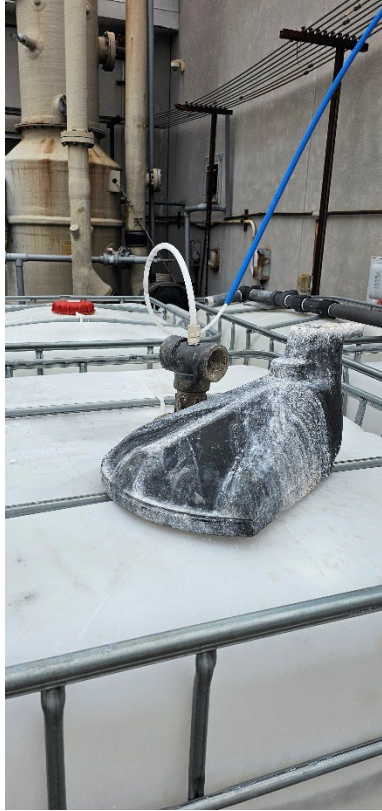
- Three 275-gallon hazardous waste totes were observed in the filling pad area. One tote was hooked up to the fill line that is pumped from the polymer lab. All three totes were not labeled and not dated. Additionally, two of the totes were not closed; one tote utilized a T pipe connector to vent vapors (figure 12), and one tote had an open hose connection attached to the top cap (figure 13).

- c. At the time of the inspection, two of the totes located in the back pad area were not closed; one tote utilized a T pipe connector to vent vapors, and one tote had an open hose connection attached to the top cap .

Figure 12: One tote located in the back pad area utilized a T pipe connector to vent vapors and was not closed.

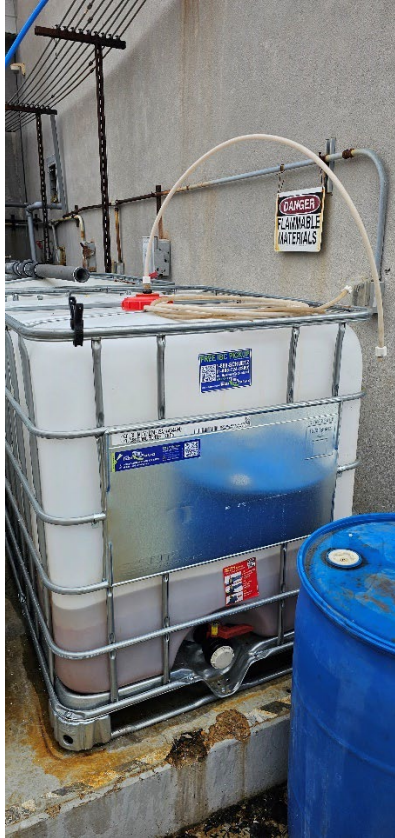
Figure 13: One tote located in the back pad area had an open hose connection attached to the top cap and was not closed.

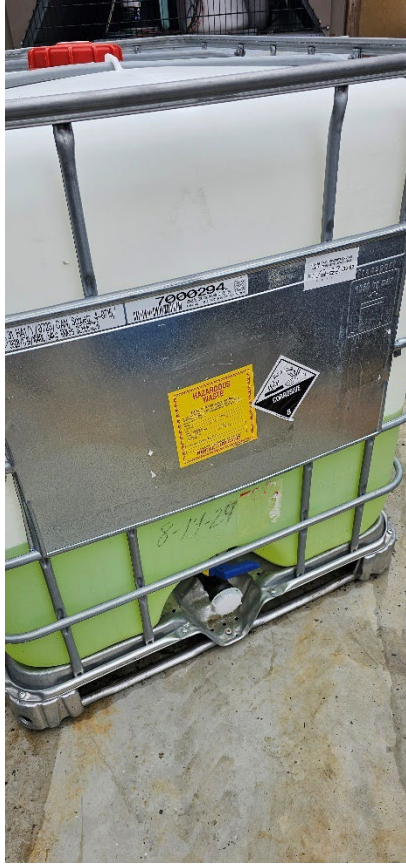
- One 275-gallon hazardous waste tote used to collect corrosive scrubber wastes did not have a date on the hazardous waste label. However, a date was observed written on the hazardous waste tote for 08/14/2024, and the facility representative stated the tote has been accumulating waste on site for approximately 6-months (figure 14).

Figure 14: One 275-gallon hazardous waste tote located in the back pad area used to collect corrosive scrubber wastes was not dated. A date was observed written on tote for 08/14/2024 however, the facility representative stated the tote has been accumulating waste on site for approximately 6-months

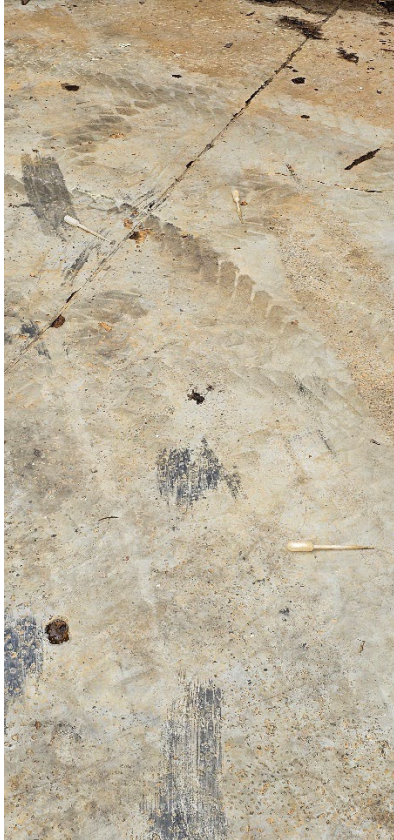
- Hazardous waste lab pipettes were observed scattered all around the back pad area, there was yellowing and staining observed inside the pipettes indicating they have been used (figure 15).

- b. At the time of the inspection, the facility had failed to make a hazardous waste determination for its laboratory equipment (pipettes, etc.) which inevitably led to the disposal of hazardous waste into the municipal waste stream.

Figure 15: This figure shows one of the many areas in the back pad area where hazardous waste lab pipettes were observed scattered on the ground.

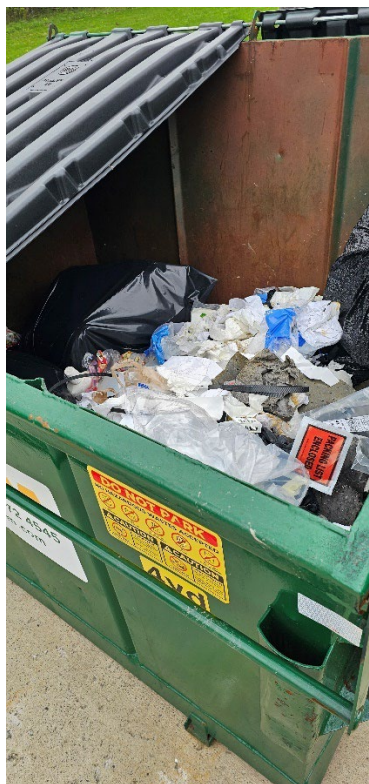
The municipal waste dumpster was located in the back pad area. Hazardous waste was observed disposed of within the municipal dumpster. Hazardous wastes that were observed at the time of the inspection include hazardous waste absorbent pads, hazardous waste PPE, hazardous waste lab equipment (pipettes, etc.), and soiled chemical-stained rags (Figures 17-19). There were several contractor bags observed with unidentified content in the dumpster as well. When the facility representative opened the dumpster, a strong solvent odor was identified coming from the dumpster's contents. The facility was ordered to remove all hazardous waste from the dumpster before close of business to ensure no further illegal disposal at a municipal waste facility. The facility representative stated the company has been disposing of the hazardous wastes identified in the municipal waste dumpster since the opening of the new location in 2018.

- a. At the time of the inspection, the facility failed to prevent hazardous waste from entering the municipal waste stream and therefore increasing the risk to human health and the environment. Various streams of hazardous waste were observed disposed of within the municipal waste dumpster. It was also determined that the hazardous waste was disposed of as municipal waste since the opening of the facility in 2018.

Figure 17: . Hazardous waste observed disposed of within the municipal dumpster in the back pad area. Hazardous wastes that were observed at the time of the inspection include hazardous waste absorbant pads, hazardous waste PPE, Hazardous waste lab equipment (pipettes, etc.), and soiled chemical-stained rags.

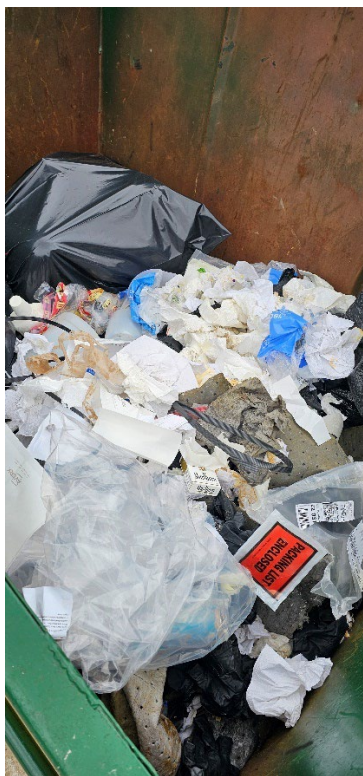
Figure 18: Hazardous waste observed disposed of within the municipal dumpster in the back pad area. Hazardous wastes that were observed at the time of the inspection include hazardous waste absorbant pads, hazardous waste PPE, Hazardous waste lab equipment (pipettes, etc.), and soiled chemical-stained rags.

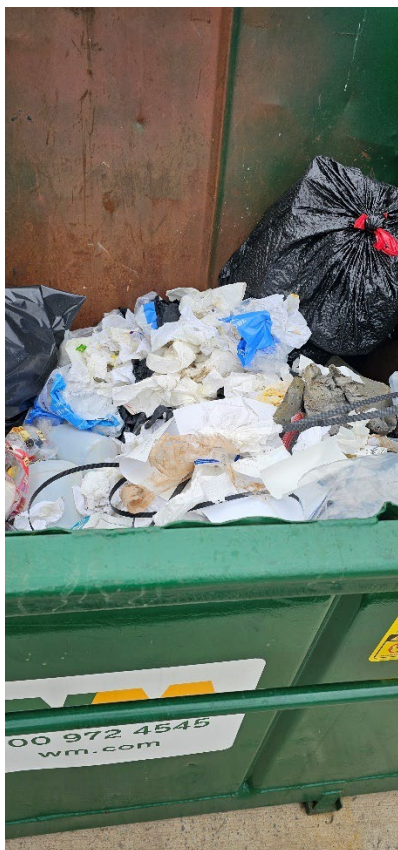
Figure 19: Hazardous waste observed disposed of within the municipal dumpster in the back pad area. Hazardous wastes that were observed at the time of the inspection include hazardous waste absorbant pads, hazardous waste PPE, Hazardous waste lab equipment (pipettes, etc.), and soiled chemical-stained rags.
