**Region 6 - Enforcement & Compliance Assurance Division**  
**INSPECTION REPORT**

| Inspection Date(s): | 03/02/2026 | |
| Company Name: | Cotac | |

Appendix 1 – Photo Log – 16 photos taken 3/2/26

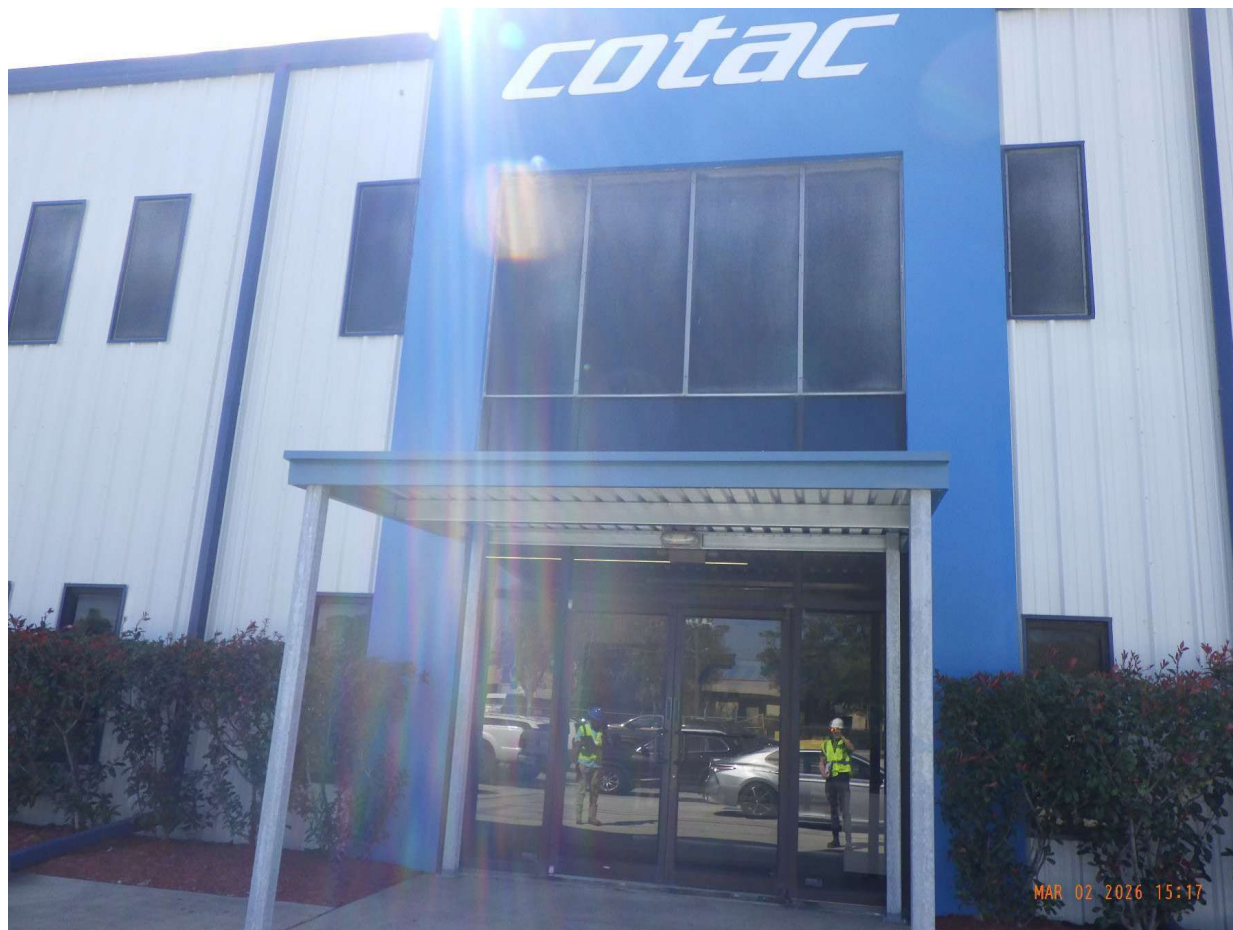
Photo No. 1

| Description: | Front of facility. | | |

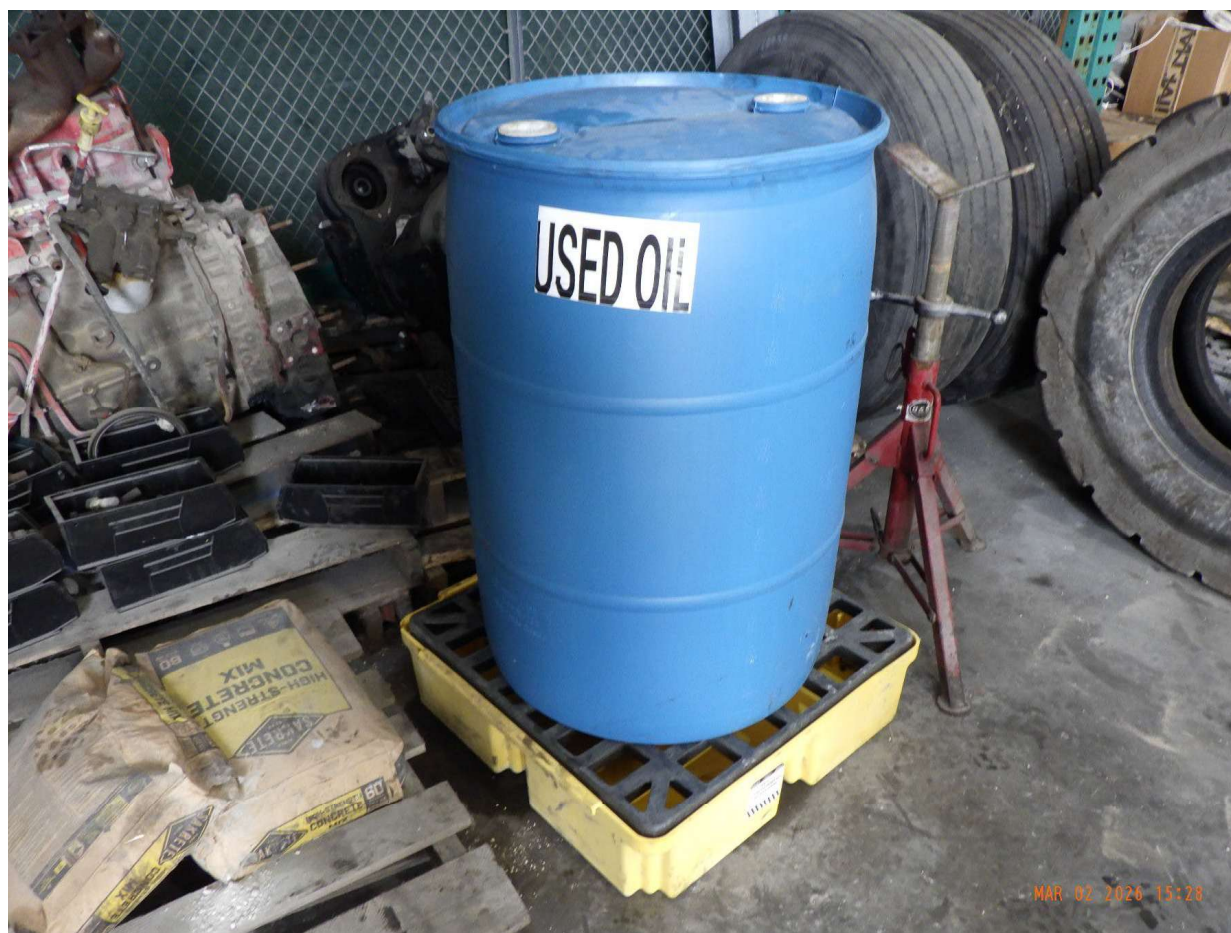
Photo No. 2

I observed a used oil container labeled with the words used oil (Appendix 1, Photo 2). I also observed two cut-down poly drums being used as drip pans for used oil servicing (Appendix 1, Photo 3).

| Description: | Used oil container in maintenance building labeled with the words used oil. | | |

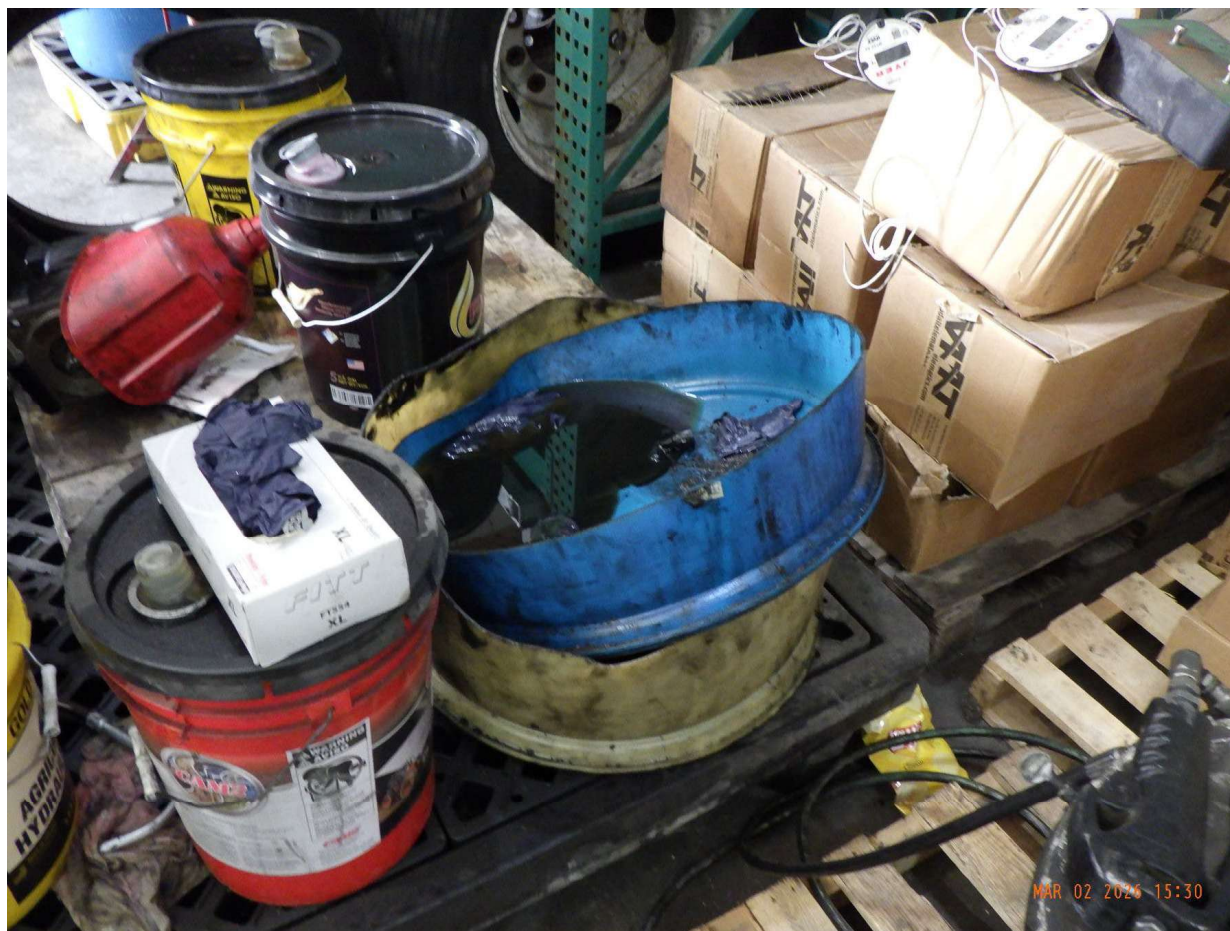
Photo No. 3

| Description: | Used oil drip pans. | | |

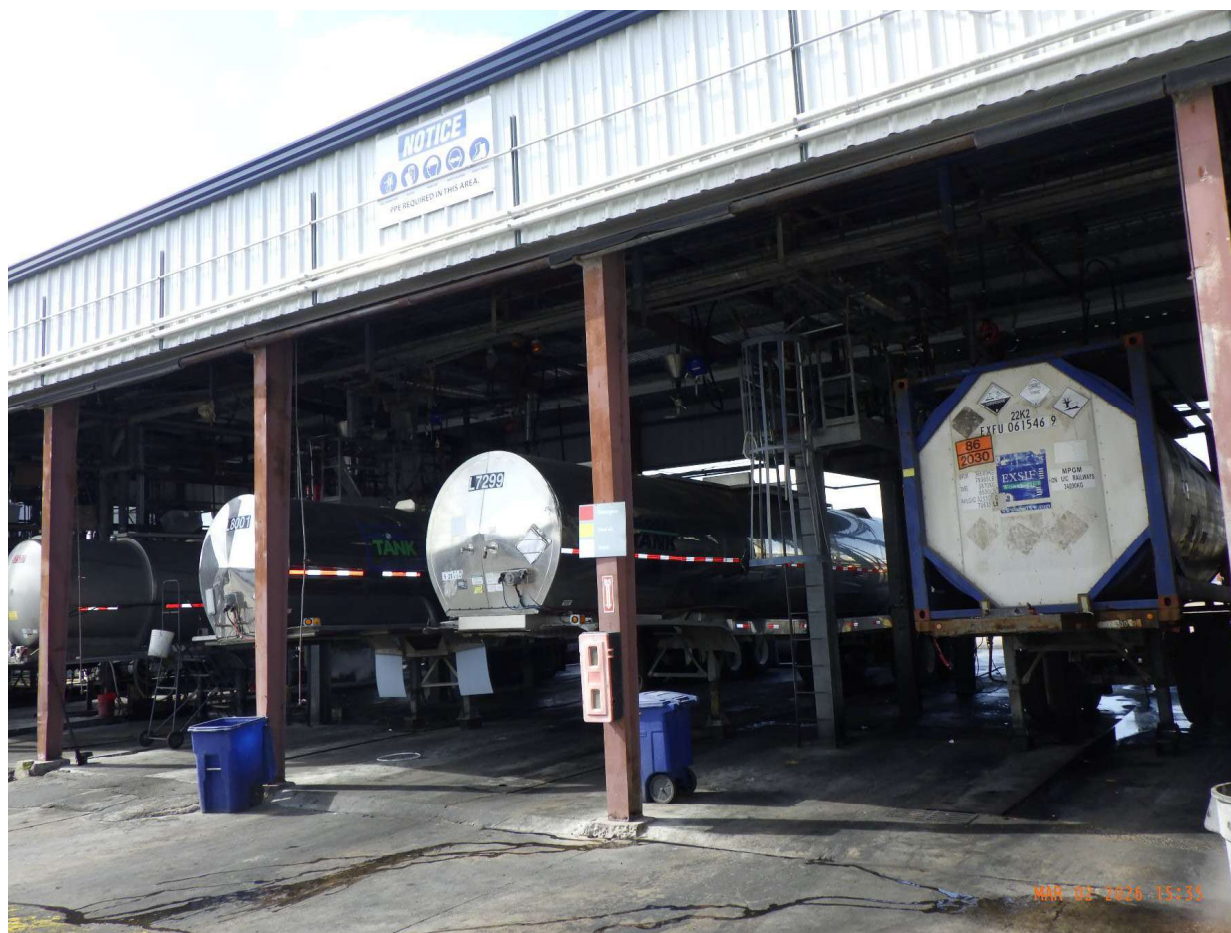
Photo No. 4

The tank wash and wastewater area consists of eleven (11) wash bays and the wastewater treatment system. Per the cleaning manager, the tank wash at Cotac only washes containers that previously held product and that washing of the containers (tanker trucks) is done after small amounts of product heels are removed. Per the cleaning manager, most of the washing is done with hot water. If additional washing is necessary, the facility will use diesel fuel, then caustic, then additional hot water. I observed wash water being drained from the tanker truck containers into the floor drains of the tank wash area. Per the cleaning manager, the floor drains will drain into a sump that is pumped into a large above ground storage tank (AST) (Appendix 1, Photo 16). Wastewater in the AST is run through an oil water separator. Oil removed from the oil water separator goes into totes and is recycled. Water removed from the oil water separator is sent to a sump at the front of the facility and piped directly to Gulf Coast Authority (GCA). In the tank wash area, I observed wash bays 1-5 (Appendix 1, Photos 4 and 6) and

| Description: | Tank wash bays 1-5. | | |

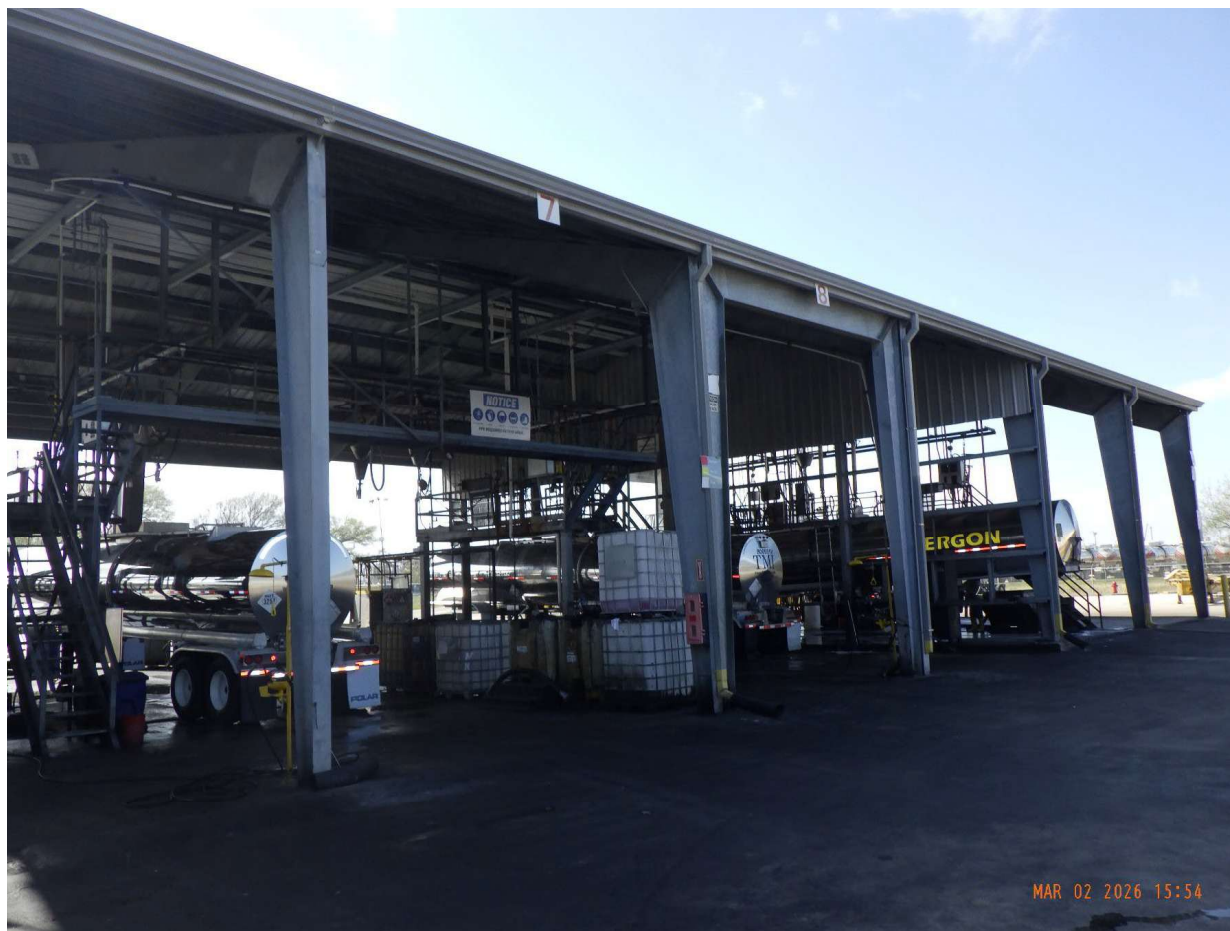
Photo No. 5

wash bays 6-11 (Appendix 1, Photos 5 and 14). I observed wash water on the floor (Appendix 1, Photo 12) of the wash bays and in wash bay 6 the cleaning manager used pH paper to sample the wash water on the floor and the pH paper showed a pH around 7 (Appendix 1, Photo 13). I also observed the storage containers for diesel and caustic that are used in the wash bays (Appendix 1, Photo 14).

| Description: | Tank wash bays 6-11. | | |

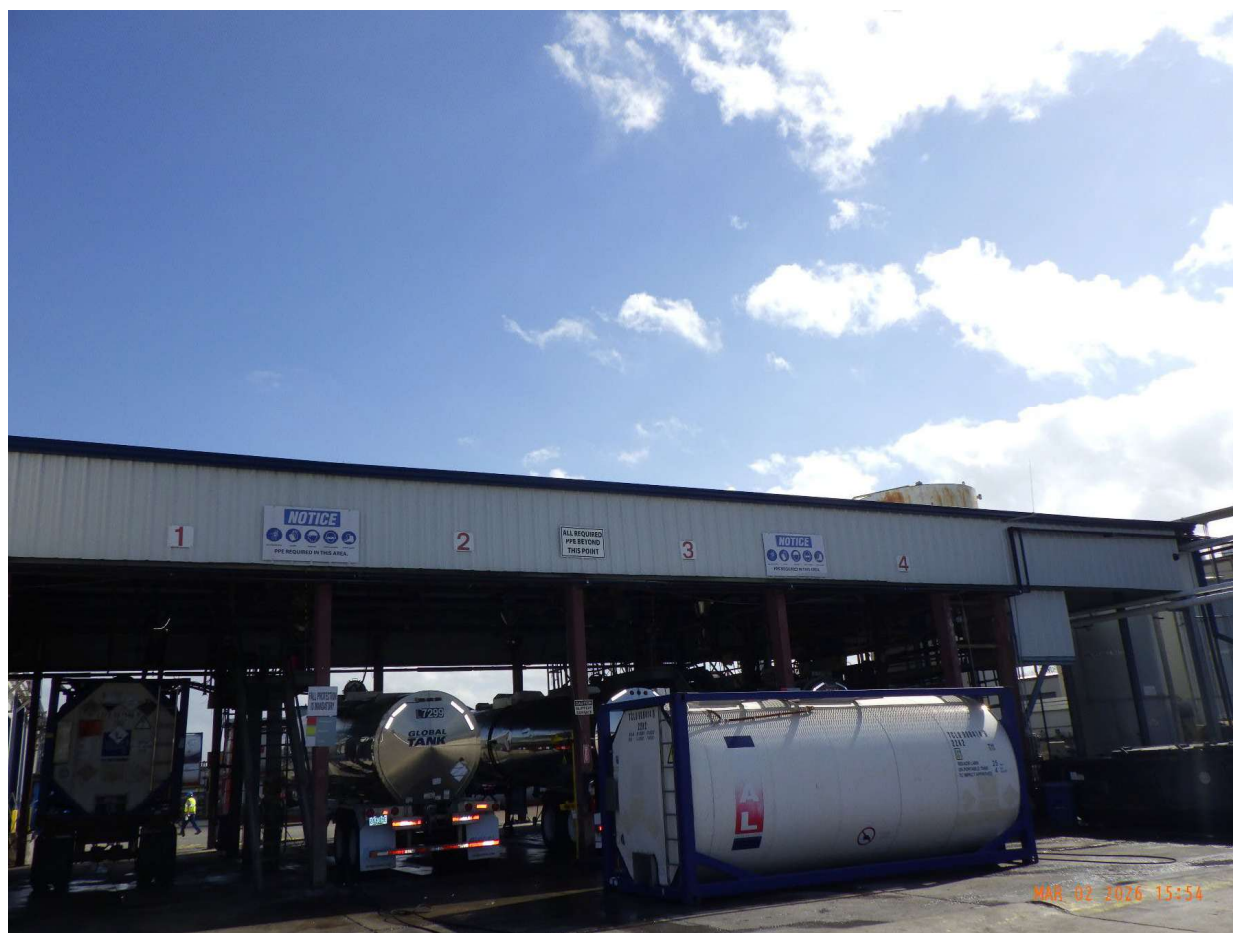
Photo No. 6

| Description: | Tank wash bays 1-5 other side. | | |

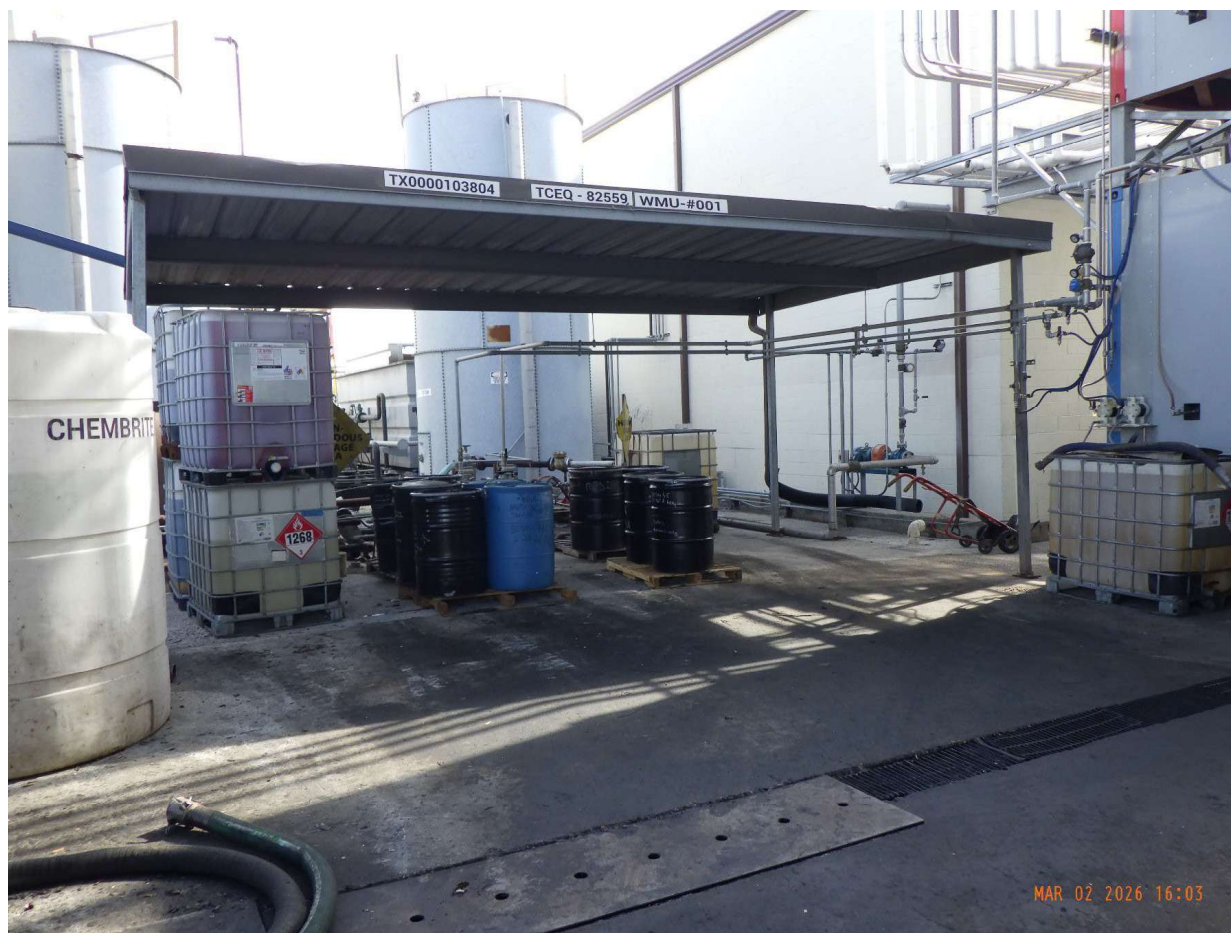
Photo No. 7

I observed several containers of hazardous waste in the CAA (Appendix 1, Photo 7). The hazardous waste in the containers was generated from heels removed from containers prior to cleaning. I observed 3 drums of hazardous waste not labeled with the words "Hazardous Waste", or an indication of the hazards of the contents (Appendix 1, Photos 8, 9, and 11). I observed one drum of hazardous waste not labeled with an indication of the hazards of the contents (Appendix 1, Photo 10).

| Description: | Centralized accumulation area (CAA). | | |

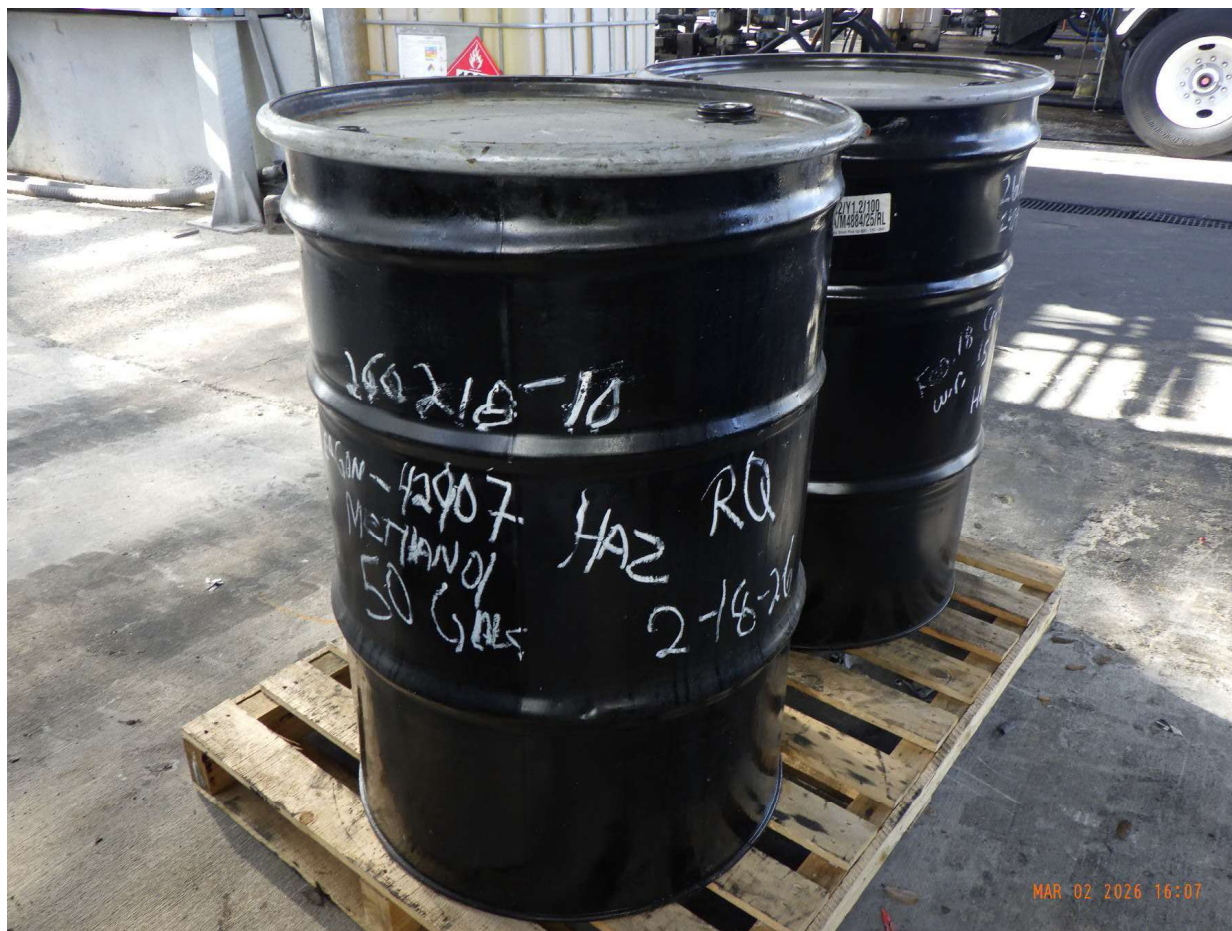
Photo No. 9

- AOC 1 - Drums of hazardous waste in the CAA were not labeled with the words "Hazardous Waste" and/or an indication of the hazards of the contents per requirements of conditions of exemption for LQGs in 40 C.F.R. § 262.17.

| Description: | Drum of hazardous waste not labeled with the words "Hazardous Waste" or an indication of the hazards of the contents. | | |

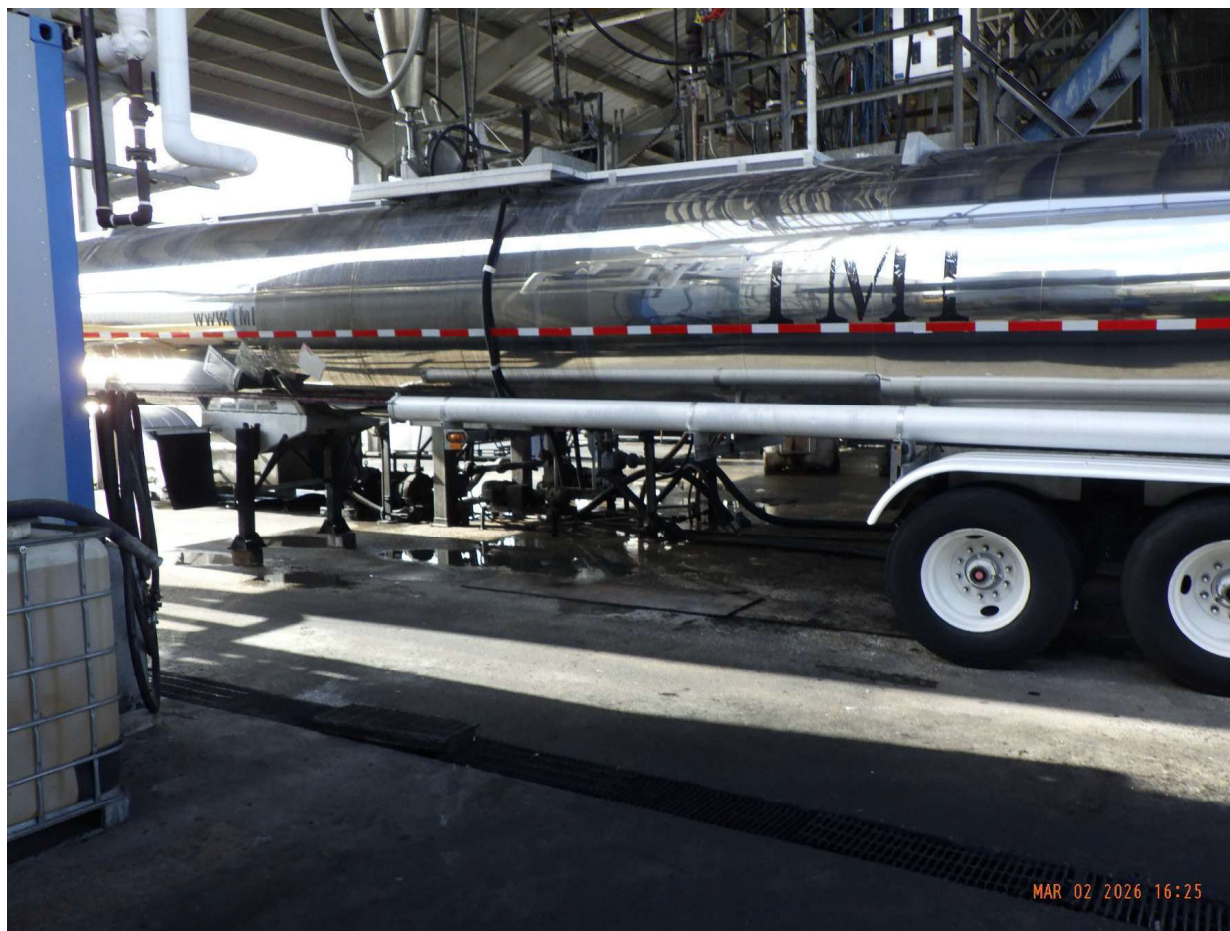
Photo No. 12

| Description: | Container being washed. | | |

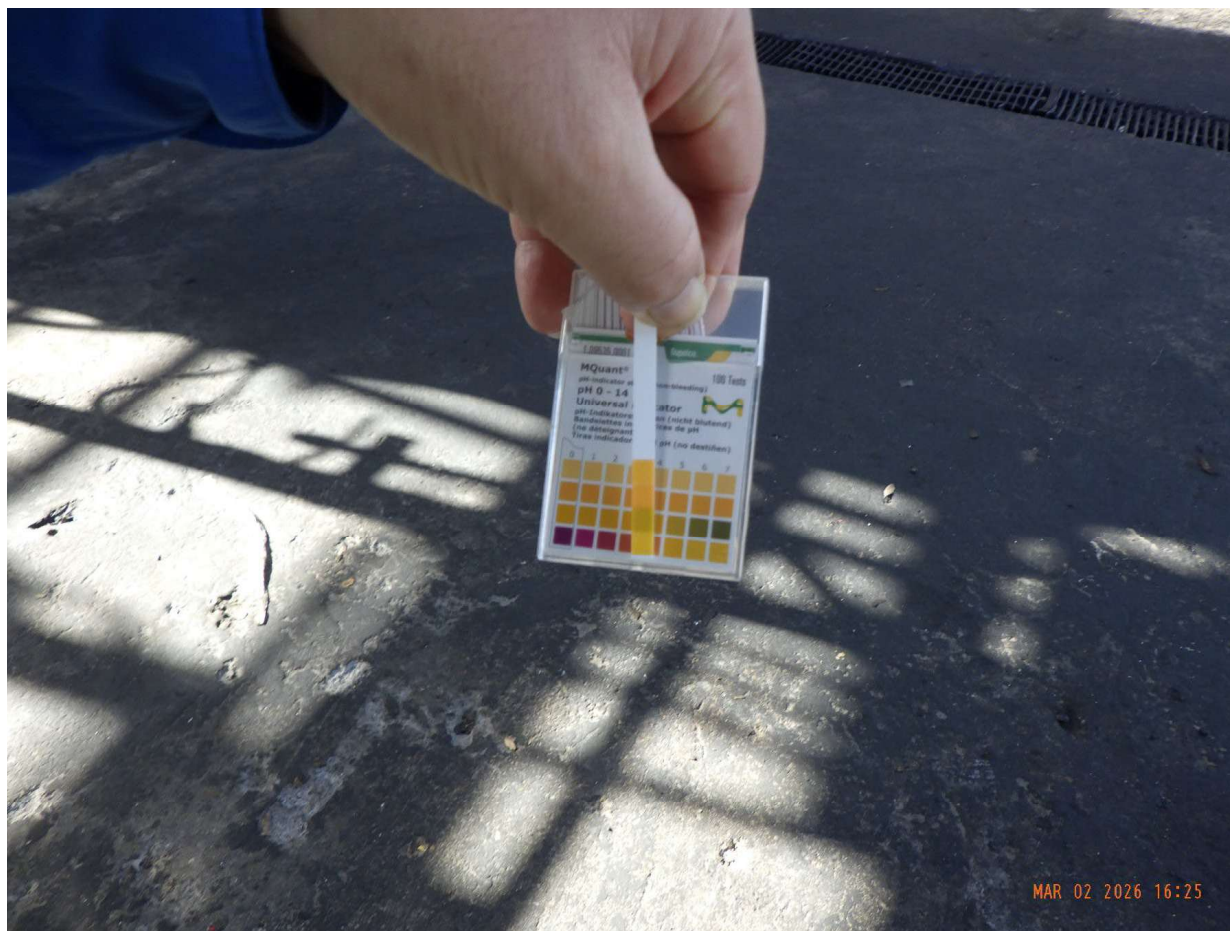
Photo No. 13

| Description: | pH paper after testing the water on the floor in wash bay 6. It was neutral. | | |

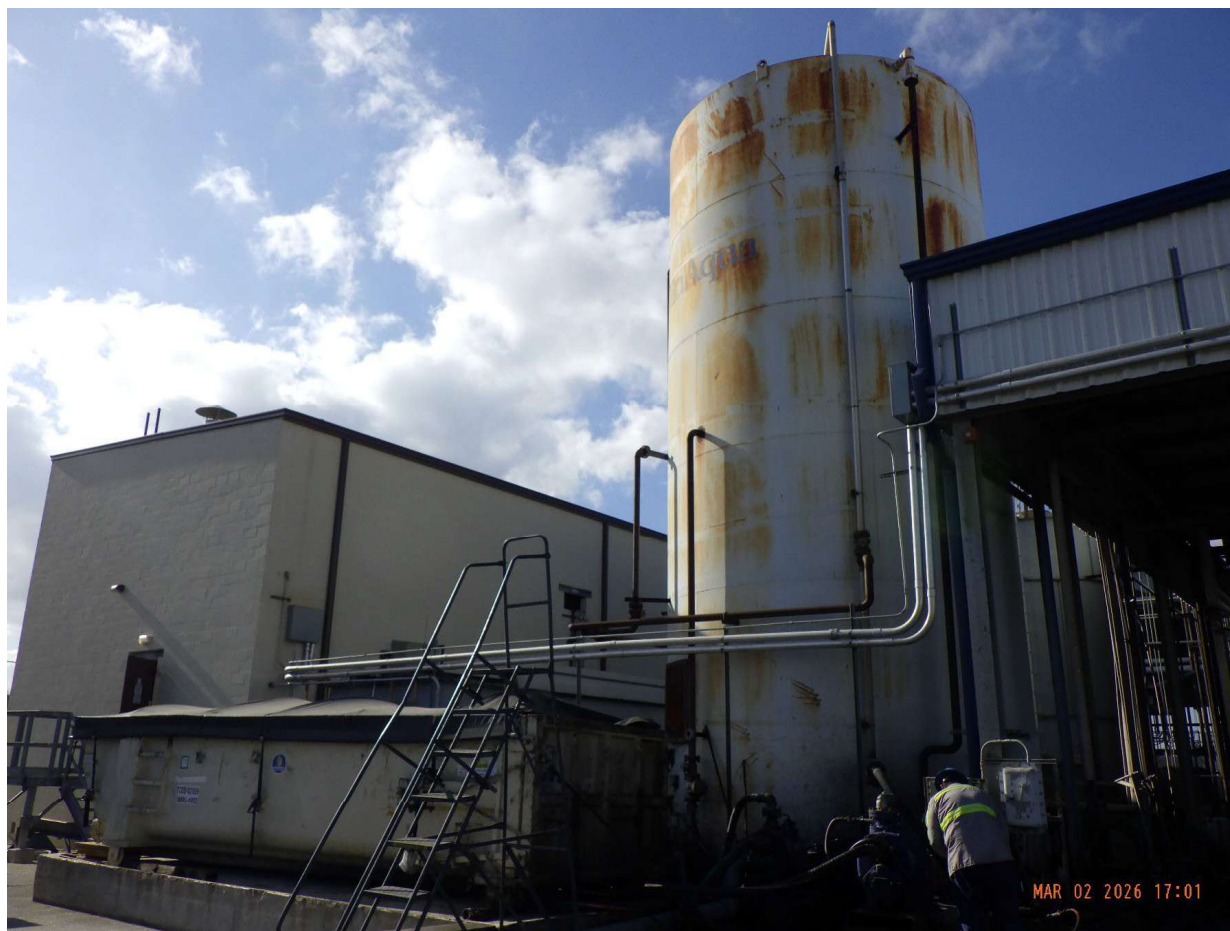
Photo No. 16

| Description: | Overview of wastewater tank, dewatering container, and oil water separator. | | |
