## Clean Water Act Section 404: Site Visit/Case Development

| Site Name | Eagle Bluff Resort, LLC | | | | |

| Inspection Purpose | Initial site visit | | |

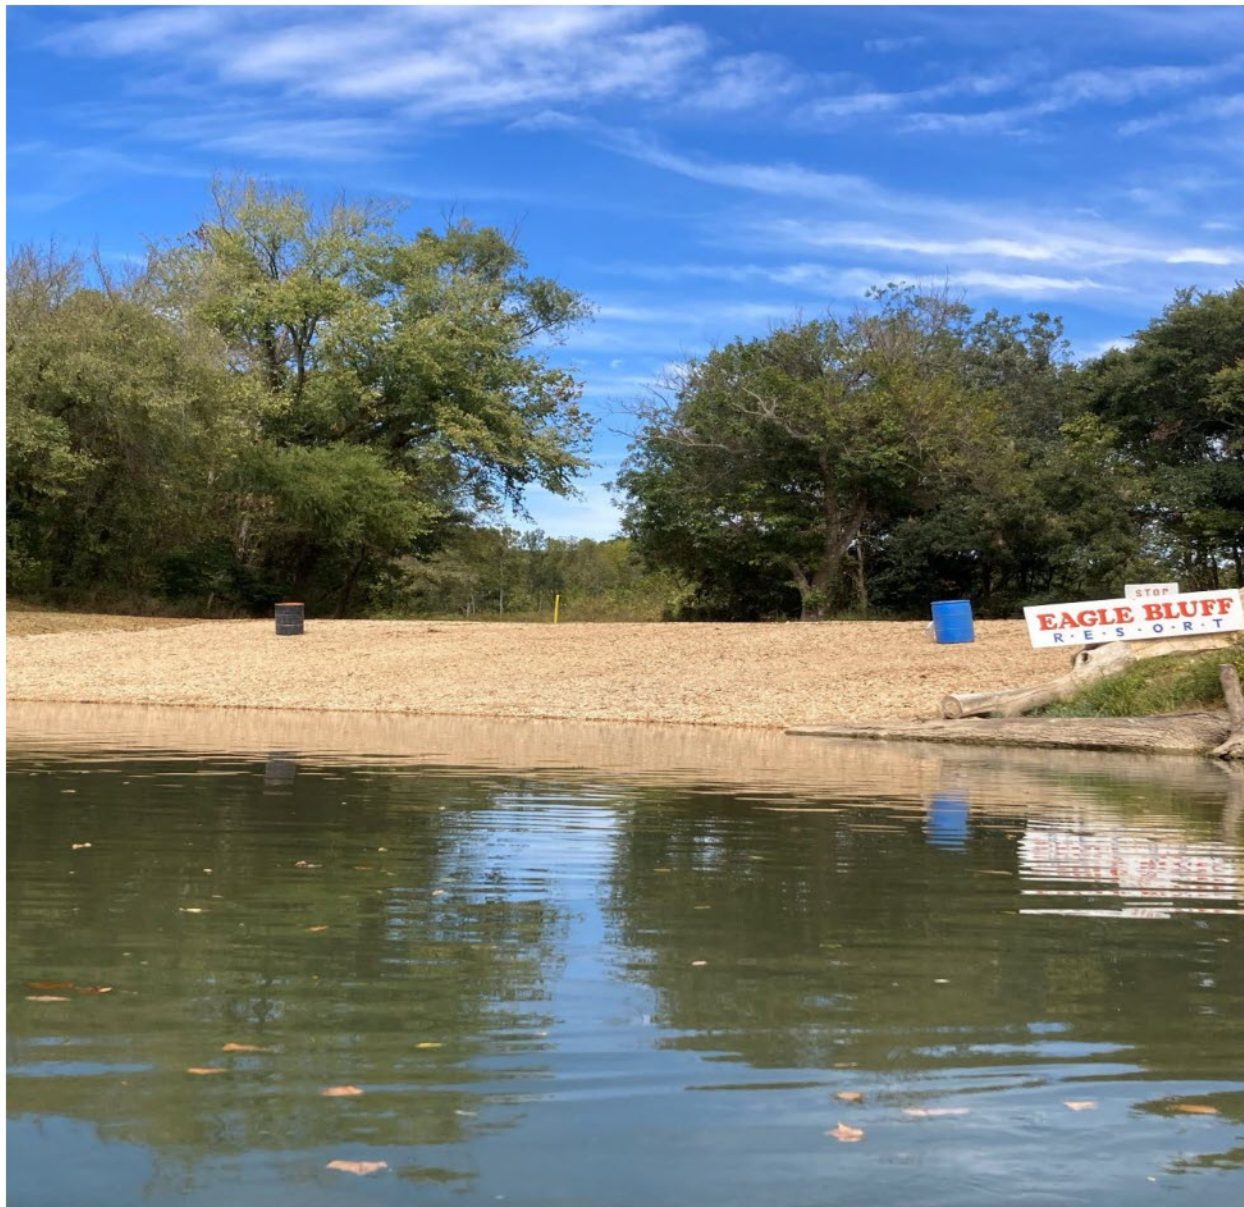
Photo No. 1

| Photo File Name | Date and Time of Photo | Photographer | Description |
|---|---|---|---|
| IMG_2283.heic | 09/27/2024, 1:09 PM | Tom Nystrom | Showing river right bank graded and fill material below the Ordinary High Water Mark. Picture taken facing river right bank, north. |

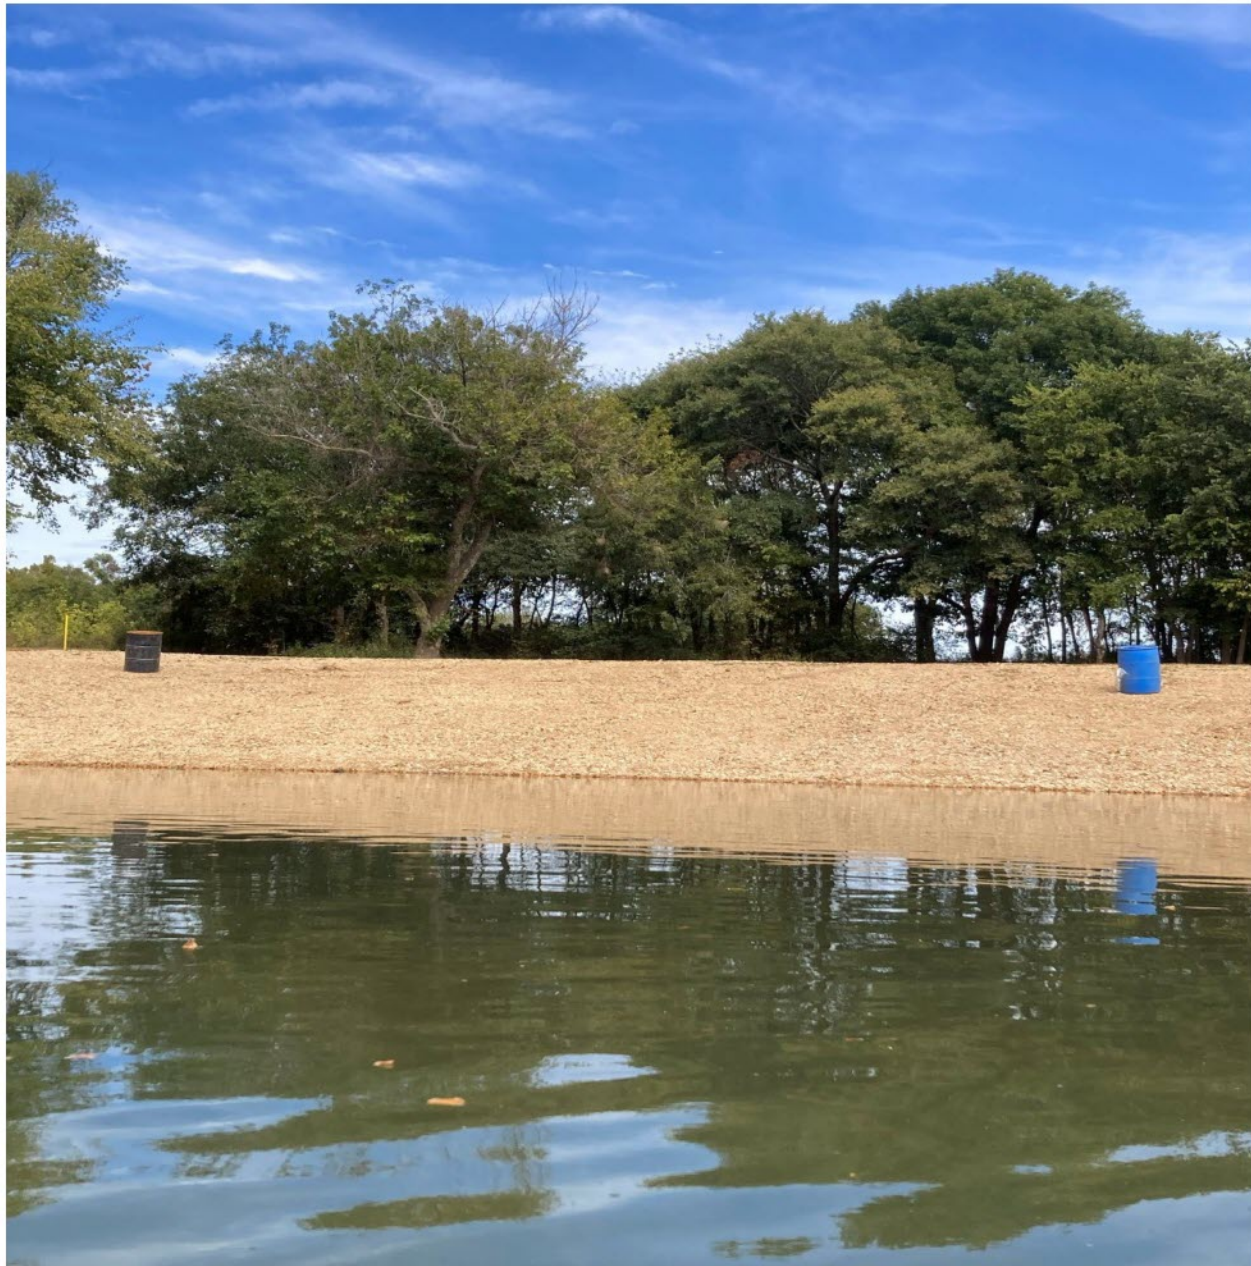
Photo No. 2

| Photo File Name | Date and Time of Photo | Photographer | Description |
|---|---|---|---|
| IMG_2284.heic | 09/27/2024, 1:09 PM | Chelsey Sherwood | Showing river right bank graded and fill material below the Ordinary High Water Mark. Picture taken facing river right bank, north. |

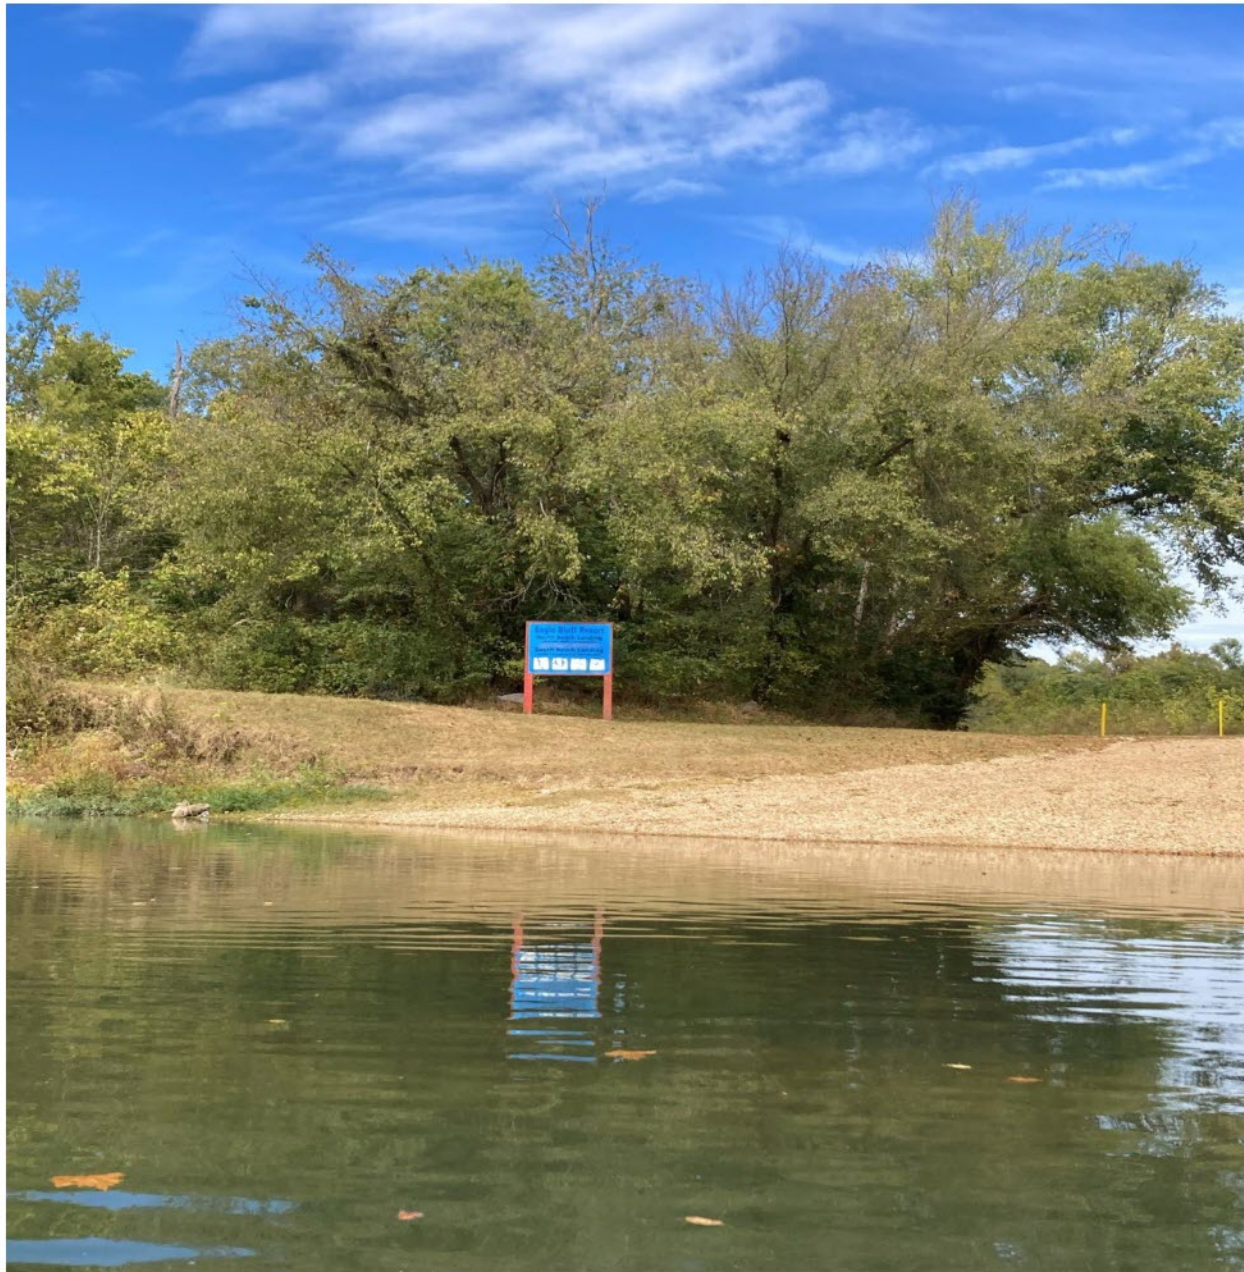
Photo No. 3

| Photo File Name | Date and Time of Photo | Photographer | Description |
|---|---|---|---|
| IMG_2285.heic | 09/27/2024, 1:09 PM | Tom Nystrom | Showing river right bank graded and fill material below the Ordinary High Water Mark. Picture taken facing river right bank, north. |
