PHOTO LOG

| Facility Name: | Amite BioEnergy (Drax) |
| EPA Media: | Stormwater - Industrial |

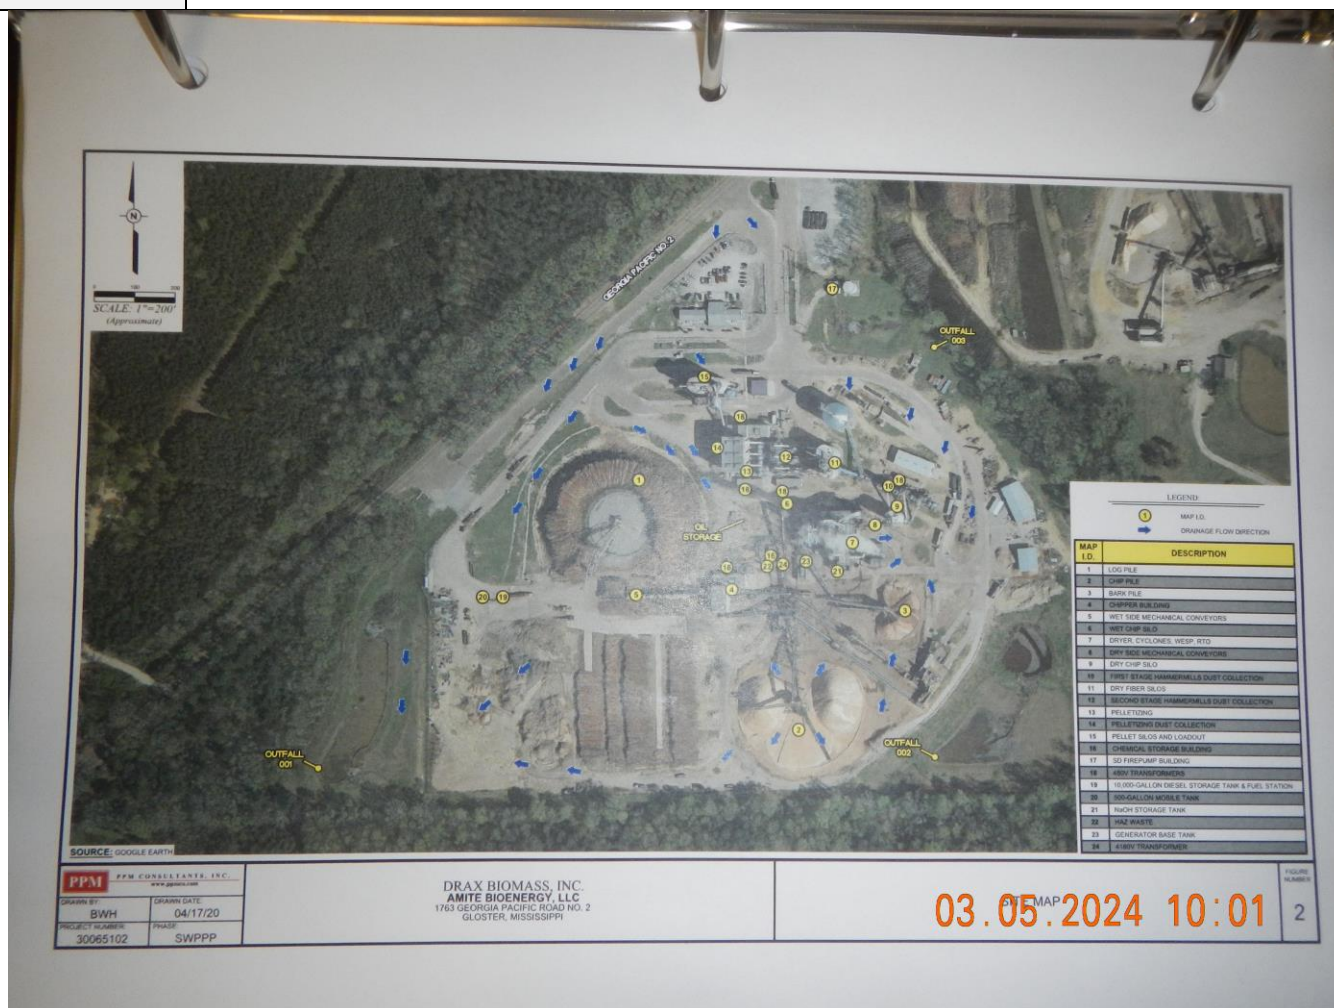
| Photo ID: | DSCN2892.JPG |

| Description: | Site map from the SWPPP, which shows three outfall locations. Outfall 004, which is no longer in use but is still covered under the 2021 permit, is not pictured. |

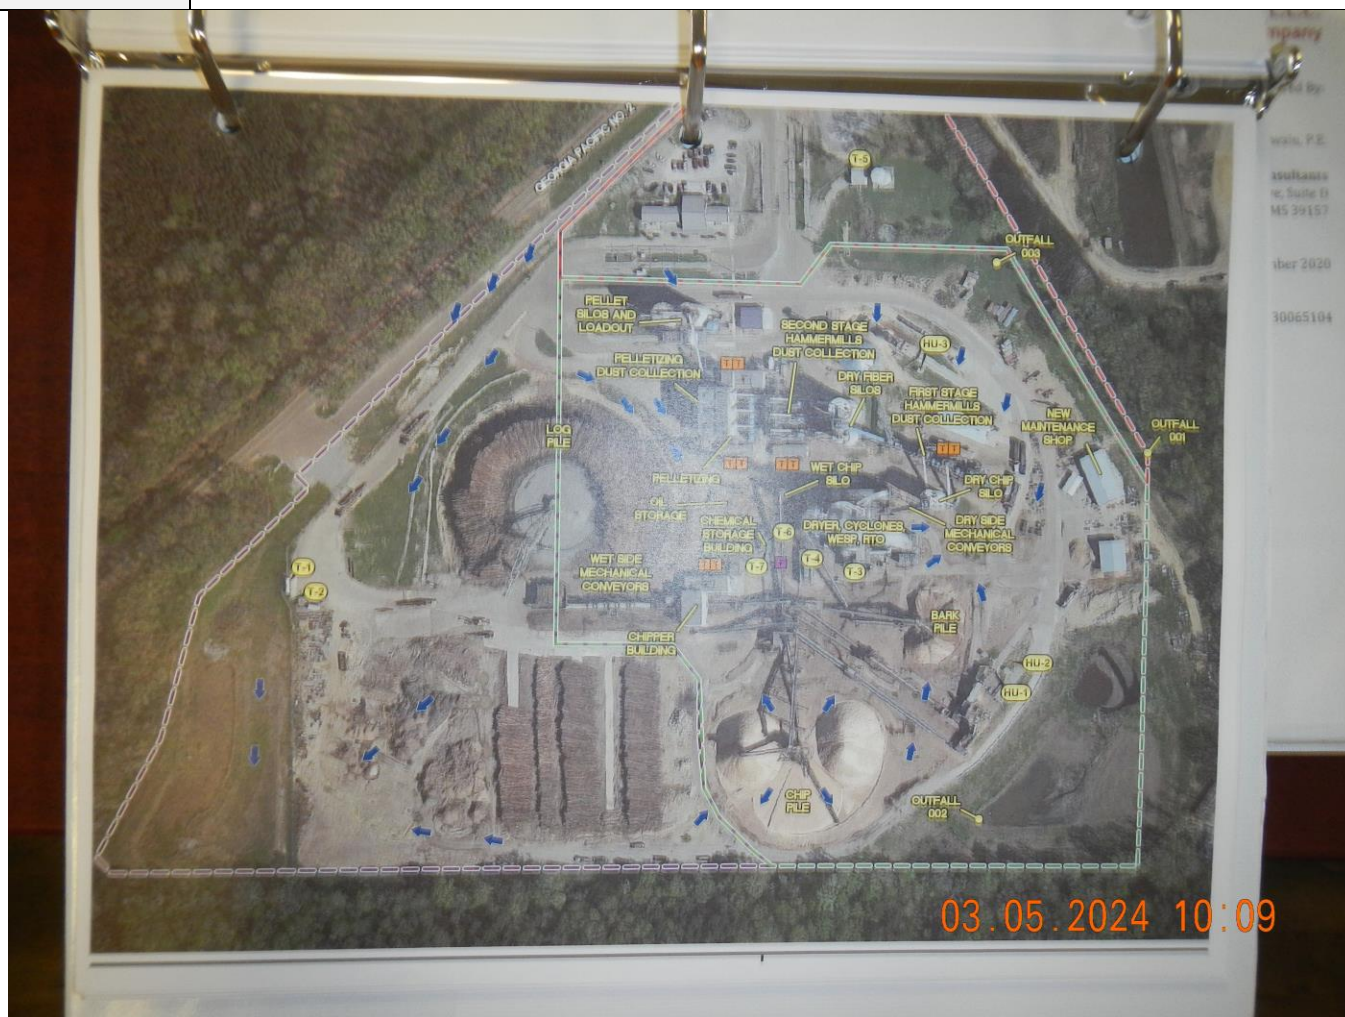
| <b>Photo ID:</b> | DSCN2893.JPG |

| <b>Description:</b> | Site map from the 2022 SPCC Plan. Outfall locations are mislabeled/inconsistent. Outfall locations in the site map shown in DSCN2892 are correct. |

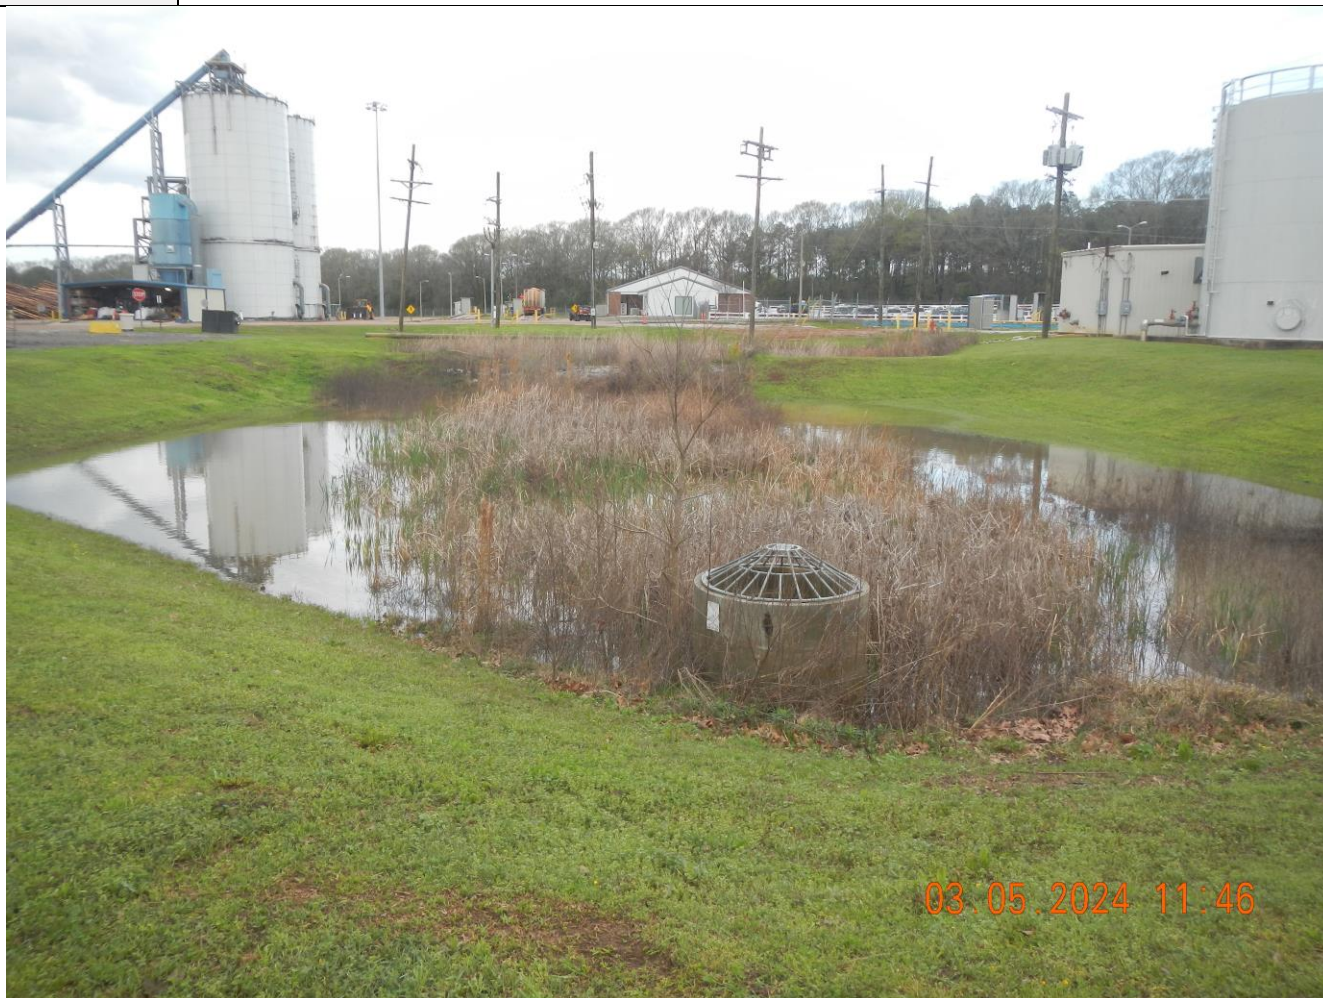
| <b>Photo ID:</b> | DSCN2894.JPG |

| <b>Description:</b> | Retention area upgradient of Outfall 003. Slopes appeared well-stabilized with vegetative cover. The outlet of this riser structure is shown in photo DSCN2895. |

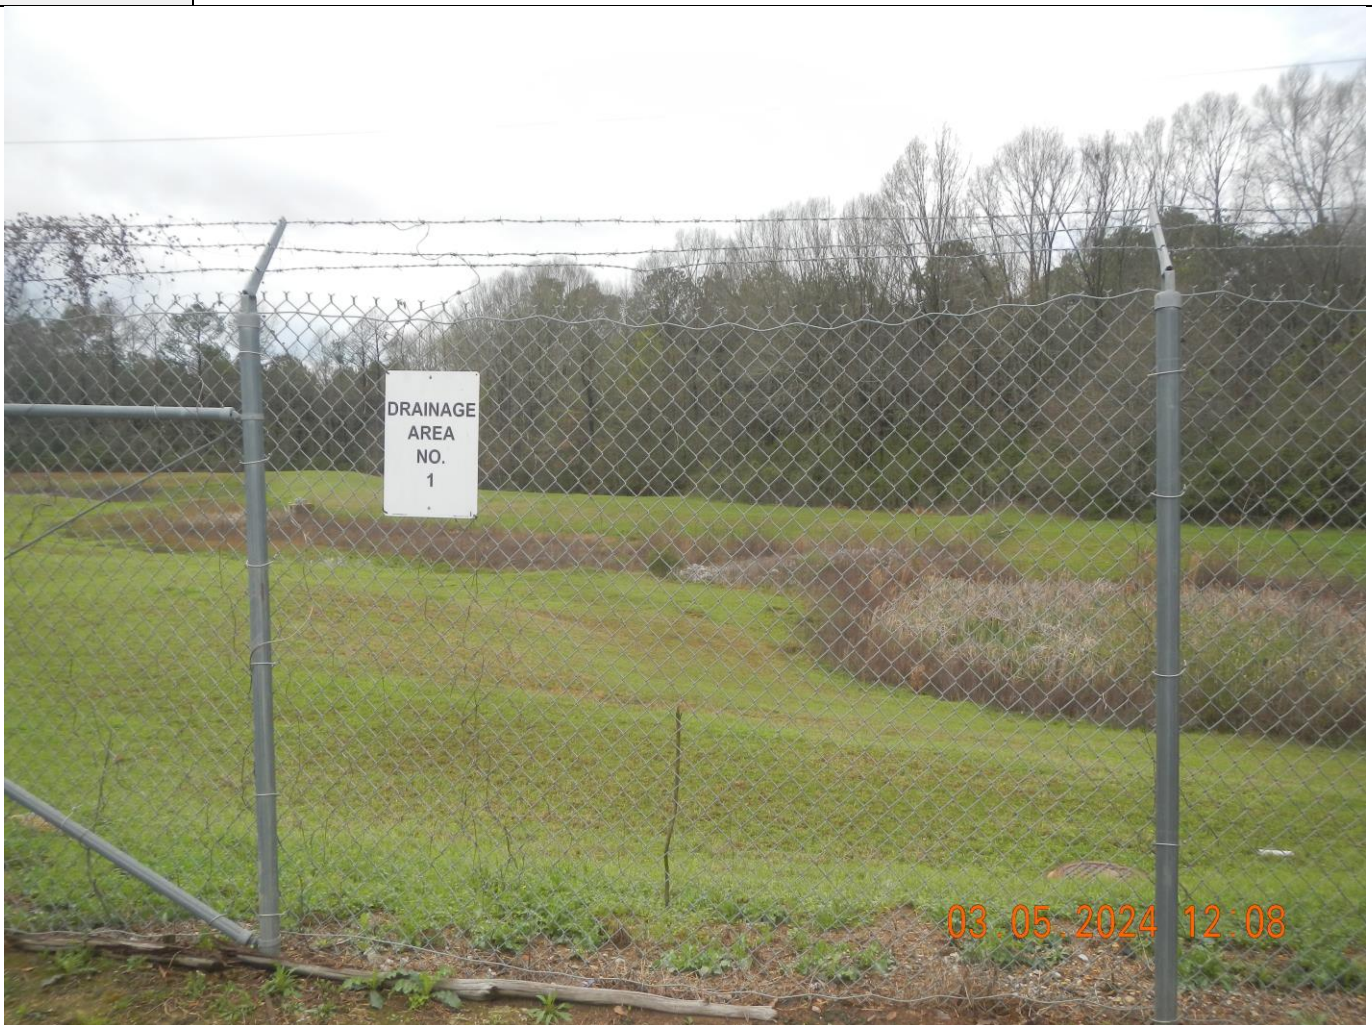
| <b>Photo ID:</b> | DSCN2908.JPG |

| <b>Description:</b> | Labels in the field correspond with the outfall numbers assigned in the SWPPP. |

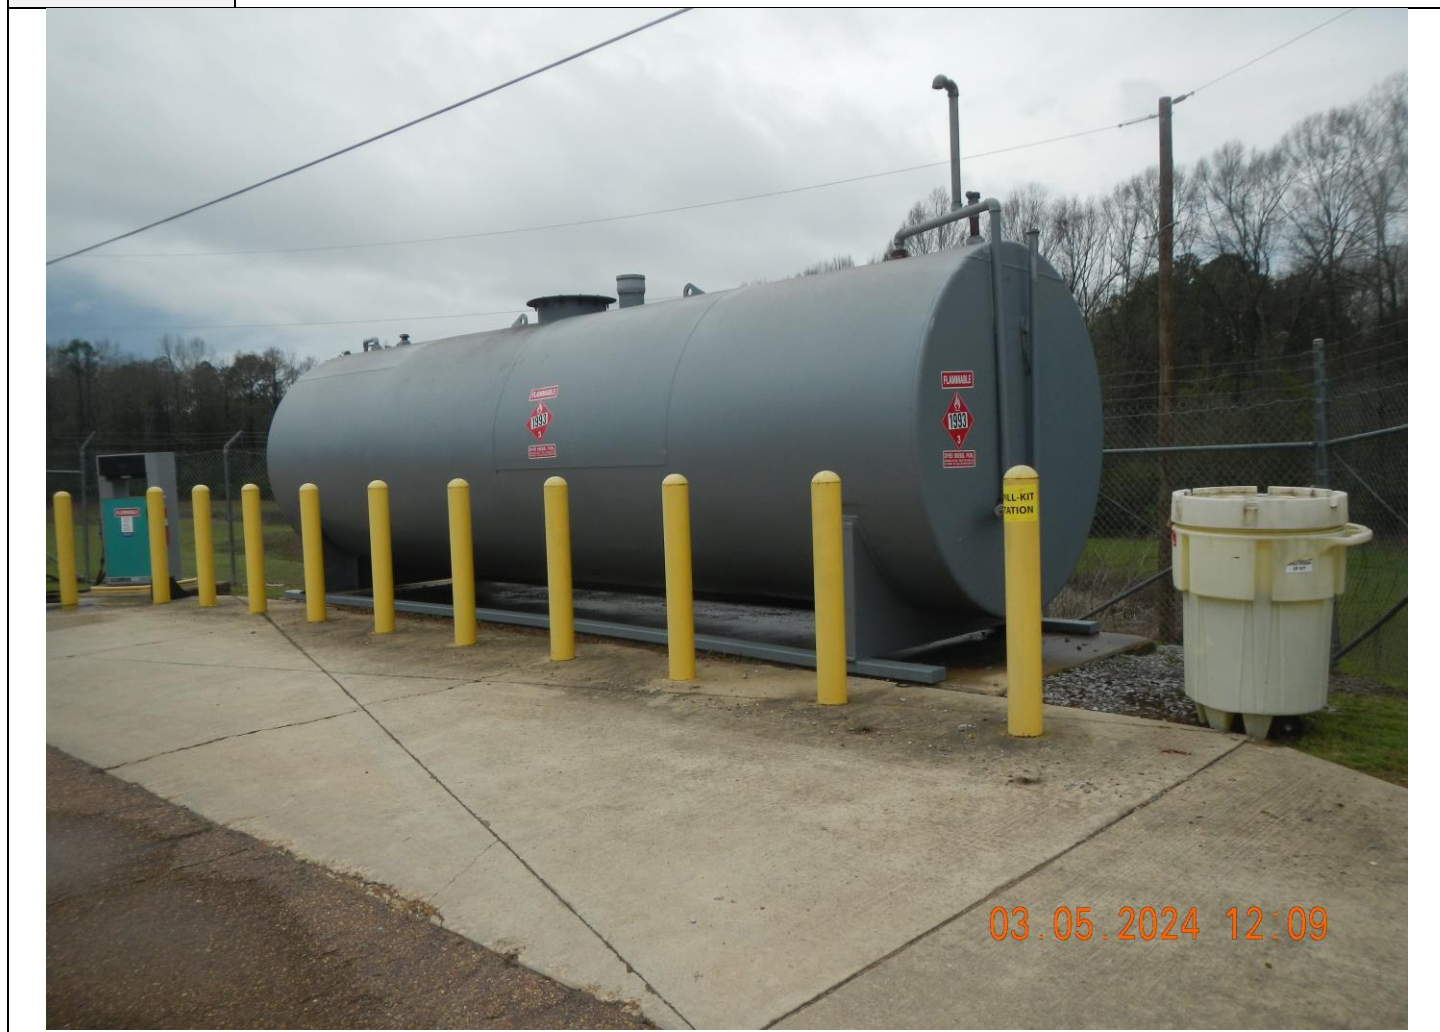
| <b>Photo ID:</b> | DSCN2909.JPG |

| <b>Description:</b> | View of the facility's diesel fuel tank and a nearby spill kit. |

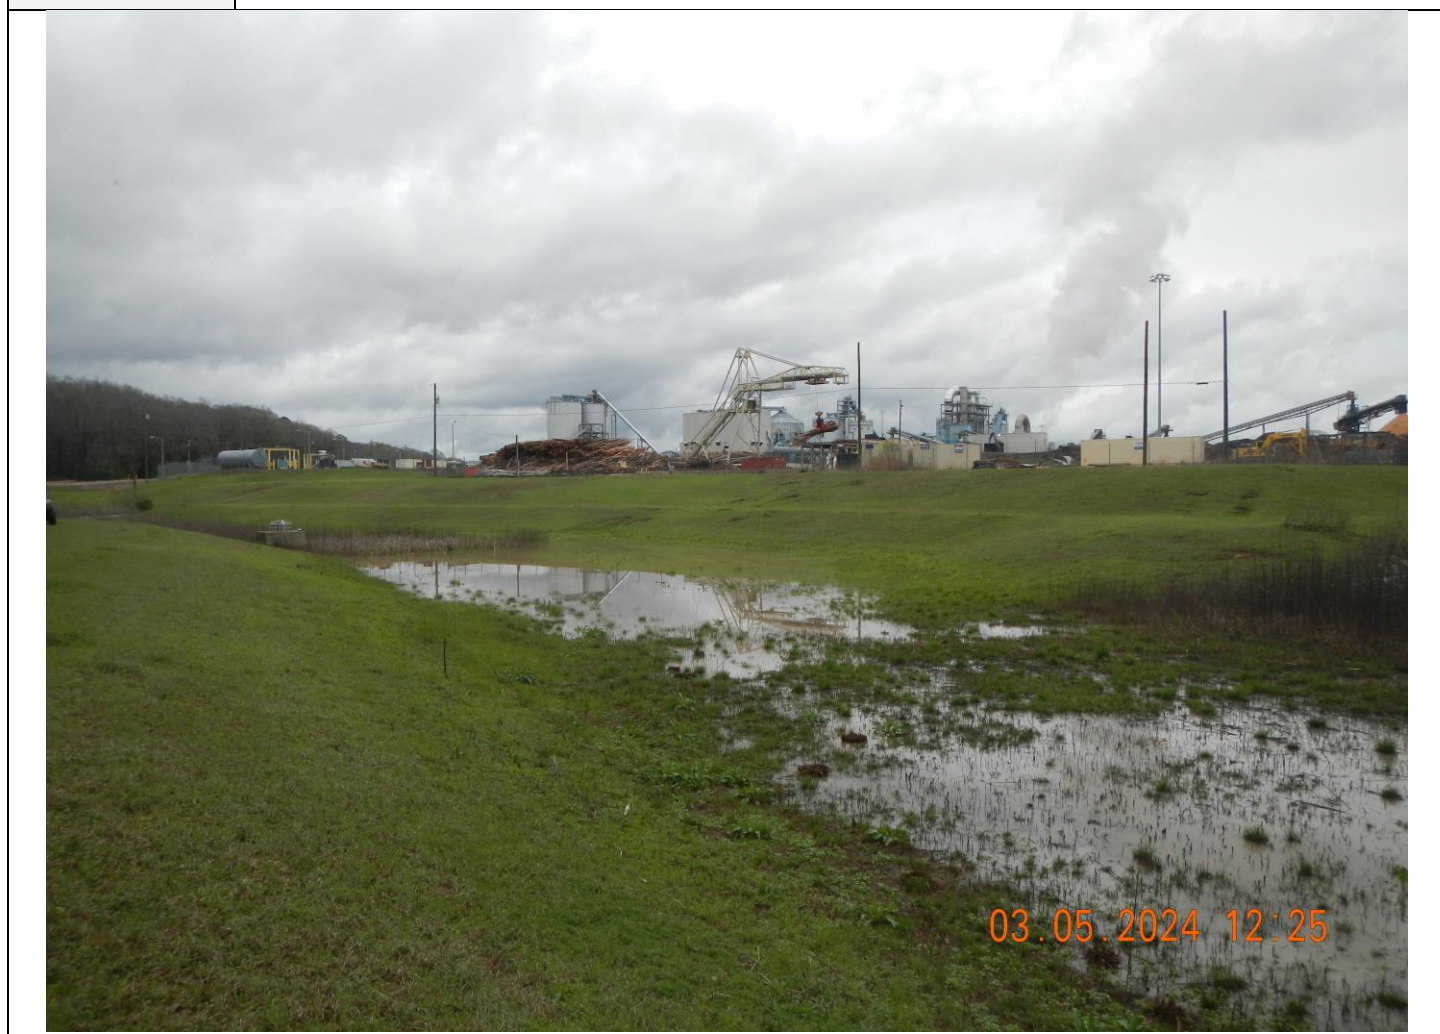
| <b>Photo ID:</b> | DSCN2918.JPG |

| <b>Description:</b> | Additional view of pond 001. The riser structure is visible in the center-left of the photo. |
