## **RCRA Inspection Report**

H & S Swansons Tool Company  
9000 68<sup>th</sup> Street  
Pinellas Park, Florida 33782-4499  
Pinellas County

EPA ID No.: FLD982160723

March 31, 2021, at 9:22 a.m.

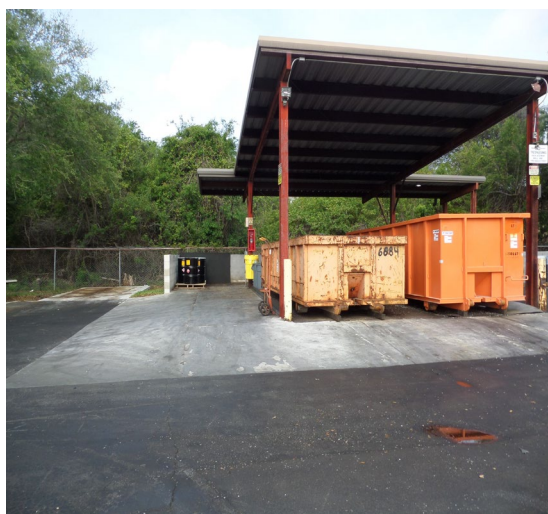
The 90-Day or Less Accumulation Area (90-Day) is in the rear of the building and is constructed with a concrete pad, that slopes toward the surrounding pavement. The concrete pad is surrounded on one side and in the rear of the pad by a four to five-foot high cinder block containment wall. A metal roof is constructed over a portion of the pad. The inspector observed Danger and Caution signs posted in this area. The property behind the facility's fence line is owned by H & S (Photograph 1).

Six 55-gallon containers were observed accumulating hazardous waste in the 90-Day. The containers were on wooden pallets, closed, in good condition, labeled with the words hazardous waste, labeled with corrosive and flammable hazard indicators and marked with the date March 30, 2021. Seven containers accumulating used oil were also observed in this area. The containers were closed and labeled with the words used oil. The used oil tank observed during FDEP's October 2, 2018 inspection was no longer on-site. The concrete pad appeared in good condition.

H & S Swansons Tool Company (H & S). 90-Day or Less Accumulation Area. Observed six 55-gallon containers accumulating hazardous waste. Photograph 1 taken at 9:47 a.m.

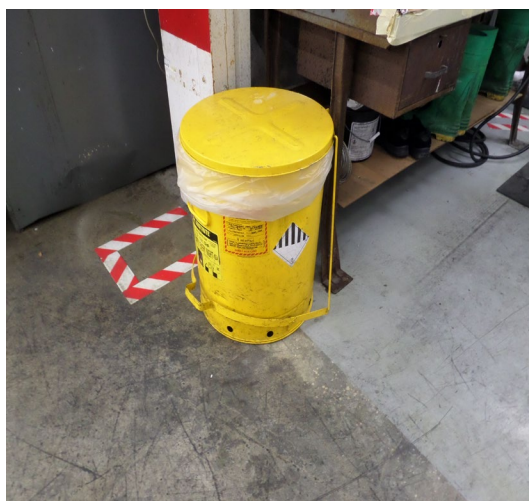
A 30-gallon step can (step can) was observed outside the entrance to the Chem Film/Chromate Room. The step can was accumulating contaminated paper towels and gloves. The step can was closed, marked with the waste codes D007, F019 and labeled as hazardous waste. The step can

was labeled with a Class 9 DOT label, which is not an indication of the ignitable, corrosive, reactive, or toxic hazard accumulating in it (Photograph 2). The hazardous waste in the step can is transferred to a 55-gallon container in the Paint Department. On March 31, 2021, Mr. Tagler emailed the EPA and FDEP a photograph documenting that corrosive and flammable solid labels were placed on the step can.

H & S. Chem Film/Chromate Room. Observed the 30-gallon step can had a Class 9 DOT label. Photograph 2 taken at 10:20 a.m.

**Pursuant to F.A.C. Chapter 62-730.160(1), [40 C.F.R. § 262.15(a)(5)(ii)], which is a condition of the SAA Permit Exemption, a generator is required to mark or label its containers with an indication of the hazards of the contents.**

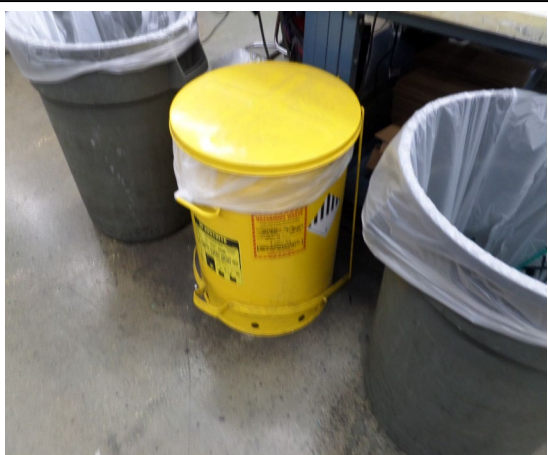
The casting is painted in this area with or without processing in the Chem Film/Chromate Room. Two 30-gallon step cans (step cans) were observed in this area. The step cans were accumulating contaminated paper towels and gloves. The step cans were closed, marked with the waste codes D007, F019 and labeled as hazardous waste. The step cans were labeled with a Class 9 DOT label, which is not an indication of the ignitable, corrosive, reactive, or toxic hazard accumulating in it (Photographs 3 and 4). The hazardous waste in the step cans is accumulated for approximately one month prior to transferring the content to a 55-gallon container in the Paint Department. The 55-gallon container was initially designated as a satellite accumulation area (SAA) but changed to a 90-Day or Less Accumulation Area during the inspection. On March 31, 2021, Mr. Tagler emailed the EPA and FDEP a photograph documenting that corrosive and flammable solid labels were placed on the 30-gallon step cans.

H & S. Paint Department. Observed the 30-gallon step can had a Class 9 DOT label. Photograph 3 taken at 10:20 a.m.

**Pursuant to F.A.C. Chapter 62-730.160(1), [40 C.F.R. § 262.15(a)(5)(ii)], which is a condition of the SAA Permit Exemption, a generator is required to mark or label its containers with an indication of the hazards of the contents.**

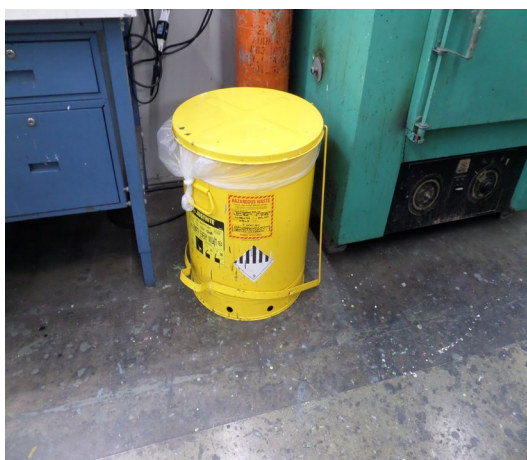
H & S. Paint Department. Observed the 30-gallon step can had a Class 9 DOT label. Photograph 4 taken at 10:22 a.m.

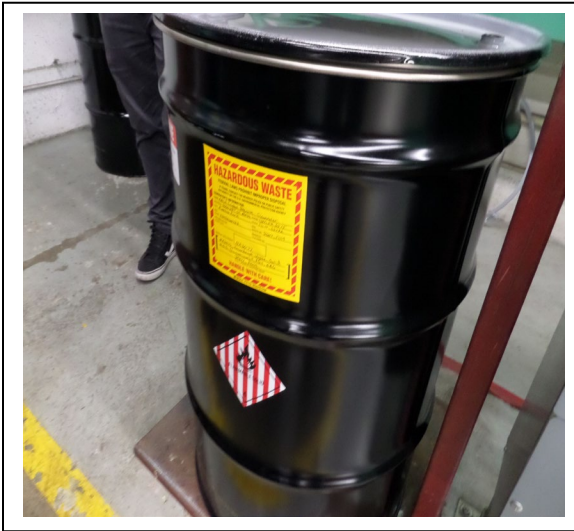
The hazardous waste is transferred from the three 30-gallon step cans to the 55-gallon container for consolidation. The 55-gallon container in the Paint Department was observed connected to a compactor. The 55-gallon container was closed, marked with the waste codes D007, F019, labeled as hazardous waste and labeled with an indication of the hazards of the contents. The

container was not marked with a date (Photograph 5). Inspectors explained the point of generation for the hazardous waste transferred to this 55-gallon container was at the three 30-gallon step cans and an accumulation start date is required to be clearly marked on the 55-gallon container. The container must be inspected weekly. H & S marked the container with a date at the time of this inspection and will begin conducting weekly inspections.

H & S. Paint Department. Observed the 55-gallon container accumulating hazardous waste as a SAA container and not marked with a date. Hazardous waste generated at other points of generation. Photograph 5 taken at 10:29 a.m.

**Pursuant to Florida Administrative Code Annotated (F.A.C.) Chapter 62-730.160(1), [40 C.F.R. § 262.15(a)], a generator may accumulate as much as 55 gallons of non-acute hazardous waste in containers at or near any point of generation where wastes initially accumulate, which is under the control of the operator of the process generating the waste, without a permit or without having interim status, as required by Chapter 403 of the Florida Statutes, Fla. Stat. § 403.702 et seq., [Section 3005 of RCRA, 42 U.S.C. § 6925], and without complying with F.A.C. Chapter 62-730.160(1), [40 C.F.R. § 262.16(b) or § 262.17(a)], except as required in F.A.C. Chapter 62-730.160(1), [40 C.F.R. § 262.15(a)(7) and (8)], provided that the generator complies with the satellite accumulation area conditions listed in F.A.C. Chapter 62-730.160(1), [40 C.F.R. § 262.15(a)].**

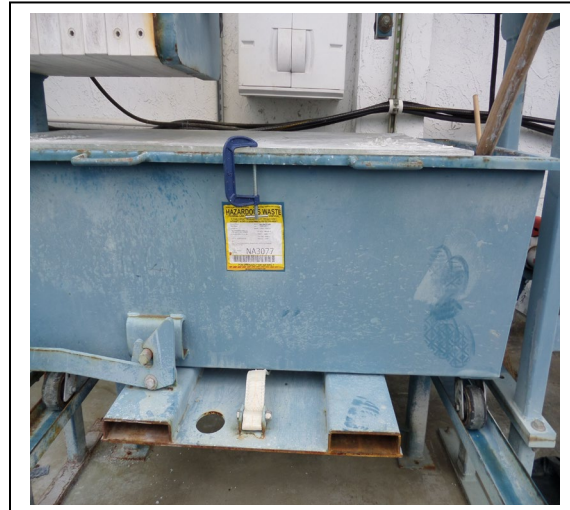
Hazardous waste solids generated from the treatment process are filtered in a plate and frame press. The dried hazardous waste solids are discharged from the plate and frame press to a 64-gallon metal hopper on wheels that can be removed from its stand using a forklift. Jordan Swift explained the hazardous waste is transferred from the hopper to a one-cubic yard container, sometimes several times per day during its daily operation. The hopper was observed labeled with the words hazardous waste, marked with the waste codes D007, F019, but it was open with a shovel inserted in the hopper and it was not labeled or marked with an indication of the hazard (Photograph 6). Hazardous waste was not being added or removed from the hopper at the time of this CEI. H & S closed the hopper (Photograph 9). The one-cubic yard container was observed closed, labeled with the words hazardous waste, and marked with the waste codes D007, F019, but it was not marked with an accumulation start date and not labeled or marked with an indication of the hazard (Photograph 7). H & S marked the container with the date March 30, 2021 (Photograph 8). H & S marked the hazardous waste labels on the hopper and one-cubic yard container with the word "Toxic" as an indication of the hazard at the time of the inspection. On April 5, 2021, Mr. Tagler emailed the EPA and FDEP photographs documenting a toxic label was placed on the one-cubic yard container. The EPA and FDEP recommended to H & S to maintain a log of the waste entering and being removed from the hopper to ensure the 55-gallon capacity is not exceeded.

H & S. Wastewater Pretreatment System. Observed hopper was open and not marked or labeled with an indication of the hazard. Photograph 6 taken at 12:22 p.m.

**Pursuant to F.A.C. Chapter 62-730.160(1), [40 C.F.R. § 262.15(a)(4)], which is a condition of the SAA Permit Exemption, a generator is required to keep containers of hazardous waste closed at all times during accumulation, except when adding, removing, or**

consolidating waste; or when temporary venting of a container is necessary for the proper operation of equipment, or to prevent dangerous situations, such as build-up of extreme pressure.

Pursuant to F.A.C. Chapter 62-730.160(1), [40 C.F.R. § 262.15(a)(5)(ii)], which is a condition of the SAA Permit Exemption, a generator is required to mark or label its containers with an indication of the hazards of the contents.

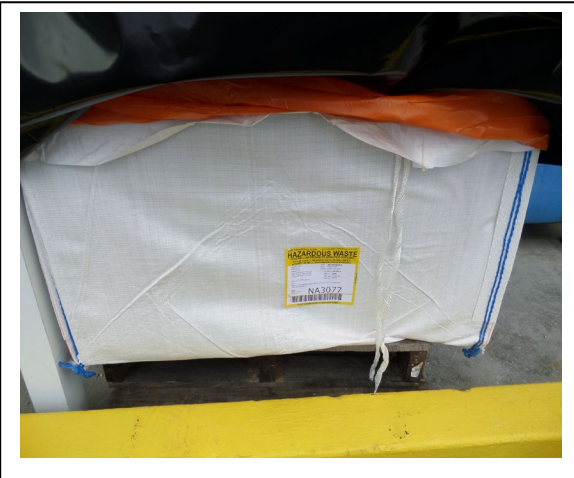
H & S. Wastewater Pretreatment System. Observed a one-cubic yard container accumulating F019 solids. Not marked with a date and no indication of the hazard. Photograph 7 taken at 12:23 p.m.

Pursuant to Florida Administrative Code (F.A.C.) Chapter 62-730.160(1) [40 C.F.R. § 262.17], a LQG may accumulate hazardous waste on-site for 90 days or less without a permit or without having interim status, as required by Chapter 403 of the Florida Statutes, Fla. Stat. § 403.702 et seq., [Section 3005 of RCRA, 42 U.S.C. § 6925], provided that the generator complies with the conditions listed in F.A.C. Chapter 62-730.160(1) [40 C.F.R. § 262.17] (hereinafter referred to as the “LQG Permit Exemption”).

Pursuant to F.A.C. Chapter 62-730.160(1), [40 C.F.R. § 262.17(a)(5)(i)(A)], which is a condition of the LQG Permit Exemption, a generator must mark or label the date upon which each period of accumulation begins clearly visible for inspection on each container.

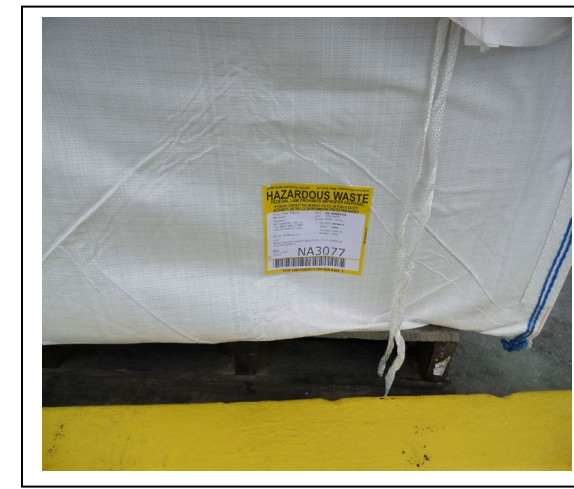
H & S. Wastewater Pretreatment System. Observed a one-cubic yard container accumulating F019 solids. H & S marked the container with the date 3/30/21 and marked it with an indication of the hazard. Photograph 8 taken at 12:23 p.m.
