Re: NPDES Permit No. MS0045187, Reconnaissance Inspection Report

The U.S. Environmental Protection Agency, Region 4, and the Mississippi Department of Environmental Quality (MDEQ) inspected the Farrell Publicly Owned Treatment Works (the facility) located off Farrell Road in Farrell, Mississippi on February 1, 2022, for compliance with its National Pollutant Discharge Elimination System (NPDES) permit and the Clean Water Act (CWA).

## Reconnaissance Inspection Report

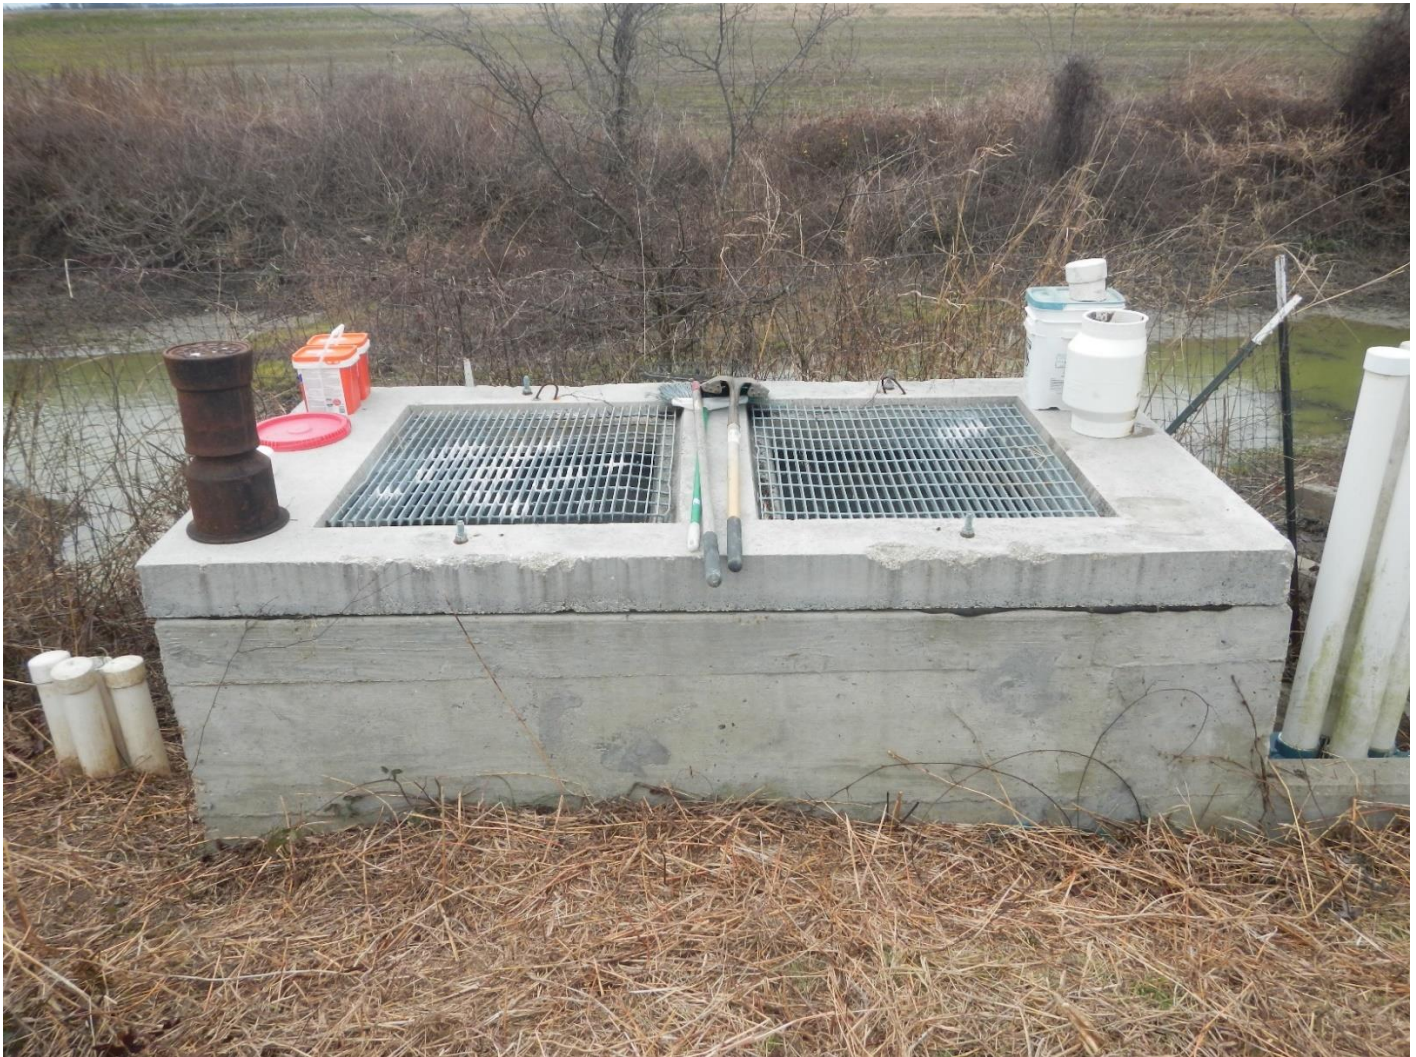
The Farrell POTW consists of a two-cell lagoon system in series with a depth of 6 to 8 feet. The POTW treats the septic overflow of approximately 200 citizens via one pump station. It was not known when exactly the facility began operation. The POTW is designated as a Minor Municipal NPDES facility with a design flow of 0.3MGD. The lagoon system is located on fenced 1-2 acres. The lagoon system utilizes a chlorination and dechlorination station with chlorine and sodium sulfate tabs (Figure 1). The discharge point has a V-notch weir to stairway aeration to a drainage ditch that eventually leads to the Yazoo River (Figure 2).

*Figure 1: Chlorination Station*

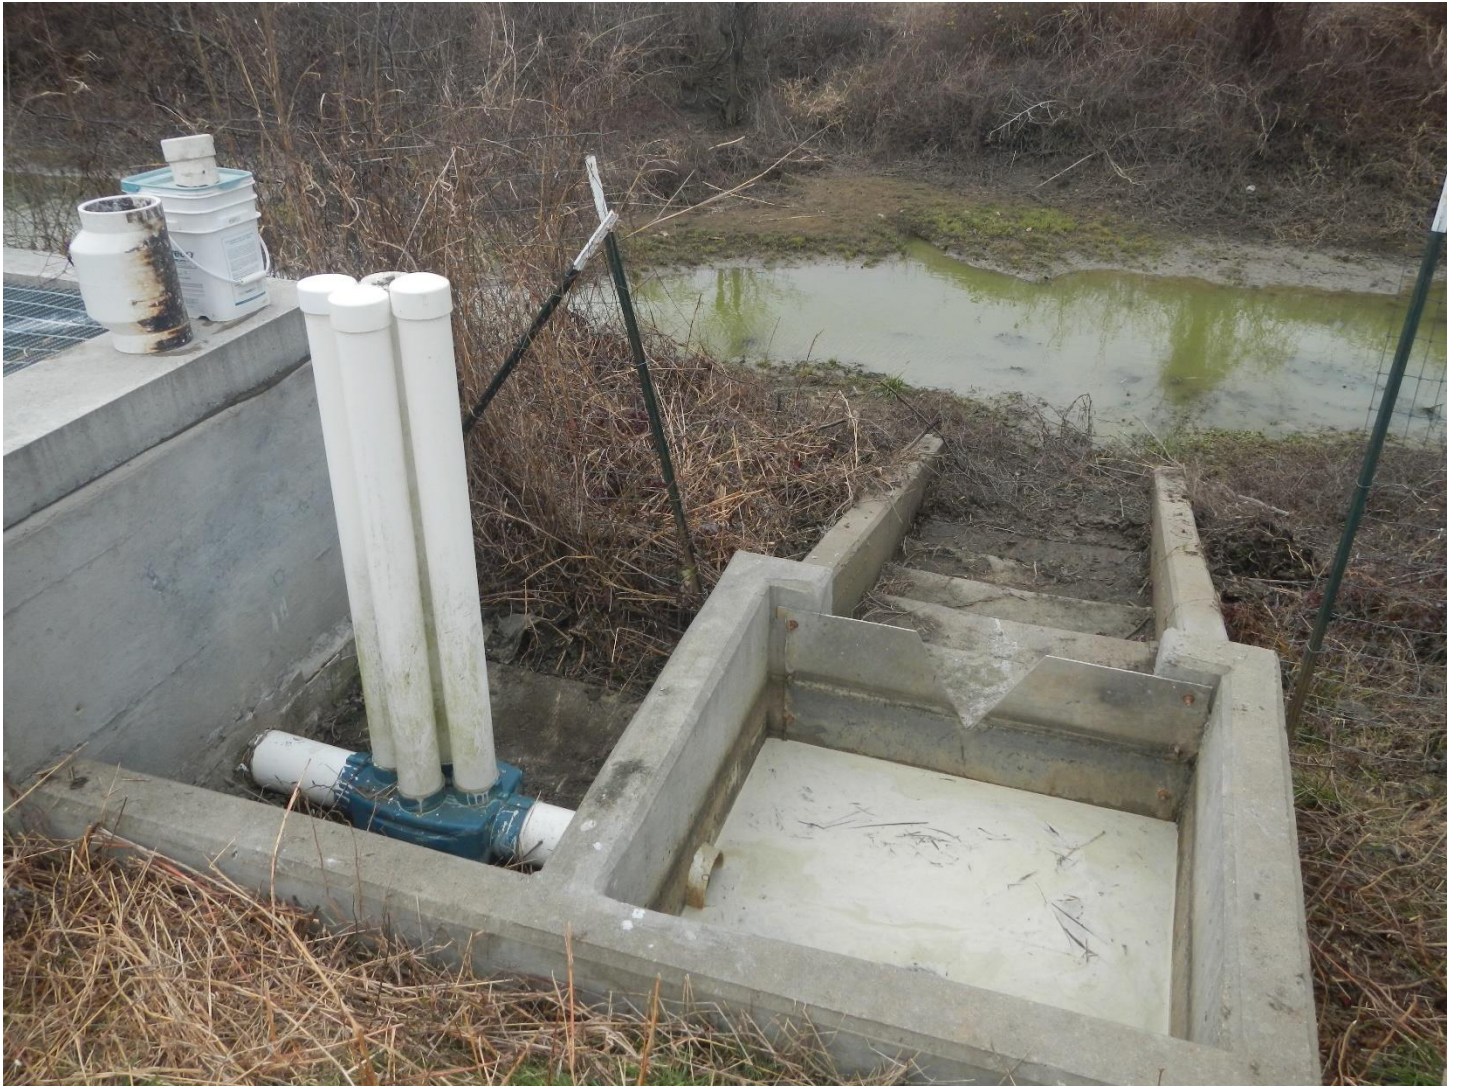
*Figure 2: Discharge point to ditch with foamy liquid before V-notch weir.*

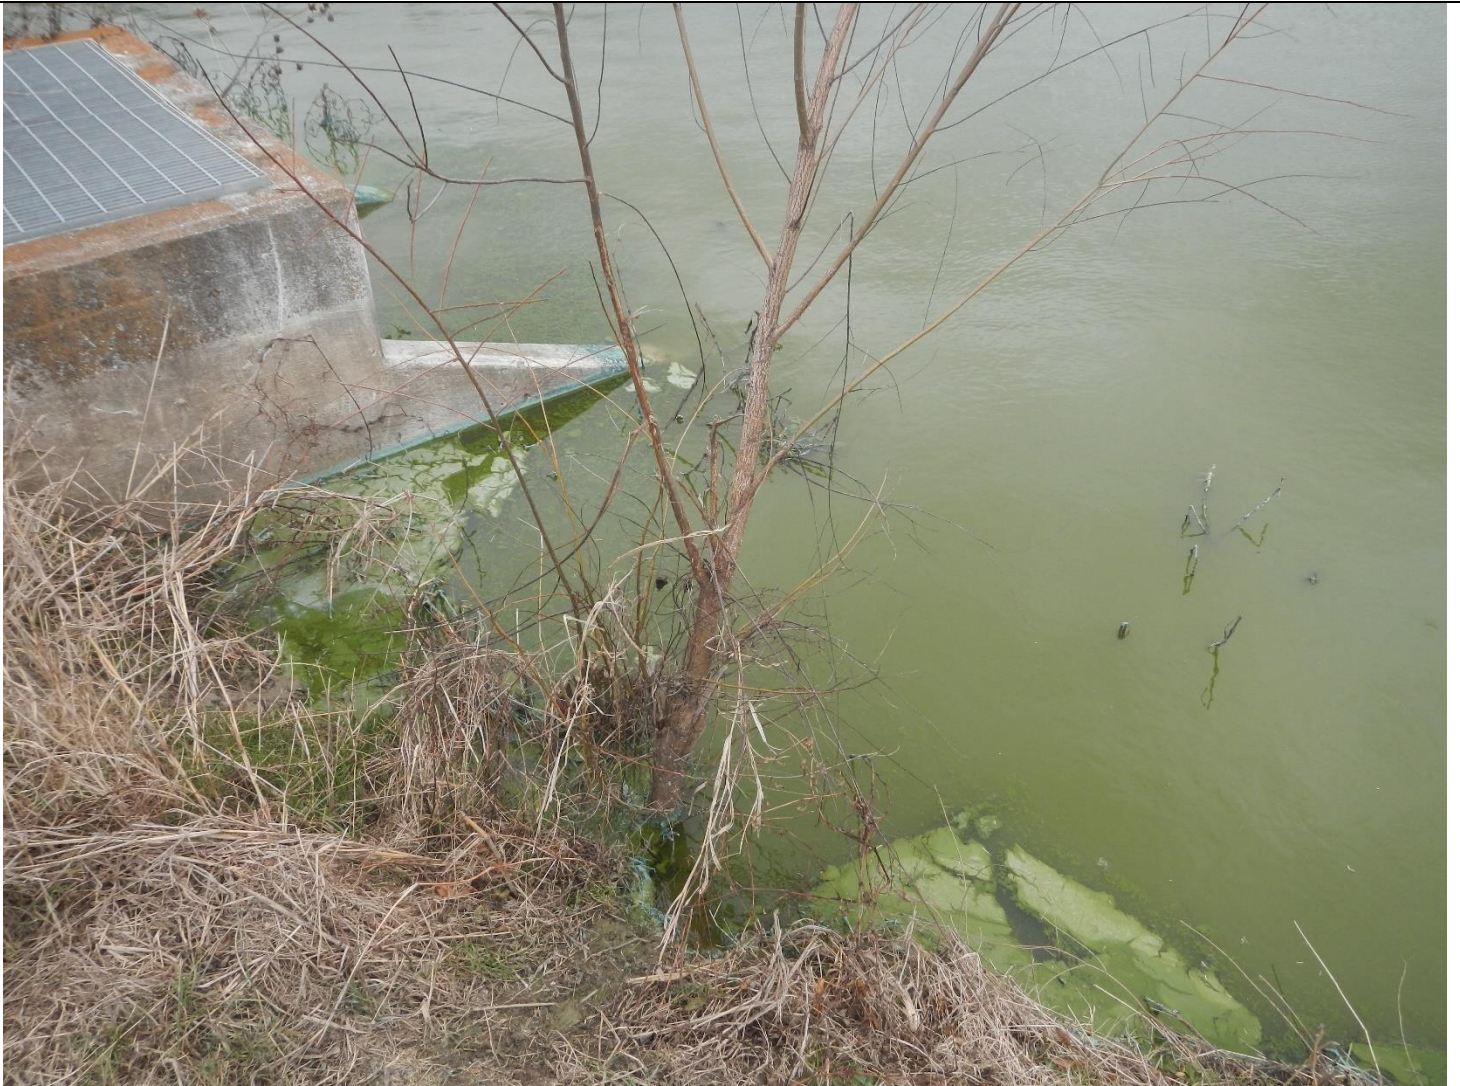
There was some vegetation growth noted with tree trunks of 1 to 3 inches around the lagoon banks that needed to be addressed (Figures 3 & 4). No floating solids were observed during the inspection. There was no discharge at the time of inspection. Mr. Robinson informed the inspectors that no discharge had been recorded in the previous year. There was a turtle carcass that had become wedged in the lagoon's line to the chlorination station. The last quarters of discharge were recorded in October 2020 to March 2021, according to Mr. Robinson. A foamy liquid was observed prior to the discharge point at the weir. When the area floods, the ditch backs up to the chlorination station.

*Figure 3: Vegetation growth that needs maintenance at cell 2.*

The EPA recommends that the facility submit any outstanding DMRs, if possible. The vegetation around the lagoon needs to be maintained. The pump station base should be maintained to prevent any damage to the structure. The chain of custody for sampling events should be properly documented. Operating logs should identify the operators performing routine inspections.

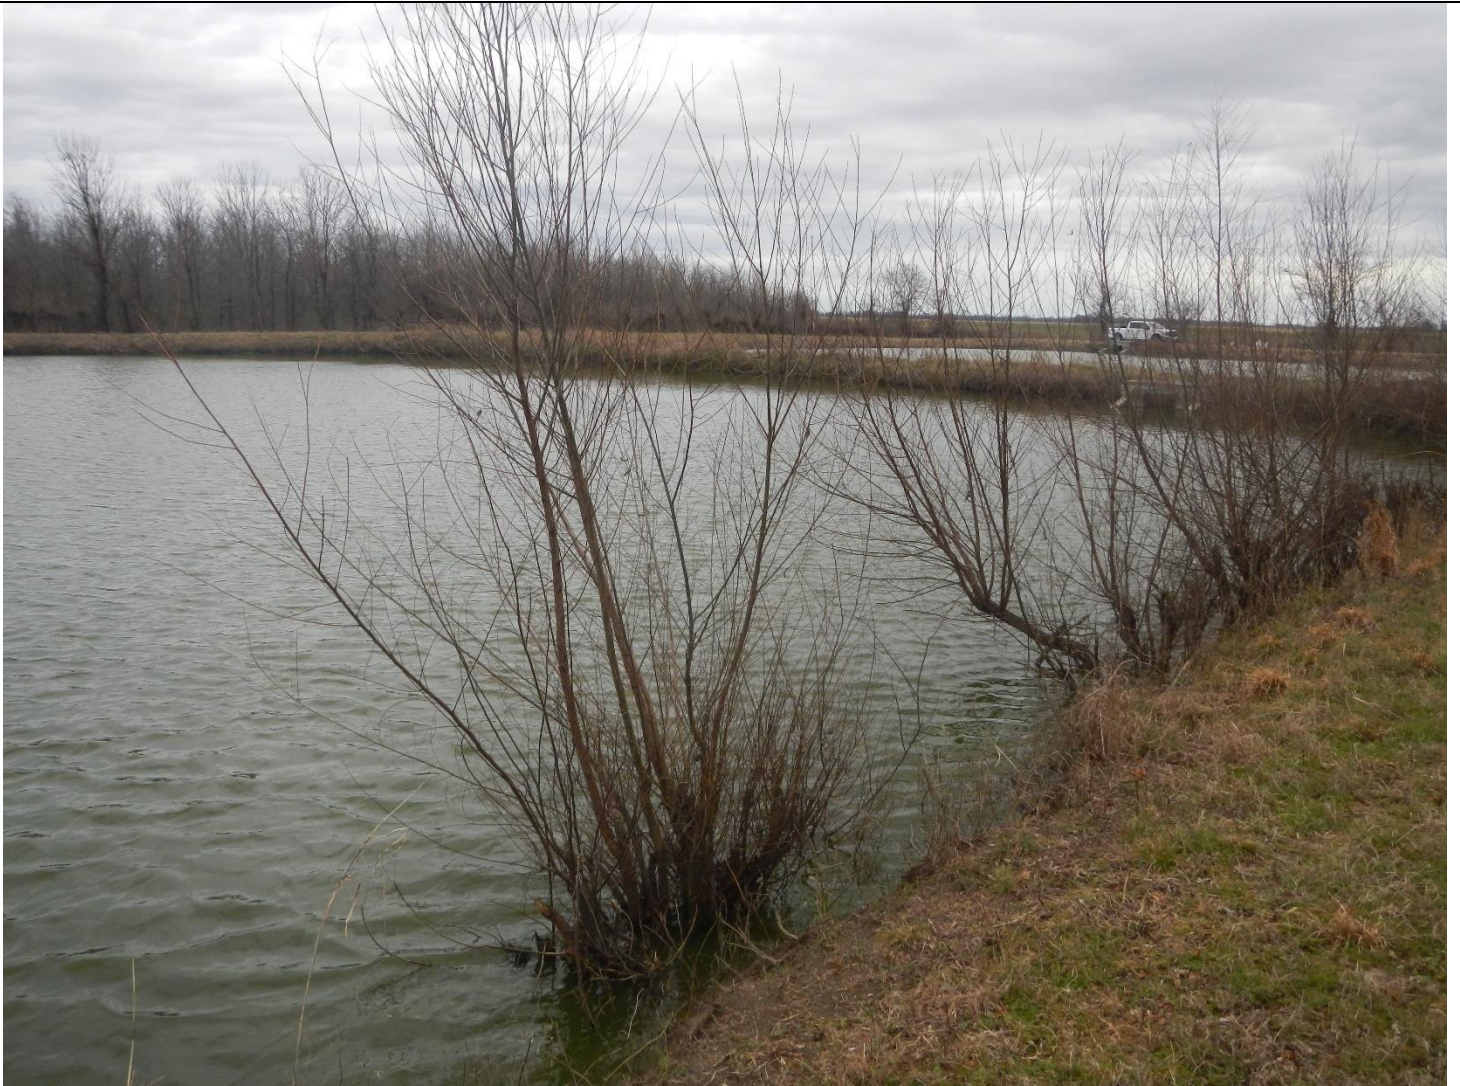
*Figure 4: Additional vegetative growth on cell 1.*

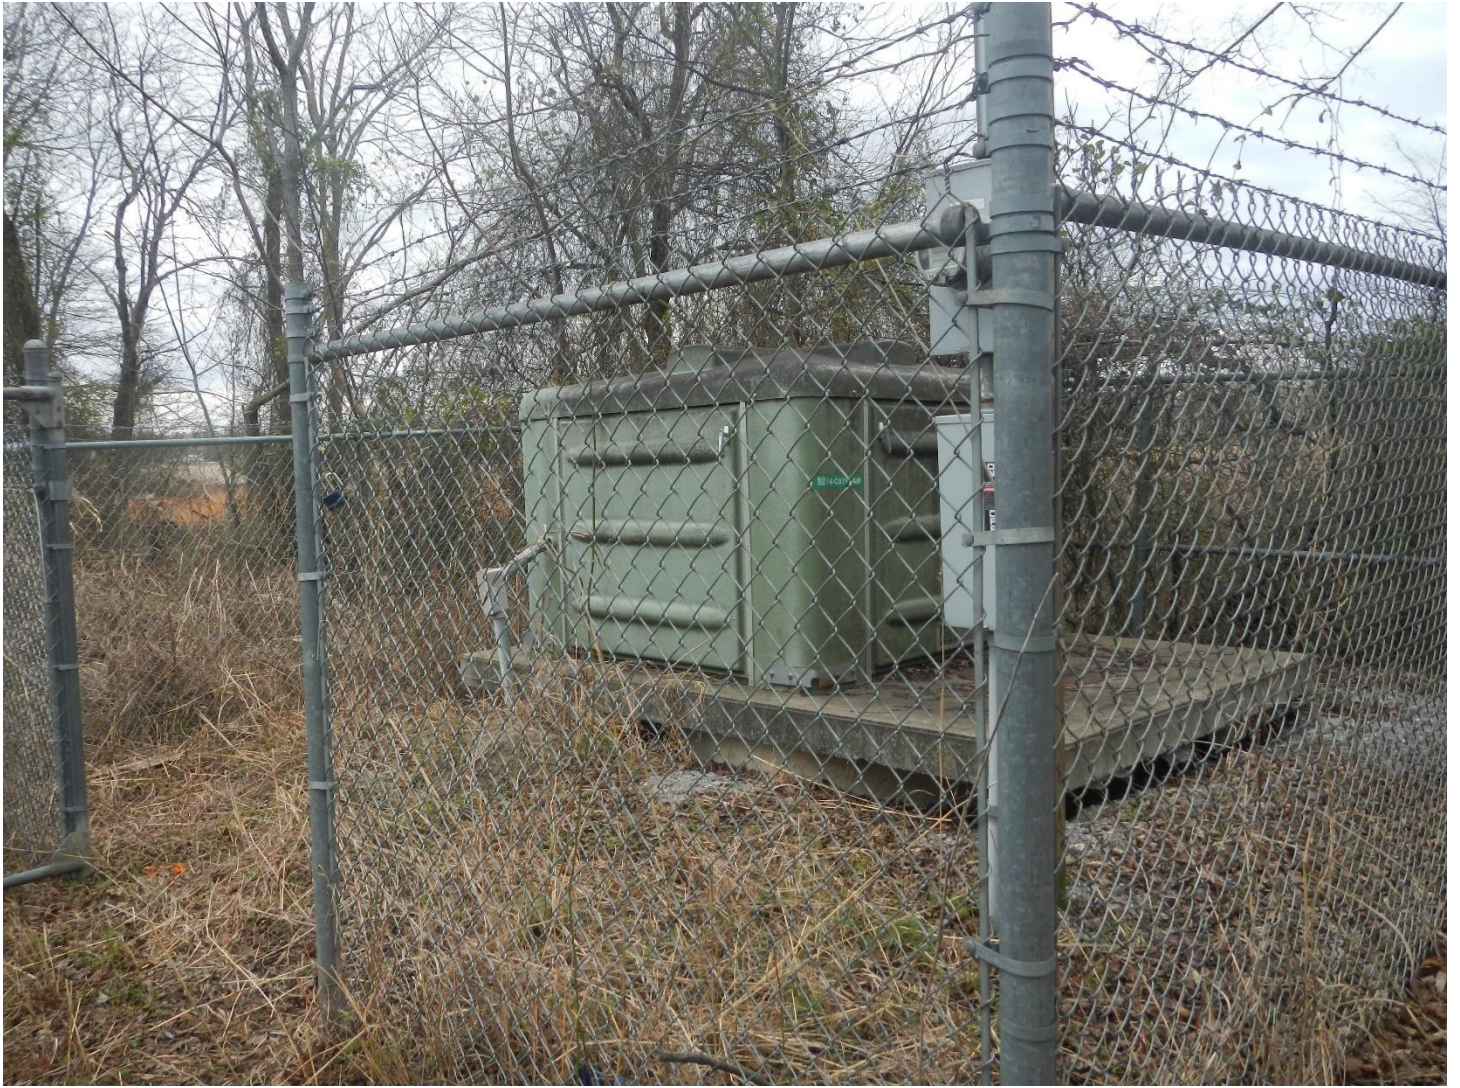
The pump station was inspected and there is still washout underneath the pad as noted in the 2019 MDEQ inspection (Figure 5). No evidence of any spills was noted, and the pump(s) were operable.

Figure 5: Washout at pump station pad.
