**Region 6 Compliance Assurance and Enforcement Division**  
**INSPECTION REPORT**

| Inspection Date(s): | | 08/08/2014 through 08/14/2014 | |
| Company Name: | | Western Refining Southwest, Inc. | |
| Facility Name: | | Gallup Refinery | |

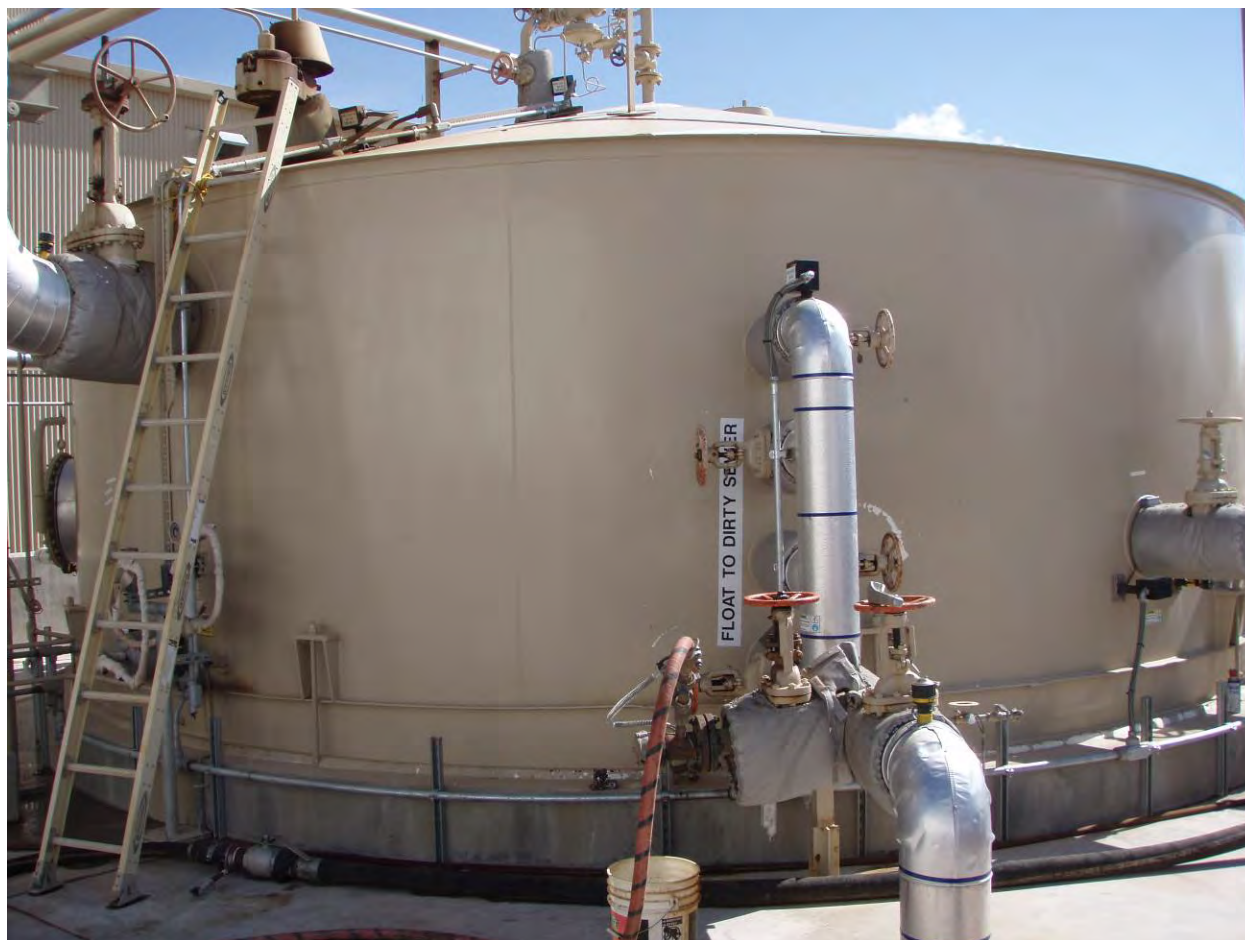
Photo File Name: P8120005  
Date of Photo: 12 August 2014  
Time of Photo: 1016  
Photographer: Wm. Mansfield  
Description: WWTP Float Tank.

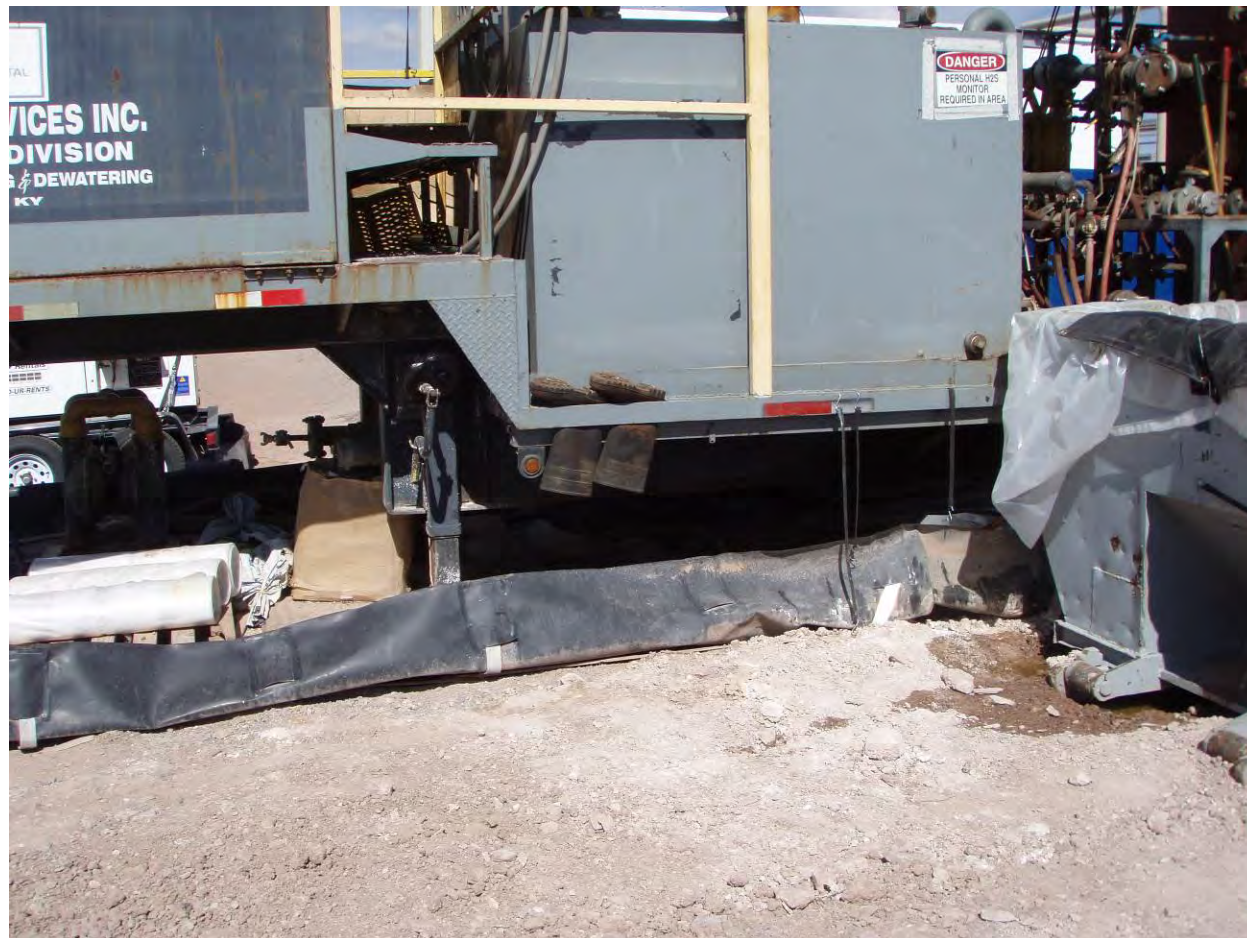
Photo File Name: P8120009

Description: WWTP Filter-Cake Press' roll-off box sitting outside of secondary containment. Noted some spillage on the ground, under and next to the roll-off box.

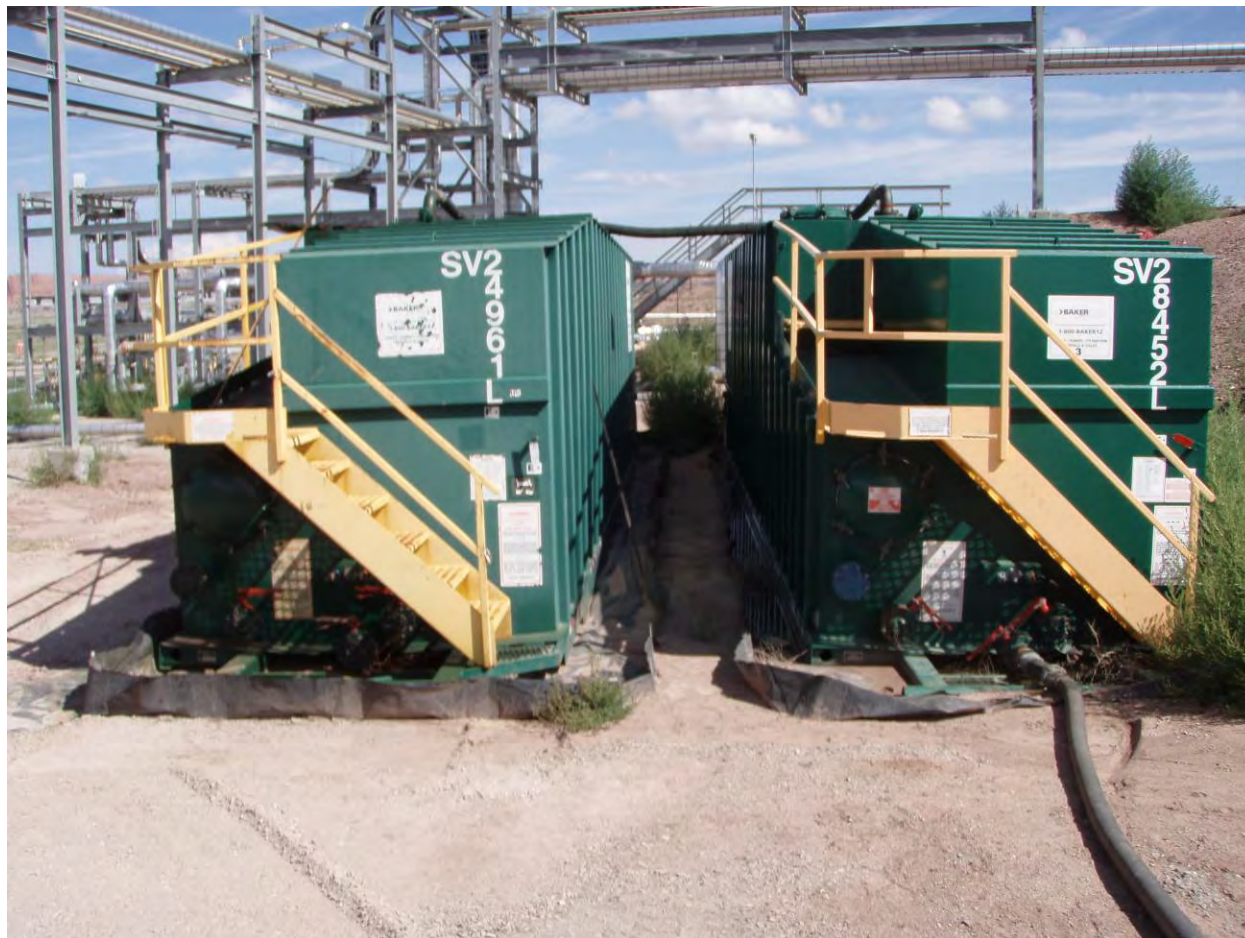
Photo File Name: P8120010

Description: WWTP - Baker tanks used as grit tanks to stored wastewater from the float tank. Inadequate secondary containment. It was also noted during the inspection that the tanks had an approximate 0.4-0.5 mile release on August 5, 2014.

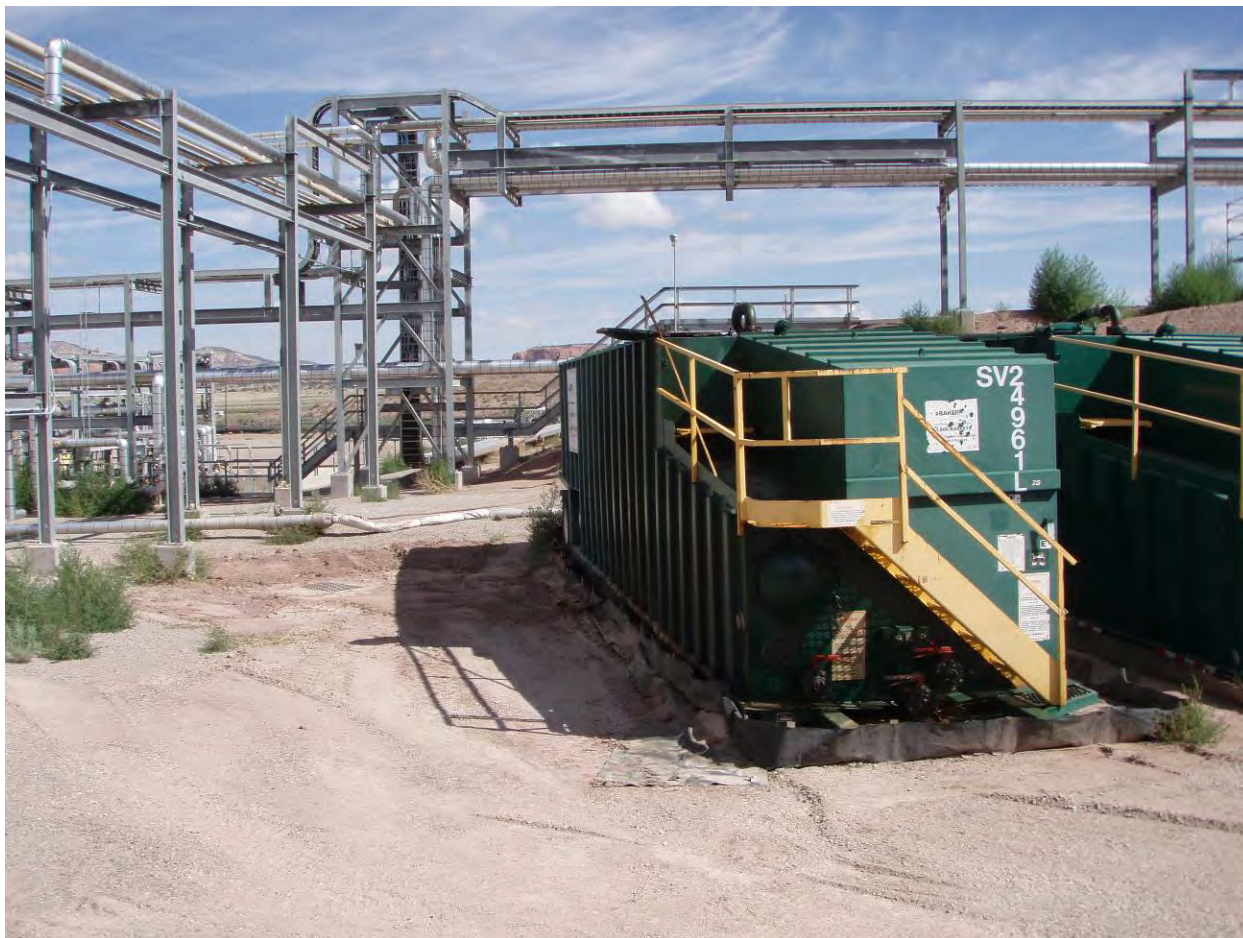
Photo File Name: P8120011

- a) Inadequate secondary containment around hazardous waste tanks, 40 CFR § 265.193. It was noted during the preparation of this inspection that a release of hazardous waste water (D018, F038) from the API overflow tanks occurred on August 5, 2014, in which the release flowed approximately 0.5 miles. A C-141 Initial Report was provided to NMED as a result of this release. During my inspection, the secondary containment was still inadequate.

Description: WWTP - Baker tanks used as grit tanks to stored wastewater from the float tank. Inadequate secondary containment. It was also noted during the inspection that the tanks had an approximate 0.4-0.5 mile release on August 5, 2014.

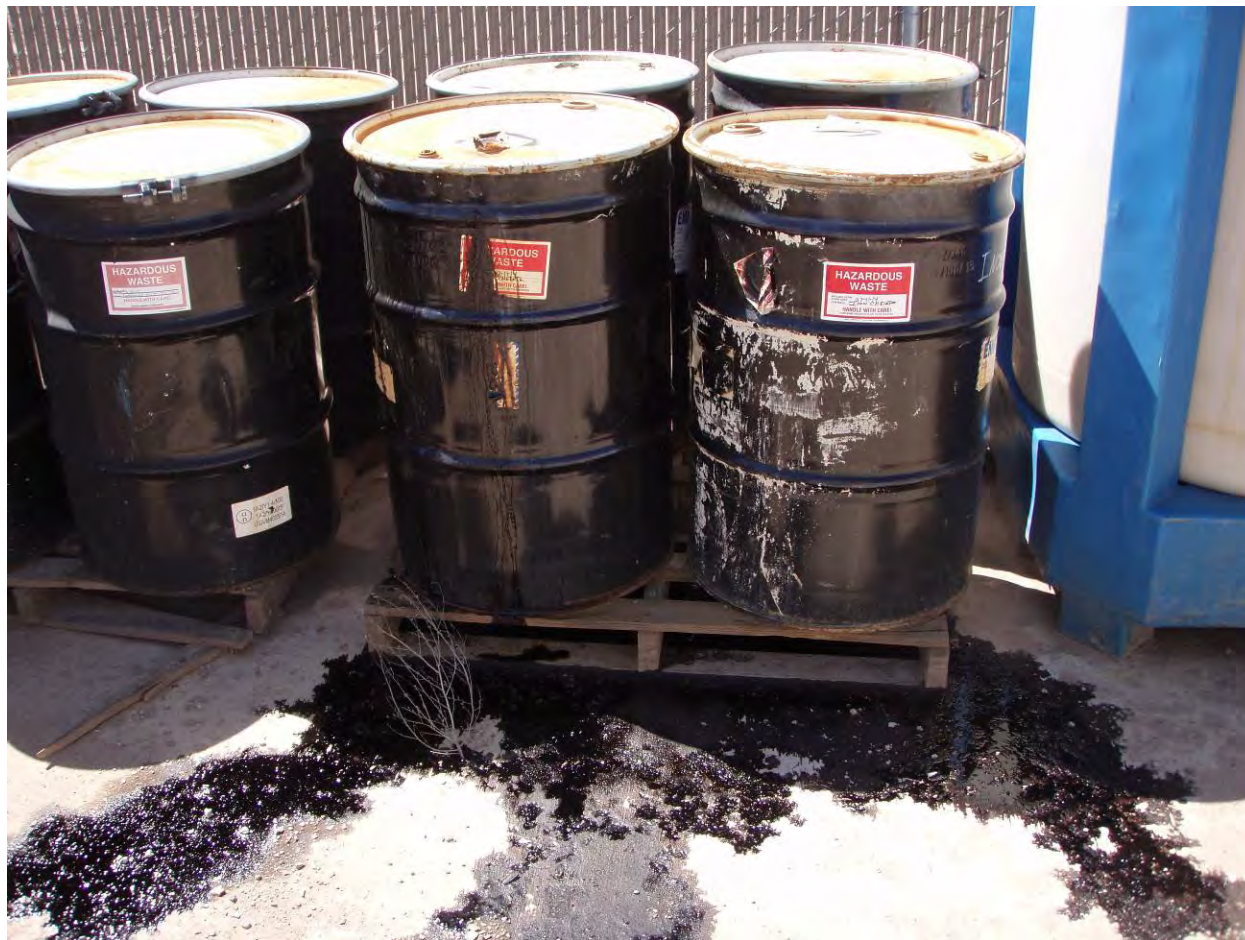
Photo File Name: P8120021

2. In the 90-day hazardous waste storage area, a drum containing iron chelate hazardous waste was leaking onto the ground. The failure to identify the leaking container, and containers that are deteriorating (e.g., cracked, rusted) or leaking must not be used. Waste stored in defective containers must be transferred to containers in good condition or handled in another way that satisfies the requirements in Part 264/265 (40 CFR § 265.171 and § 265.31).

3. Twelve (12) 55-gallon drum hazardous waste containers were identified in the 90-day hazardous waste storage area that exceeded the 90 day accumulation time as defined under 40 CFR § 262.34.

Description: 90-Day hazardous waste storage yard with leaking drum, labeled as "Hazardous Waste, Accumulation Start Date: 07-11-14, Contents: Iron Chelate". Other drums exceeded the 90 day storage limit (see Charles Barnes inspection photos).

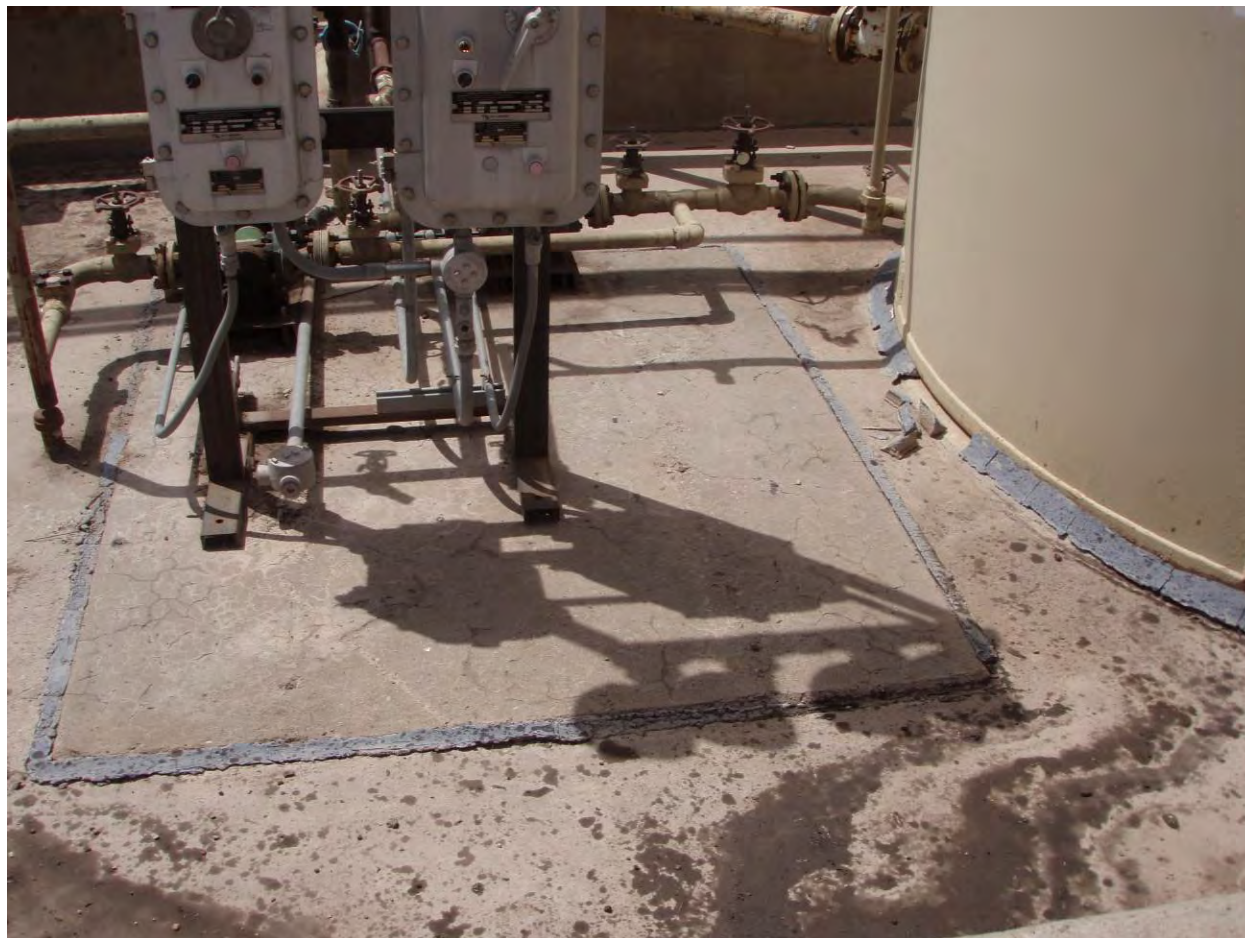
Photo File Name: P8120022

Description: SWMU-22 - Additive Tank Farm. Noted weak seal joints on the concrete floor of the secondary containment.

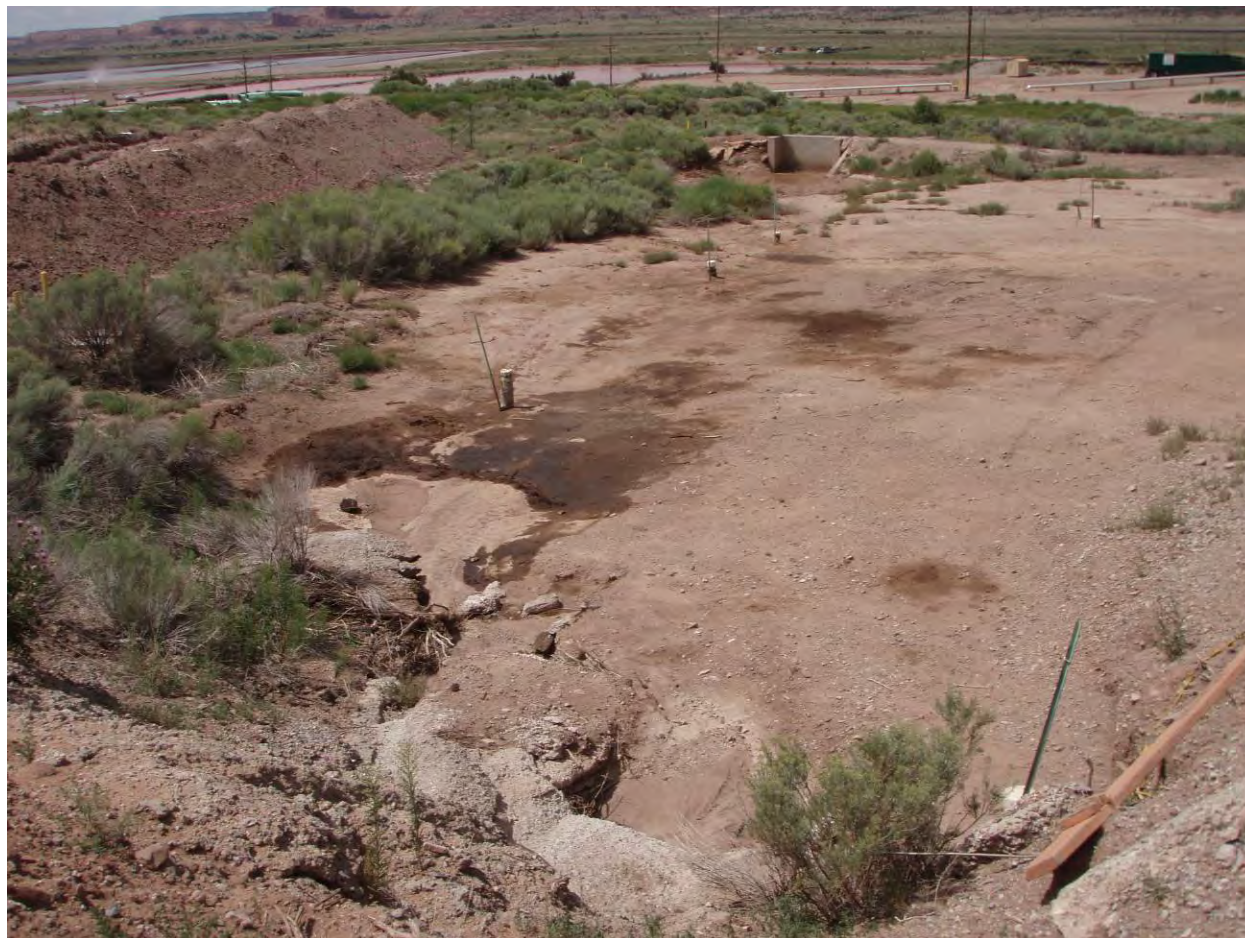
Photo File Name: P8120023

Description: Groundwater seep area with noted contamination and soil staining. Six extraction points were identified.

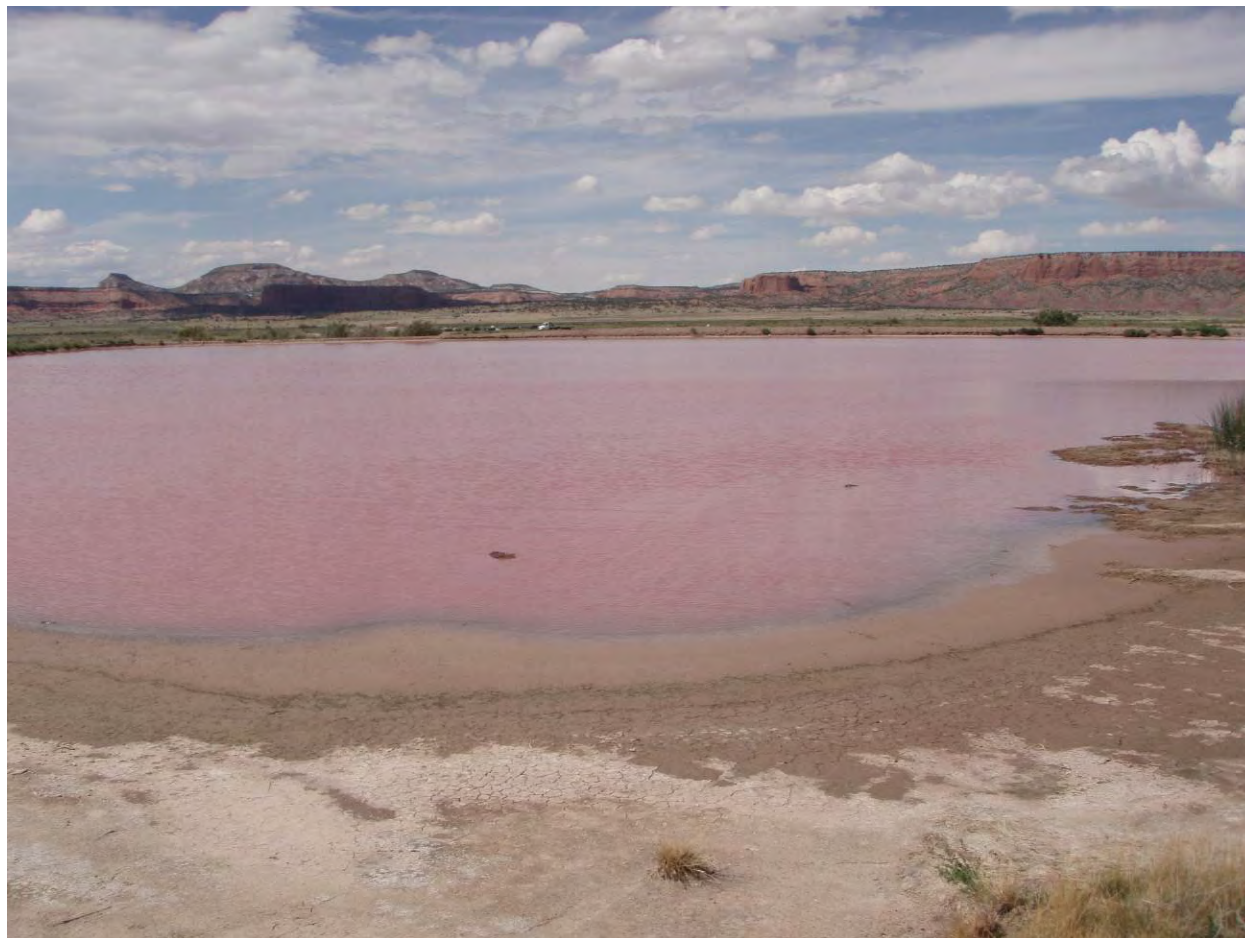
Photo File Name: P8120025

Description: Pond P-2 – Noted pinkish hue in the water.

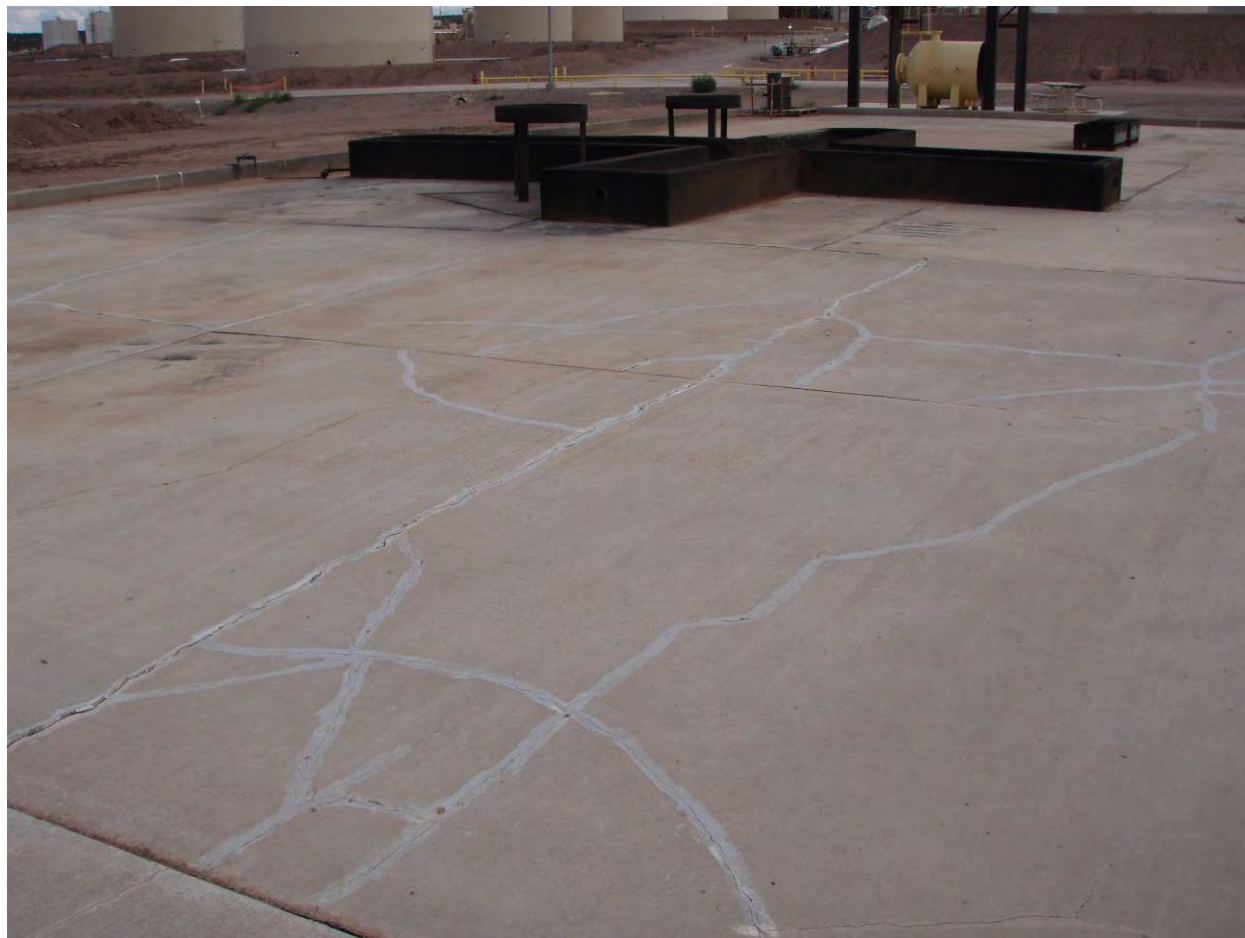
Photo File Name: P8120028

Description: New fire training area. Noted cracks and broken seals in the concrete pad.

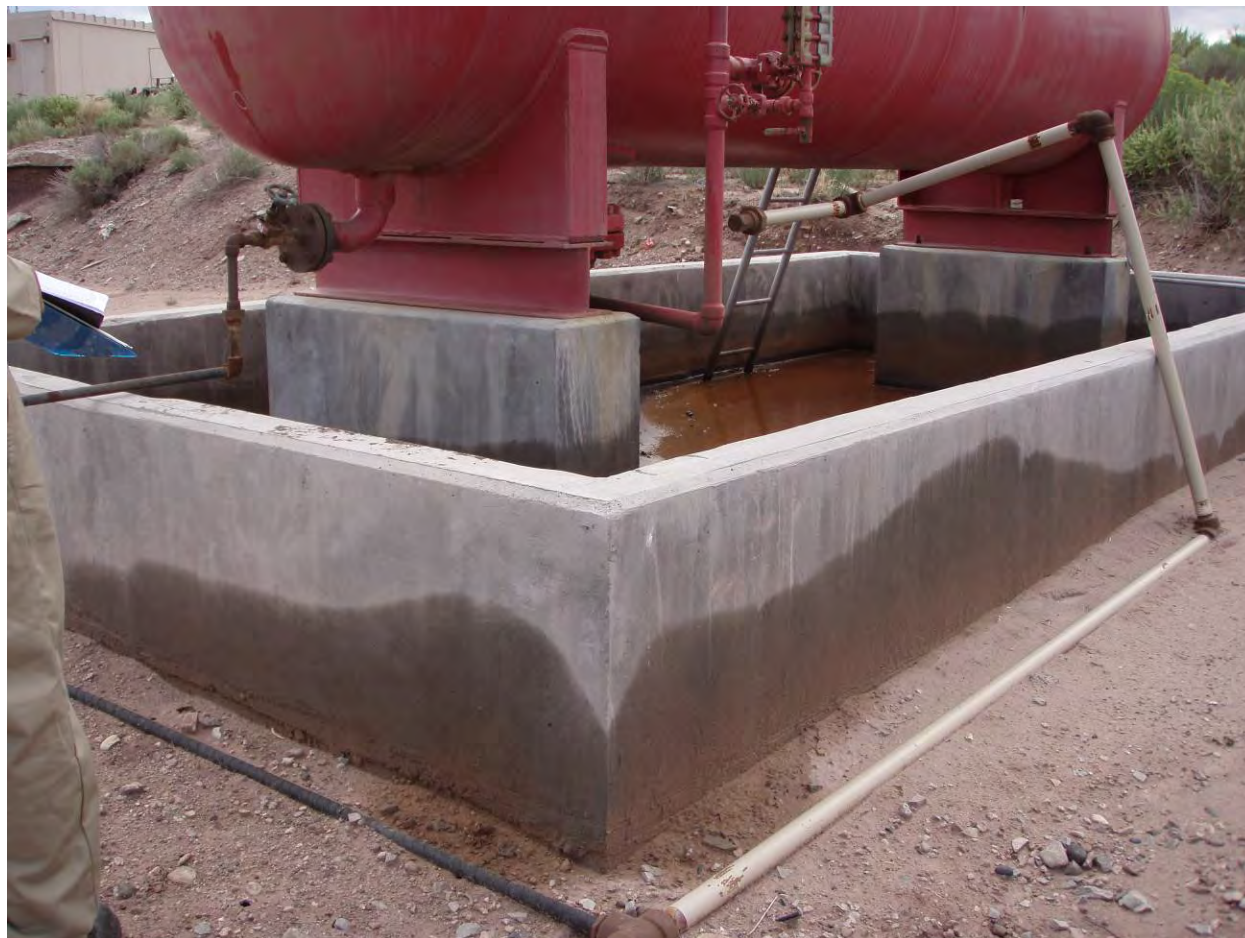
Photo File Name: P8120030

Description: Diesel tank @ Fire Training Area. Noted liquid seeping through secondary containment. Strong diesel odor noted with soils affected.

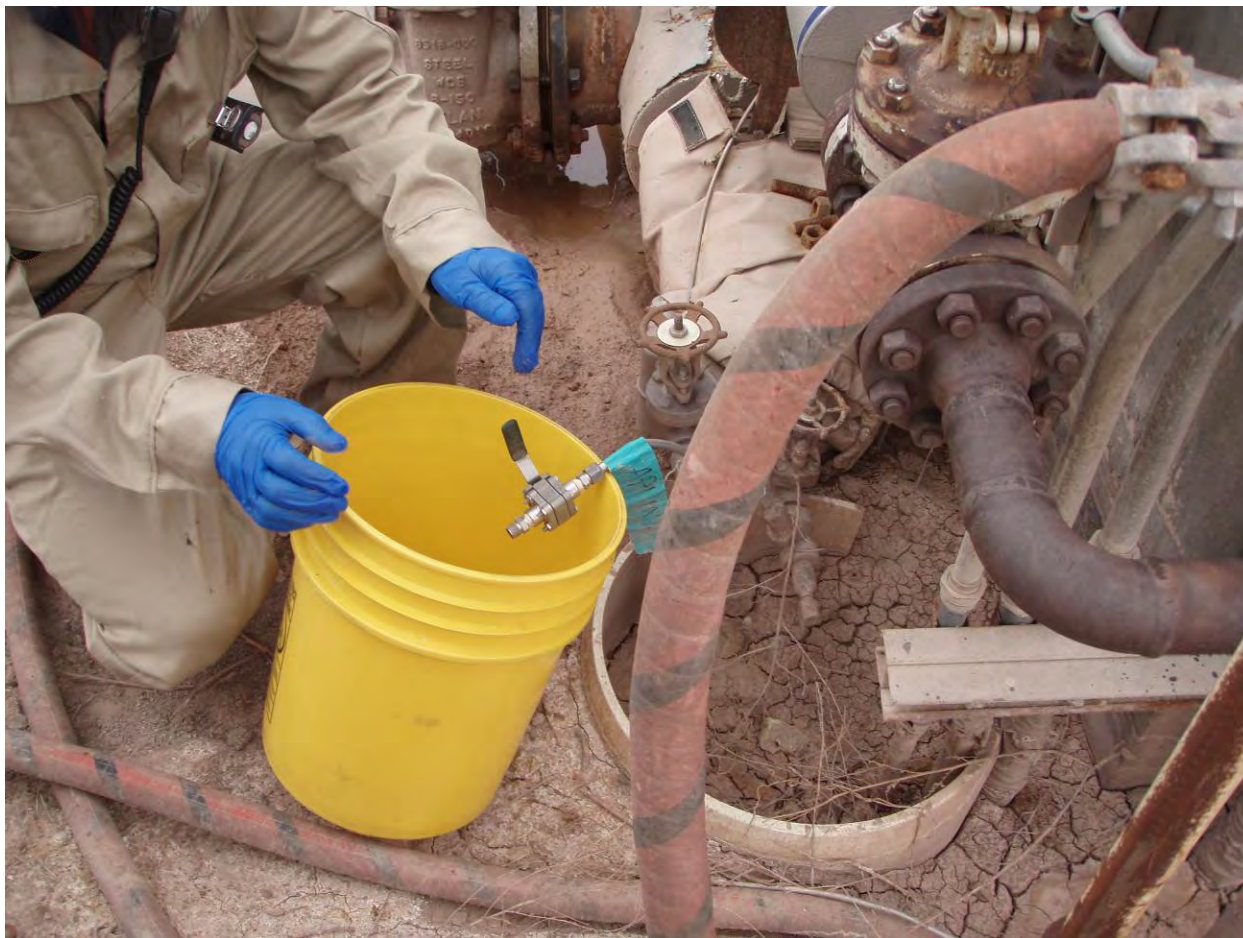
Photo File Name: P8120033

Description: Failed attempt to grab waste water sample from Pre-API sample port. No water flow due to system shut down.

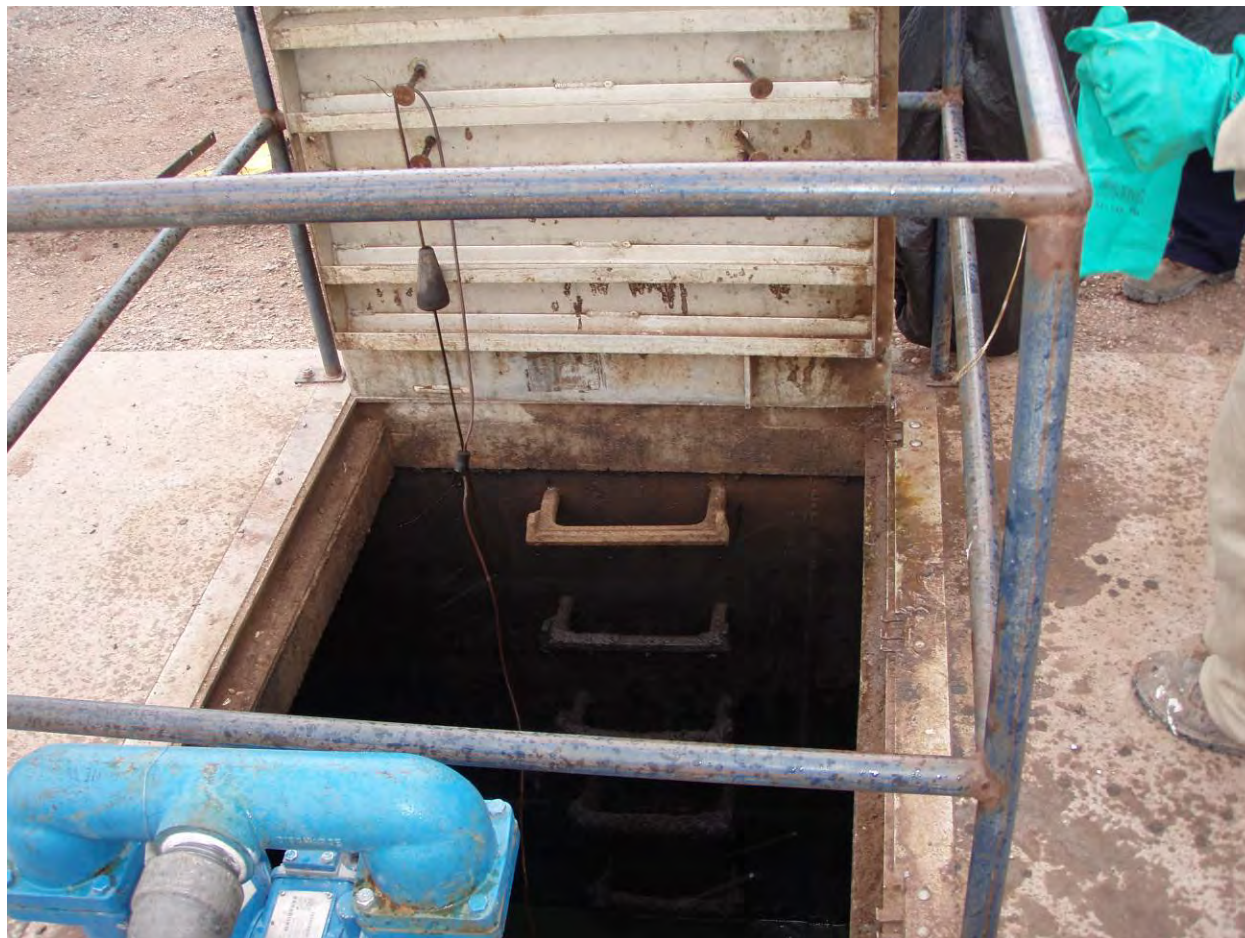
Photo File Name: P8120034

Description: Railroad loading rack sump where sample was collected for NMED Hazardous Waste Bureau.

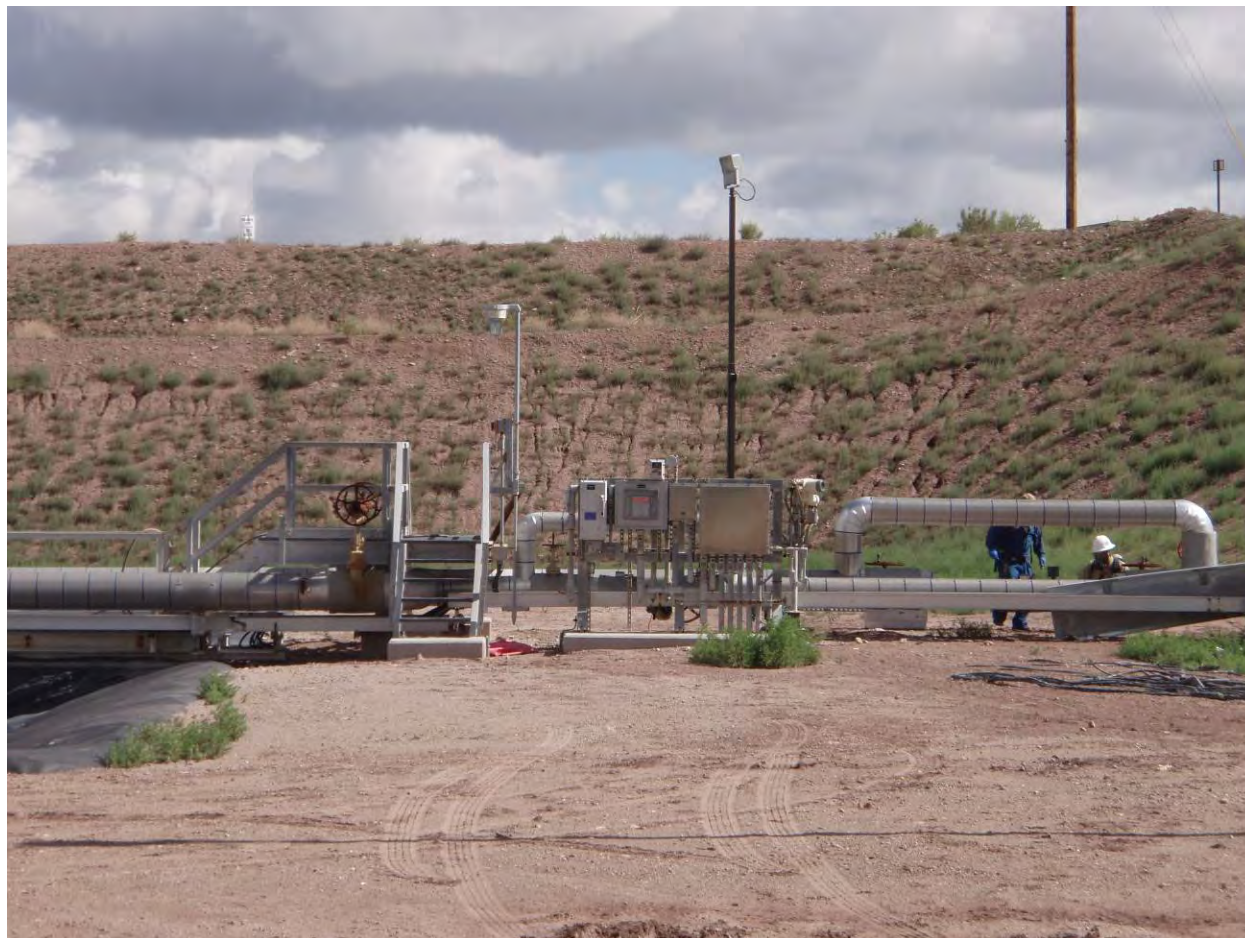
Photo File Name: P8120040

Description: Failed attempt to grab waste water sample from post-treatment sample ports. Both sample ports were completely caked/corroded.

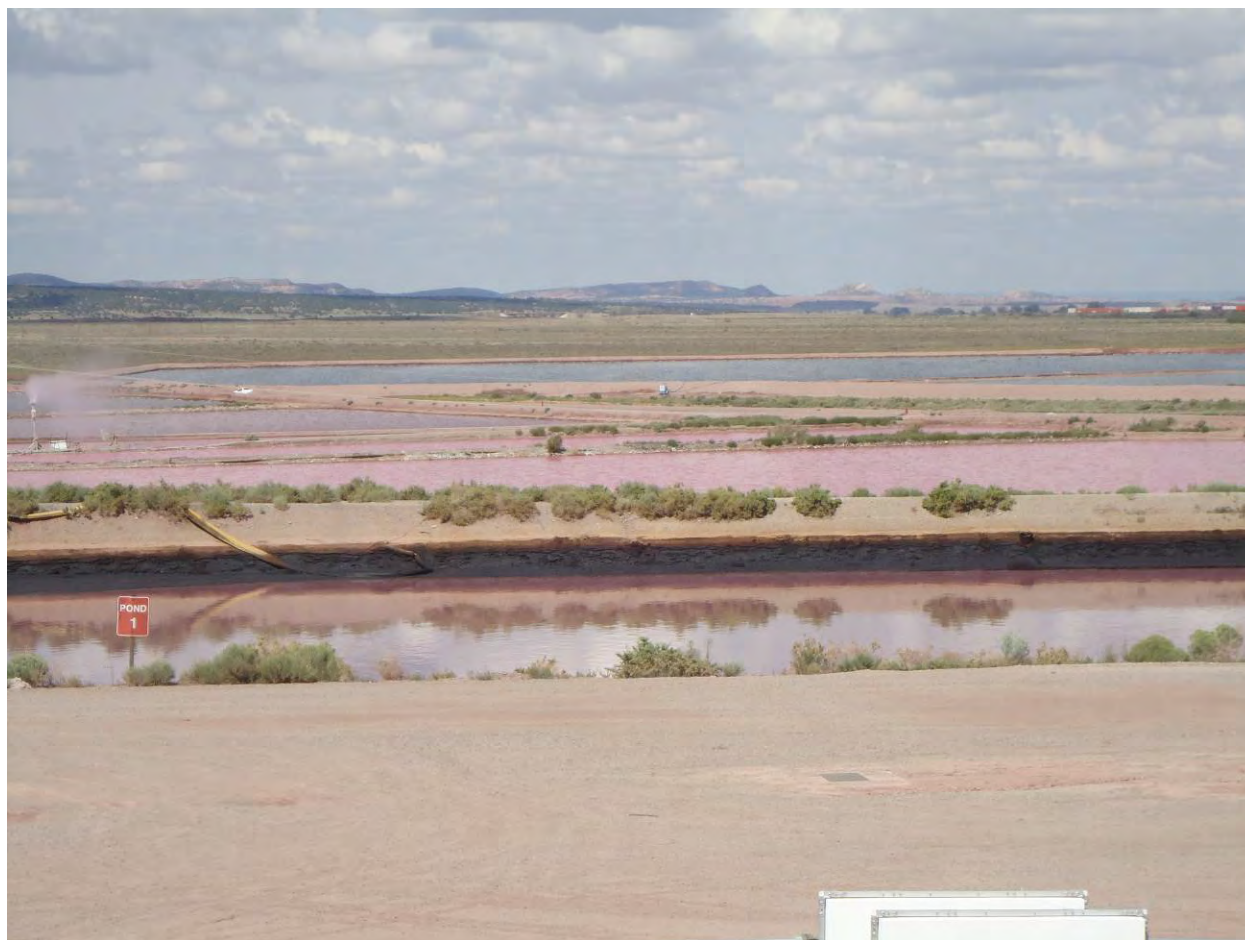
Photo File Name: 2141

Description: Pond 1 and Evaporation ponds – Pink color noted.

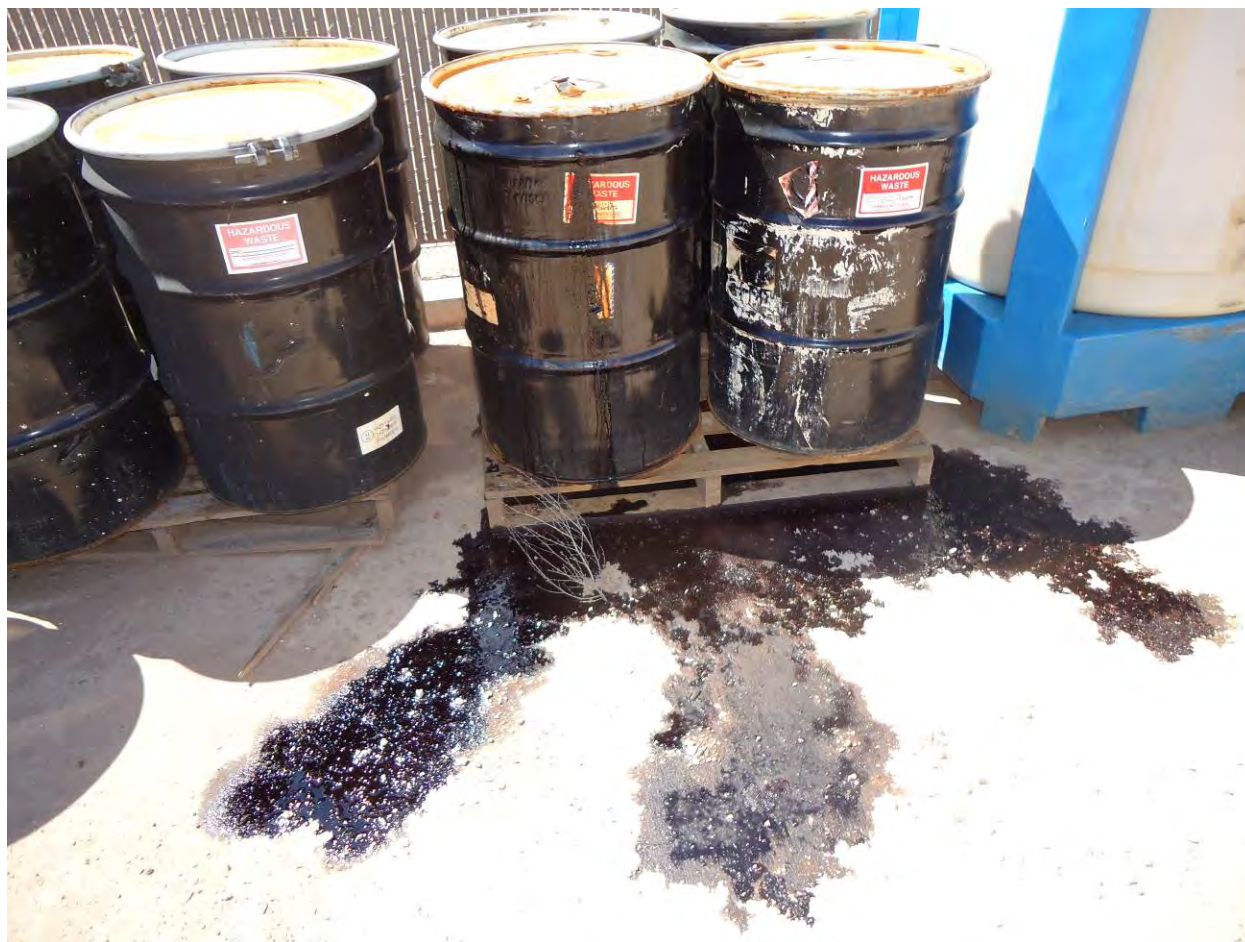
Photo File Name: 2150

Description: HW Drum Leaking

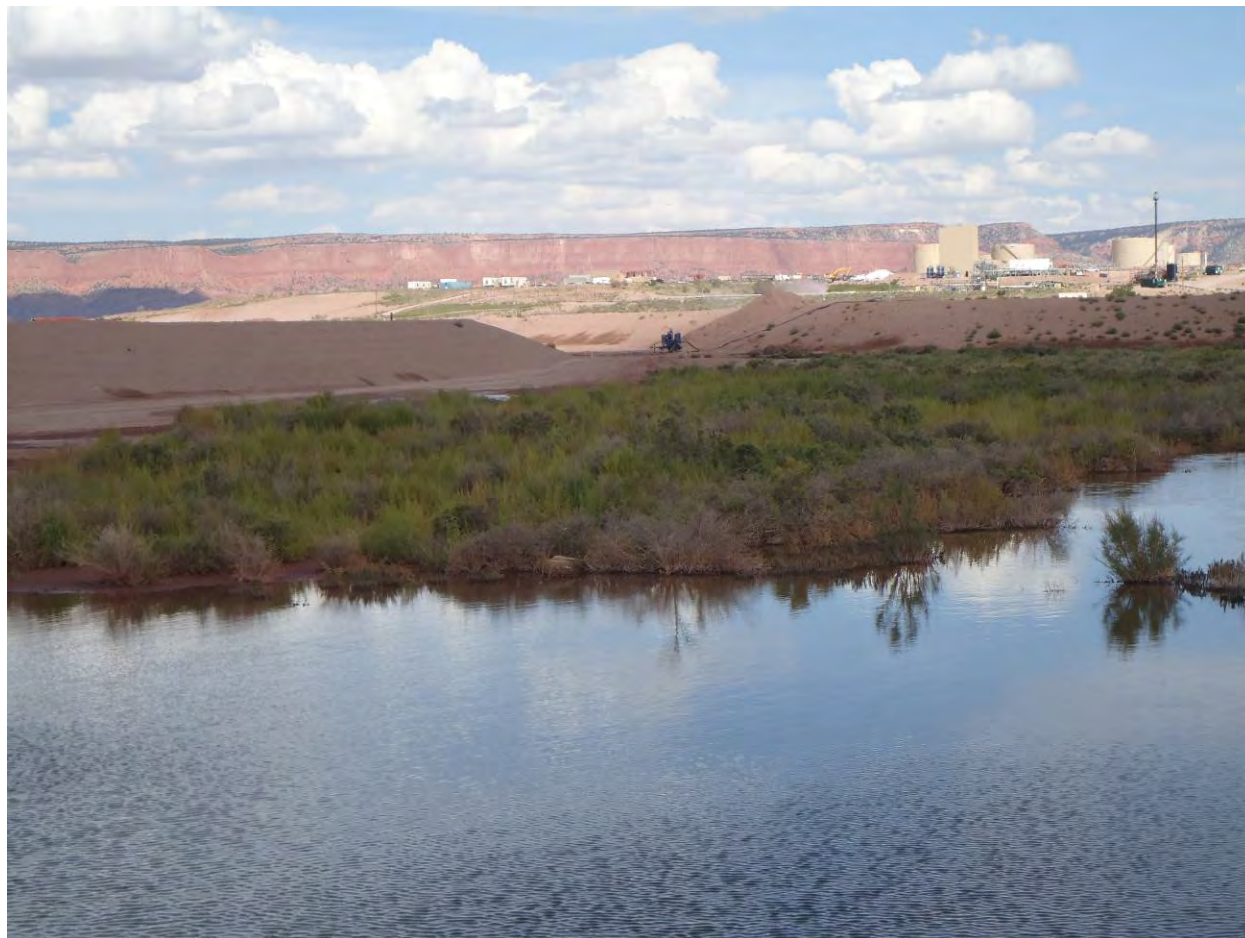
Photo File Name: 2157

Description: Storm water pond near outfall. Noted seep from adjacent ponds at base of berm

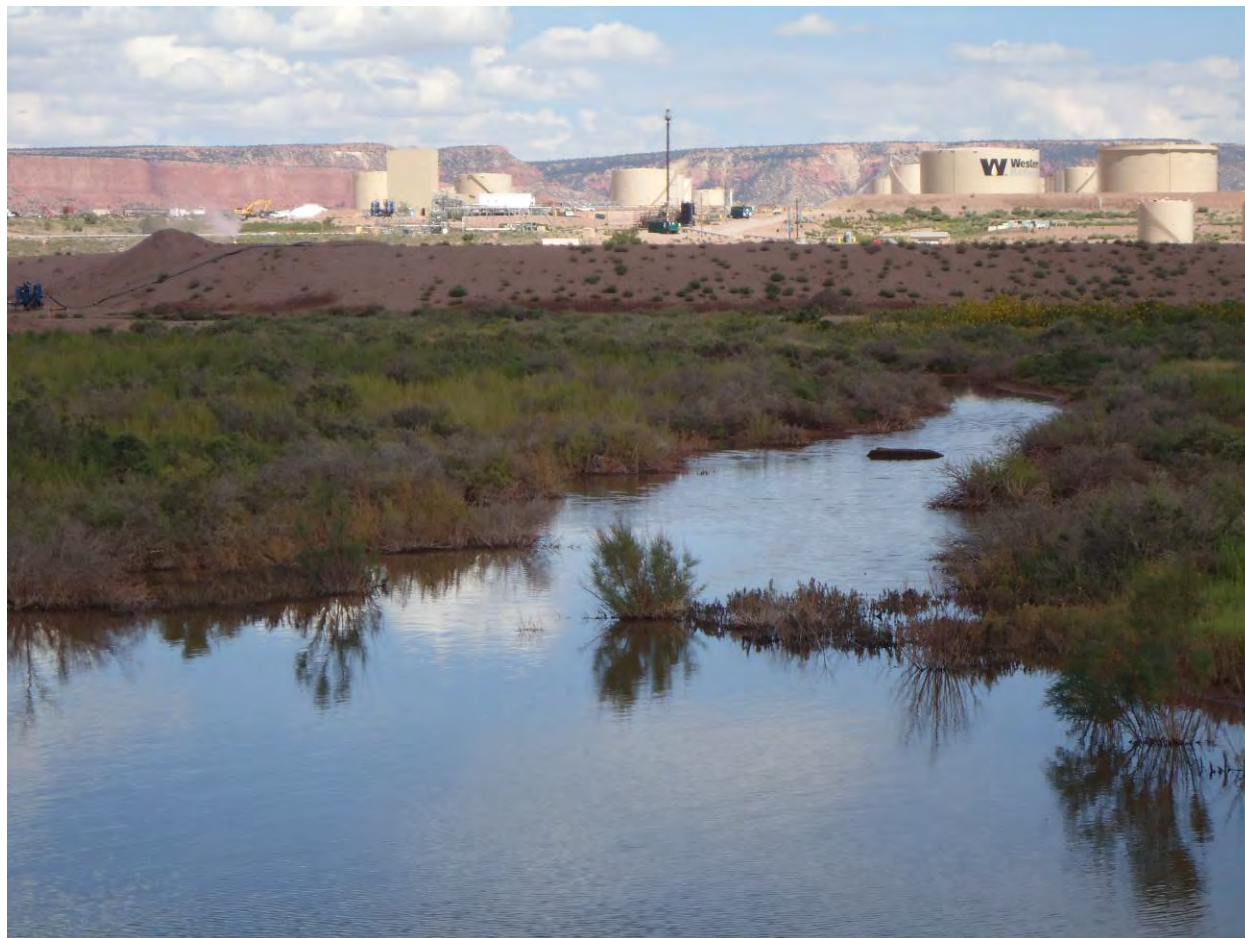
Photo File Name: 2158

Description: Storm water pond near outfall. Noted seep from adjacent ponds at base of berm

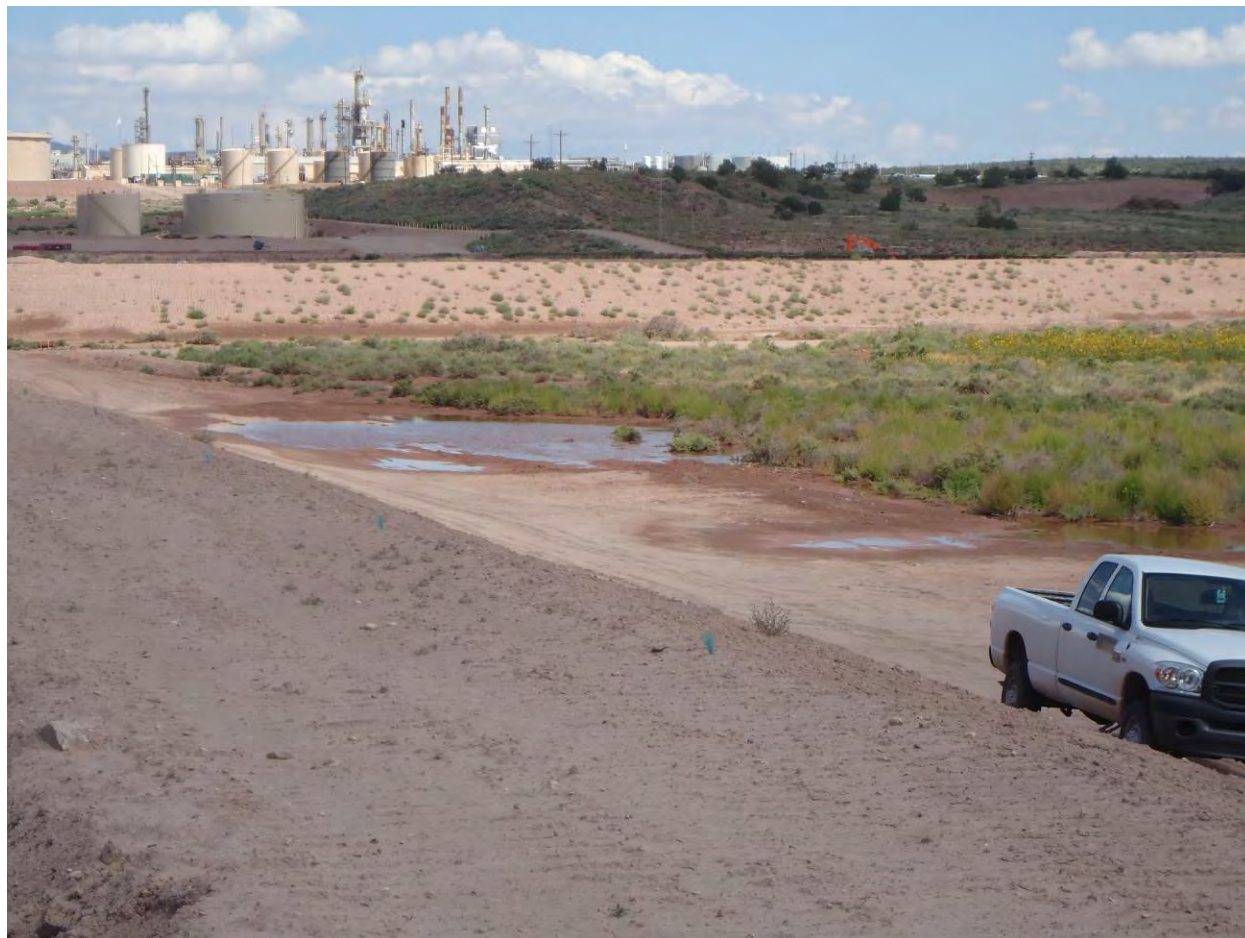
Photo File Name: 2159

Description: Noted seep at base of berm

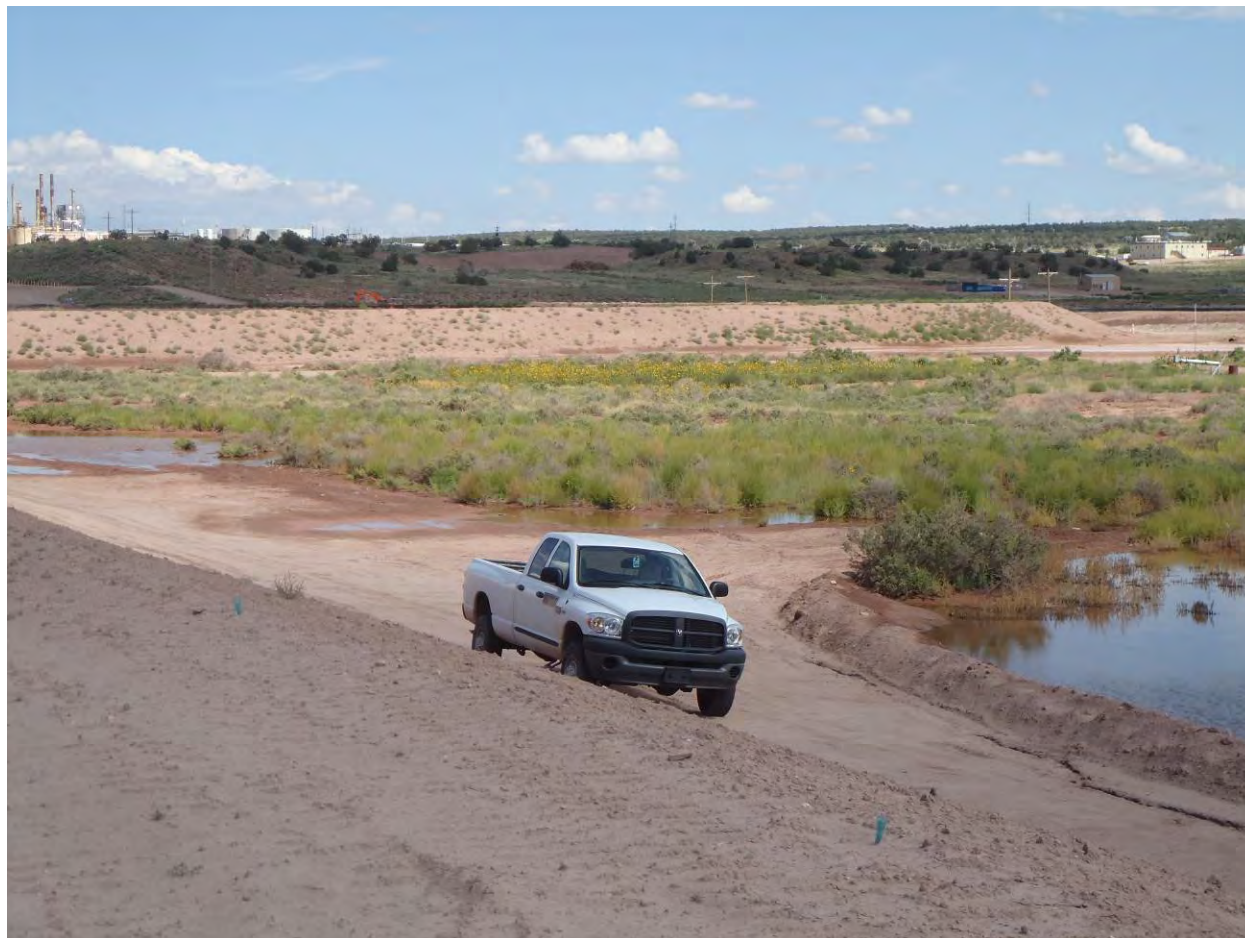
Photo File Name: 2160

Description: Noted seep at base of berm
