**Region 6 Compliance Assurance and Enforcement Division**  
**INSPECTION REPORT**

| Inspection Date(s): | | 08/08/2014 through 08/14/2014 | |
| Company Name: | | Western Refining Southwest, Inc. | |
| Facility Name: | | Gallup Refinery | |

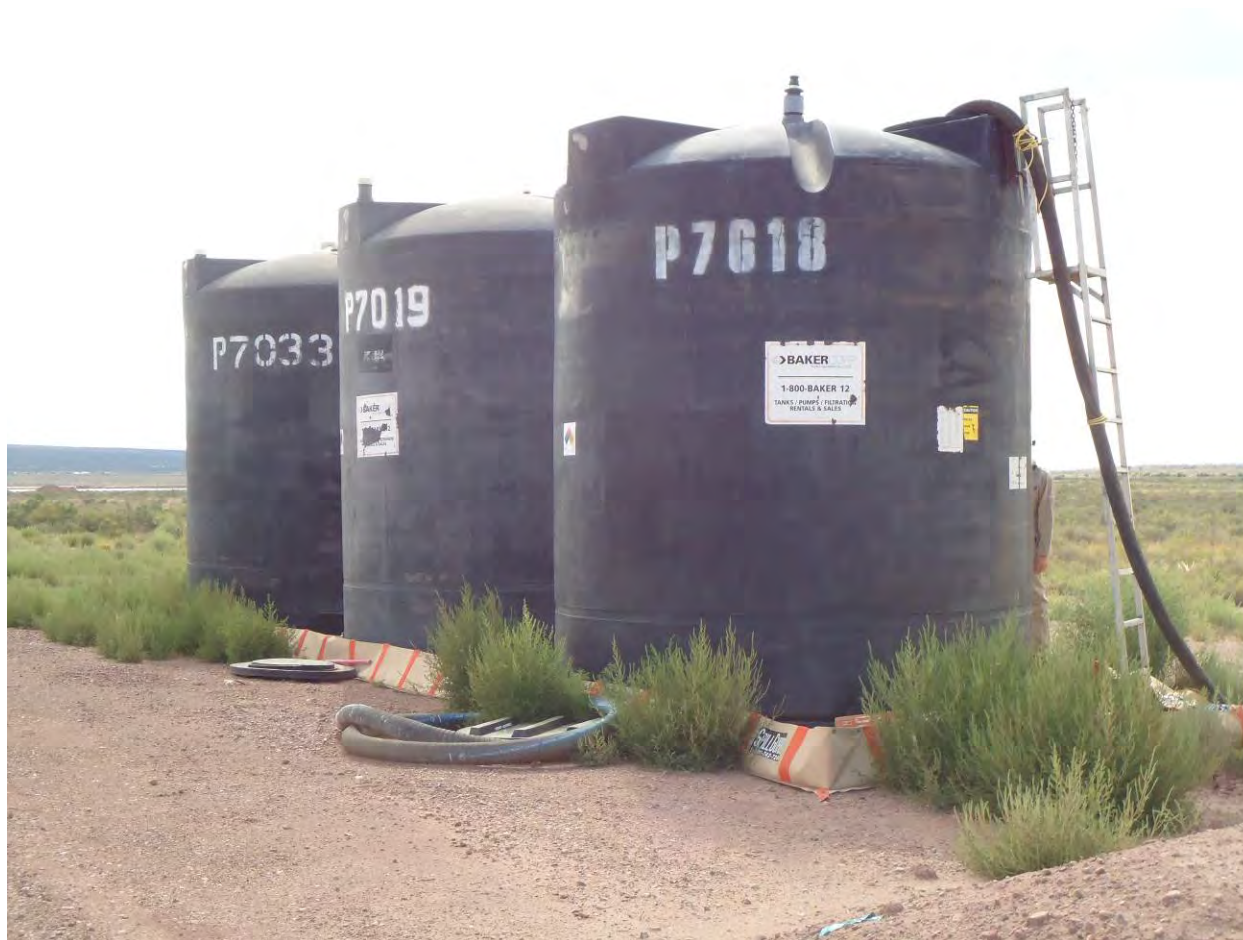
Photo File Name: 2168

During the facility tour, a treatment unit for Acid Solidified Oil (ASO) was observed. According to Mr. Riege, this is a process that was conducted by a contractor; Chemical Transportation, Inc. (CTI). The ASO was treated and solidified with soda ash and lime, then sent to another facility for recovery. CTI is an environmental transportation services company. Telephone 888-444-7077. The trailer holding the equipment had Arizona registration plates. At this point, Western considered the ASO a waste.

Description: CTI/ASO Tanks. Noted secondary containment not adequate.
