SUBJ: Resource Conservation and Recovery Act (RCRA) Compliance Evaluation Inspection (CEI)  
Naval Air Station Whiting Field  
EPA ID Number: FL2170023244

## **RCRA Inspection Report**

Naval Air Station Whiting Field  
7183 Langley Street, Building 1416  
Milton, Florida 32570  
Santa Rosa County

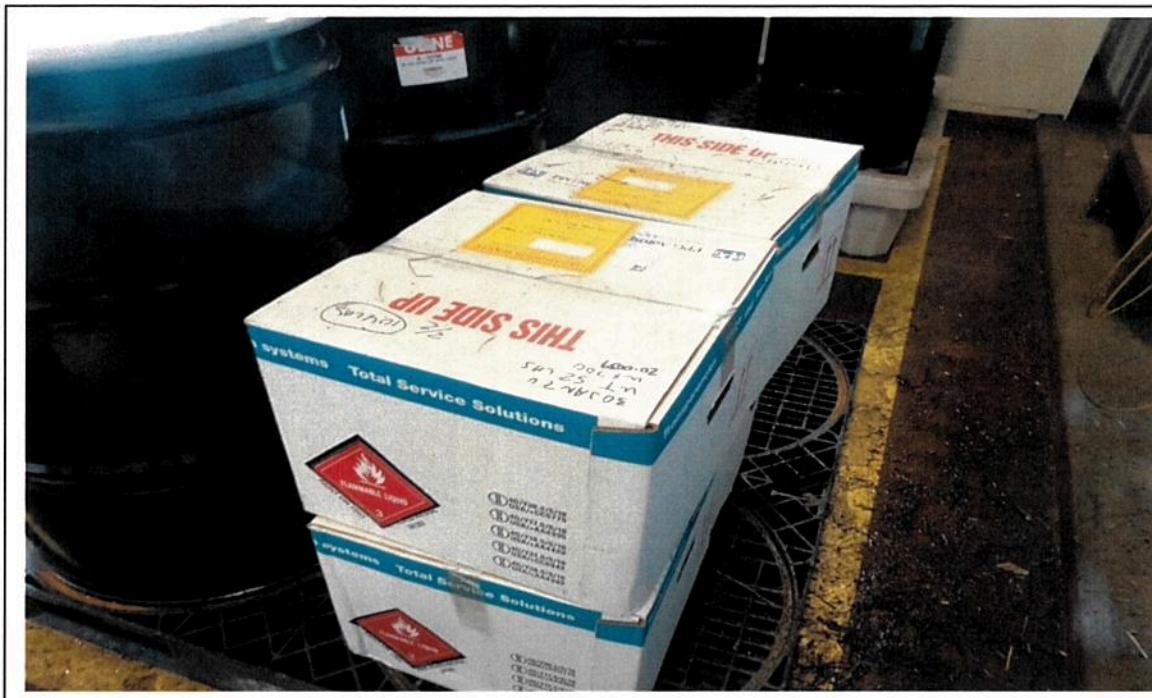
Inspectors observed five 55-gallon containers, one 30-gallon container, one 10-gallon container, and four cardboard boxes accumulating hazardous waste on containment pallets. The containers were closed, labeled with the words hazardous waste, labeled with an indication of the hazards of the contents, marked with the waste codes, and marked with the dates February 6, 2020, February 7, 2020, January 14, 2020, January 14, 2020, January 13, 2020, January 9, 2020, and January 23, 2020. Inspectors observed the four cardboard boxes were stacked two high. The two bottom boxes were not clearly labeled or marked with the words hazardous waste due to the positioning of the two top boxes. Mr. Egri repositioned the boxes one-high and inspectors observed the boxes were closed, labeled with the words hazardous waste, labeled with an indication of the hazards of the contents, marked with waste codes, and marked with the dates January 30, 2020 (photographs 1 and 2).

Naval Air Station Whiting Field. Main 90-Day or Less Accumulation Area Building 3156. Observed four boxes stacked two high on a poly pallet. Inspectors could not observe the hazardous waste label on each of the bottom boxes due to the double stacking. The facility removed the two top boxes revealing the labels. Photograph 1 taken at 10:16 a.m. WK.

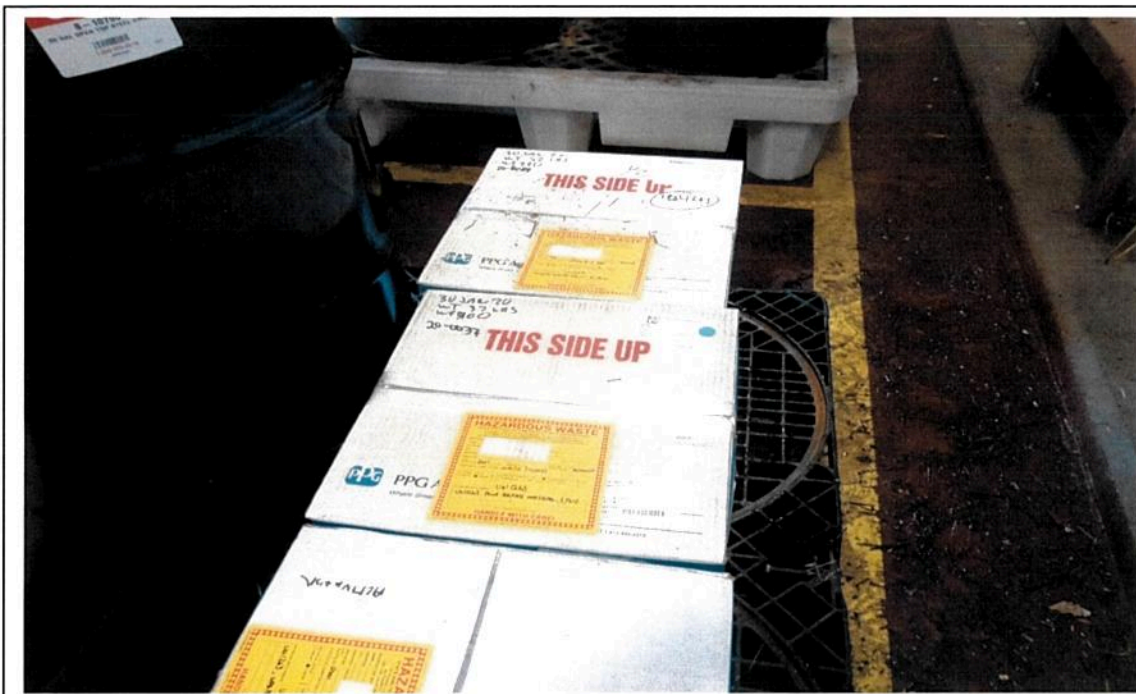
Naval Air Station Whiting Field. Main 90-Day or Less Accumulation Area Building 3156. Observed four boxes stacked two high on a poly pallet. Inspectors could not observe the hazardous waste label on each of the bottom boxes due to the double stacking. The facility removed the two top boxes revealing the labels. Photograph 2 taken at 10:16 a.m. WK.

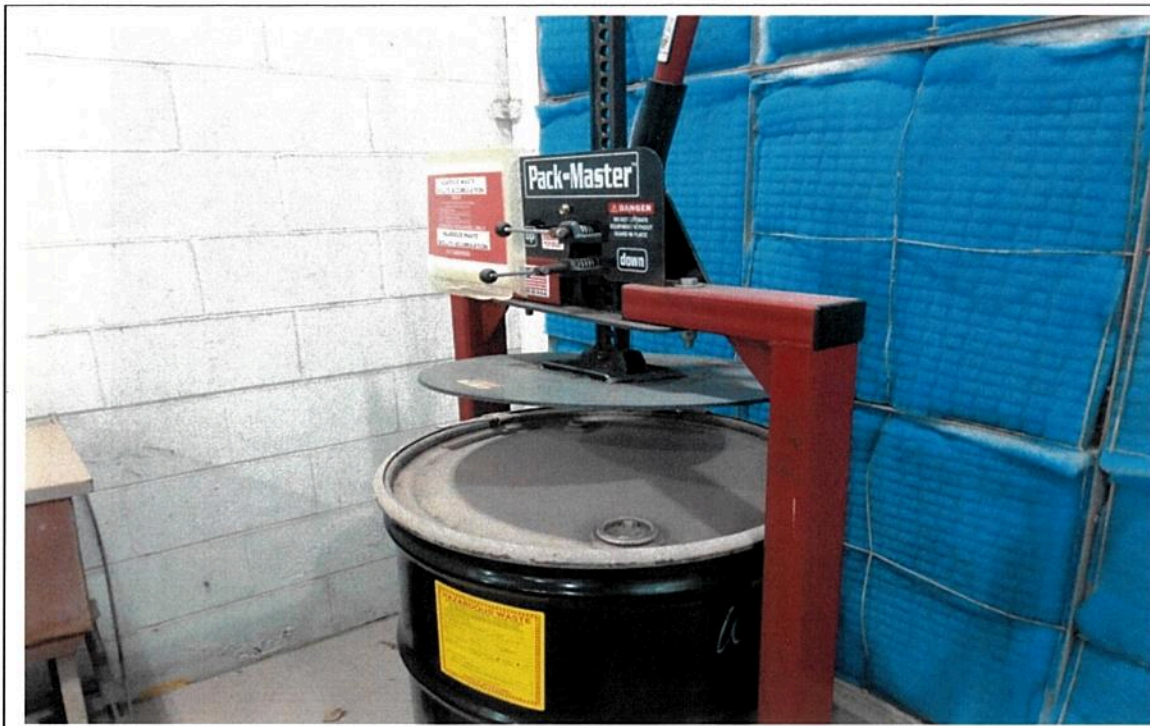
Inspectors observed one 55-gallon container accumulating waste tape and paint contaminated debris positioned under a compactor (photograph 3). The container was closed, labeled with the words hazardous waste, labeled with an indication of the hazards of the contents, and marked with waste codes.

Naval Air Station Whiting Field. Paint Booth and Corrosion Building 3024. Observed one 55-gallon container under a manual drum compactor. Container was on a pallet. Photograph 3 taken at 11:16 a.m. WK.
