# NPDES Compliance Inspection Report

## Spokane Tribal Hatchery Ford, Washington

**Permit #: WAG130019**

**Inspection Date: August 3, 2021**

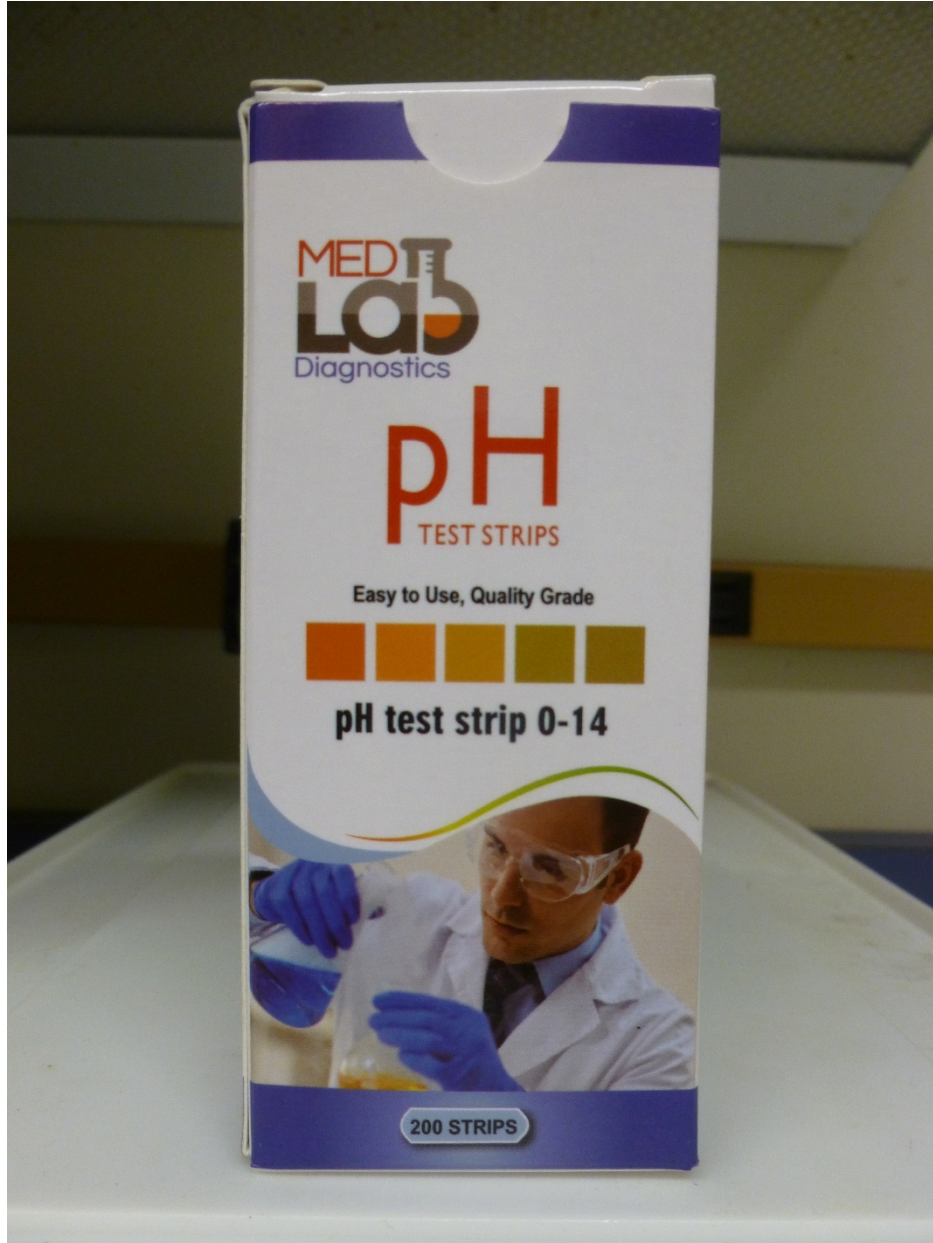
**Photo 1 / P1000985** – pH Test Strips Box, front view.

Mr. Peone took me on a brief tour of the site. Located right outside Mr. Peone's office is a small laboratory maintained by the facility and used to perform the in-house analysis of settleable solids and pH. The facility uses test strips (**Photos 1 & 2**) to test the pH level of water samples.

At the time of the inspection, I asked Mr. Peone how pH was tested, and he showed me the container of test strips the facility uses to determine pH. Sampling pH with test strips rather than a pH meter does not meet the requirements of the permit which states “meter” as the monitoring “Sample Type”.

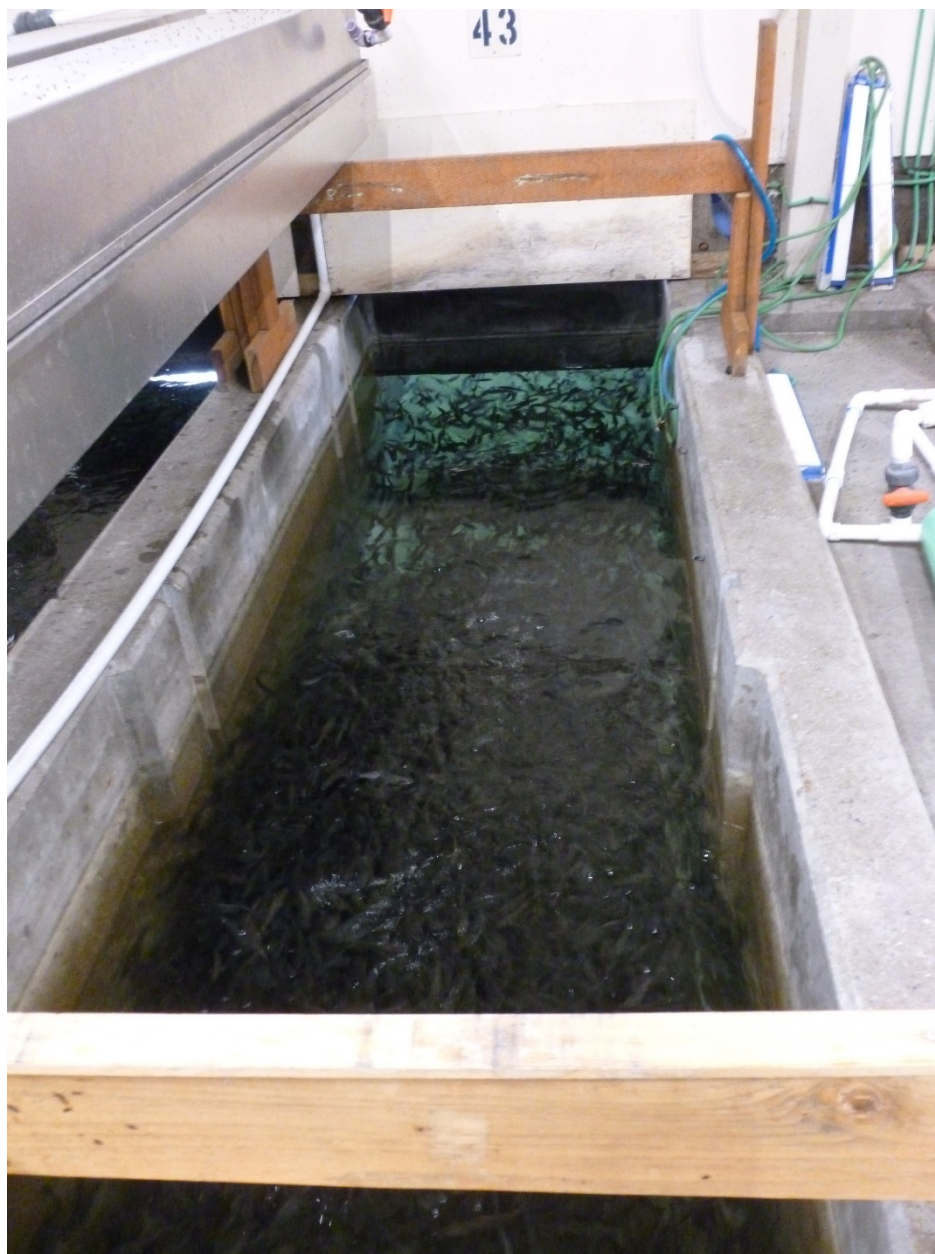
**Photo 3 / P1000991** – Raceway, indoor section facing toward wall.

The facility was clean and well-maintained. I did not observe any excess food, mortalities, or algal growth during the inspection. The facility's raceways extend from inside the building (**Photo 3**) to an outside covered portion (**Photo 4 & 5**).

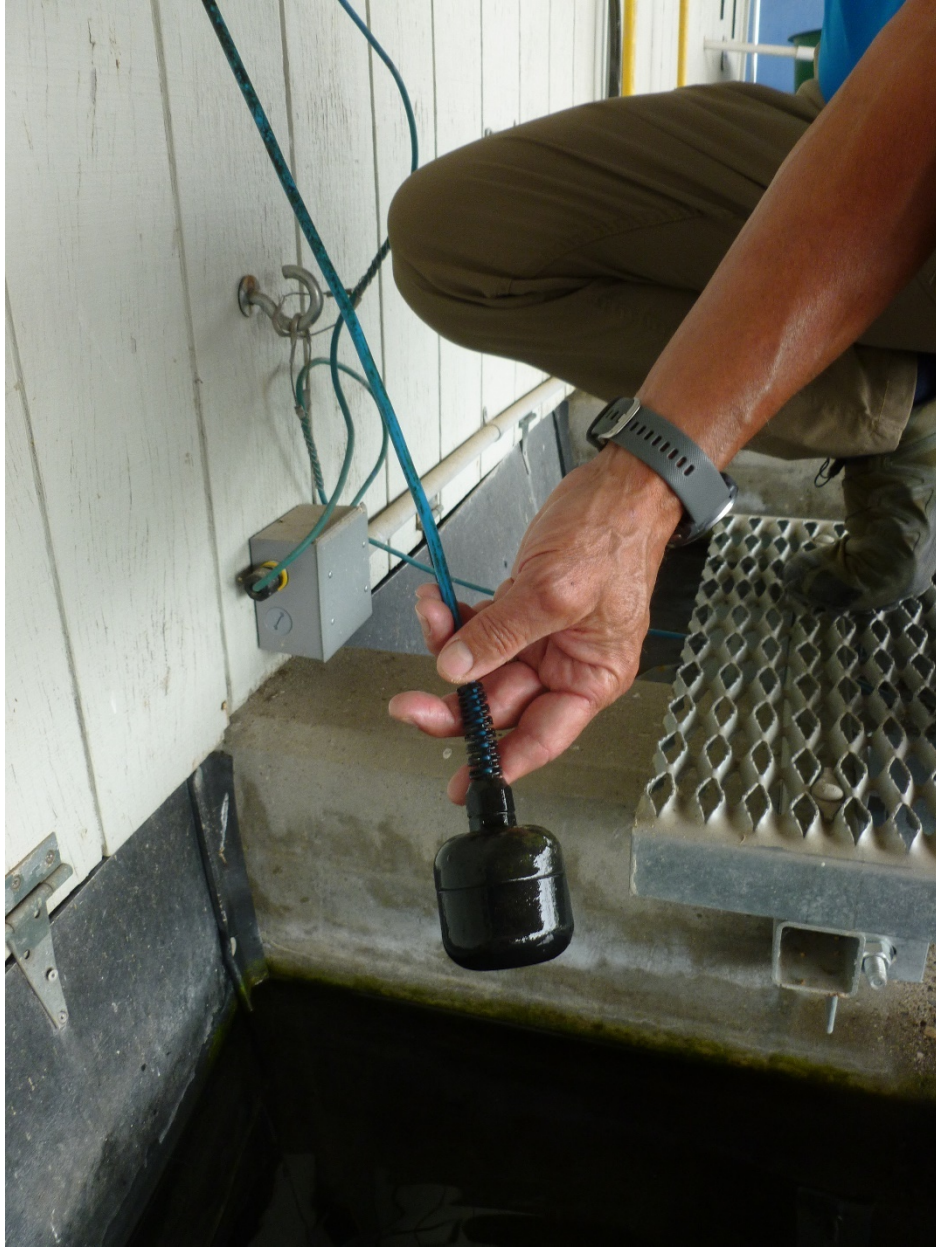
**Photo 7 / P1000994** – Oxyguard® Probe.

The facility uses an Oxyguard® system to monitor dissolved oxygen and temperature in each raceway. The system is primarily composed of monitoring probes (**Photo 7**) located in the exterior section of raceway and monitoring & control units (**Photo 8**) located on the wall between the interior and exterior sections of the raceways.

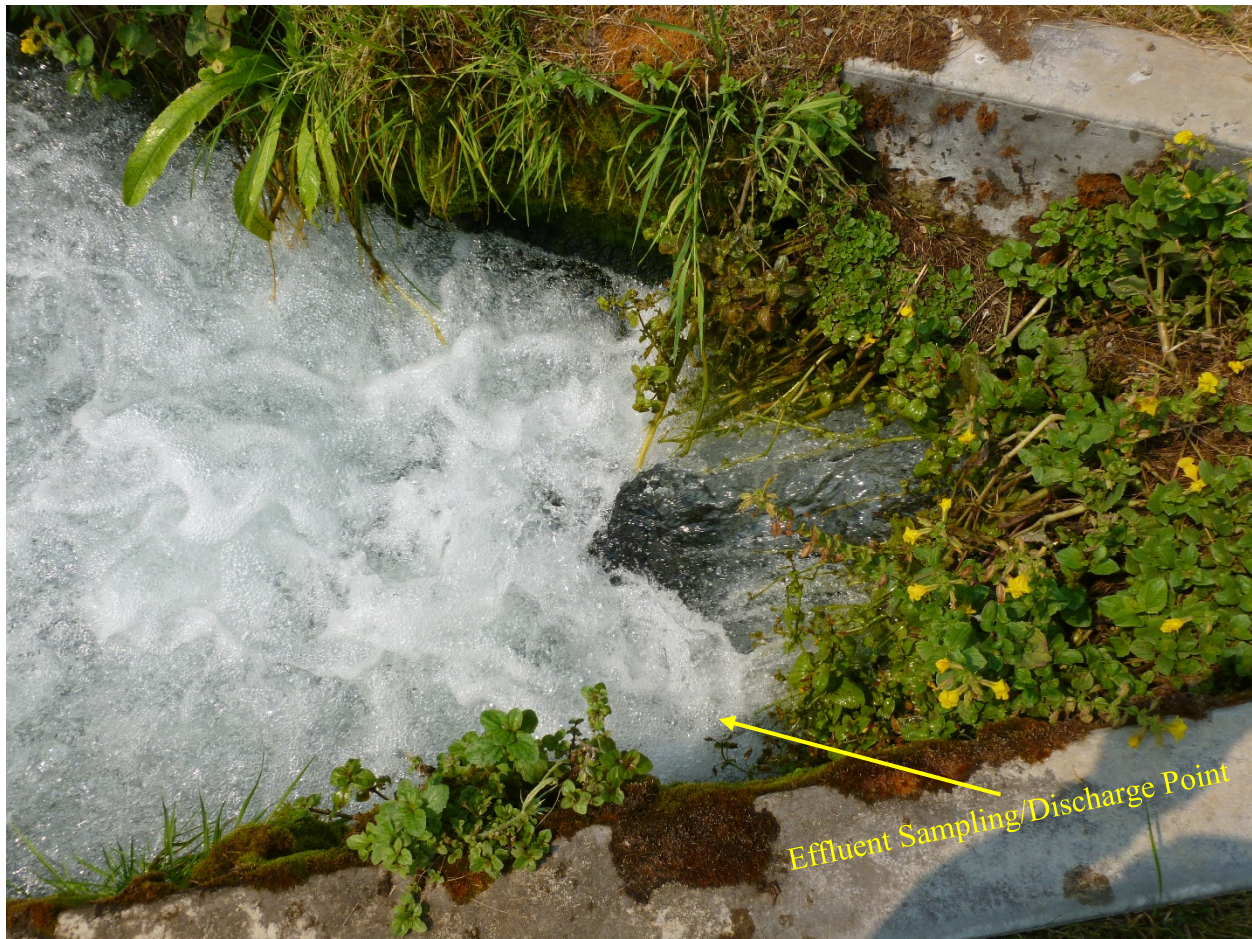
**Photo 9 / P1000996** – Effluent Sampling/Discharge Point.

The facility discharges directly into Tshimakain Creek at a point downstream from the facility as annotated on the aerial photo in Appendix A. The facility collects a grab sample of the effluent at the discharge point (**Photo 9**).
