## **RCRA Inspection Report**

Gulfstream Aerospace Corporation - Main  
500 Gulfstream Road  
Savannah, Georgia 31408  
EPA ID # GAD061022216  
NAICS Code: 336411 - AIRCRAFT MANUFACTURING

June 2, 2021, 09:00 hours

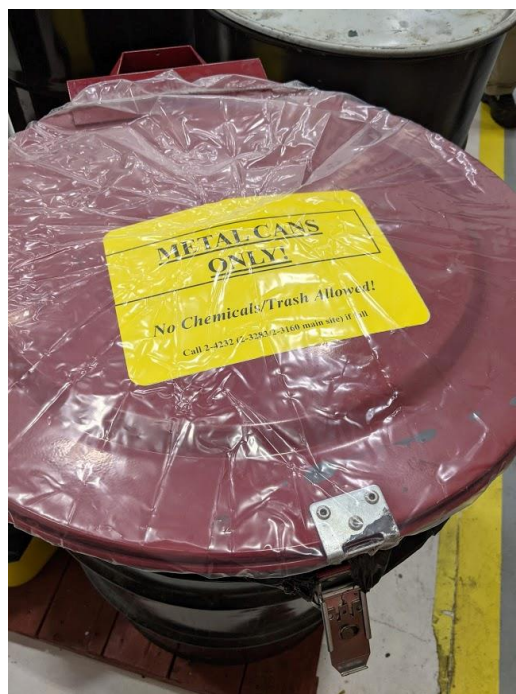
Hanger 2 is where the final inspection and testing of the aircraft is conducted. This area consists of the same SAA set up as Hanger 1. At the time of the inspection, a non-hazardous container that was labeled “Metal Cans Only” consisted of hazardous personal protective equipment (PPE) (Photographs 1 and 2 of 3). This container was not labeled hazardous waste and did not have the indication of the hazardous contents.

Photograph 1 of 3: SAA Hanger 2 Metal Cans Container

**Pursuant to Ga. Comp. R. and Regs. 391-3-11-.08(1) [40 C.F.R. § 262.15(a)(5)], which is a condition of the SAA Permit Exemption, a generator is required to do the following: mark or label its containers (i) with the words “Hazardous Waste” and (ii) with an indication of the hazards of the contents.**

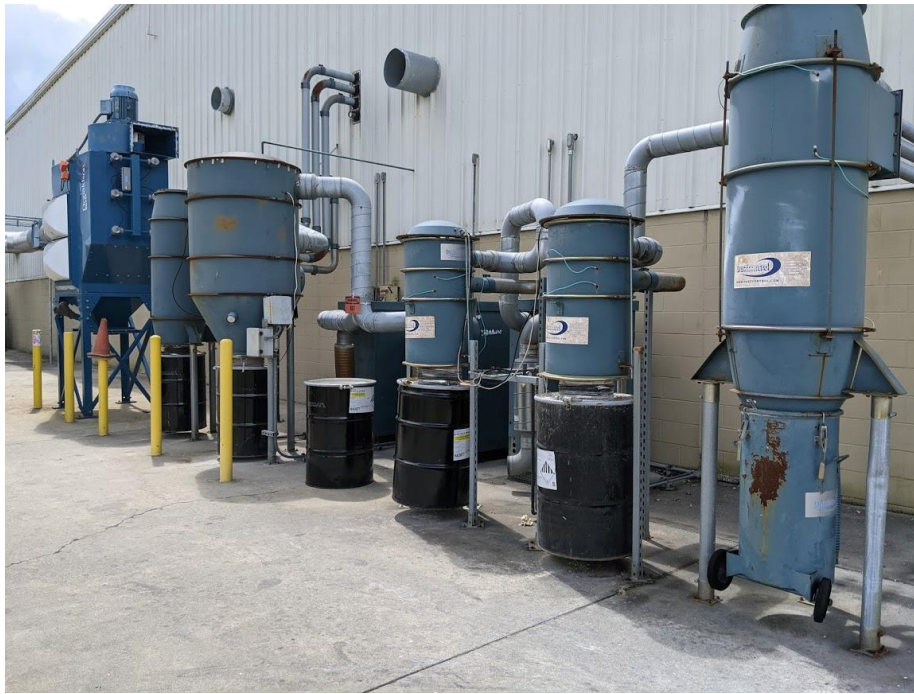
The wood shop is divided into 6 separate workstations throughout building. Each workstation has a 55-gallon container managing paint sealant hazardous waste and a 55-gallon container of toxic hazardous waste blast media (EPA waste codes: D005, D006, D007, and D008). At the time of the inspection, all SAA paint sealant containers were labeled hazardous waste, had the indication of the hazardous contents, and were closed. Blast media is collected from workstations and transferred via duct conduit to an outside collection area (Photograph 3 of 3). The sealant around the rim of the 55-gallon SAA container where the duct conduit meets the container had been compromised and deemed open by the inspection team.

Photograph 3 of 3: Hazardous Waste Blast Media Collection Area

**Pursuant to Ga. Comp. R. and Regs. 391-3-11-.08(1) [40 C.F.R. § 262.15(a)(4)], which is a condition of the SAA Permit Exemption, a generator is required to keep containers of hazardous waste closed at all times during accumulation, except when adding, removing, or consolidating waste; or when temporary venting of a container is necessary for the proper operation of equipment, or to prevent dangerous situations, such as build-up of extreme pressure.**
