**Region 6 - Enforcement & Compliance Assurance Division**  
**INSPECTION REPORT**

| Company Name: | <b>Trophy Signature Homes, LLC</b> | |
| Facility Name: | <b>Painted Tree Lakeside District (Phases 1-3)</b> | |
| Identification/Permit Number: | TXR1534MI | |

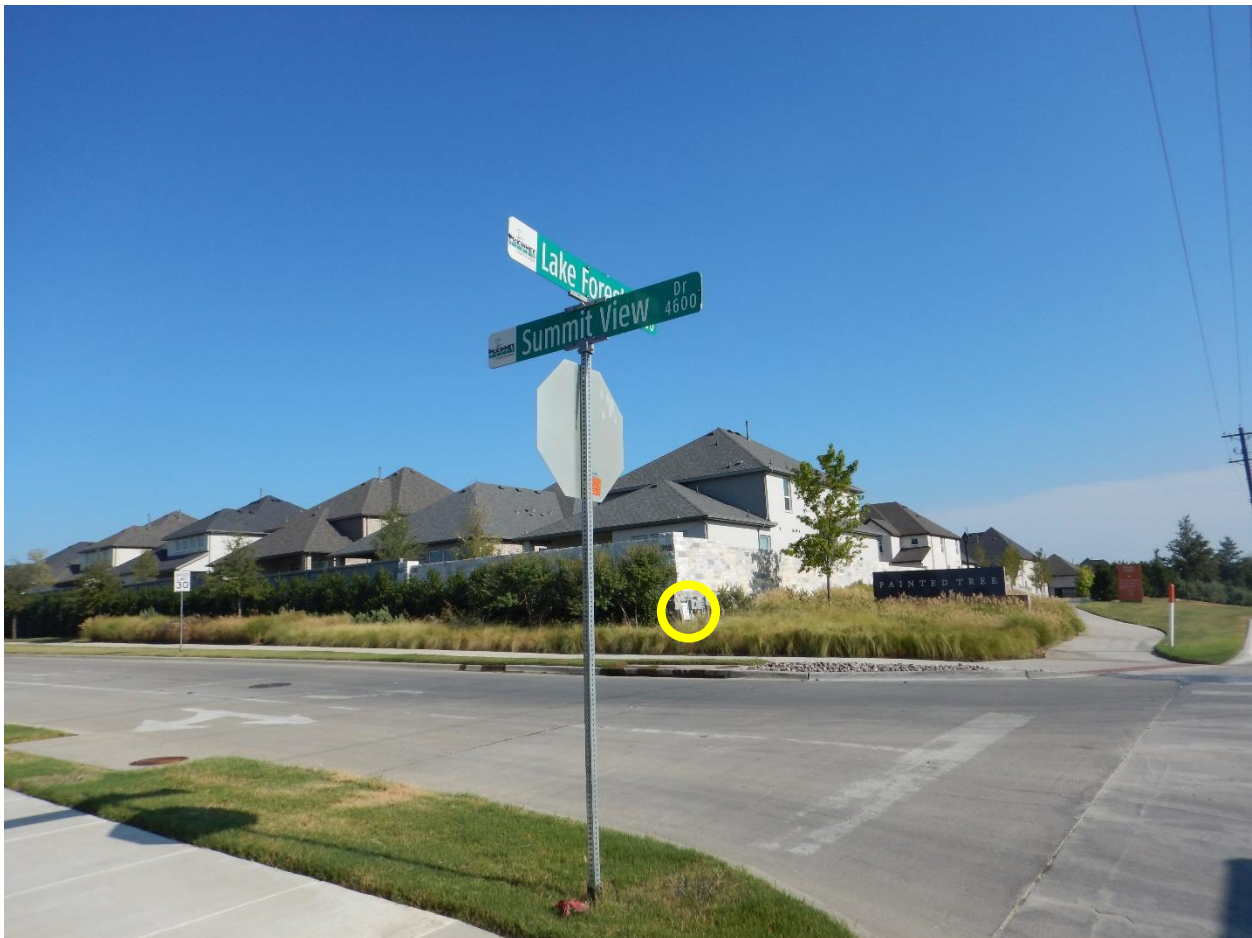
Photo No. 1

Description: Picture/view, of Stormwater Pollution Prevention (SWPPP) Large Construction Site Notice posted at the intersection of Lake Forest Dr. and Summit View Dr. A closer view of the Site Notice is captured in Photo No.2 (see yellow circle).

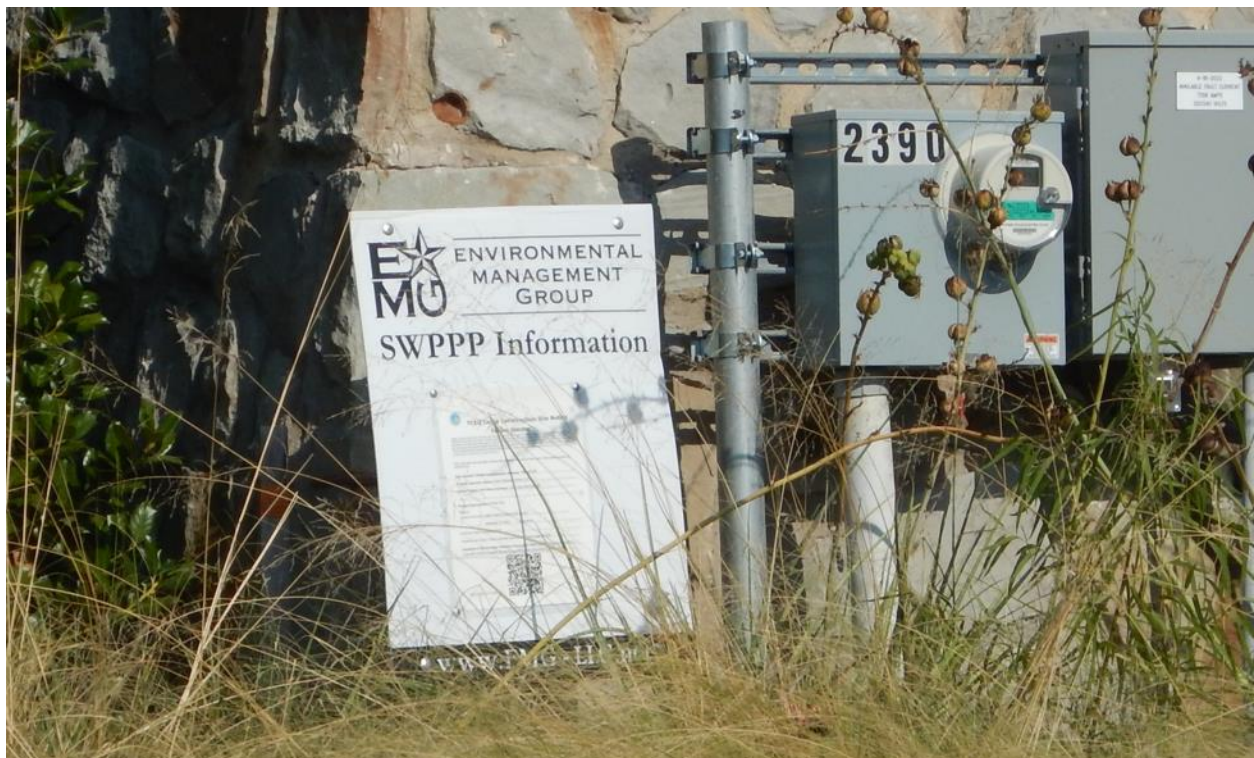
Photo No. 2

Description: Closer view, of Stormwater Pollution Prevention (SWPPP) Large Construction Site Notice posted at the intersection of Lake Forest Dr. and Summit View Dr.

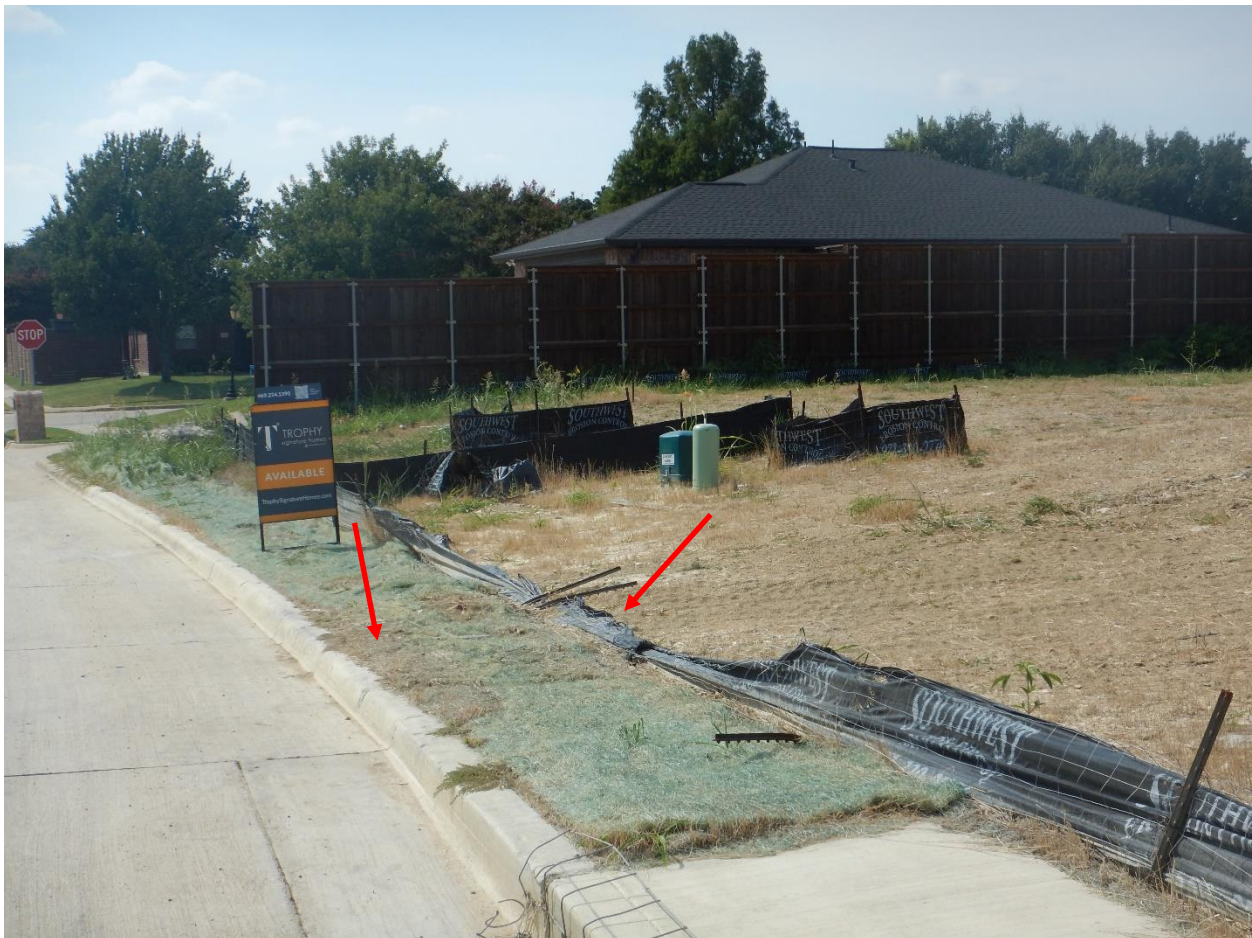
Photo No. 3

- i. Absent or damaged silt fencing and/or erosion blanket(s), and/or accumulated sediment observed in multiple areas (see Appendix 1, Photograph Log, Photo Nos. 3, 5, 7, 9, 10, 11, and 12);

Description: View, of Rustic Ridge Dr. near Highridge Dr. with ineffective BMPs indicated by (i.e., damaged erosion blanket and silt fencing).

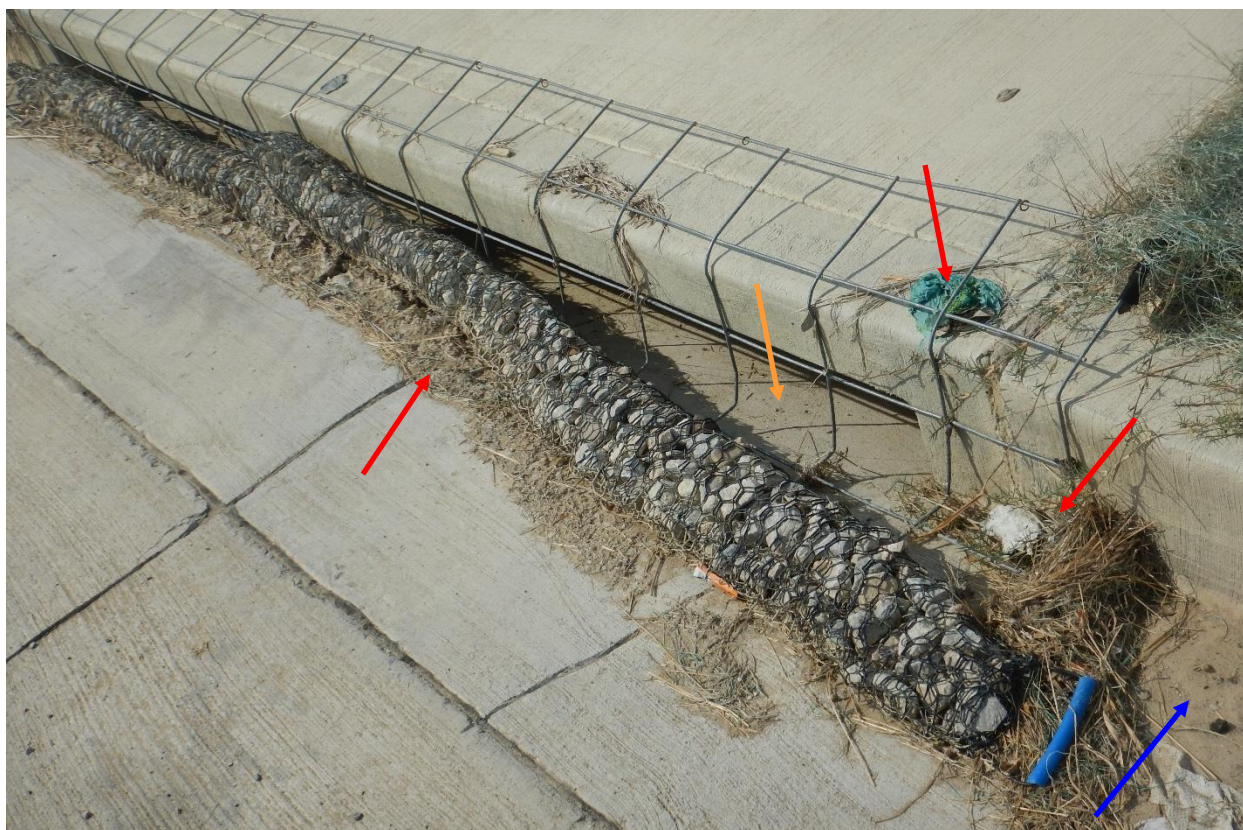
Photo No. 4

- ii. Sediment carry over into the access street from the construction area (see Appendix 1, Photograph Log, Photo Nos. 4, 5, 6, 7, and 9);
    - iii. Inlet protection was not maintained in an effective operating condition in multiple areas. The inlet protection was full of sediment and/or trash with the presence of

sediment leading to the inlet (see Appendix 1, Photograph Log, Photo Nos. 4, 6, and 13); and

- iv. Trash and/or construction debris was observed throughout the construction site (see Appendix 1, Photograph Log, Photo Nos. 4, 6, 7, 9, and 12).

Description: View, of inlet protection on Rustic Ridge Dr. (near Highridge Dr.), not maintained in an effective operating condition (e.g., inlet protection filled with and surrounded by sediment, dead vegetative growth, and debris (see red arrows). Sediment carry over observed in the in the access street (see blue arrow). In addition, there was also a noticeable gap in between the inlet protection and the drain (see orange arrow), which has the potential for the access vegetation, sediment, and debris to enter the storm drain.

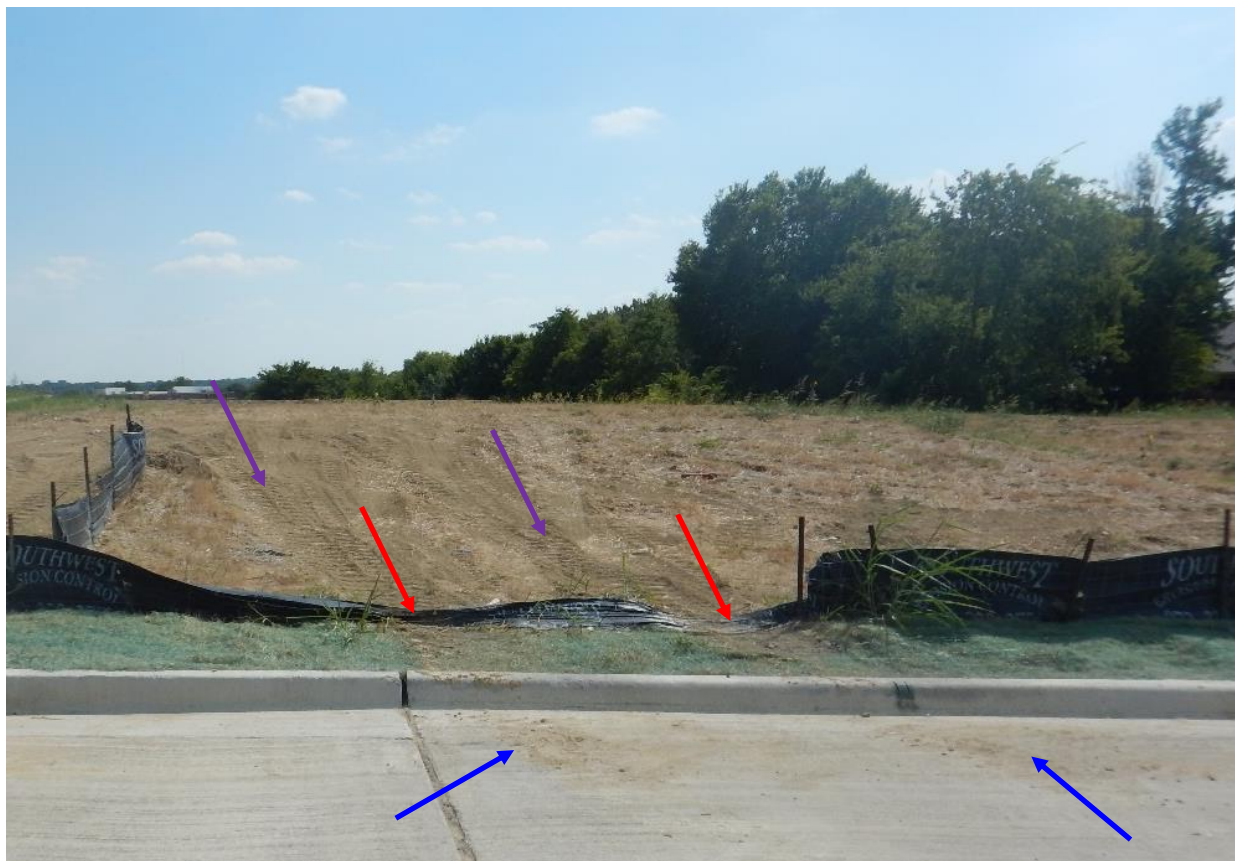
Photo No. 5

Description: View, of Rustic Ridge Dr. near Masfield Rd. with ineffective BMPs indicated by red arrows (i.e., damaged silt fencing). Tire tracks were also observed leading towards the access street from the construction area (see purple arrows). Sediment carry over observed in the in the access street (see blue arrow).

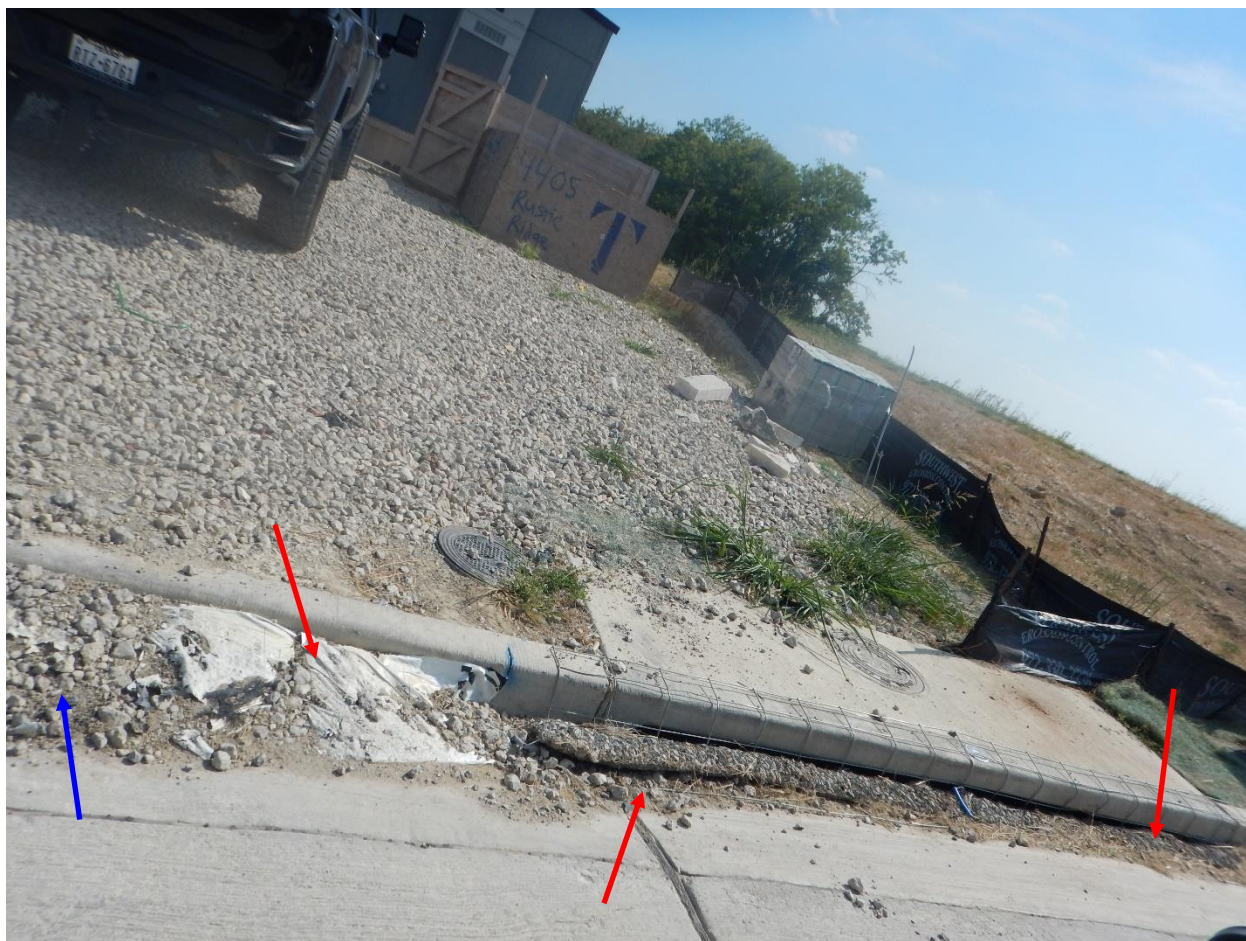
Photo No. 6

Description: View, of inlet protection near the corner of Rustic Ridge Dr. near Masefield Rd. (and immediately in front of the construction trailer), not maintained in an effective operating condition (e.g., inlet protection filled with and surrounded by sediment, gravel, and dead vegetative growth (see red arrows). Sediment carry over, gravel, and debris were observed in the in the access street (see blue arrow).

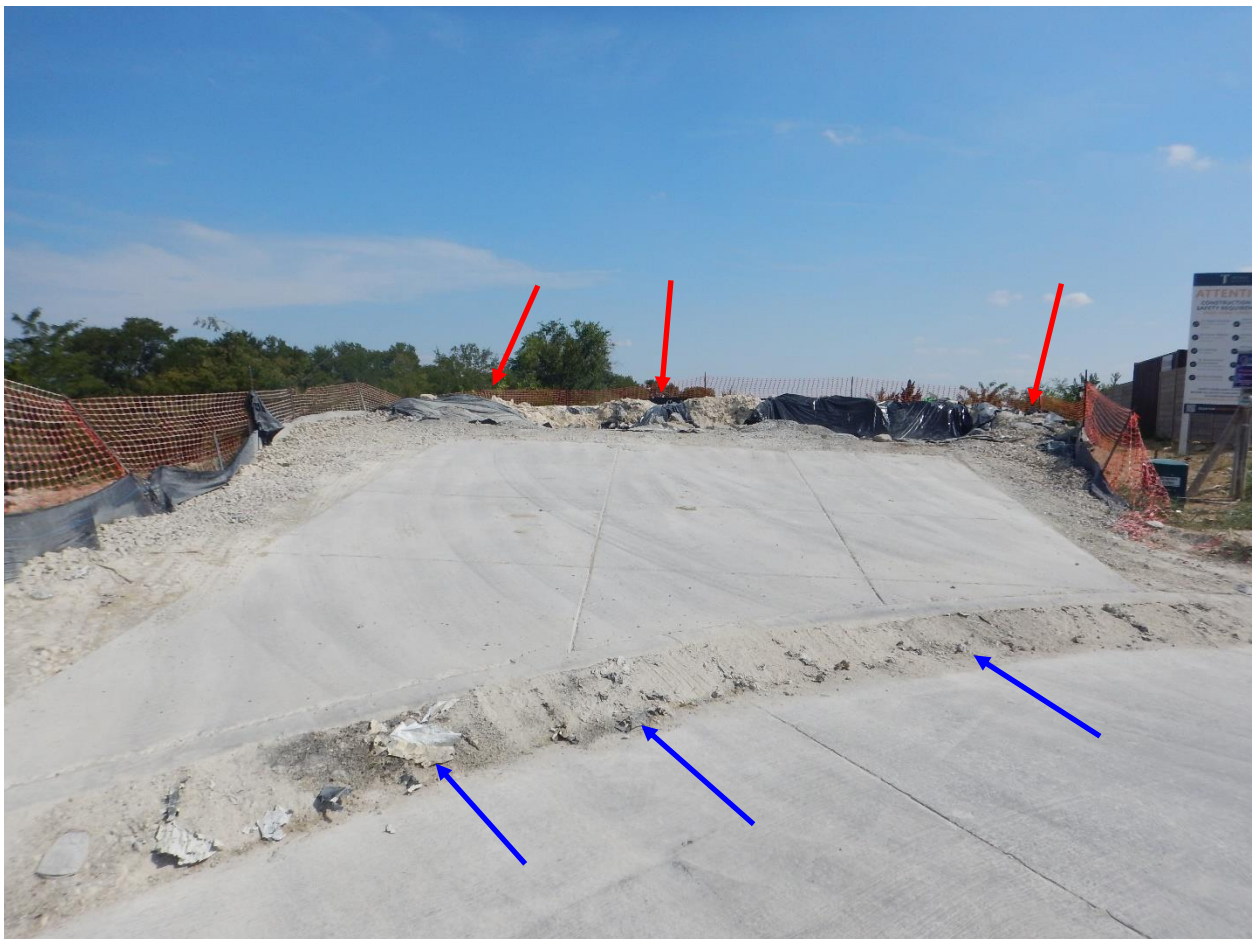
Photo No. 7

Description: View, of the construction site's concrete washout pad located at the intersection of Rustic Ridge Rd. and Masefield Rd., not maintained in an effective operating condition indicated by red arrows (e.g., damaged silt fencing). In addition, there was evidence of concrete washout, sediment carry over, and debris into the access road (immediately on the incline to the concrete washout pad) indicated by blue arrows. Closer views of concrete washout pad are captured in Photos #8 and #9.

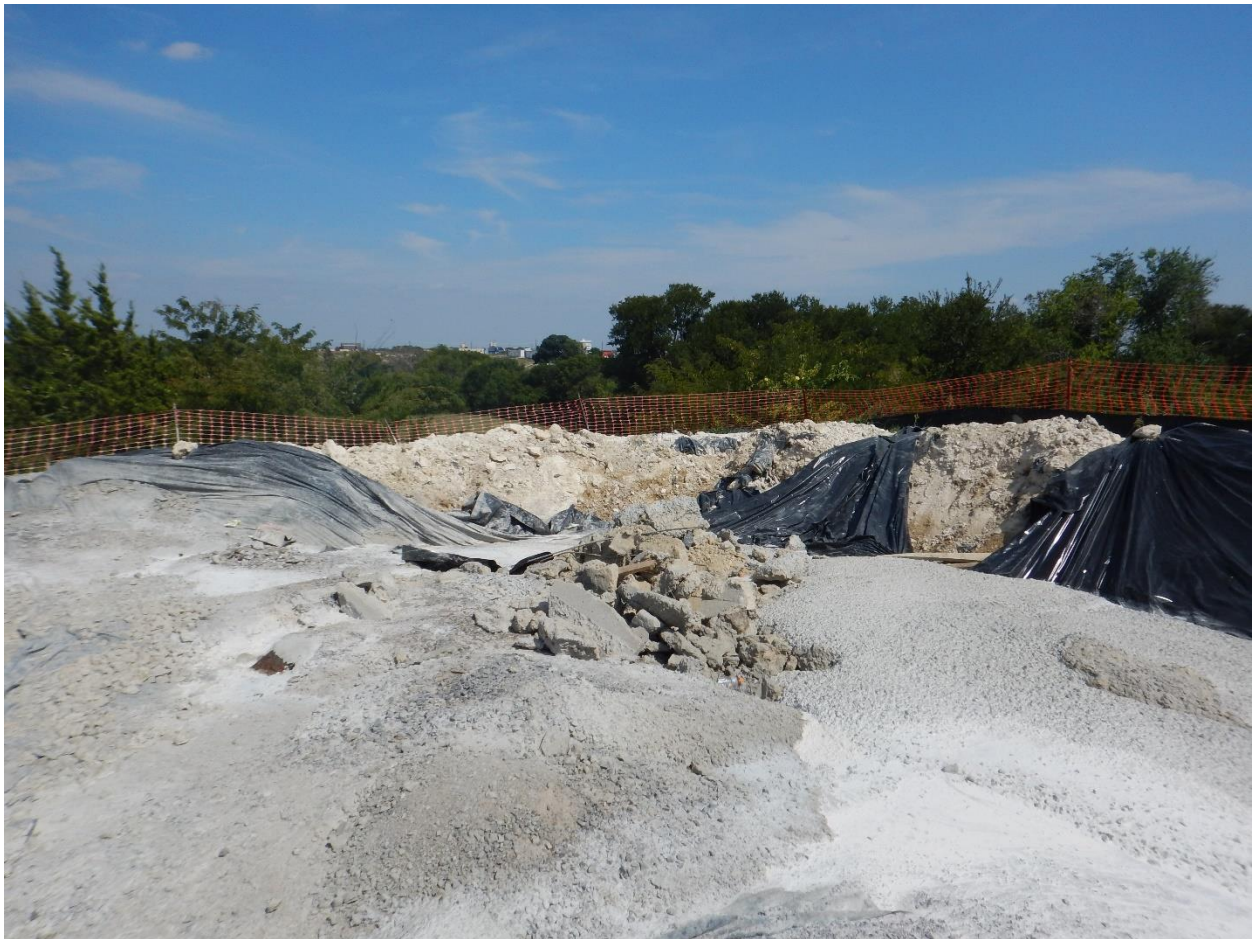
Photo No. 8

Description: Closer view, of the construction site's concrete washout pad located at the intersection of Rustic Ridge Rd. and Masefield Rd., not maintained in an effective operating condition.

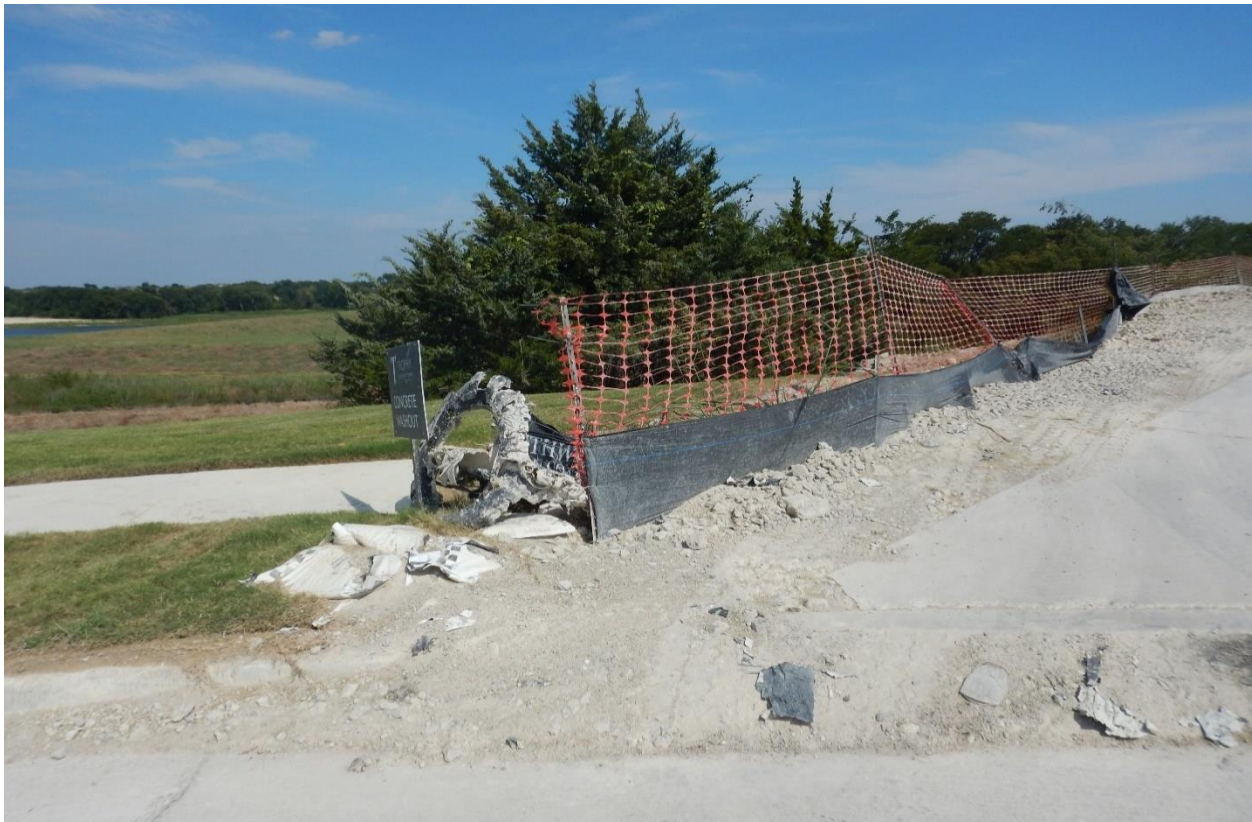
Photo No. 9

Description: Closer view, of the construction site's concrete washout pad located at the intersection of Rustic Ridge Rd. and Masefield Rd., not maintained in an effective operating condition.

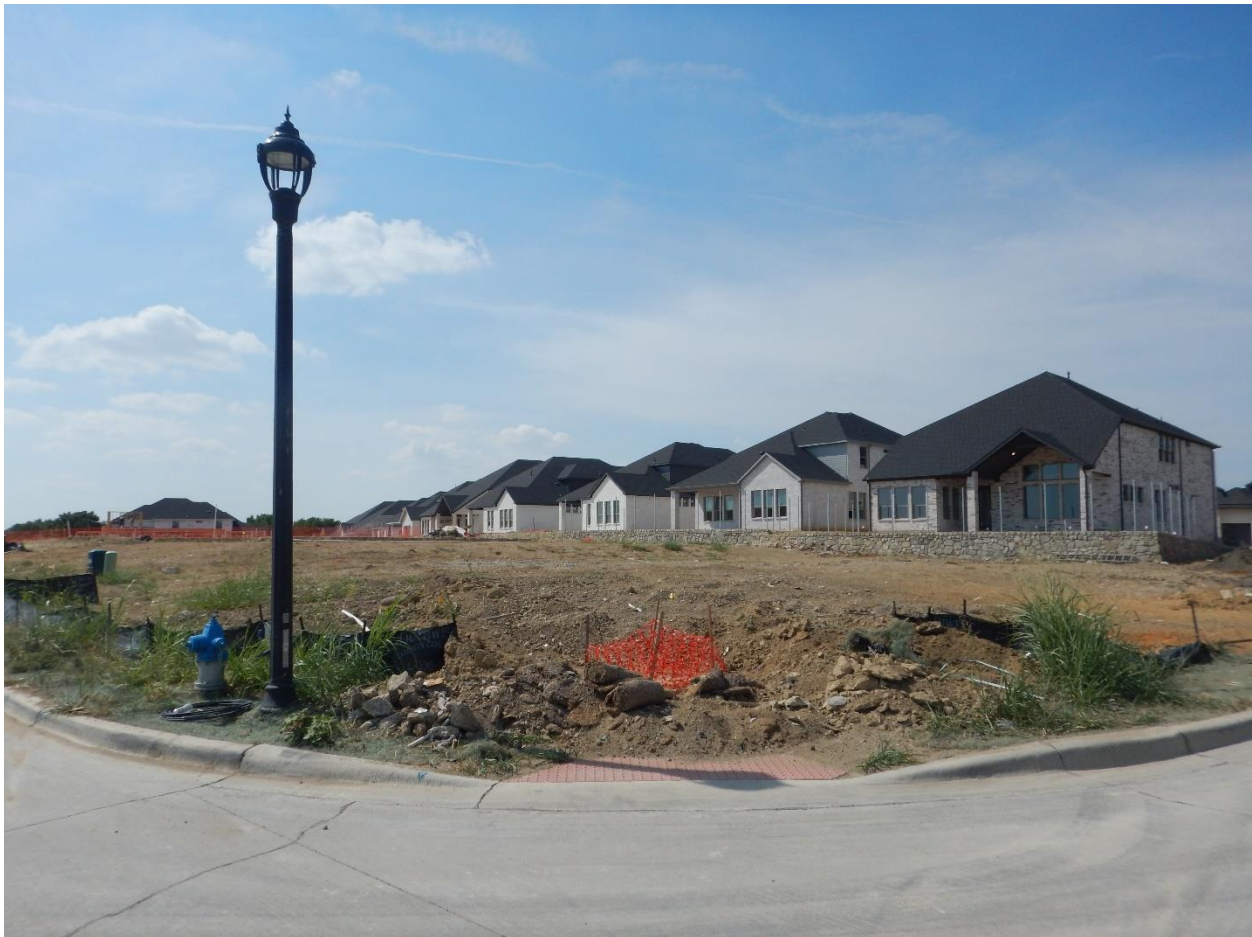
Photo No. 10

Description: View, of construction area on Rustic Ridge Dr. and Masefield Dr. a view of ineffective BMPs indicated by red arrows (i.e., damaged and/or no silt fencing). Mounds of loose gravel and dirt were noted on the sidewalk.

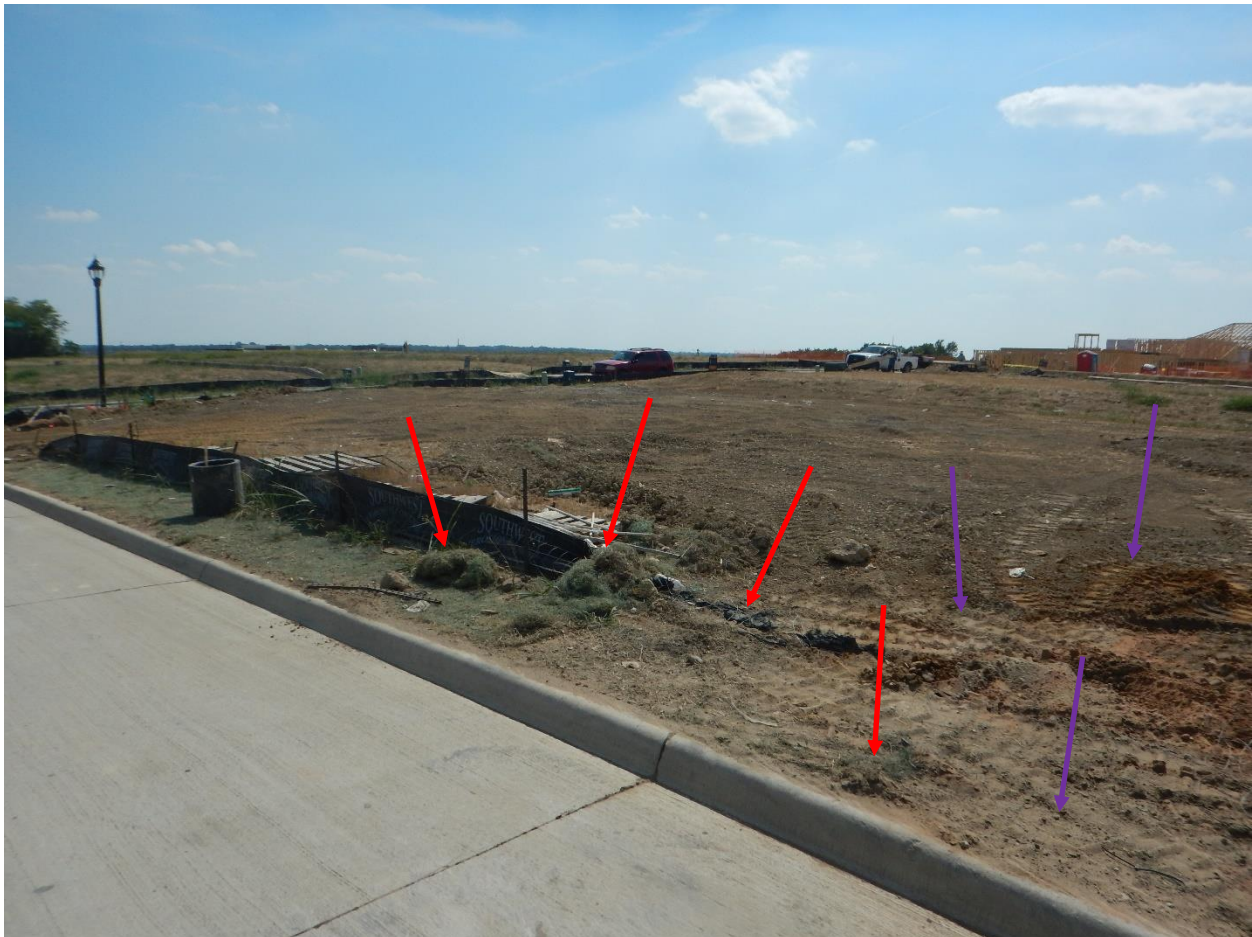
Photo No. 11

Description: View, of construction area on Masefield Rd., of ineffective BMPs indicated by red arrows (i.e., damaged erosion blanket(s) and absent and/or damaged silt fencing). Tire tracks were also observed leading towards the access street from the construction area (see purple arrows).

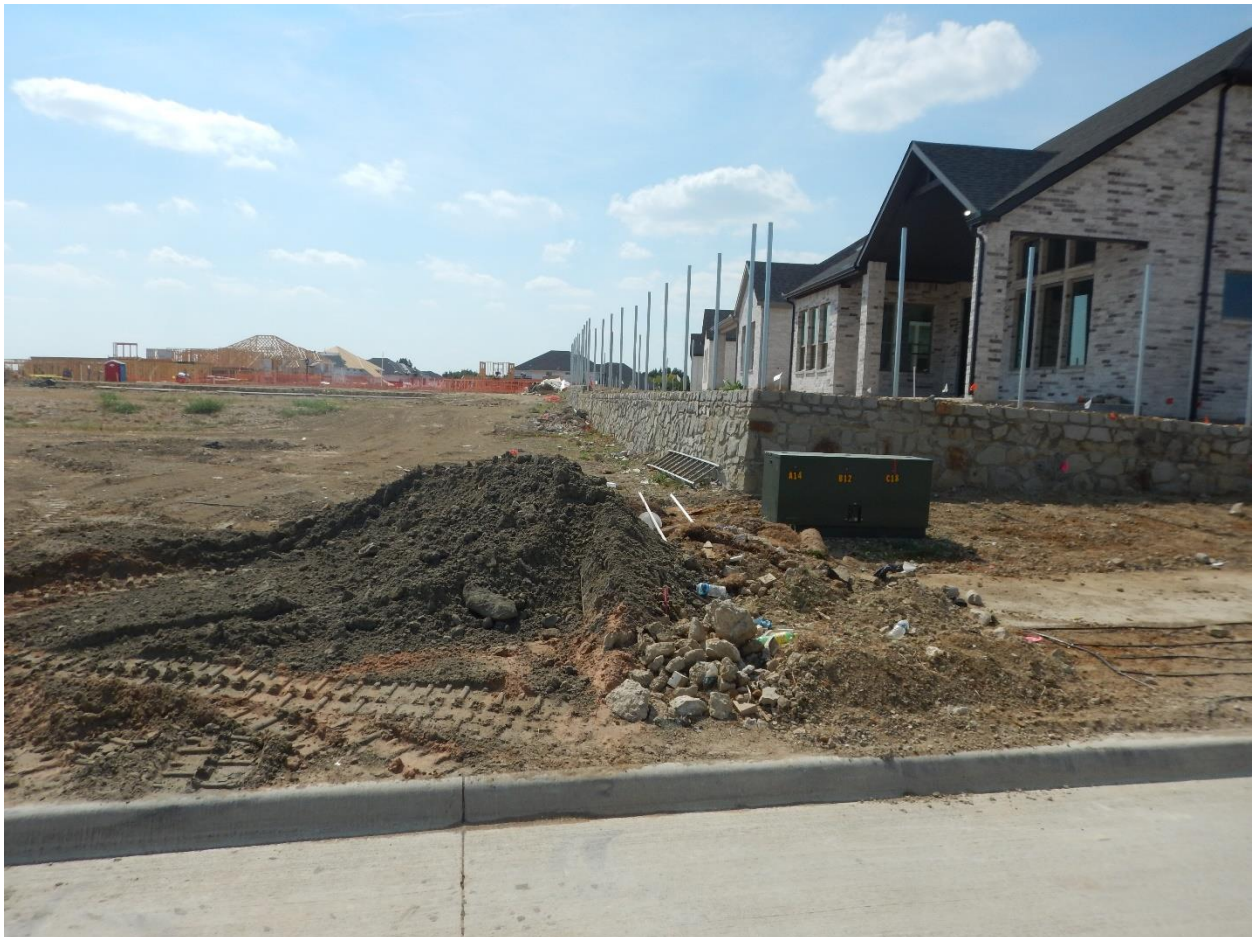
Photo No. 12

Description: View, of uncontained dirt, gravel, and sediment with trash and other debris contained throughout the area. Note: Tire tracks were also observed leading towards the access street from the construction area.

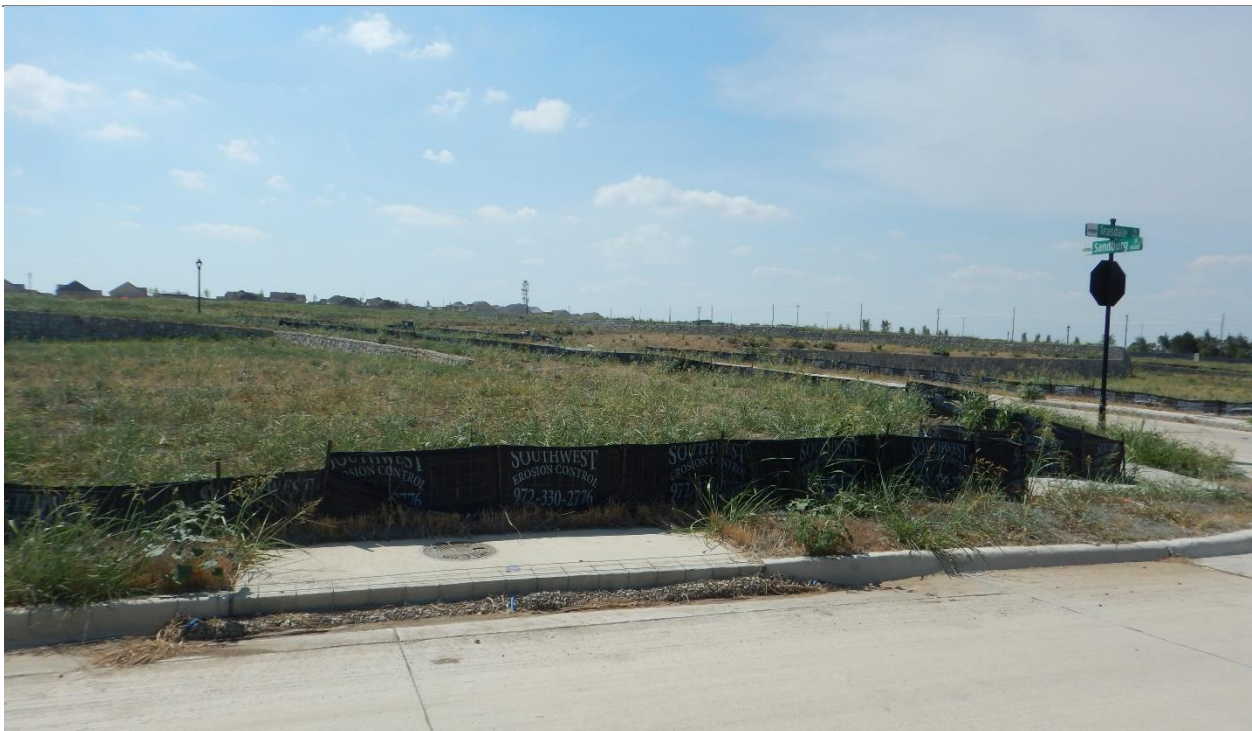
Photo No. 13

Description: View, of inlet protection on Teasdale Dr. near Sandburg St., not maintained in an effective operating condition (e.g., inlet protection filled with and surrounded by sediment and dead vegetative growth. Sediment carry over was observed in the in the access street.
