**Region 6 Compliance Assurance and Enforcement Division  
INSPECTION REPORT**

| Facility Name: | Ogle Cattle Co. | | |
| Identification/Permit Number: | TXG920157 | | |

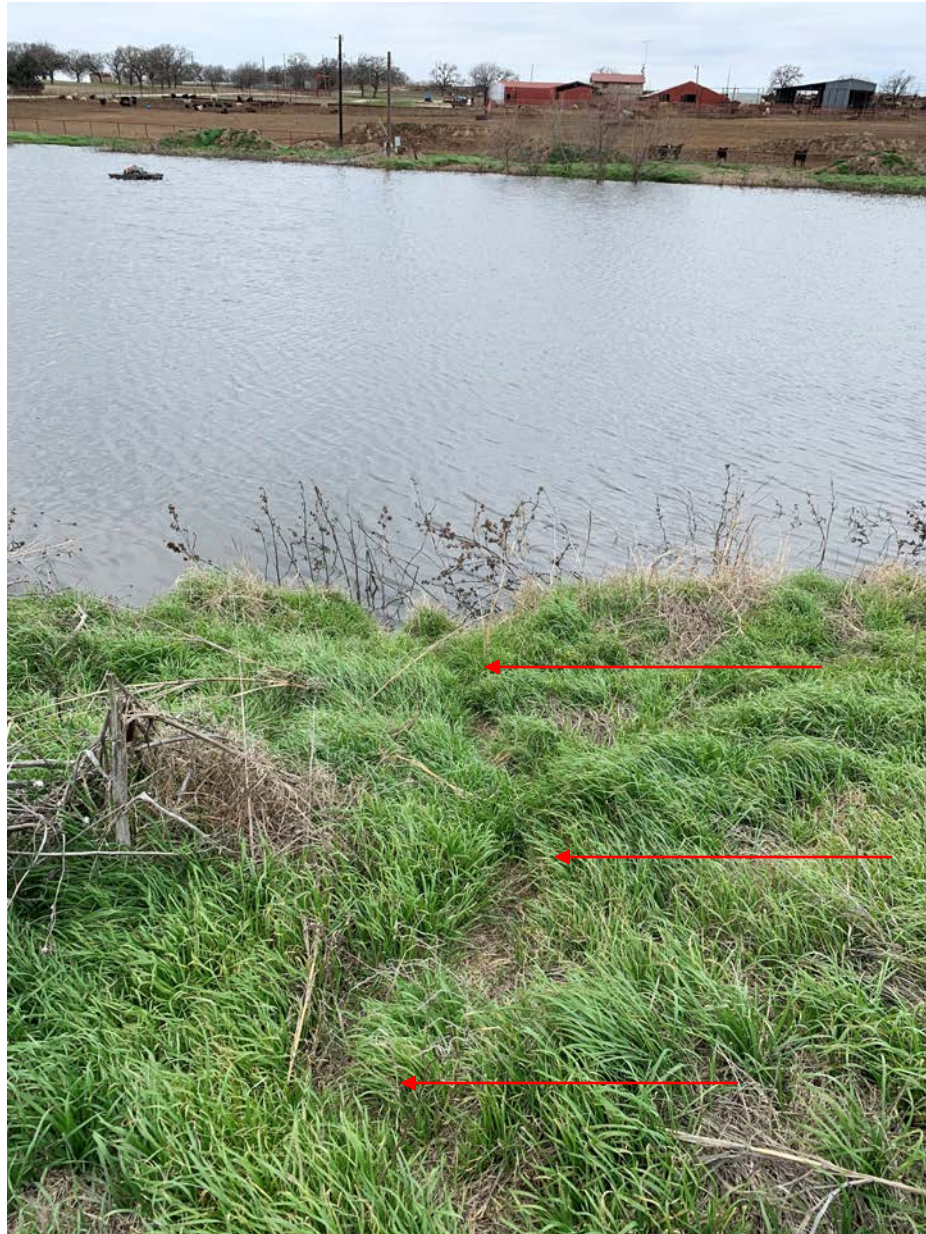
Photo No. 1

Description: This photo was taken from the northern berm of RCS #1 facing west. Note the impression evident in the berm. The facility's consultant informed us that they believed them to be wild hog walk-line tracks.

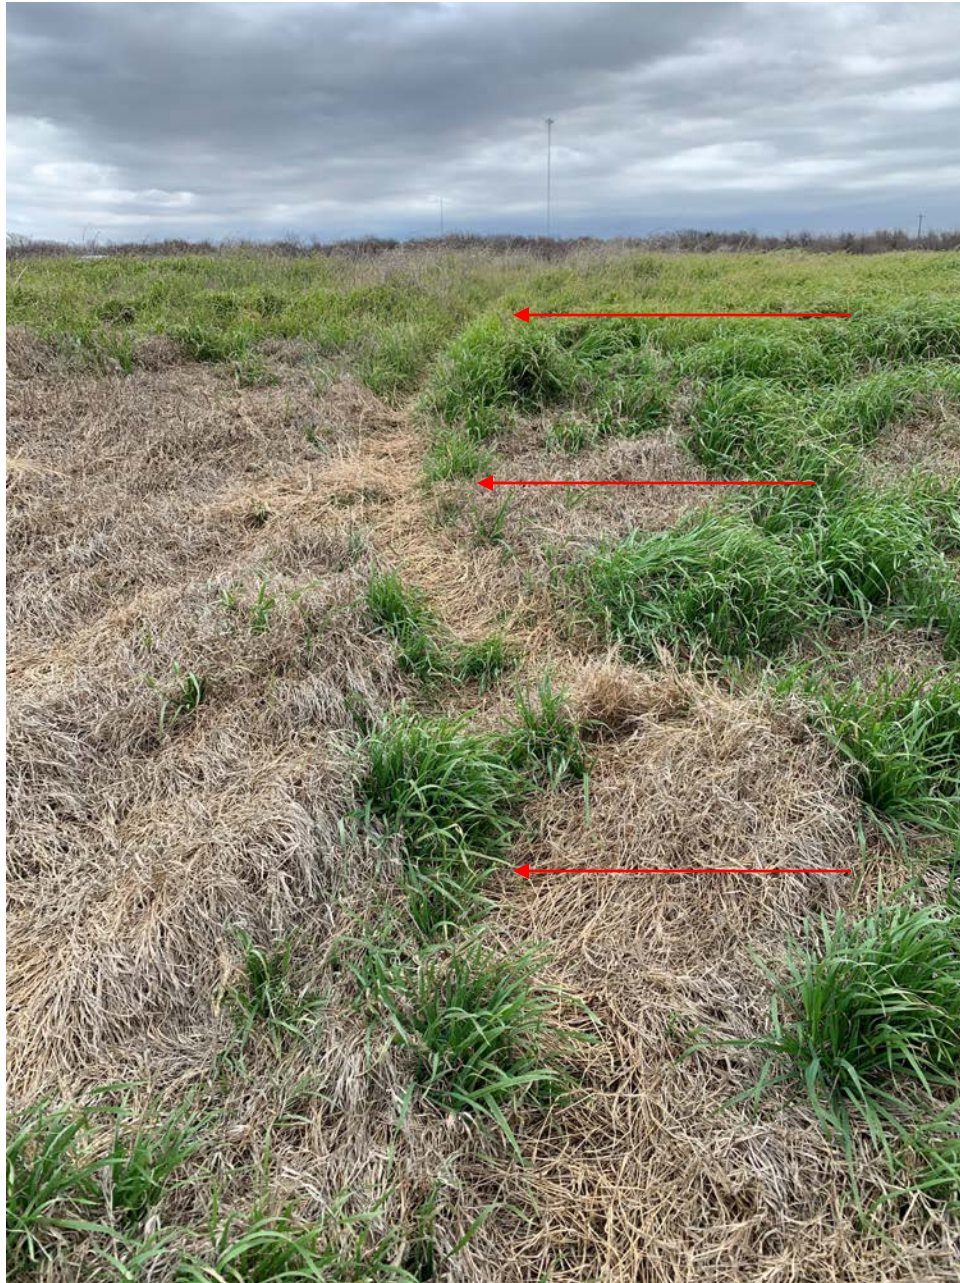
Photo No. 2

Description: This photo was taken from base of the northern berm of RCS #1 facing south. Note the impression evident in the berm. The facility's consultant informed us that they believed them to be wild hog walk-line tracks.

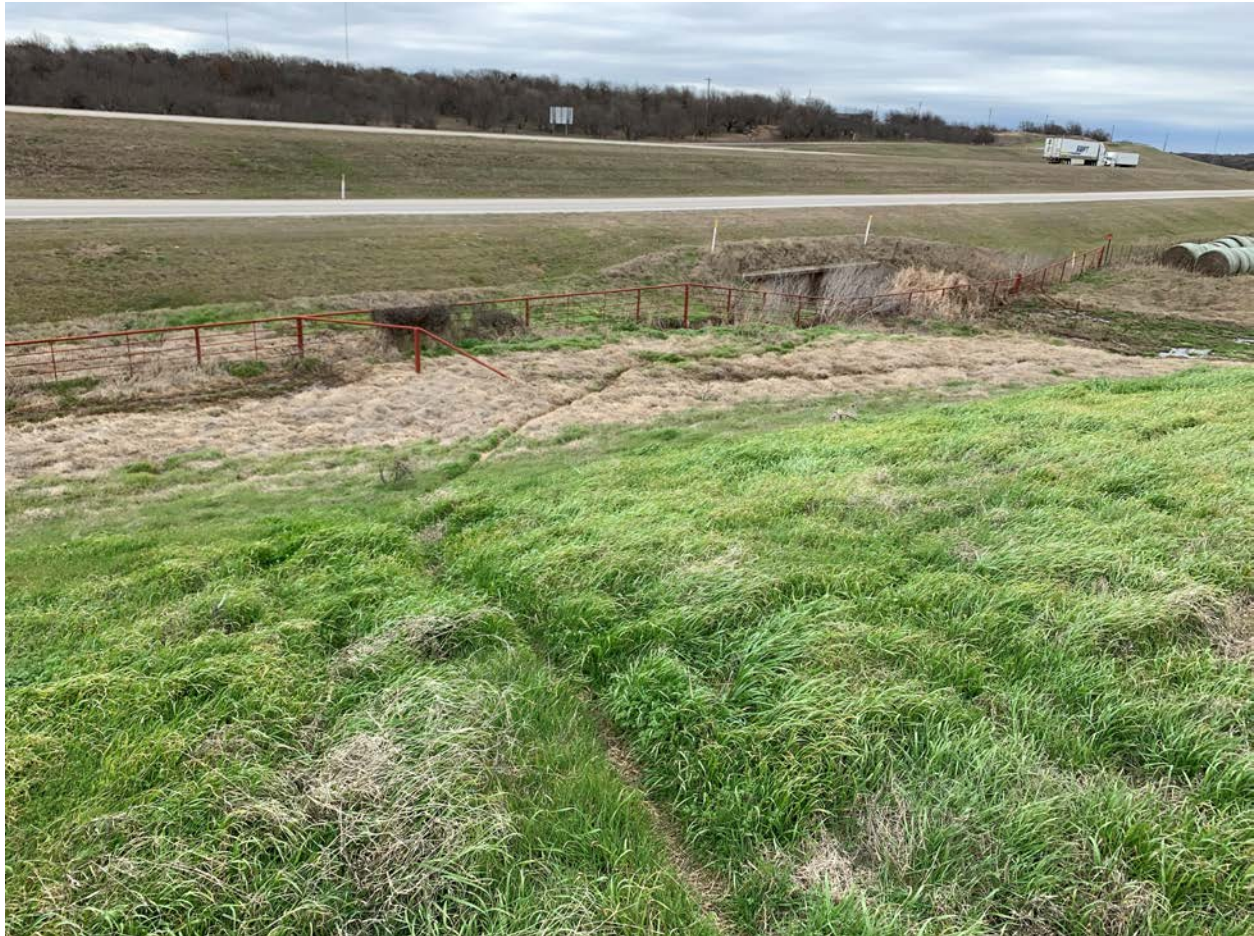
Photo No. 3

Description: This photo was taken from the top of the northern berm of RCS #1 facing east. Note the impression which appears to run from the interior of RCS #1 directly to Brier Creek. The facility's consultant informed us that they believed them to be wild hog walk-line tracks.

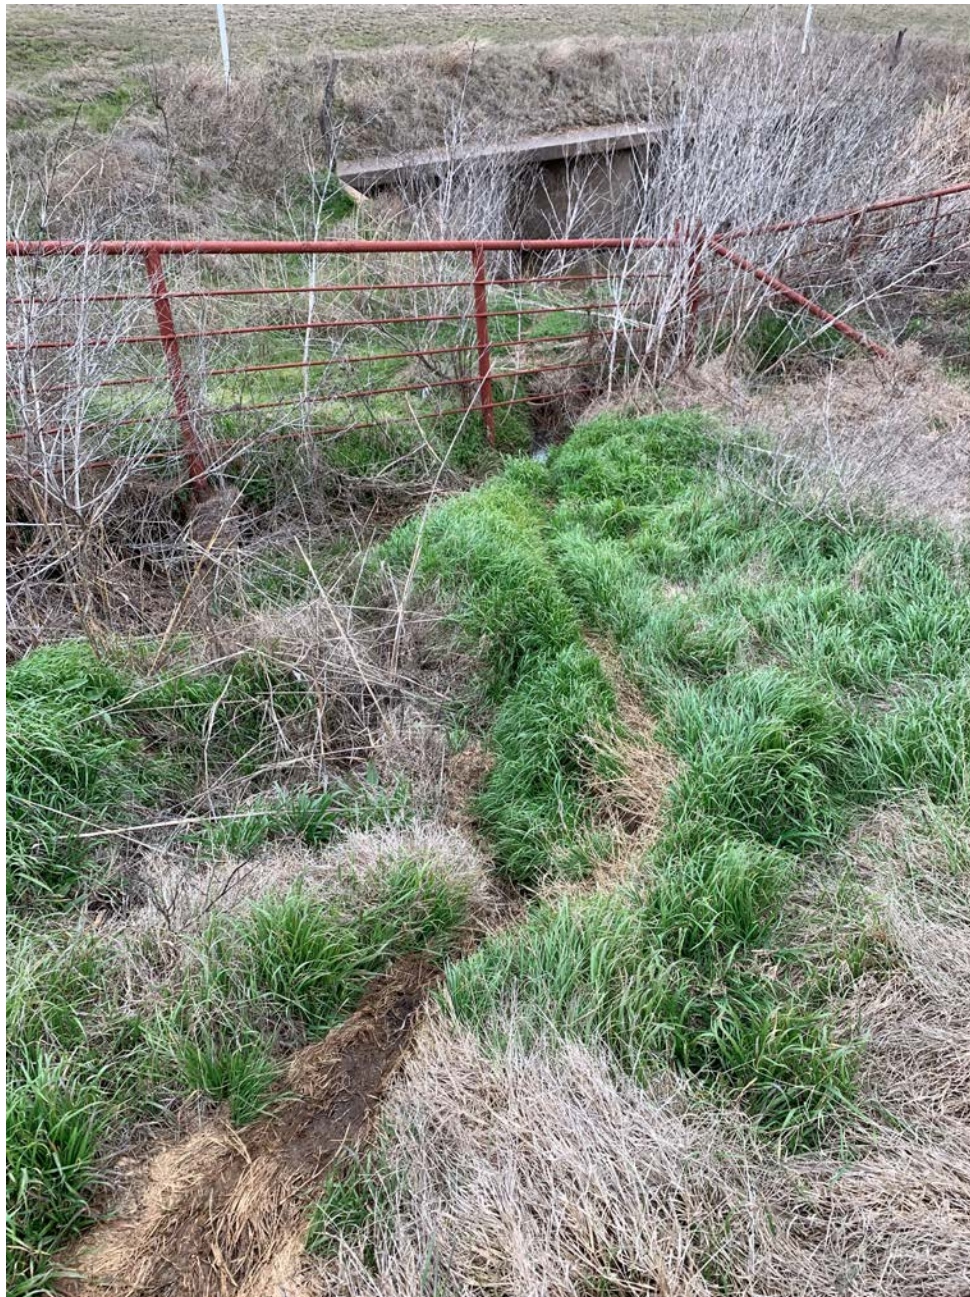
Photo No. 4

Description: This photo was taken at the point where the impression meets the RCS #1 discharge conveyance.

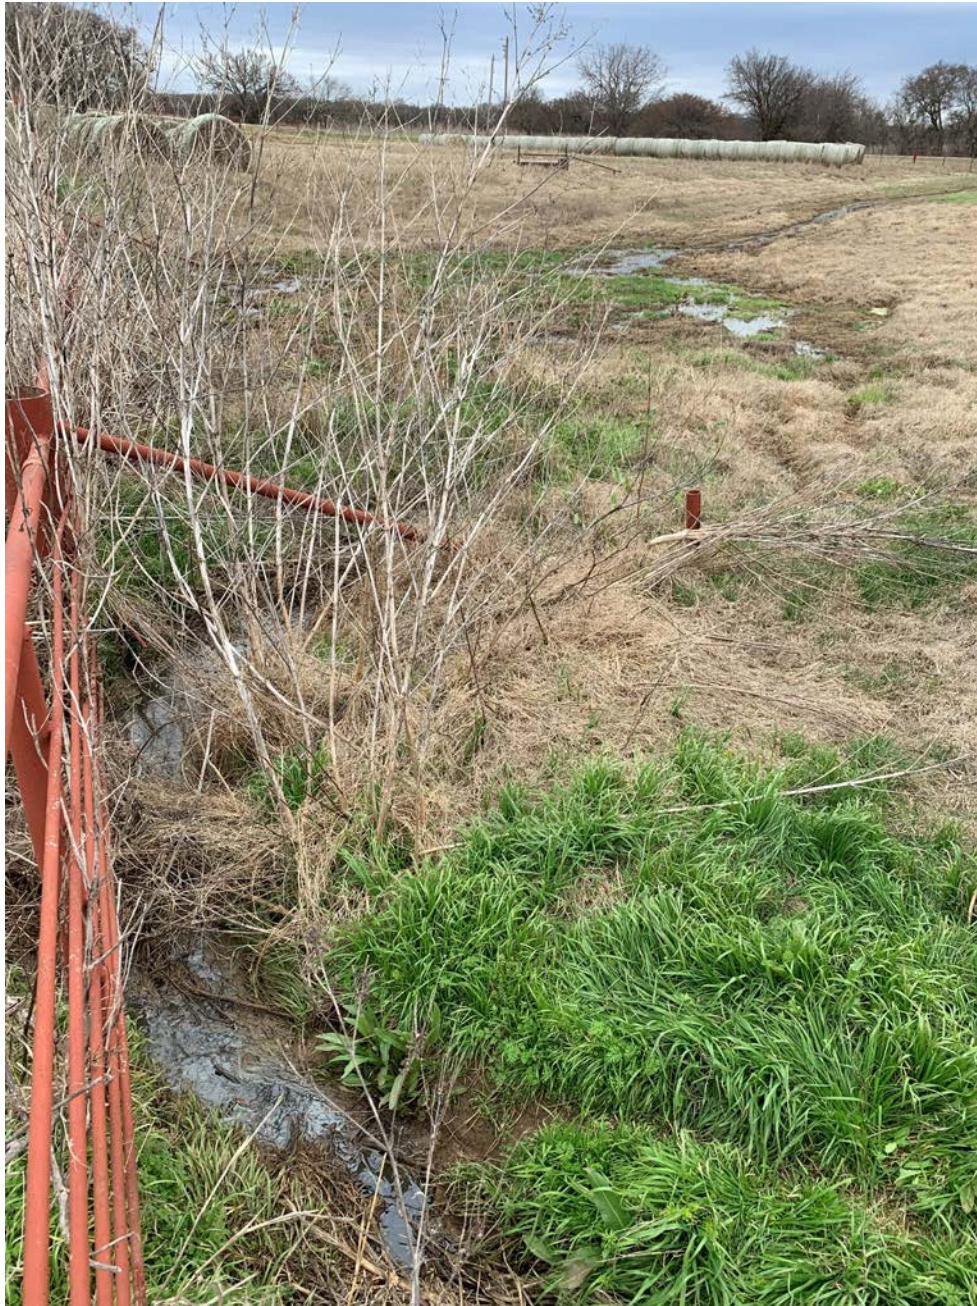
Photo No. 5

Description: This photo was taken facing southeast toward the point at which the discharge from RCS #1 meets Brier Creek.

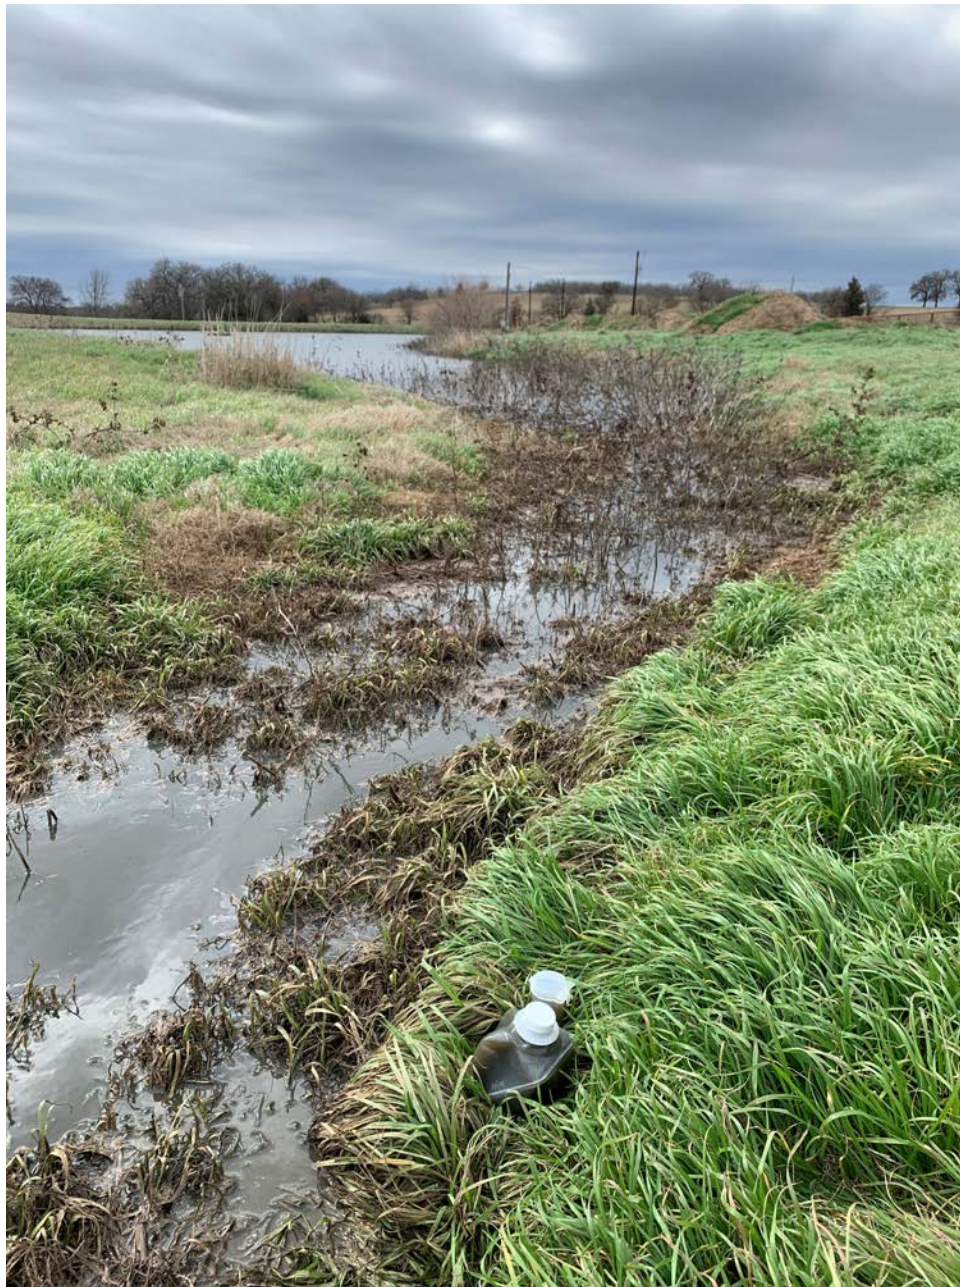
Photo No. 6

On the day of the inspection we observed a discharge emanating from the northwestern corner of RCS #1 [AOC 3] (Photo #6). We followed the flowpath of this discharge until it reached Brier Creek (Photos #11-12). We collected two samples of this discharge which are explained in Discharge Sampling Results

3. Process wastewater was discharging from the northwestern corner of RCS #1. Per TXG920157, the facility shall not discharge unless at least one of the criteria in Part III.A.5(3)(ii) is met.

Description: This photo was taken facing west across the discharge as it exited RCS #1 The sample containers in the photo were sitting just to the right of where they were collected.

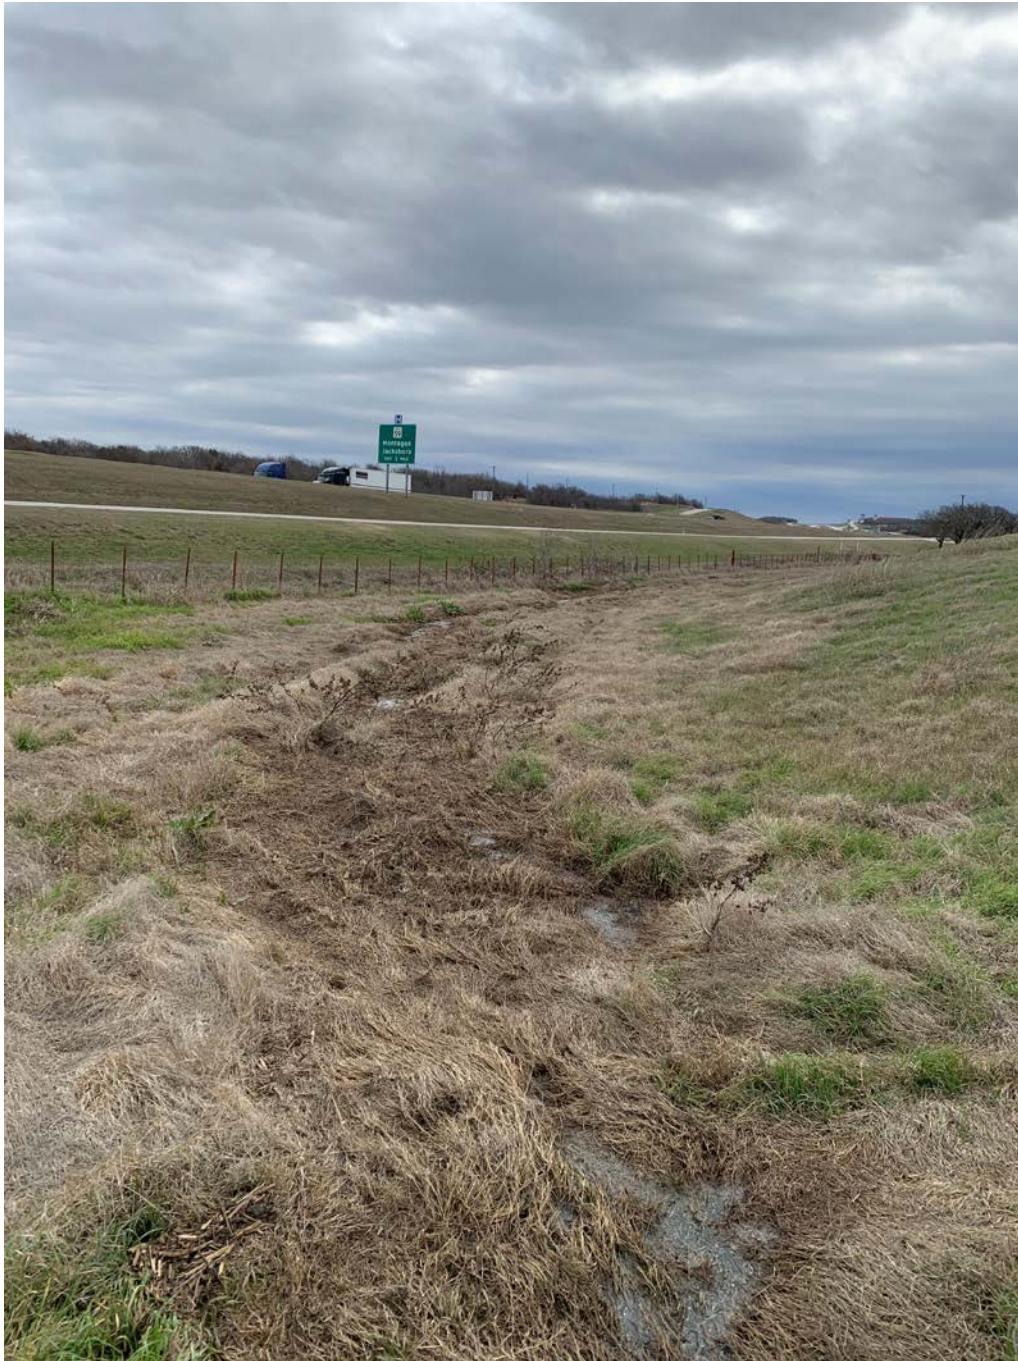
Photo No. 7

Description: This photo was taken facing east across the flowpath of the discharge.

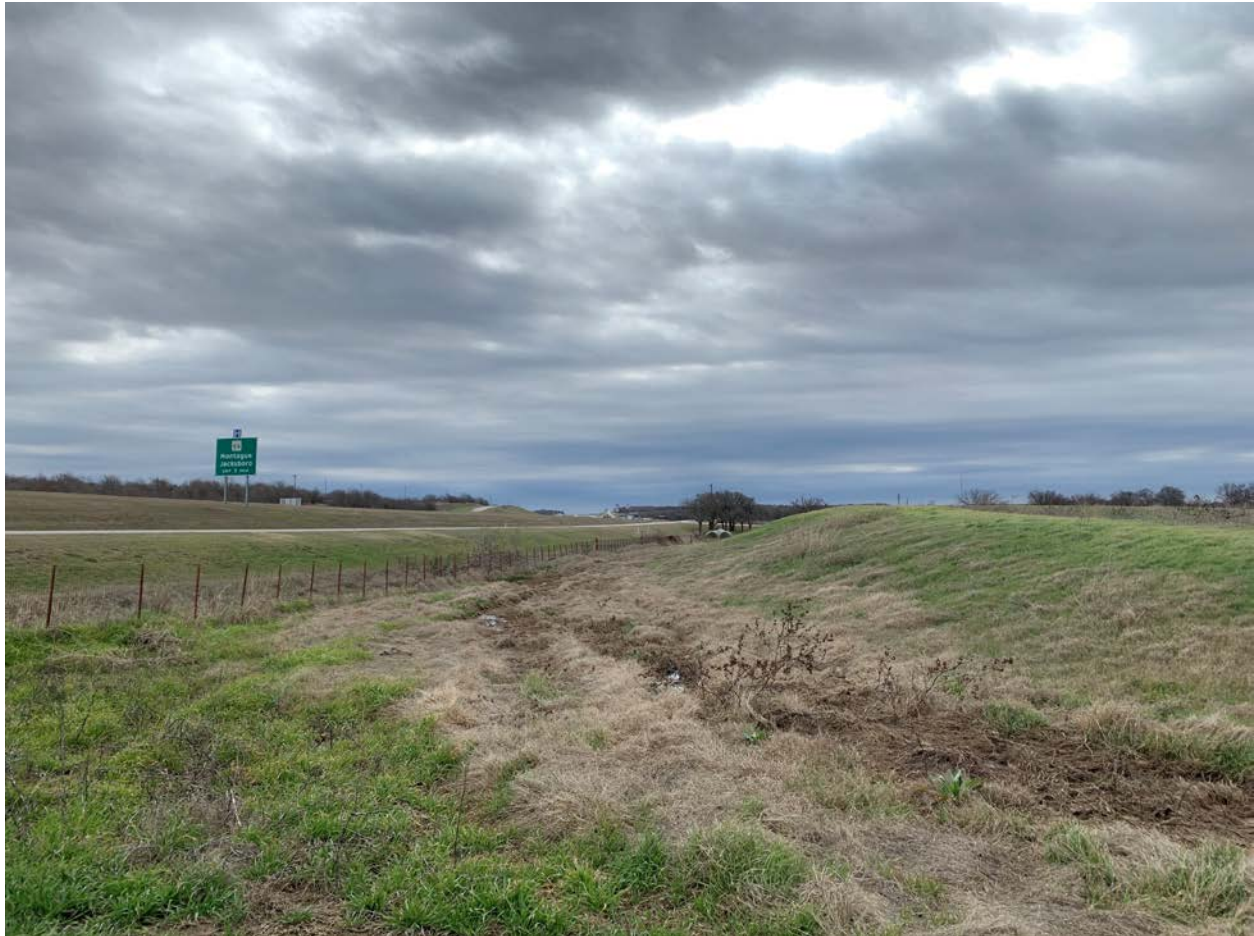
Photo No. 8

Description: This photo was taken facing southeast across the flowpath of the discharge from RCS #1.

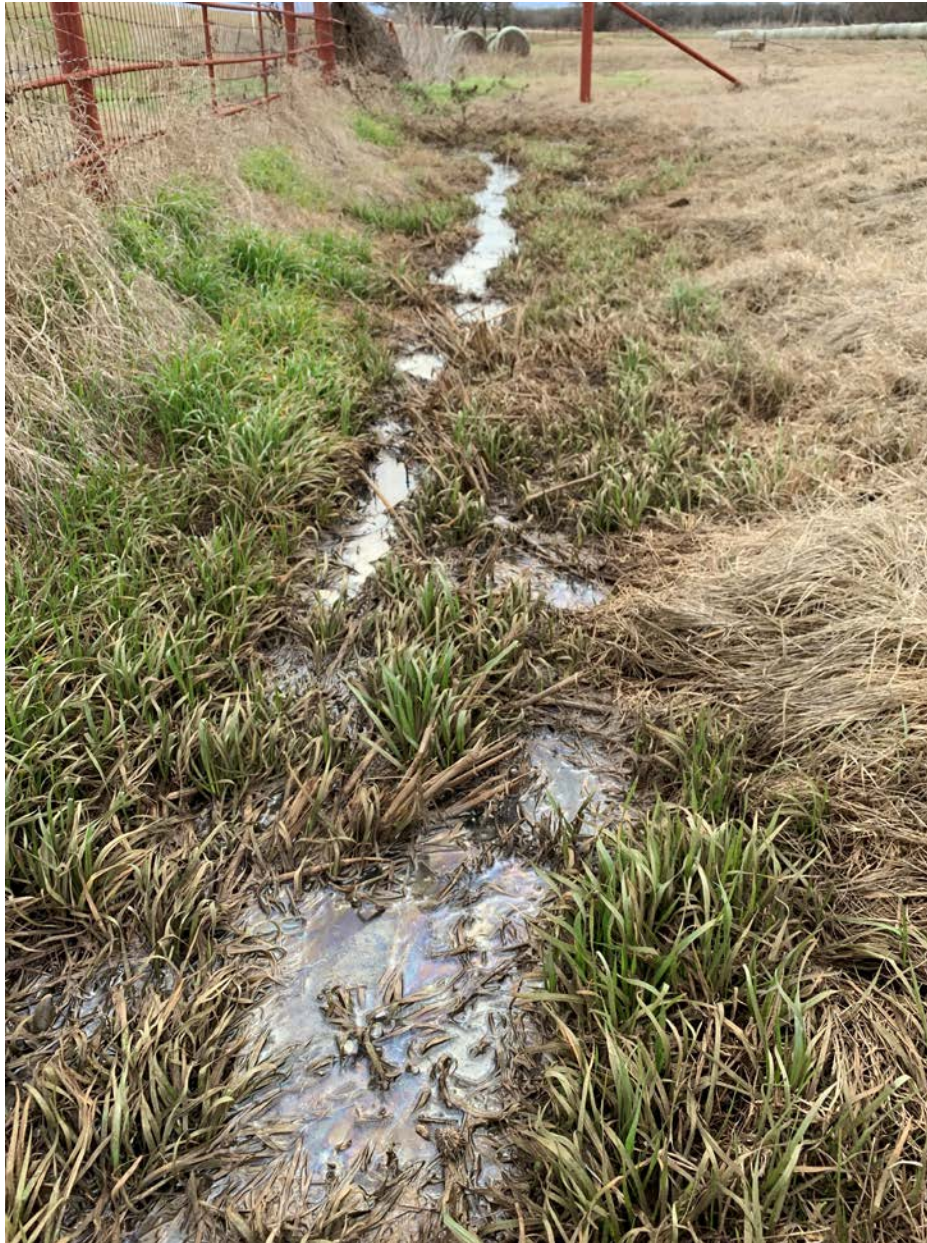
Photo No. 9

Description: This photo was taken facing southeast across the flowpath of the discharge from RCS #1.

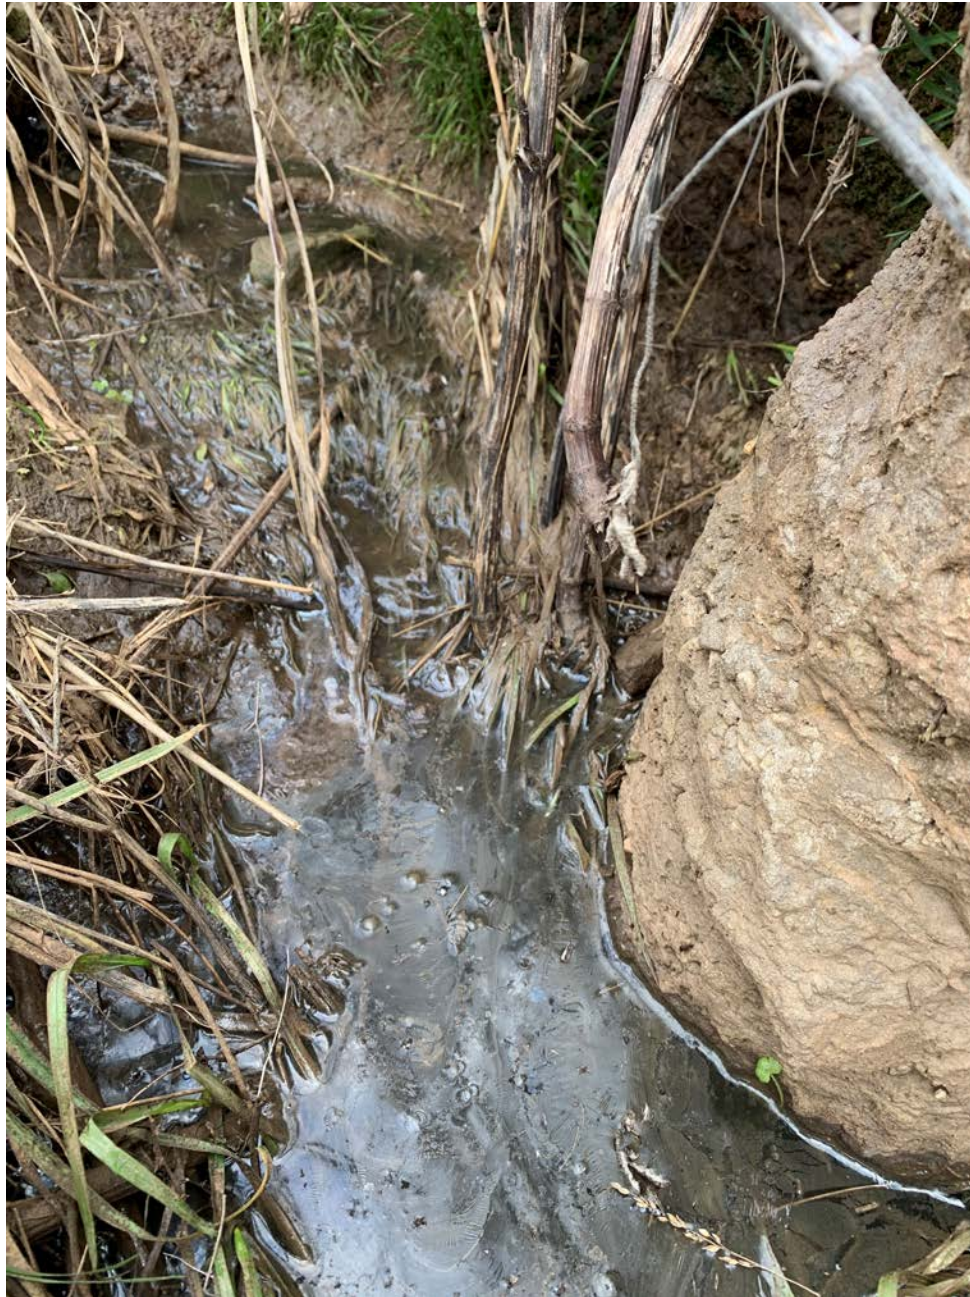
Photo No. 10

Description: This photo was taken facing the discharge from RCS #1. Note the ripples in the discharge which were evidence of active flow.

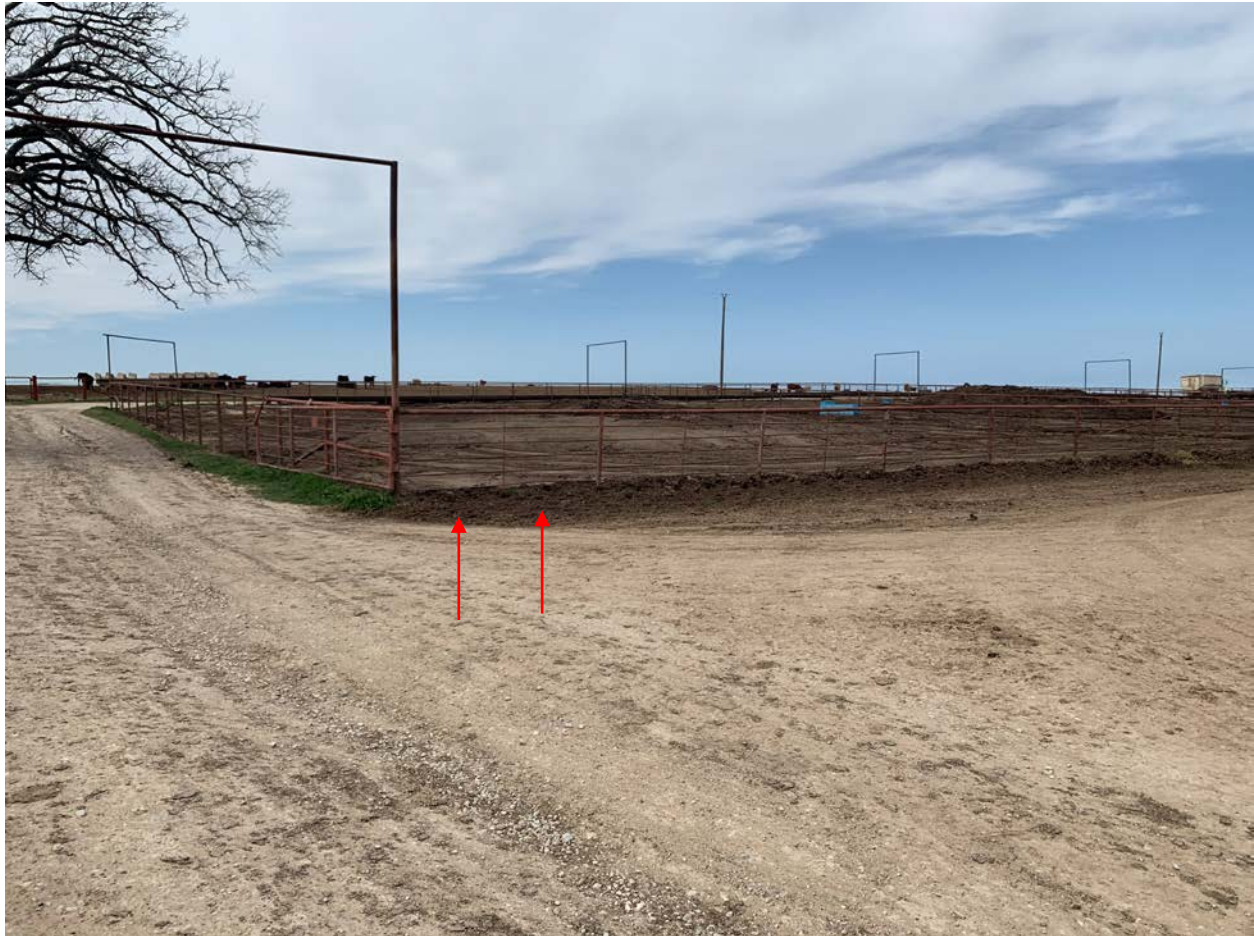
Description: This photo was taken facing northwest toward the southernmost open lot on the west side of the production area. The very low berm present at this corner would likely be inadequate to channel and contain the 25 yr/24 hr rain event toward the RCS. Because of this, runoff from this area would likely go to the bar ditch and thence Brier Creek.

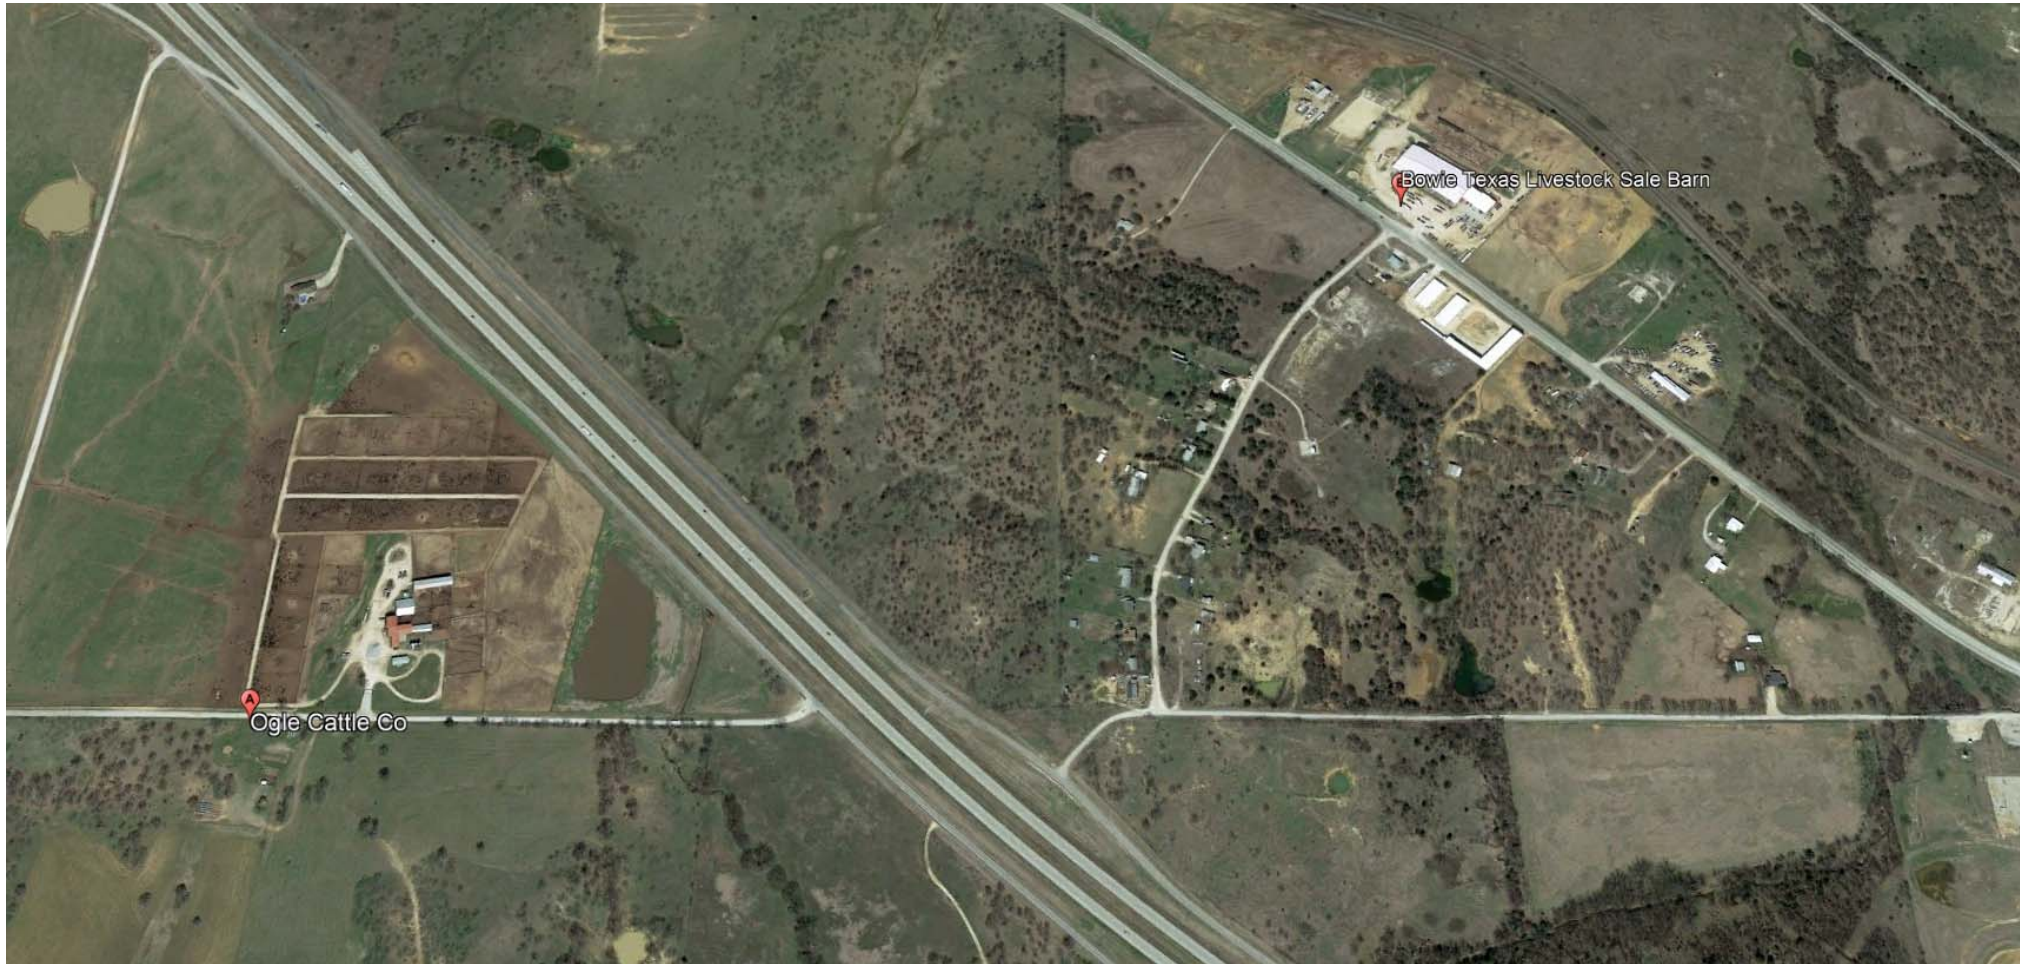
**Fig 1. USGS Aerial Map showing Ogle Cattle Co and Bowie Texas Livestock Sale Barn.**

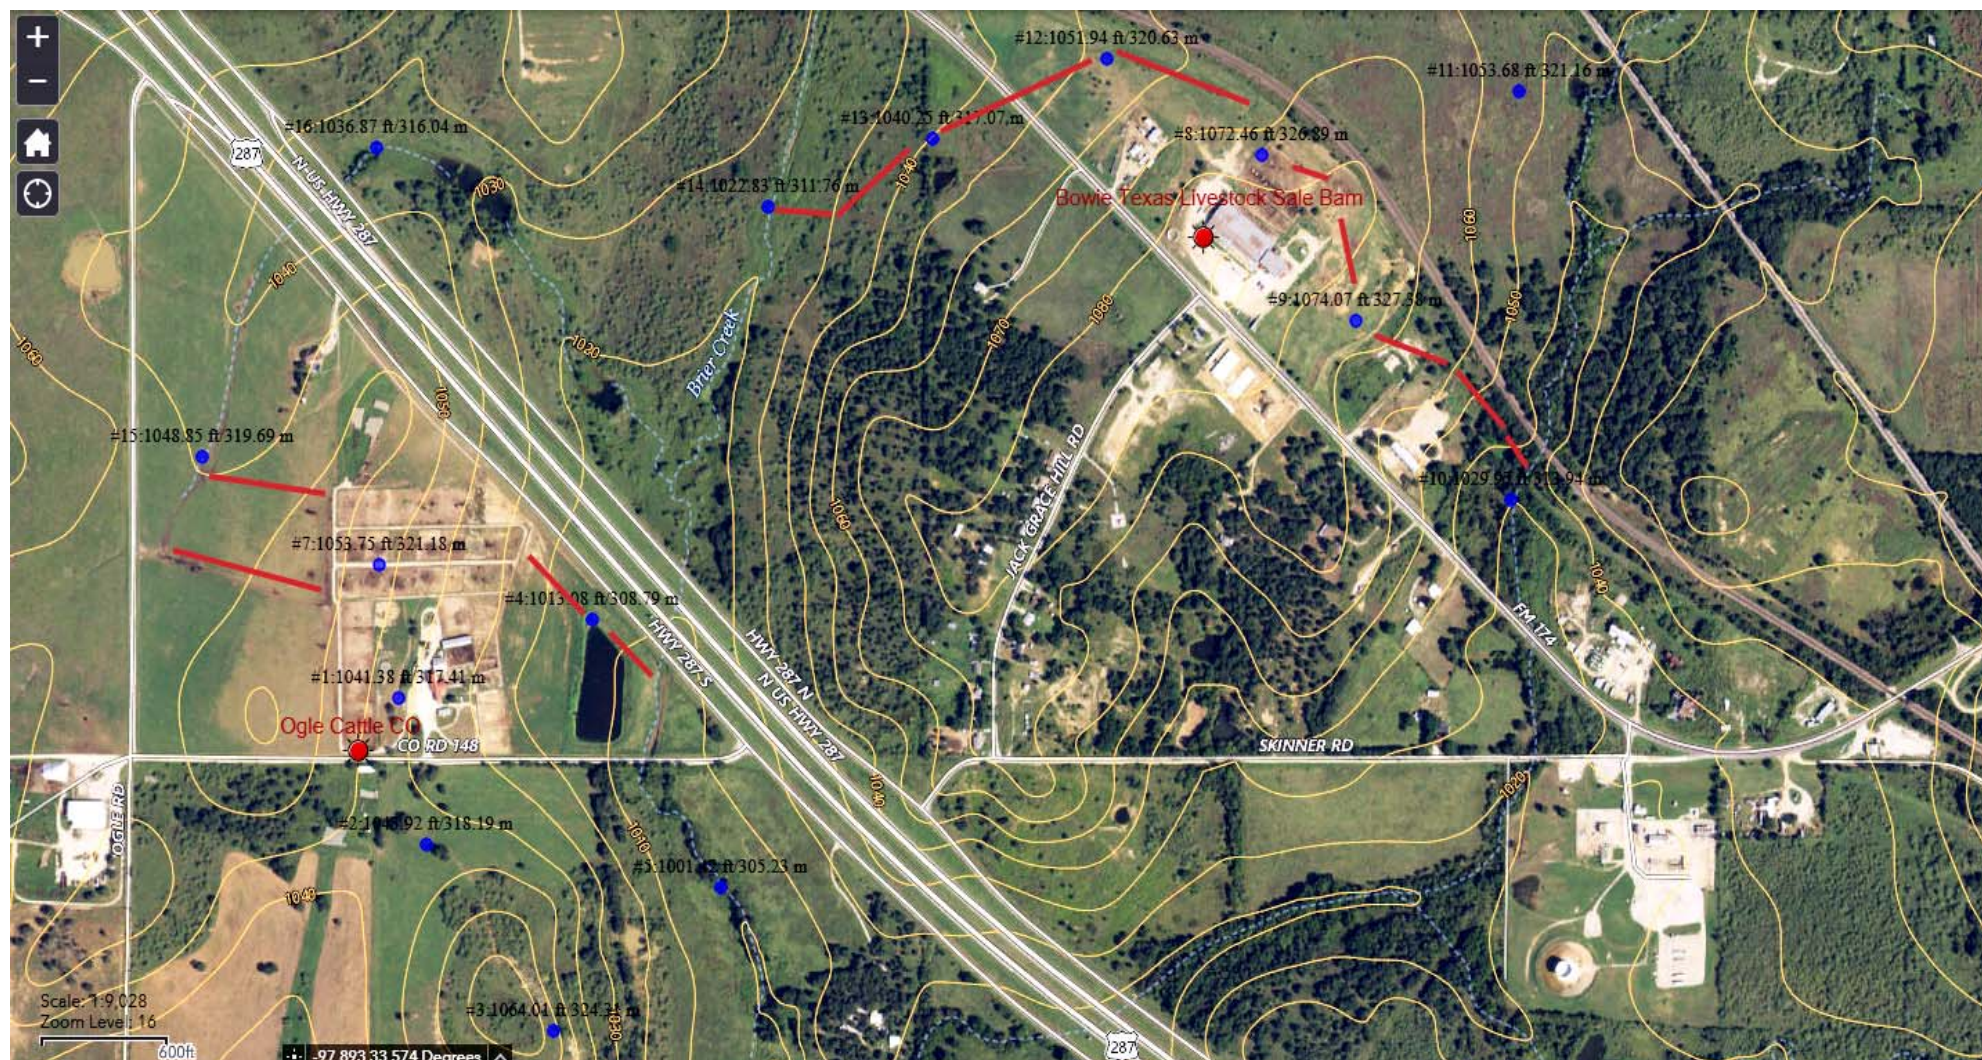
Fig 2. USGS Aerial Map showing Ogle Cattle Co and Bowie Texas Livestock Sale Barn. The red colored pin indicates the location of facilities, blue line indicates intermittent stream and a relative permanence, red lines indicates potential pathways of discharge, and blue dots indicates elevation.

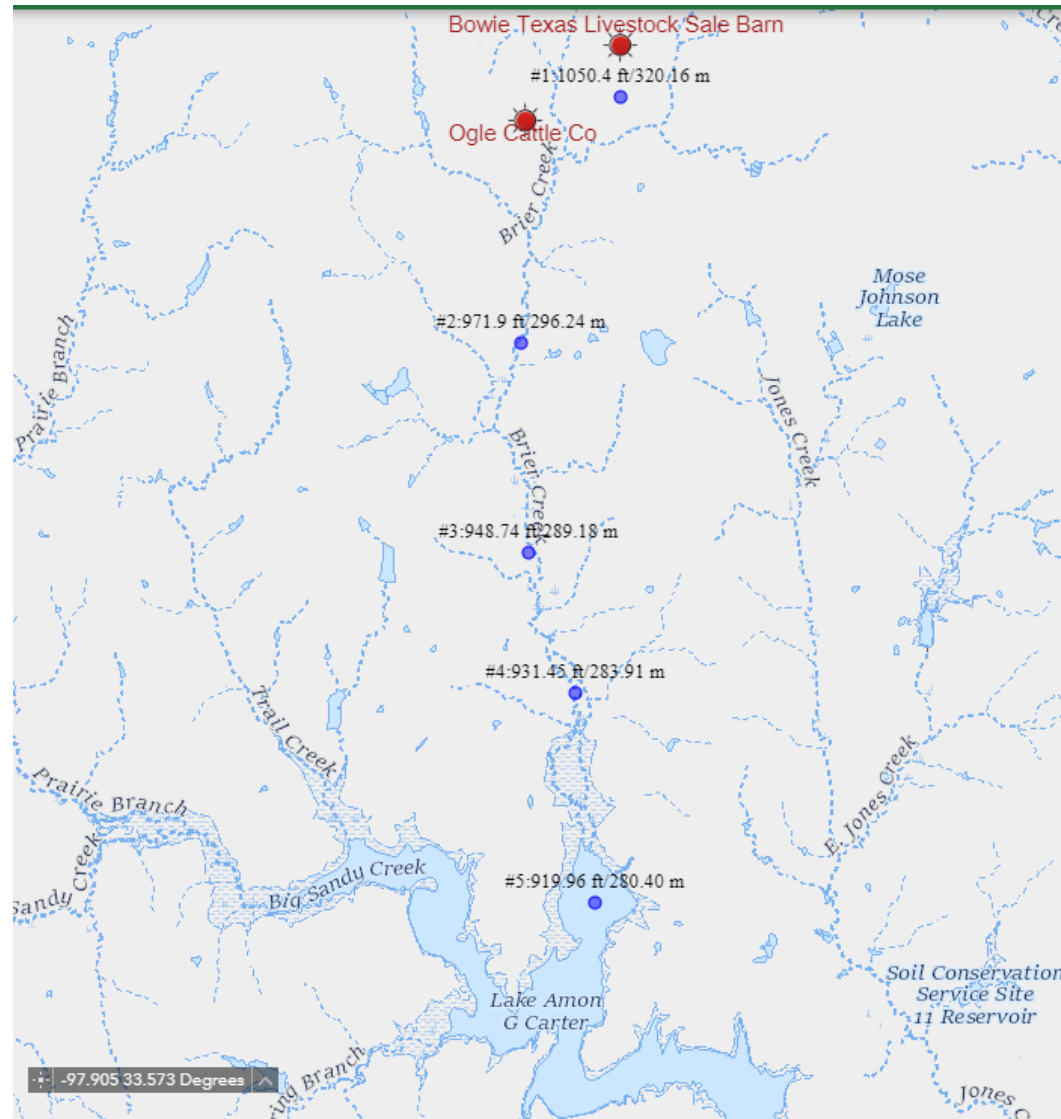
Fig 5. USGS Hydro-NHD Map showing Ogle Cattle Co and Bowie Texas Livestock Sale Barn. The red colored pin indicates the location of facilities, blue line indicates intermittent stream and a relative permanence, and blue dots indicates elevation.
