REPORT OF COMPLIANCE EVALUATION INSPECTION  
(INDUSTRIAL STORMWATER)

**NEBCO Inc. dba Husker Ready Mix Concrete**  
**201 S. 1st Street**  
**Lincoln, Nebraska 68508**

Authorization Number: **ISW-202200648**

ON  
**August 1 and 5, 2024**

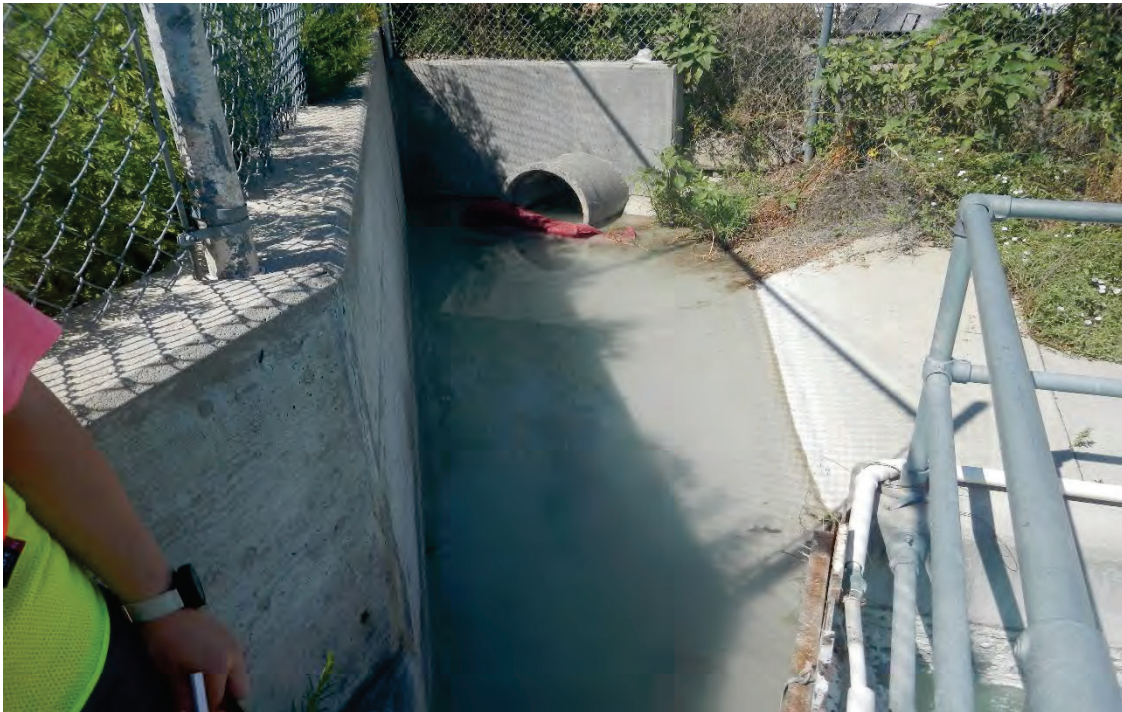
3. At the time of the inspection, I observed non-stormwater discharging from Outfall 01 located at the southwest corner of the site (photo 13). The discharge water was the washout water from the washout holding pits. Therefore, I issued Notice of Preliminary Finding number 2 (NOPF#2) because Outfall 01 was discharging (Unauthorized Discharge) process wastewater from the washout holding pits without obtaining a permit as required by the CWA-NPDES and Nebraska §81-1506 (2)(a). It appeared that the discharge was because the gate at the end of the pit was not completely closed or was faulty. Site personnel discussed that they would investigate fixing or completely blocking the discharge.

**Photo 13, Outfall 01 discharging Washout Holding Pits water**

Husker Ready mix was discharging (Unauthorized Discharge) process water/washout water from the washout holding pits via Outfall 01 without obtaining a permit as required by the CWA-NPDES and Nebraska §81-1506 (2)(a).

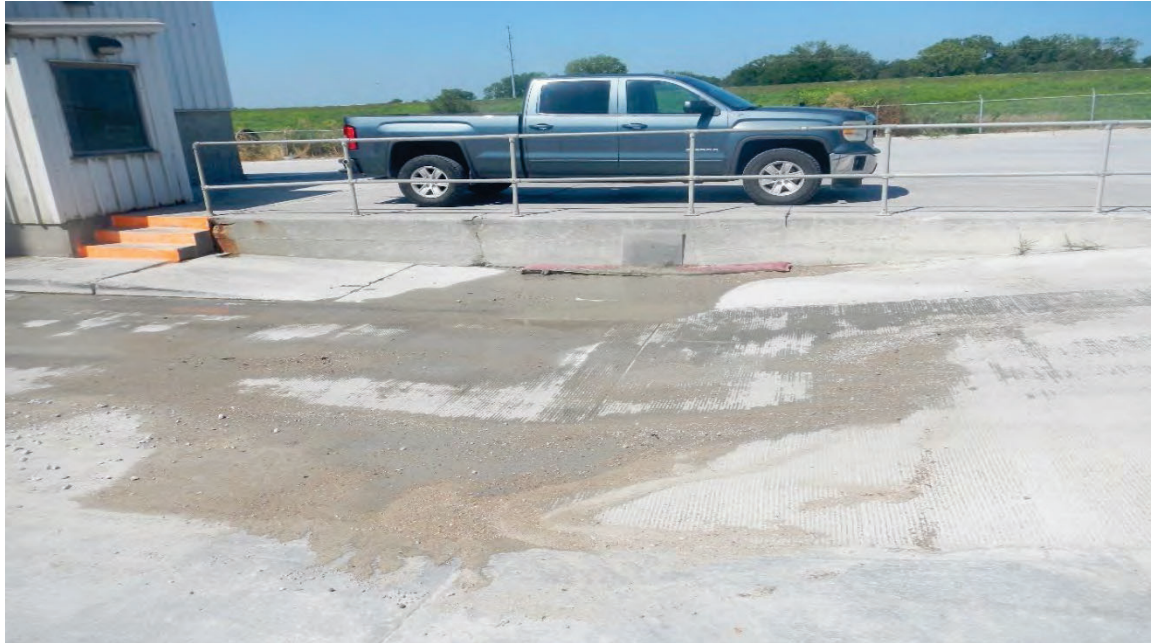
4. During the inspection I noticed that there was standing water at the outlet of Outfall 02. As mentioned above, Outfall 02 receives sheet flow from area 2 and the inlet pipe located in front of the ready-mix loading bay where trucks add water to the dry mix (add-on-mix water). The

inlet pipe shown in photo 7 and photo 8 had a steel plate and wattle as BMPs to prevent discharge to Outfall 02.

**Photo 8, Inlet pipe connected to Outfall 02**
