## **RCRA Inspection Report**

Colonial Terminals Inc.  
101 North Lathrop Avenue  
Savannah, GA 31415  
EPA ID Number # GAD006926430

**ATTACHMENT A**  
**COLONIAL TERMINALS INC.**  
**SAVANNAH, GA 31415**  
**EPA ID: GAD006926430**  
**RCRA COMPLIANCE EVALUATION INSPECTION**  
**AUGUST 25, 2021**

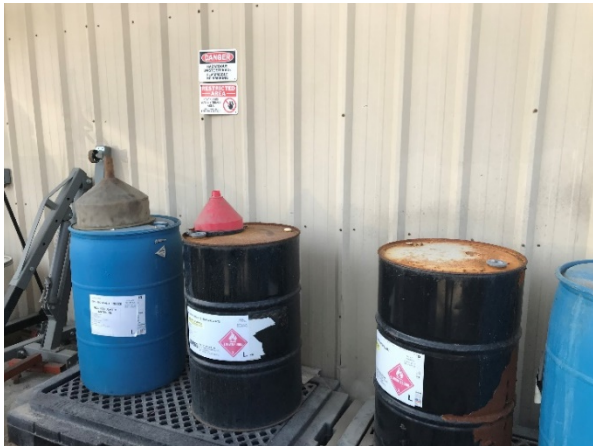
The inspectors observed three SAAs in the Truck Stop Area. There were two 55-gallon spent solvent (D001) drums on a spill pallet. One spent solvent drum contained hexane and methanol and the other 55-gallon spent solvent drum contained a mixture of wastewater, xylene and cumene (Picture-1). A third 55-gallon drum (D001) contained an aerosol can puncture device with a filter mounted on the drum (Picture-2). The drained aerosol containers are sent for metals recycling. All the SAA drums were observed to be closed and intact. The SAA drums were observed to be labeled with the words "Hazardous Waste" and an indication of hazards of the contents. There was a signage indicating "Danger" and "No Smoking" in the SAA. There were no leaks or spills observed near the SAA drums.

*Picture 1: Two SAA Drums (Truck Stop Area, Terminal Plant #2)*

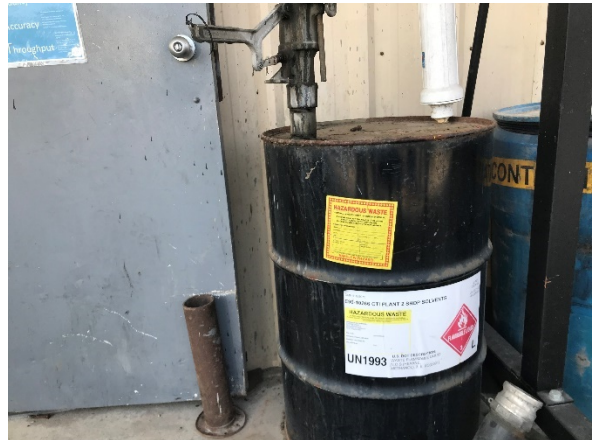
*Picture 2: One SAA Drum with Aerosol Can Puncture Device and a filter (Truck Stop Area, Terminal Plant #2)*
