## THATCHER CO OF NEW YORK INSPECTION REPORT

| <b>Facility or Site Name:</b> | Thatcher Company of New York | |
| <b>Facility/Site Physical Location:</b> | 4135 NY Route 104 | |

A Compliance Evaluation Inspection (CEI) was conducted to determine the facility's compliance with the Resource Conservation and Recovery Act (RCRA) requirements for hazardous waste management.

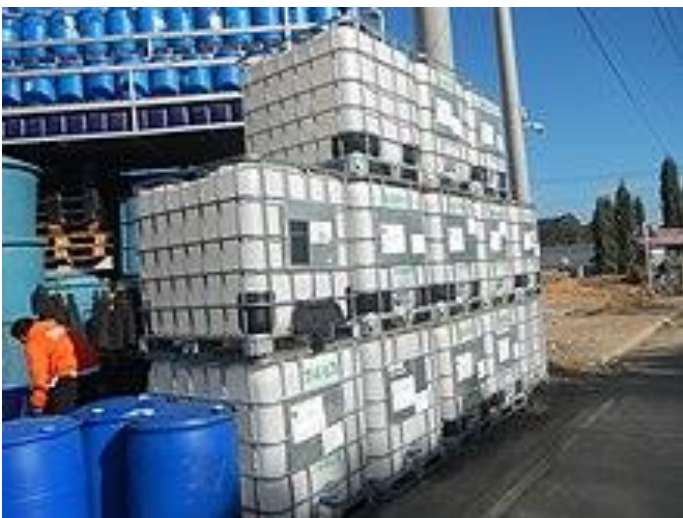
The most widely utilized and known IBC is the limited re-use, caged IBC tote container. [Caged IBC totes](#) are composite intermediate bulk containers — a white/translucent [plastic container](#) (typically high-density [polyethylene](#)) contained and protected by a tubular [galvanized steel](#) grid, common. Caged IBC totes are commonly used due to their low cost, wide compatibility, and versatility.
