# NPDES Compliance Inspection Report

## AM Manufacturing

**NPDES Permit Tracking Number  
# WAU000669**

**Inspection Date: 05/12/2023**

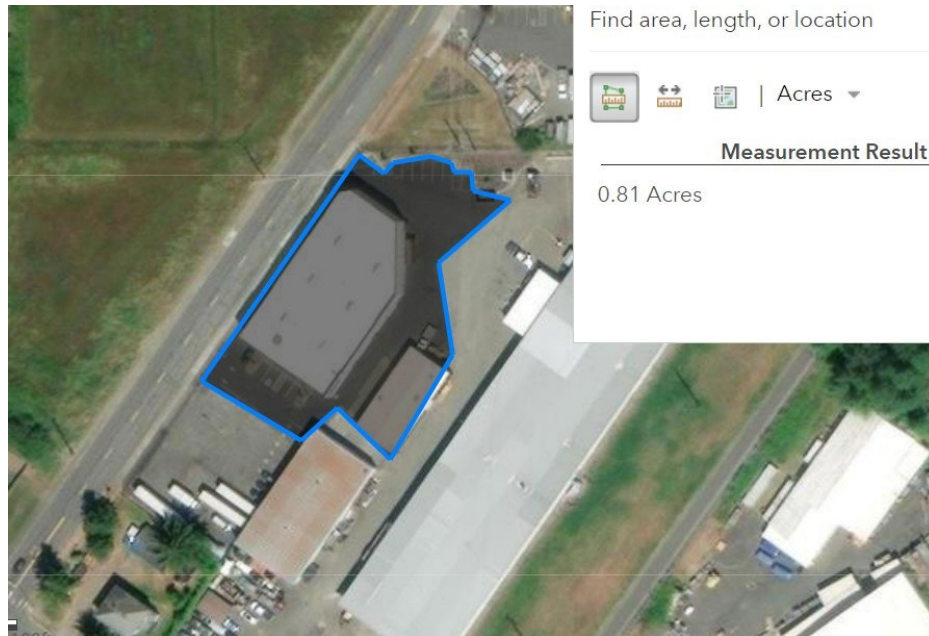
Figure 1: AM Manufacturing property shown in shaded portion, with drawn blue border.

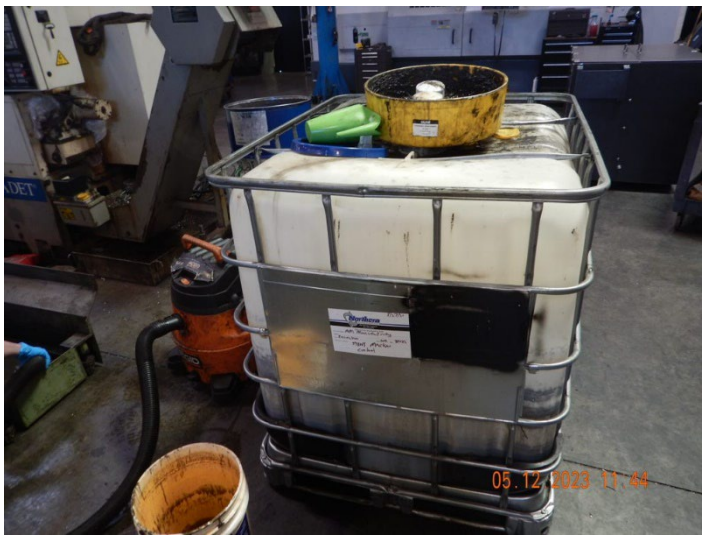
We walked through the main production floor inside the Facility. Ms. Harjo pointed out where the different machines sat. She told us Facility staff were performing maintenance on some of the equipment in the shop. We saw an approximately 275-gallon intermediate bulk container ("tote") holding used oil from the machining equipment (**Photo 1**). Ms. Harjo told us it took about one year for the Facility to fill up a tote with used oil. At that point, they would coordinate a pick-up with their used oil vendor. We asked if the Facility kept a stocked spill kit, Ms. Harjo showed us their spill kit, which sat approximately 50 feet from the where staff performed the oil changes during our site tour.

Photo #: 01 (DSCN0603)  
Description: Approximately 275-gallon intermediate bulk container holding used oil.

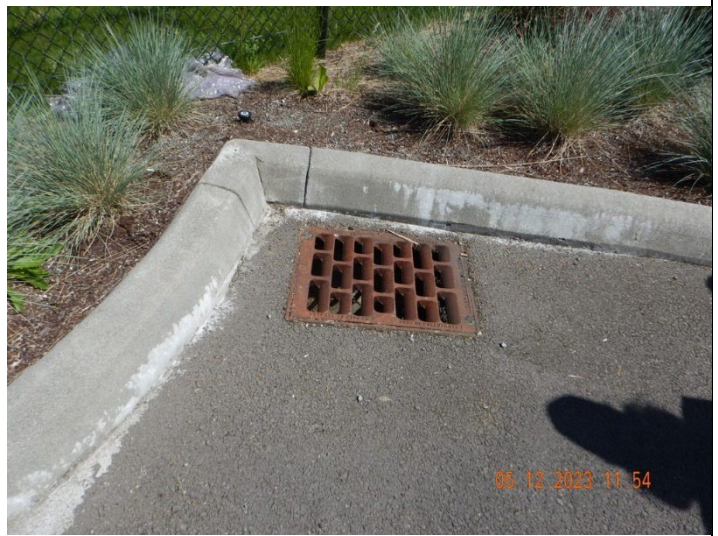
and Ms. Harjo said she was not aware of any activity occurring outside the building. We completed walking the perimeter. At the northern boundary we saw a catch basin collecting stormwater from the area, which appeared to convey to a neighboring retention pond (**Photo 2**). We did not see any potential pollutant sources relating to industrial activity during the inspection.

Photo #: 02 (DSCN0604)  
Description: Facing north, catch basin at perimeter of facility. Stormwater flows north into nearby retention basin.
