# Compliance Evaluation Inspection Report

## Pico Electronics, Inc.

### Pelham, New York

#### March 24, 2022

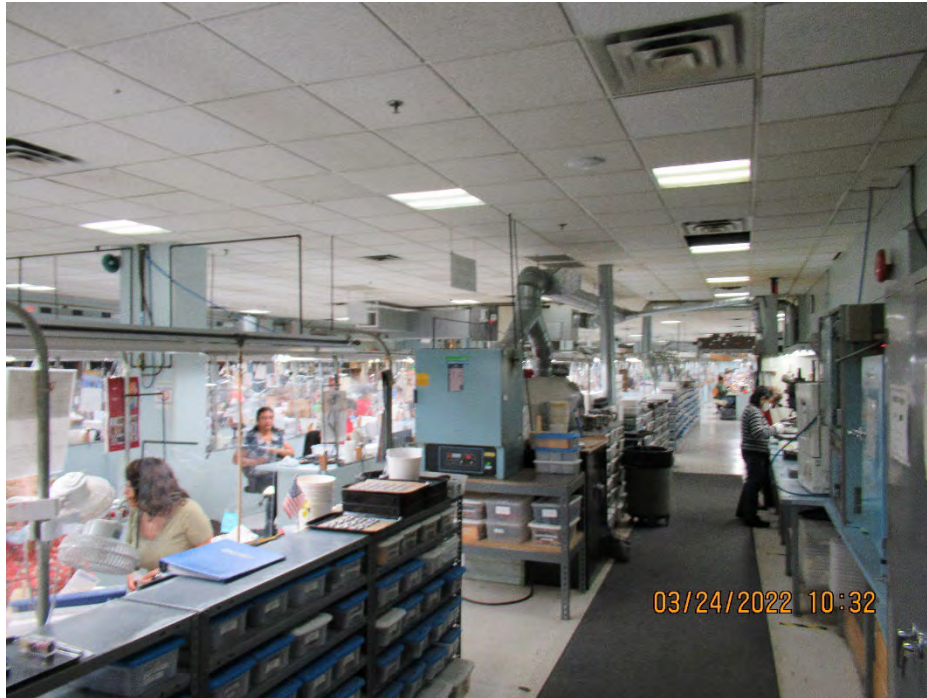
**Photograph #1 – View of general work area**

Mr. Kapitula and I began the facility tour at the point of hazardous waste generation for the spent vapor degreaser solvent. The unit was a Baron Blakeslee MLR-120 located in the general workspace (See, Photograph #6) where there are dozens of women working on small parts (See, Photographs #1 & #2). Pico has two vapor degreasers, but only one is currently in service. Parts

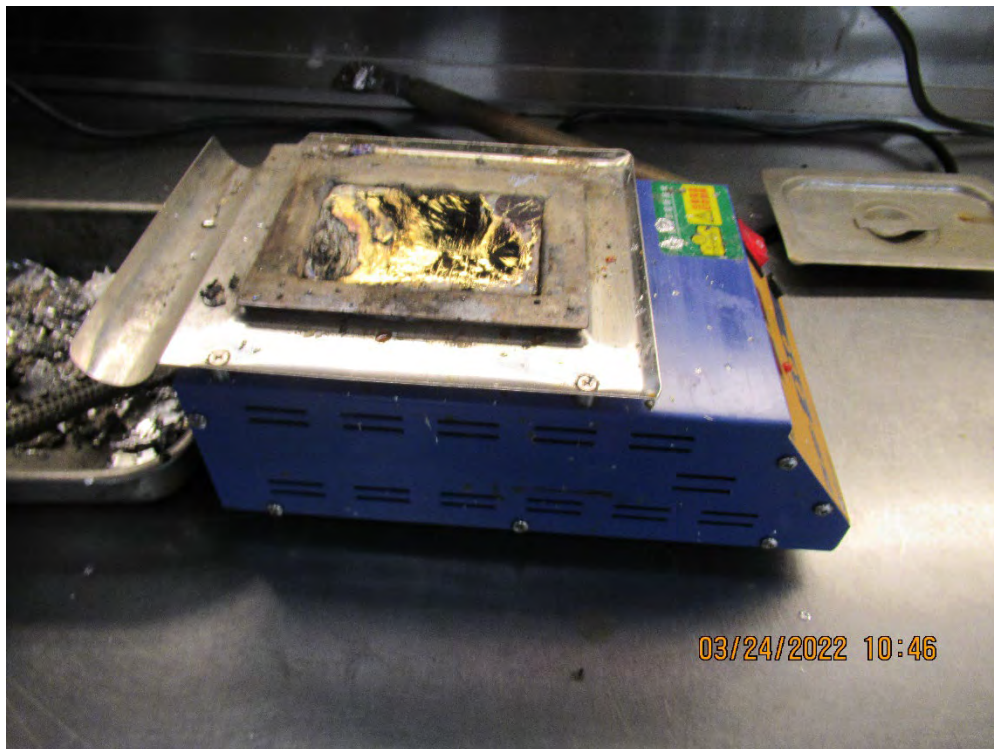
**Photograph #3 – Hot solder for hand dipping of parts**

We then reentered the main building and walked toward the north building to get down to the basement. To get to the north building we passed through the work area again. There are numerous stations where cleaning, hand working, and soldering are taking place. Many of these stations have ductwork that is intended to capture any fumes associated with manual parts working or cleaning and to induce the fumes away from the worker. There are also hooded spaces dedicated for specific work (See, Photograph #3 & #5). Soldering waste, such as dross, was encountered along the way (See, Photograph #4).

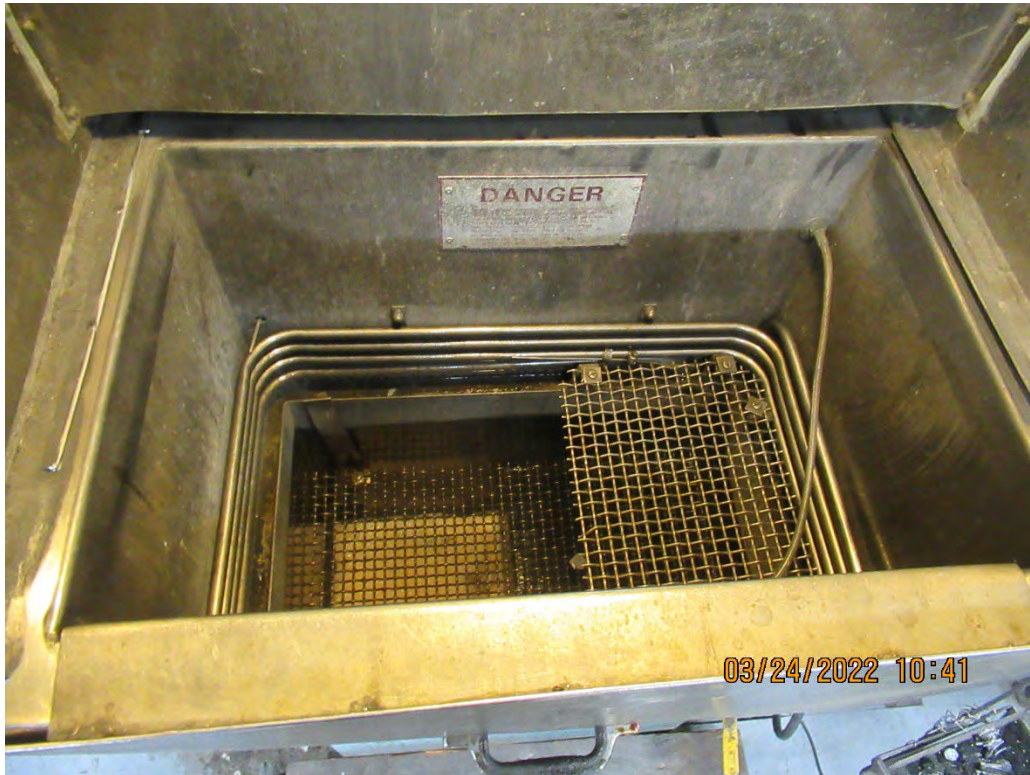
**Photograph #7 – Work area in vapor degreaser**

are taken by employees to the degreaser, placed in a mesh basket and spray-washed with liquid trichlorethylene in a vapor zone of the same solvent (See, Photograph #7). The unit has cooling coils which condense the trichlorethylene vapors and the condensate drips from the coils into small collection gutters that returns the solvent back to service in the degreaser (See, Photograph #8). Every Friday, an employee drains “the dirty side” of the degreaser into a one-gallon plastic container via a spigot at the bottom of the vapor degreasing unit (see, Photograph #9) and takes the container to the hazardous waste storage area for discharge into a 55-gallon drum. The plastic containers that are used for this transfer are repurposed containers that had held some chemical prior and not the more typical dedicated and labeled safety can. They are not conspicuously colored like a lab can or labeled as hazardous waste. It was clear that there have been releases associated with this operation as the floor tiles beneath the spigot were stained and degraded. There were also two (2) pans of what Mr Kapitula called rosin waste on the floor beside the degreaser. One of the pans was clearly acting as containment in case the valve that is part of the spigot started to leak (See, Photograph #9). It was not clear how the rosin waste was removed from the vapor degreaser.

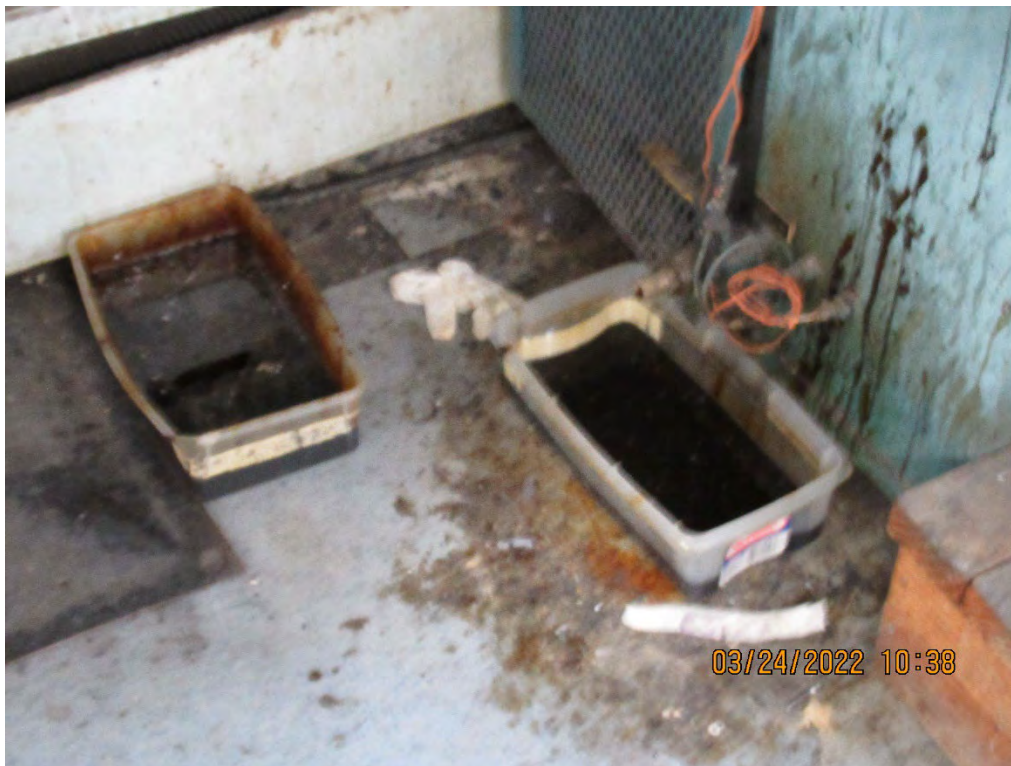
**Photograph #9 – Pans of waste rosin at vapor degreaser**

| REGULATORY, STATUTORY OR PERMIT REFERENCE | FIELD OBSERVATION |
|---|---|
| Pursuant to 6 NYCRR 373-3.3(b), a facility must be maintained and operated to minimize the possibility of a fire, explosion, or any unplanned sudden or non-sudden release of hazardous waste or hazardous waste constituents to air, soil or surface water which could threaten human health or the environment. | At the time of the inspection, there was evidence of releases beneath the floor level spigot of the vapor degreaser (See, Photograph #9). |

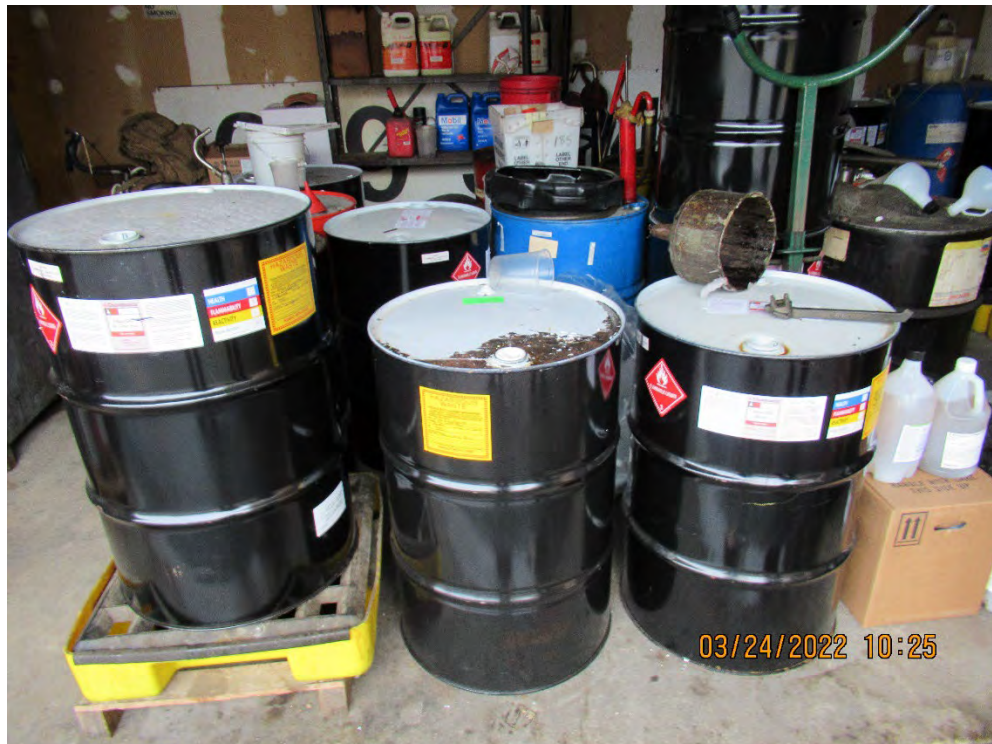
**Photograph #10 – Hazardous waste storage area**

Next, we proceeded to the hazardous waste storage area, which is in an attached garage in the back of the building. At that time, there were three 55-gallon drums of spent degreaser solvent being stored (See, Photograph #10). One drum, the one with an accumulation start date of October 26, 2021, was on a spill pallet (See, Photograph #11). The other two drums were on the floor and dated January 12, 2022, and February 15, 2022, respectively (See, Photographs #12 & 13). All the drums were in good condition and closed. There was also a 55-gallon drum of used oil being accumulated (See, Photograph #14). It was on a spill pallet and labeled as “waste oil” instead of the proper labeling of “used oil.” There were also four 55-gallon drums that were receiving metals destined for reclamation at Electrum<sup>2</sup> in Rahway NJ (See, Photograph #15). The drums were dedicated to collecting nickel, copper, aluminum, and lead for reclamation. There was a no smoking sign; however, the name and telephone number of the emergency coordinator; location of fire extinguishers and spill-control material, and telephone number of the fire department was not posted. Although the position of the fire extinguisher was obvious (i.e., on the wall to the right of the hazardous waste storage).

| REGULATORY, STATUTORY OR PERMIT REFERENCE | FIELD OBSERVATION |
|---|---|
| Pursuant to 6 NYCRR Part 373-3.9(d)(3), as referenced by 6 NYCRR Part 372.2(a)8(iii)(b), containers holding hazardous waste must be marked with the words "Hazardous Waste" and with other words identifying their contents. | Three drums that were in the 180-day Hazardous Waste Storage Area were lacking words identifying their contents (See, Photograph #10 - #13). |

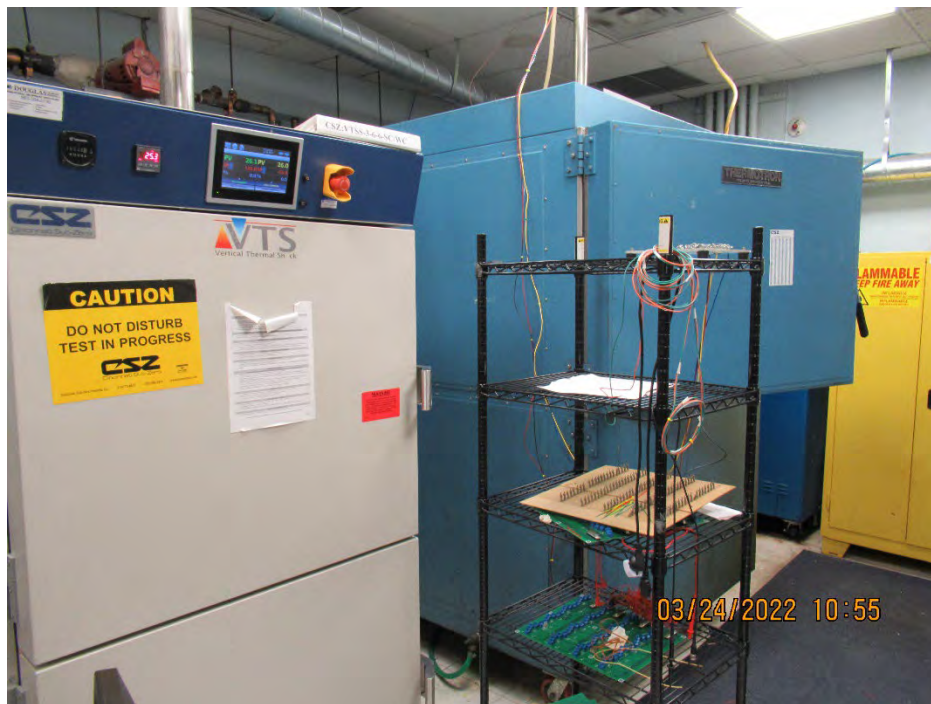
**Photograph #16 – Product testing area**

In the northern portion of the basement there were storage areas for raw materials and spare parts. There was some groundwater weeping into the basement and some pipe wrap that may be asbestos (See, Photograph #20). We then went back upstairs and inspected the testing area where there is equipment that simulates the environments that Pico’s products may encounter. There was testing equipment from Cincinnati Sub-Zero and Thermotron (See, Photograph #16).

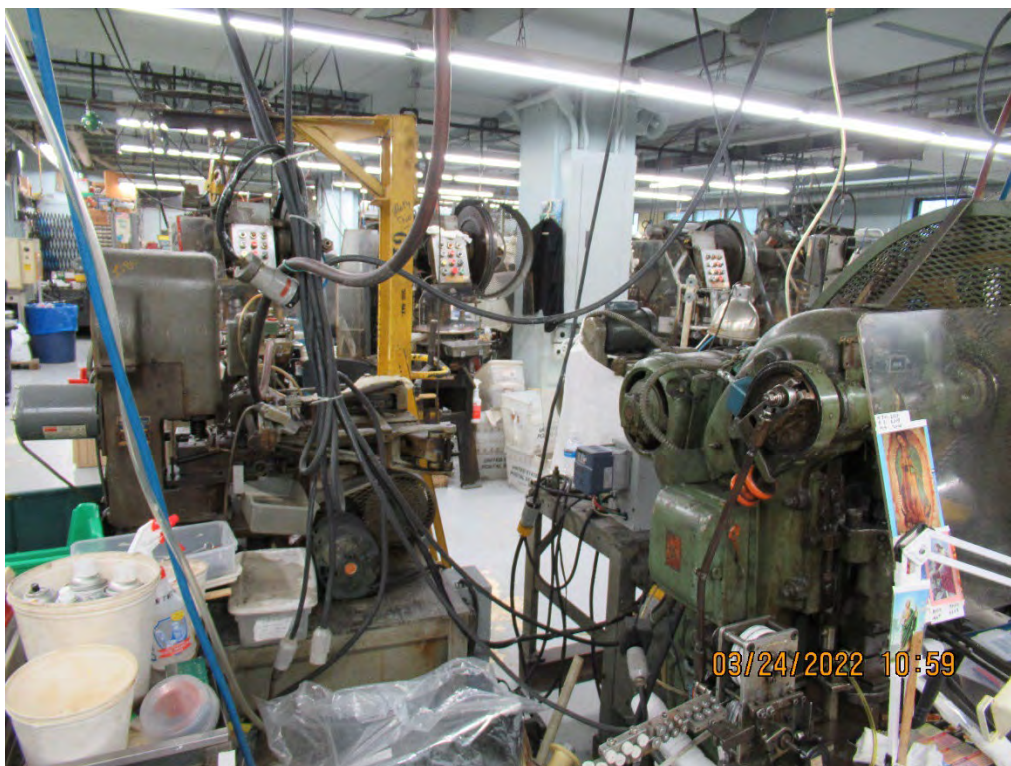
**Photograph #17 – Machine shop in building basement**

After passing through the Engineering Department, from the lobby at the southern end of the building, we walked down to the basement. Besides the lunchroom, this area housed a large machine shop (See, Photographs #17 - #19). This shop is the source of all the scrap metal that doesn't emanate from soldering, such as dross. There were turnings and shavings being collected at all the workstations, as well as floor sweepings. This is also the source of the used oil, as the parts being machined need lubrication (See, Photograph #18).
