**Well Inspection**  
**Osage DNR / Environmental Protection Agency**  
**1201 Elm Street, Suite 500**  
**Dallas, Texas 75270**

| | | <b>Lease Name</b> | Osage-Rogers | | |
| | | <b>Well ID</b> | 2R | | |
| <b>Location</b> | SE 03 28N 10E | <b>Status</b> | Active | <b>Well Type</b> | Disposal |

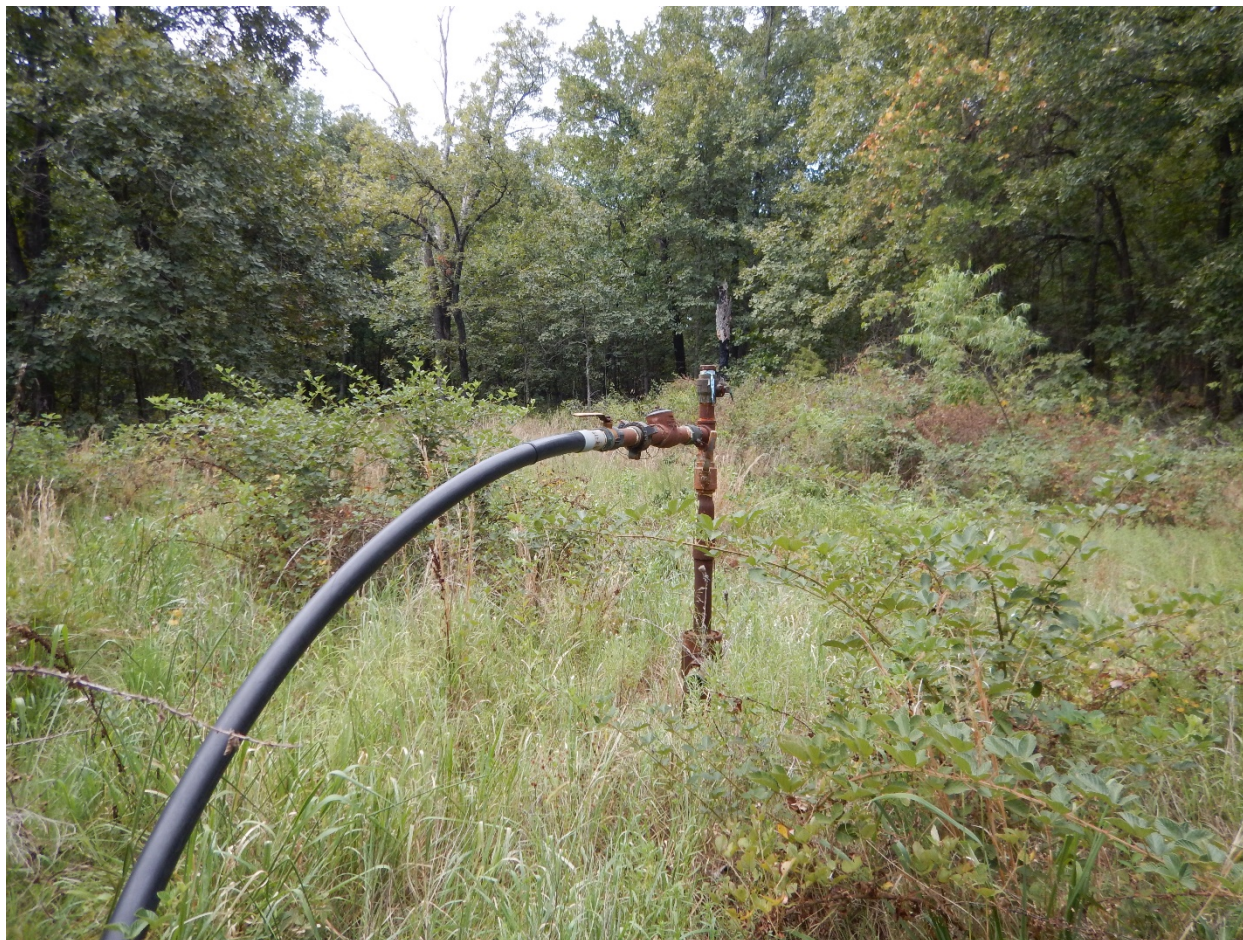
Photo No. 1

**Description:** This was a photo showing well OS1970. The well was connected and open for injection at the time of the inspection. The well sign could not be located during the inspection.

| <b>Inspection Comments</b> | At the time of the inspection, well OS1970000 (Osage-Rogers 2R) was connected with the flowline and tubing valves open to allow injection. The well was equipped with ball valves and female fittings to allow for connection of gauges to monitor tubing and annulus pressures. The operator should install a well sign at the well. There were no areas of concern at the time of the inspection. | | | | |

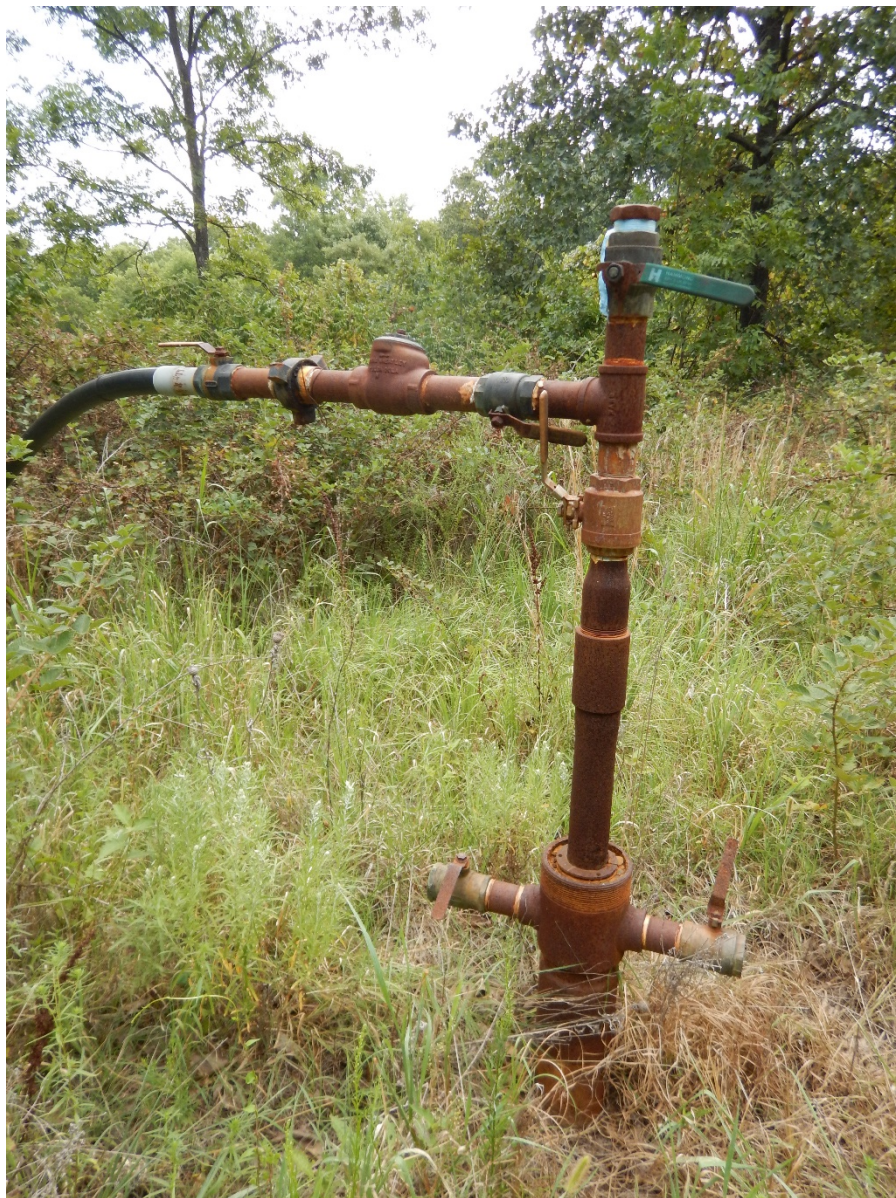
Photo No. 2

**Description:** This was a photo showing a closeup view of all the valves and their position at the time of the inspection.
