INSPECTION REPORT

**CITY OF WEST COLUMBIA PUBLIC WATER SYSTEM  
DRINKING WATER TREATMENT PLANT  
WEST COLUMBIA, SOUTH CAROLINA**

**U.S. ENVIRONMENTAL PROTECTION AGENCY  
REGION 4  
ENFORCEMENT AND COMPLIANCE ASSURANCE DIVISION  
WATER ENFORCEMENT BRANCH  
DRINKING WATER ENFORCEMENT SECTION**

March 16 - March 17, 2022

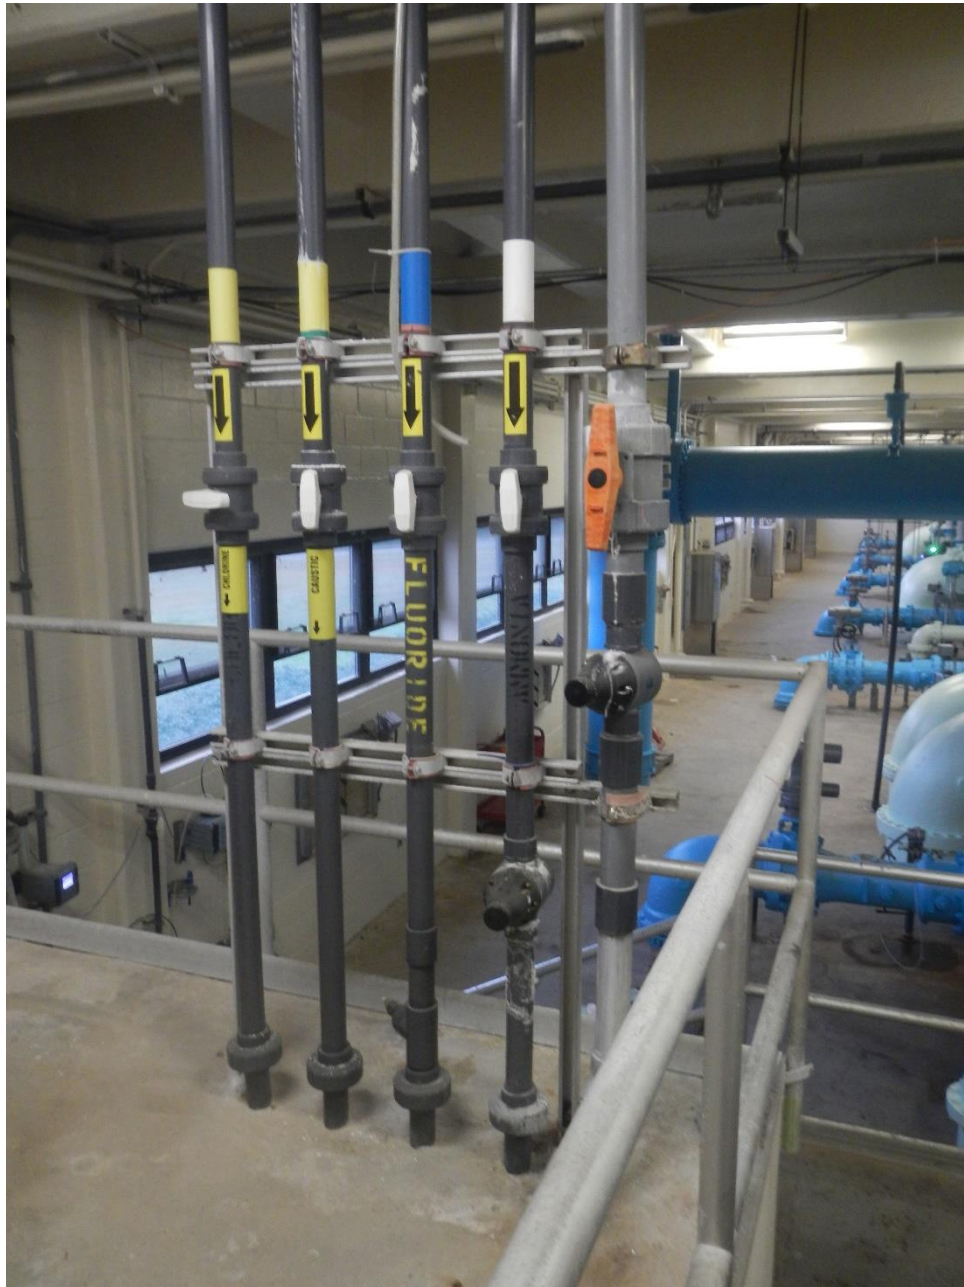
1. **Observation:** Chemical dosing pipes at the Lake Murray plant were improperly labeled. The plant uses an unlabeled pipe for chlorine dosing, and the pipe labeled for chlorine is valved off (refer to Appendix A, Photograph 1).

**Photograph 1:** Misabeled chemical injection pipes at Lake Murray plant.

**Comments:** Chemical dosing pipes should be properly labeled with the type of chemical being fed. Mislabeled pipes can lead to confusion, lack of consistency in plant operation, and potentially cross contamination.

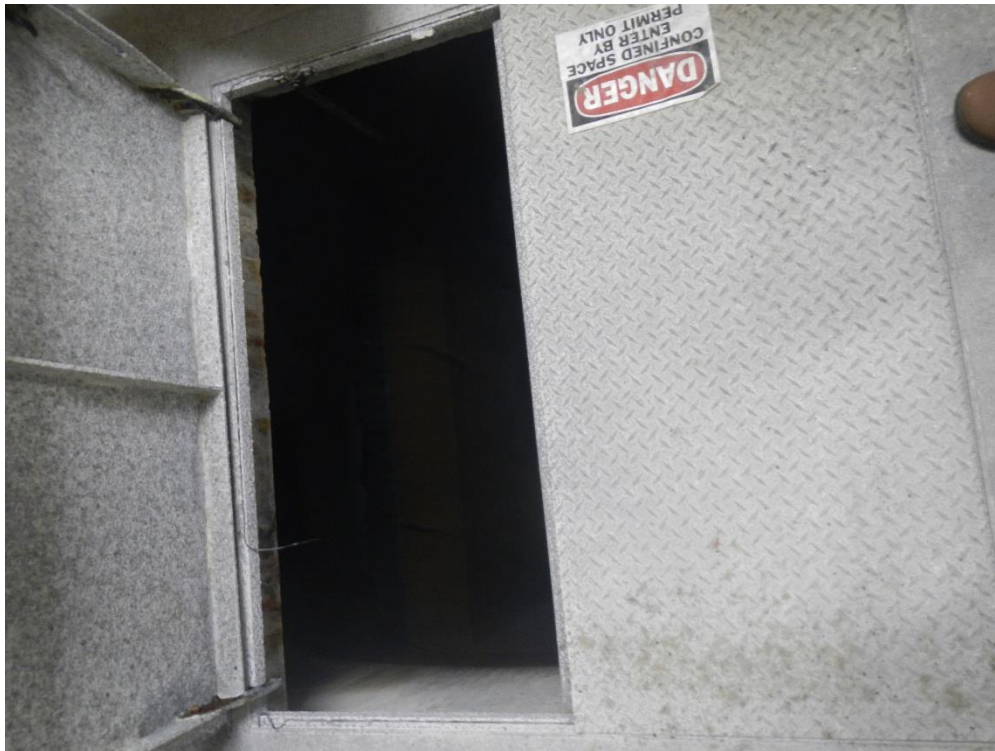
2. **Observation:** The hatch leading to the post-mix basin at the Lake Murray plant lacks a sanitary seal (refer to Appendix A, Photograph 2).  
**Comment:** Hatches should be properly sealed to prevent entry of contaminants to finished water.

**Photograph 2:** Post-mix basin hatch, which lacks sanitary seal.

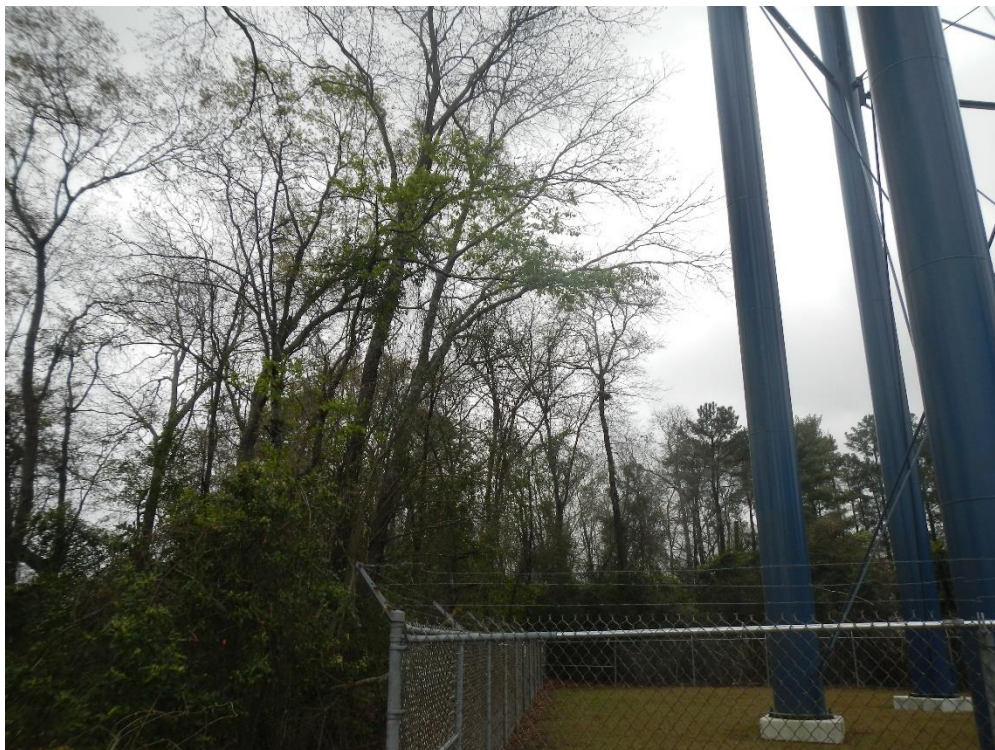
3. **Observation:** Vegetative growth in the vertical plane was noted at Platt Springs and Pony Hill elevated storage tanks (refer to Appendix A, Photograph 3-5).

**Photograph 3:** Base of Platt Springs elevated storage tank with vegetation in the vertical plane.

**Comment:** The vertical plane should be kept free of vegetation to prevent damage to the tanks and entry of contaminants or animals to the finished water.

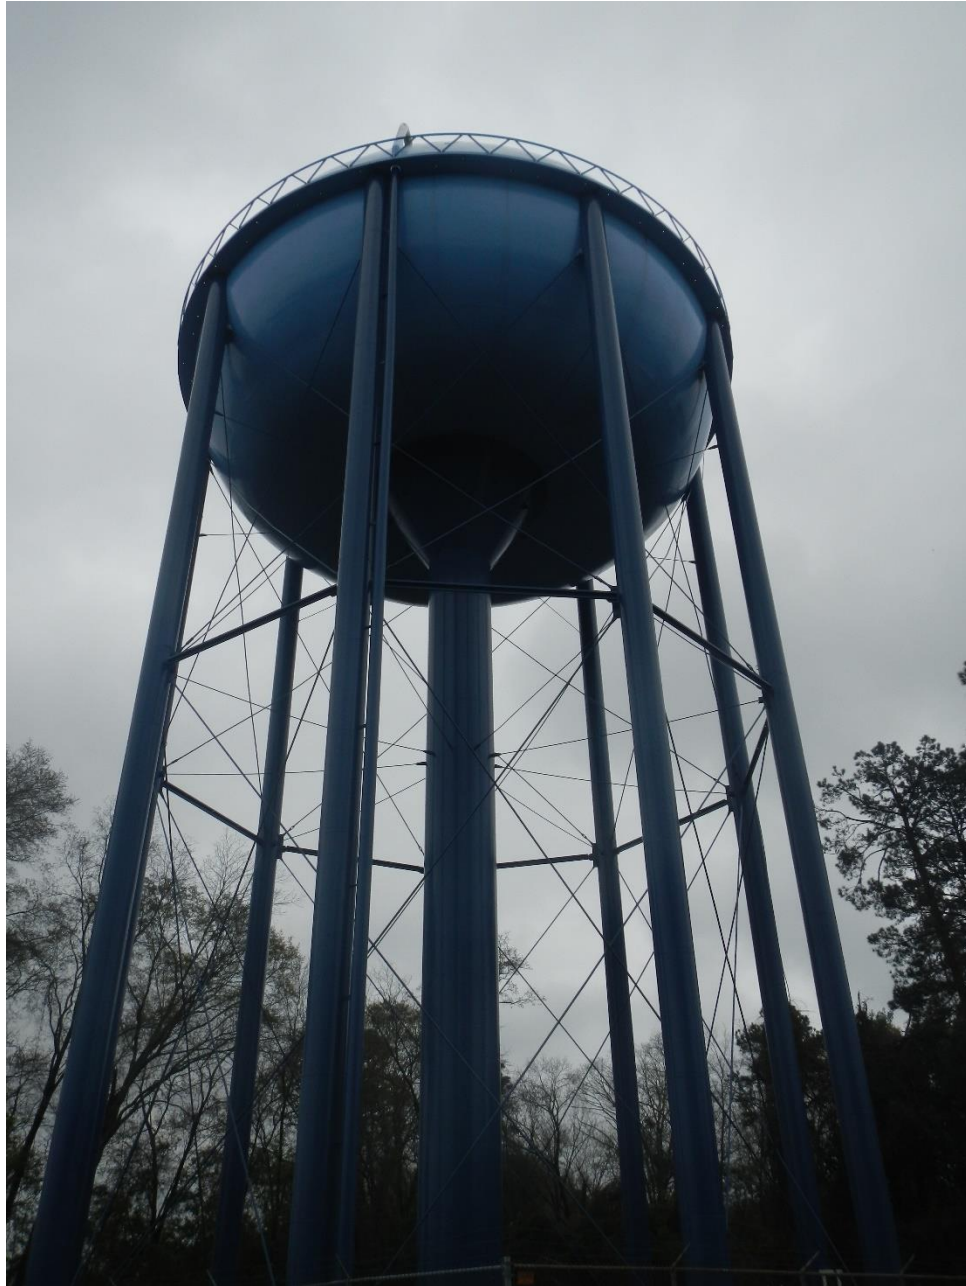
**Photograph 4:** Platt Springs elevated storage tank with vegetation in the vertical plane.

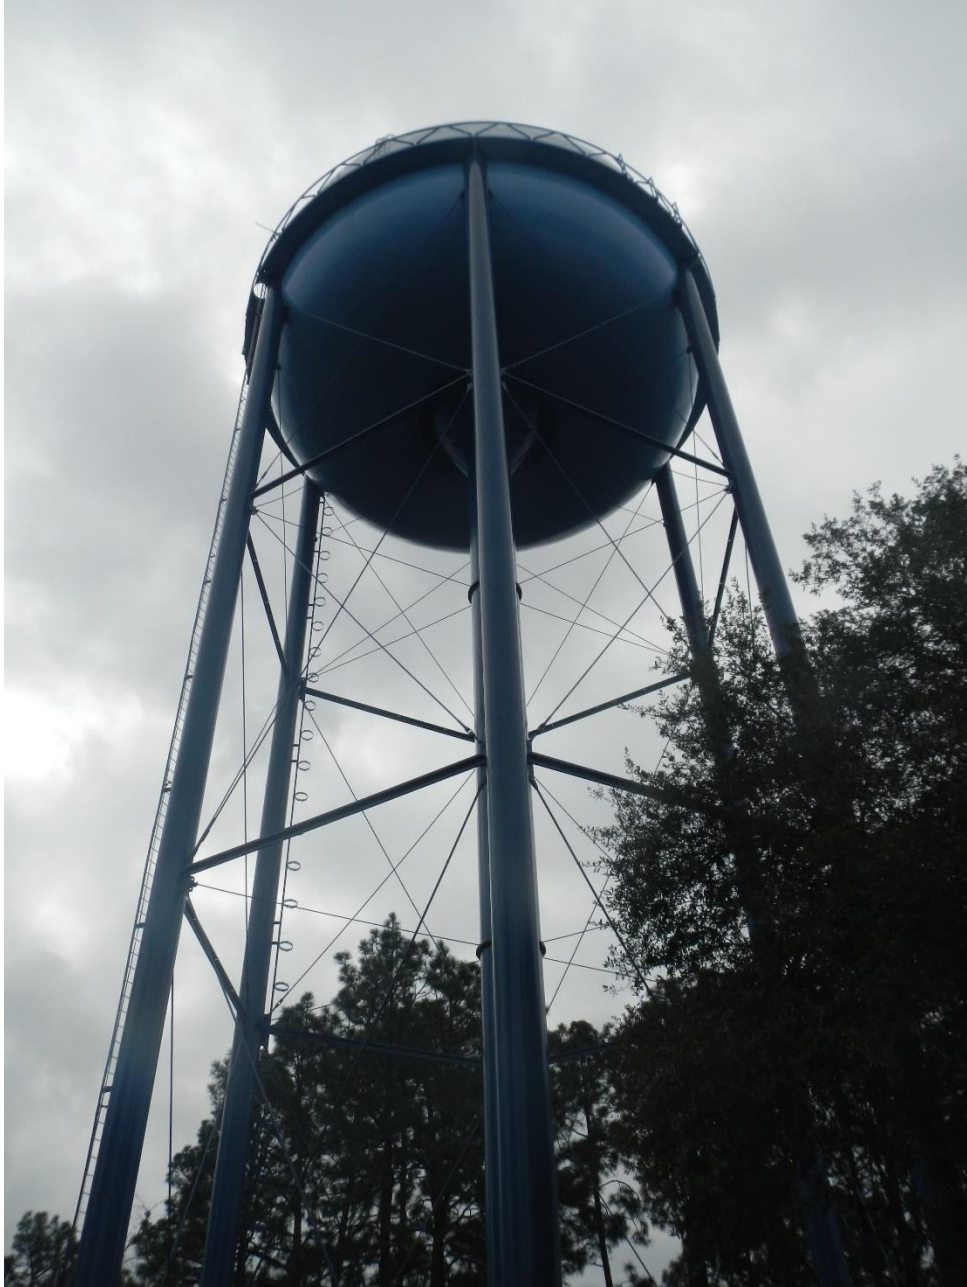
**Photograph 5:** Pony Hill elevated storage tank with vegetation in the vertical plane.

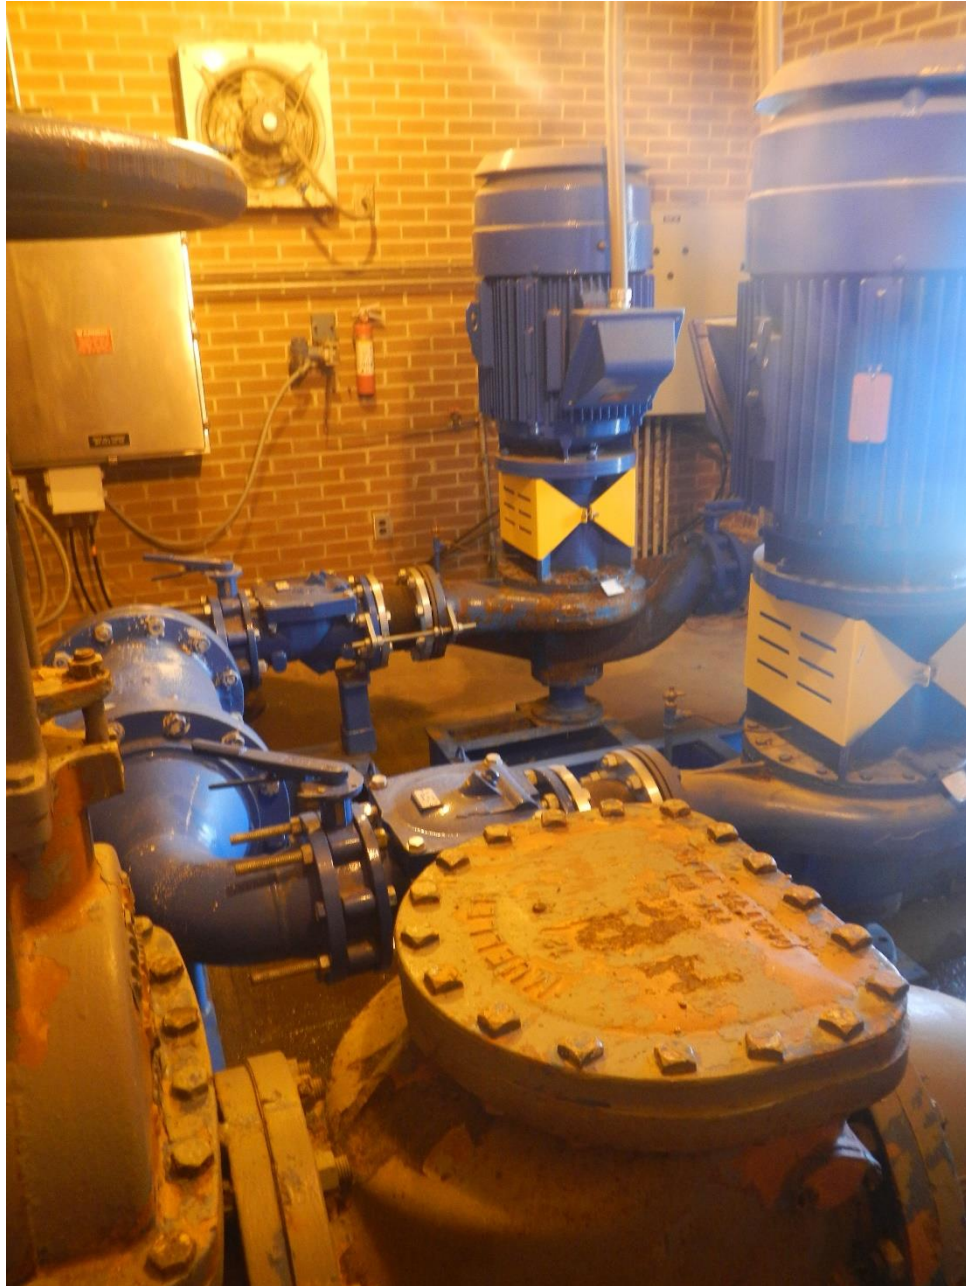
4. **Observation:** The altitude valve at the Green Hill high service pump station exhibited rusting and signs of corrosion (refer to Appendix A, Photograph 6).

**Photograph 6:** Altitude valve at Green Hill high service pump station exhibiting corrosion.

**Comment:** Pump appurtenances should be kept clean and free of rust to reduce the risk of pump failure.
