# RCRA Inspection Report

WIKA Instrument, LP  
1000 Wiegand Blvd  
Lawrenceville, Georgia 30043  
Gwinnett County

February 15, 2023

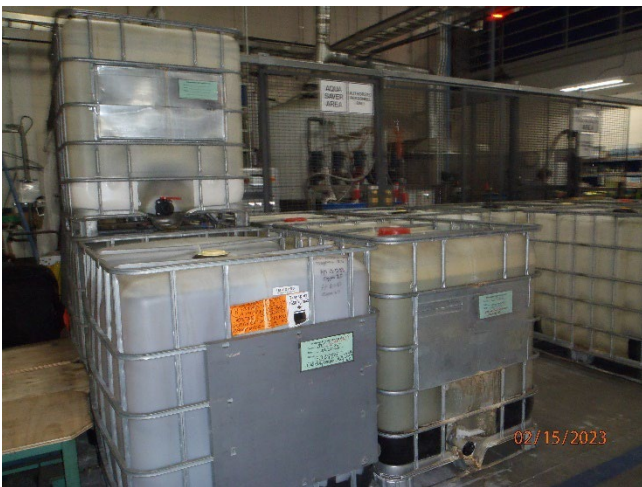
The inspectors observed, twelve (12) totes of hazardous waste (Figure 1) by the Sockets Area. The totes were all dated and sealed, no hazardous waste labels or hazard indications were noted on any of them. These totes were storing hazardous waste, rinse waters generated primarily from the parts washing operation in the Sockets Area, prior to the pretreatment process. The area where the totes were stored did not meet any of the CAA requirements, including but not limited to proper signage, a spill kit, weekly inspections, or a fire extinguisher. Because the facility did not identify the waste as a hazardous waste they did not follow through with the appropriate management of the waste, which would include appropriate signage, labeling, inspections, etc. The facility representatives were informed that the hazardous waste in the totes near the Sockets Area did not appear to be properly managed according to applicable RCRA regulations.

Figure 1: P2150008.JPG – Totes of Rinse Water stored prior to Pretreatment

**Pursuant to Ga. Comp. R. and Regs. 391-3-11-.08(1) [40 C.F.R. § 262.11], a person who generates a solid waste, as defined in Ga. Comp. R. and Regs. 391-3-11-.07(1) [40 C.F.R. § 261.2], must make an accurate determination as to whether that waste is a hazardous waste in order to ensure wastes are properly managed according to applicable RCRA regulations. A hazardous waste determination is made using the methods articulated in Ga. Comp. R. and Regs. 391-3-11-.08(1) [40 C.F.R. § 262.11].**

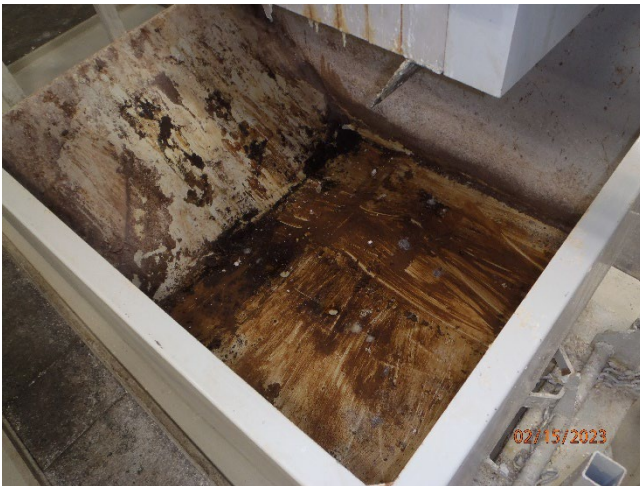
Additionally, the area contained two (2) large container-like hoppers that were positioned to collect waste from the filter press machines. Although this waste is considered hazardous, the containers are left open. Waste is only added to the tanks once per week when the machine is drained, which fills them completely. The hazardous waste is promptly removed from the hopper like containers, then they are promptly cleaned and the waste containerized into approximately one and a half 55-gallon containers. At the time of the inspection the hoppers appeared RCRA empty (Figure 9).

Figure 9: P2150019.JPG – Hopper in the ECM Area

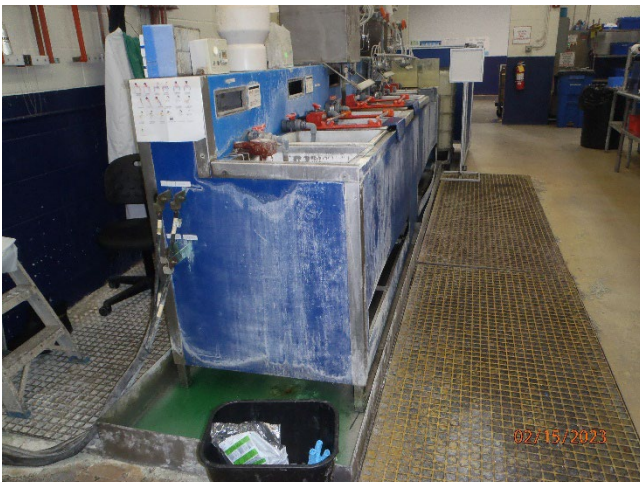
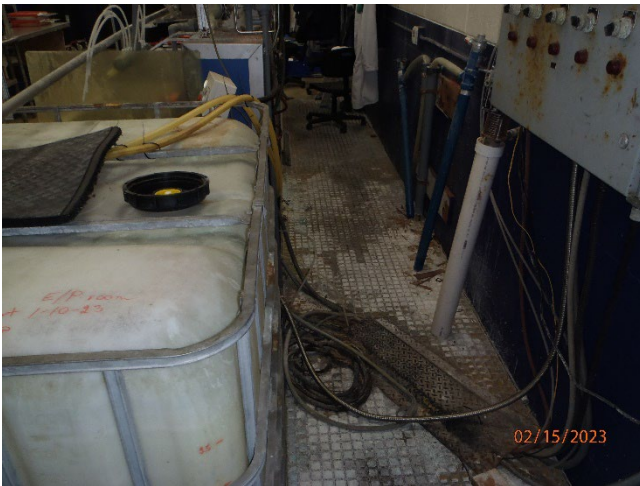
hazardous, but the facility made it clear that these chemicals remained usable in their electropolishing process. Inspectors observed a tote at the end of the old line. This tote did not appear to contain 55 gallons of waste. However, the facility representatives were reminded of the SAA requirements. Additionally, the area behind this old system appeared to be covered with a white substance from the machine (Figures 10 and 14).

Figure 10: P2150022.JPG – Old Electropolishing Line

Figure 14: P2150027.JPG – Floor in the rear of the Old Electropolishing Line and Tote

**Pursuant to Ga. Comp. R. and Regs. 391-3-11-.08(1) [40 C.F.R. § 262.17(a)(6)], which incorporates Ga. Comp. R. and Regs. 391-3-11-.08(1) [40 C.F.R. § 262.251], and is a condition of the LQG Permit Exemption, a generator is required to maintain and operate its facility to minimize the possibility of a fire, explosion, or any unplanned sudden or non-sudden release of hazardous waste or hazardous waste constituents to air, soil, or surface water which could threaten human health or the environment.**

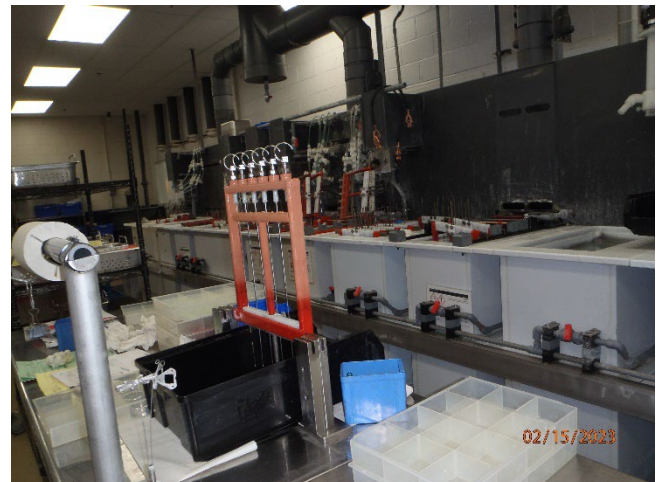
The Electropolishing Area had two (2) separate lines that could be used for electropolishing. The old electropolishing apparatus, involving many tanks used for procedural chemical baths of gauge parts, had been recently replaced with a new set-up on the opposite side of the room (Figure 11). This new set-up had gone out of order a weeks before the inspection, forcing the facility to refill some of the previously empty, old tanks with chemicals (Figure 10). Upon the restart of the new system, the chemicals were left in these open tanks in the old system to sit in case a similar situation were to arise again. The chemicals in these open containers are

Figure 11: P2150023.JPG – New Electropolishing Line

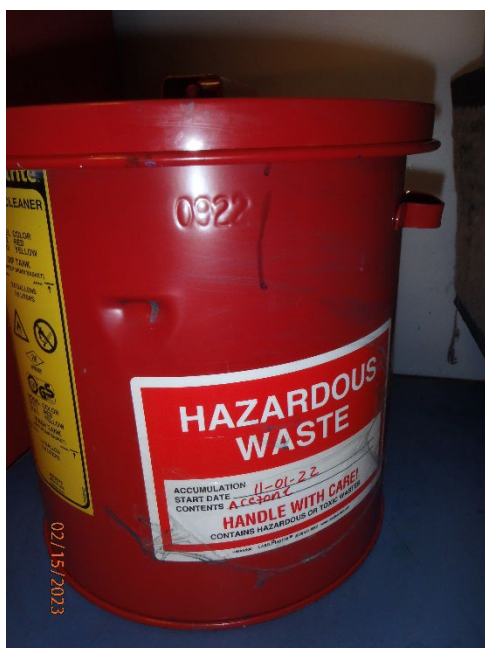
- The Gun Drill Machine SAA contained one (1) 55-gallon container of gun drill filters and chips.
- The CNC Department SAA contained two (2) 55-gallon containers of used oil.
- The Electropolishing SAA contained one (1) 55-gallon container of nitric acid, one (1) 55-gallon container of deox C, and one (1) 55-gallon container of non-regulated waste. (Figures 12 and 13)
- The SAA in the interior of the Printing Room contained one (1) 3-gallon bucket of waste acetone, which was dated despite not having to be, the container did not provide a seal that would prevent release of its contents. (Figure 18)

Figure 18: P2150032.JPG – Printing Room container to collect Acetone

**Pursuant to Ga. Comp. R. and Regs. 391-3-11-.08(1) [40 C.F.R. § 262.15(a)(4)], which is a condition of the SAA Permit Exemption, a generator is required to keep containers of hazardous waste closed at all times during accumulation, except when adding, removing, or consolidating waste; or when temporary venting of a container is necessary for the proper operation of equipment, or to prevent dangerous situations, such as build-up of extreme pressure.**

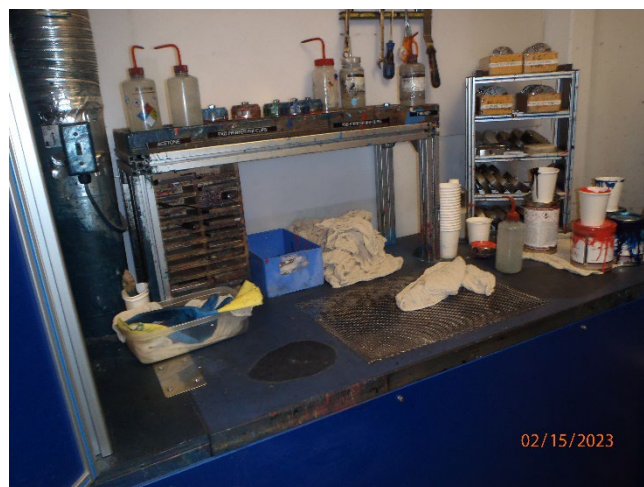
At the time of inspection, the inspectors observed the hood in the interior of the Printing Room. The hood did not appear to be in proper operation and there appeared to be build up in the ventilation beneath the workstation, as seen in Figure 19.

Figure 19: P2150033.JPG – Hood in the Printing Room

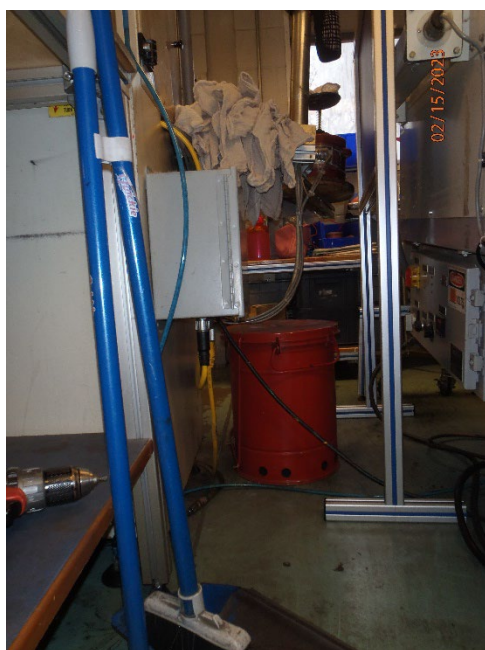
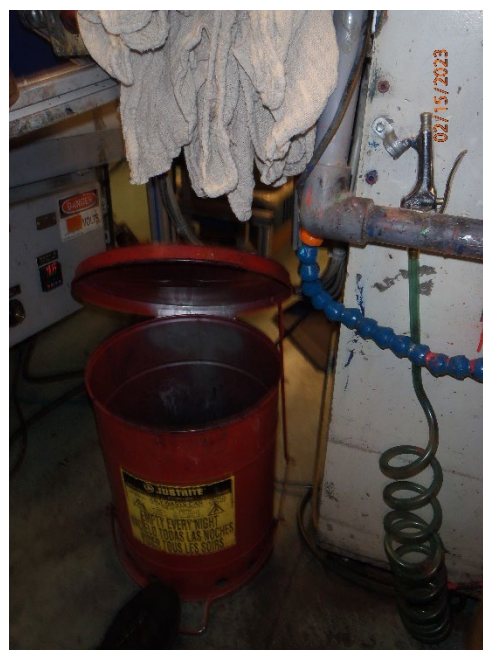
- The SAA at the operators' work stations in the Printing Room contained 3-gallon buckets of solvent waste rags, which were not labeled (Figures 20 and 21).

Figure 20: P2150034.JPG – Solvent wipe container at workstation in Printing Room

Figure 21: P2150035.JPG – Solvent wipe container at workstation in Printing Room

**Pursuant to Ga. Comp. R. and Regs. 391-3-11-.08(1) [40 C.F.R. § 261.4(a)(26)(i)], Solvent-contaminated wipes that are sent for cleaning and reuse are not solid wastes from the point of generation, provided that (i) The solvent-contaminated wipes, when accumulated, stored, and transported, are contained in non-leaking, closed containers that are labeled "Excluded Solvent-Contaminated Wipes." The containers must be able to contain free liquids, should free liquids occur. During accumulation, a container is**

**considered closed when there is complete contact between the fitted lid and the rim, except when it is necessary to add or remove solvent-contaminated wipes. When the container is full, or when the solvent-contaminated wipes are no longer being accumulated, or when the container is being transported, the container must be sealed with all lids properly and securely affixed to the container and all openings tightly bound or closed sufficiently to prevent leaks and emissions.**

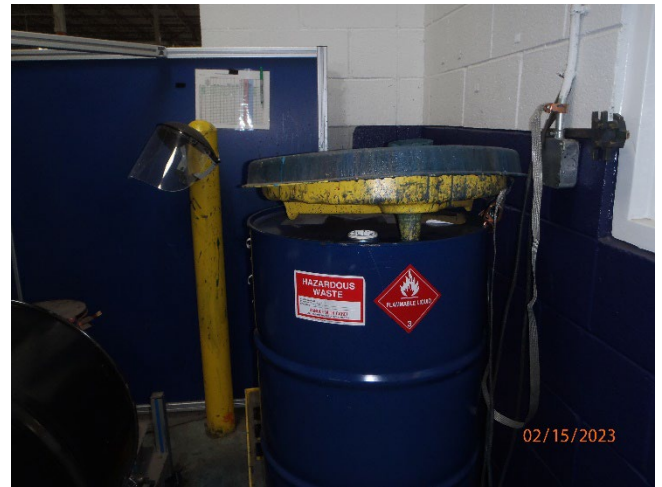
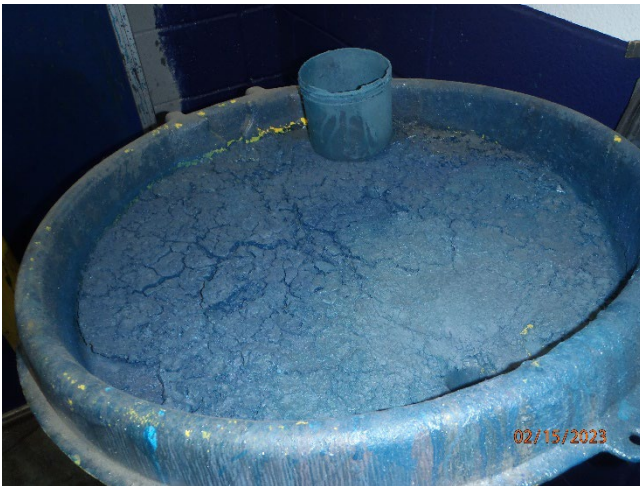
- The SAA on the exterior of the Printing Room contained one (1) 55-gallon container of waste acetone and three (3) 30-gallon containers of solvent contaminated rags. The container of acetone was capped with a funnel that was very dirty (Figures 23 and 24). It was advised that the facility clean this funnel, as the substances on it were most likely residues of the hazardous waste kept in the container. Additionally, this container is not at or near the point of generation of the waste.

Figure 23: P2150037.JPG – Container of Acetone outside the Printing Room

Figure 24: P2150038.JPG – Container of Acetone outside the Printing Room

**Pursuant to Ga. Comp. R. and Regs. 391-3-11-.08(1) [40 C.F.R. § 262.15(a)], a generator may accumulate as much as 55 gallons of non-acute hazardous waste in containers at or near the point of generation where wastes initially accumulate, which is under the control of the operator of the process generating the waste.**

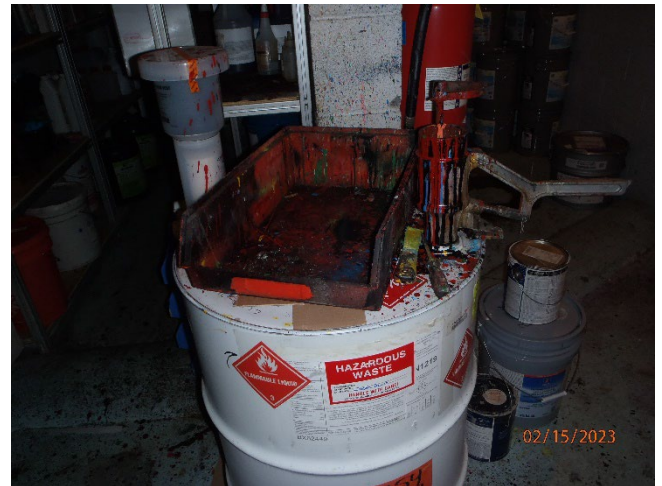
- The chemical storage SAA contained one (1) 55-gallon container of waste paint fitted with a puncturing mechanism for aerosol paint cans. The container was properly labeled but was stuck open (Figure 25) due to what looked like excess paint buildup. The opening in the puncture system could not be closed at the time of inspection.

Figure 25: P2150039.JPG – Aerosol Can Puncturing Station

**Pursuant to Ga. Comp. R. and Regs. 391-3-11-.08(1) [40 C.F.R. § 262.15(a)(4)], which is a condition of the SAA Permit Exemption, a generator is required to keep containers of hazardous waste closed at all times during accumulation, except when adding, removing, or consolidating waste; or when temporary venting of a container is necessary for the proper operation of equipment, or to prevent dangerous situations, such as build-up of extreme pressure.**

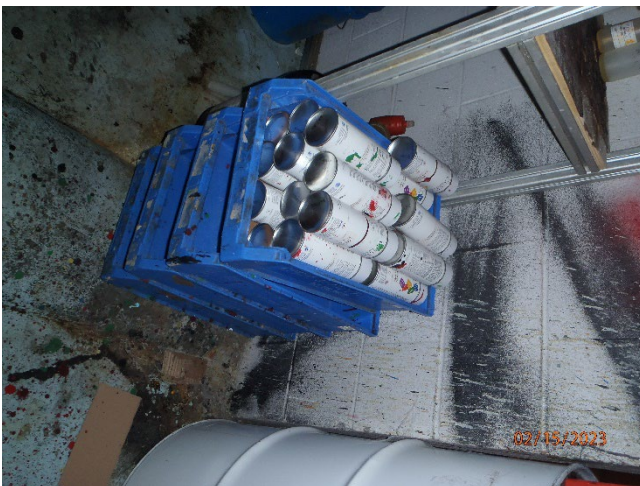
It was noted that the SAA also contained a pile of waste aerosol cans, which were being staged for puncturing once enough cans were piled up. Once punctured and fully drained, the empty cans would be recycled. These aerosol cans were kept in an unlabeled, open bin (Figure 26), which would easily allow for the cans to tip over and spill on the floor. It was advised that the facility begin puncturing cans as soon as they are moved into this room, so as to avoid any future build-ups of unlabeled hazardous/universal waste.

Figure 26: P2150040.JPG – Pile of aerosol cans awaiting puncturing.

**Pursuant to Ga. Comp. R. and Regs. 391-3-11-.08(1) [40 C.F.R. § 262.15(a)(5)], which is a condition of the SAA Permit Exemption, a generator is required to mark or label its containers (i) with the words “Hazardous Waste” and (ii) with an indication of the hazards of the contents.**

**Pursuant to Ga. Comp. R. and Regs. 391-3-11-.08(1) [40 C.F.R. § 262.15(a)(4)], which is a condition of the SAA Permit Exemption, a generator is required to keep containers of hazardous waste closed at all times during accumulation, except when adding, removing, or consolidating waste; or when temporary venting of a container is necessary for the proper operation of equipment, or to prevent dangerous situations, such as build-up of extreme pressure.**
