## REGION 10 Enforcement Division

### INSPECTION REPORT

| <b>Company Name:</b> | Harvest Alaska, LLC | | |
| <b>Facility or Site Name:</b> | SWANSON RIVER OIL PIPELINE | | |

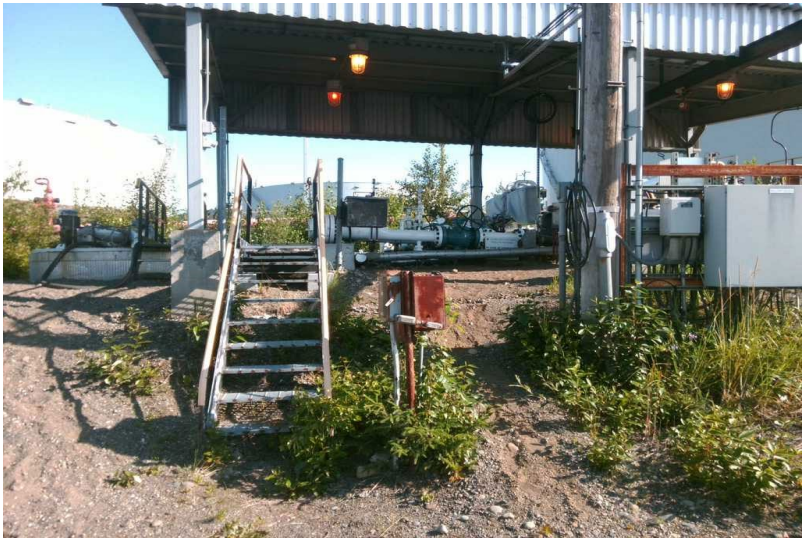
| Pigging Station | |

| View of the pigging station at the Swanson River Oil Pipeline facility. | |

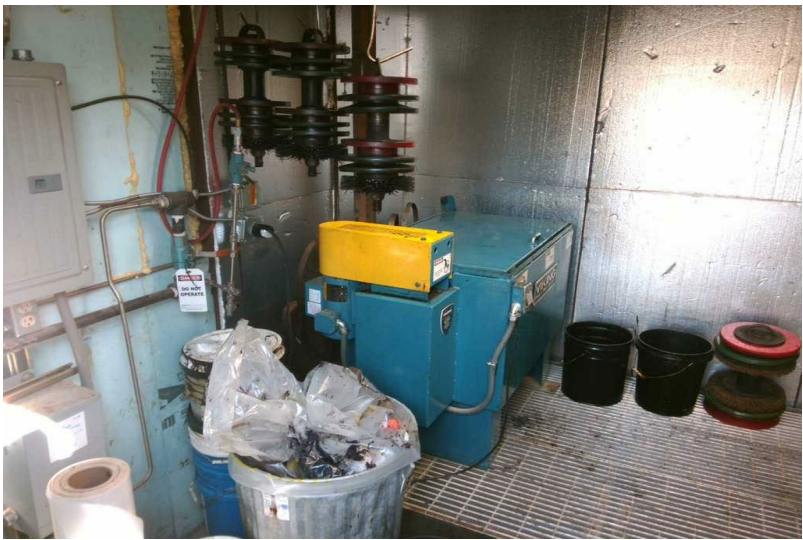
| KPL Junction Pig Cleaning Area | |

| <b>Building:</b> Pigging Station | <b>Area:</b> | <b>Sub-area:</b> |
|---|---|---|
| Pig is taken across the street to the Kenai Pipeline (KPL) Junction where it's placed inside of a hot wash tank. Once inside the wash tank, all the solids float up to the top and are collected on absorbent pads. The absorbents pads are collected in a trash can and then taken to the Harvest Alaska-Midstream Pipeline Division-East Forelands facility and burned in the smart ash burner. | <b>Citations:</b> | <b>Sections:</b> |

| View of the pigs hanging above the hot wash tank at the KPL Junction, adjacent to the trash can, full of the absorbent pads with pig wax residue. | |

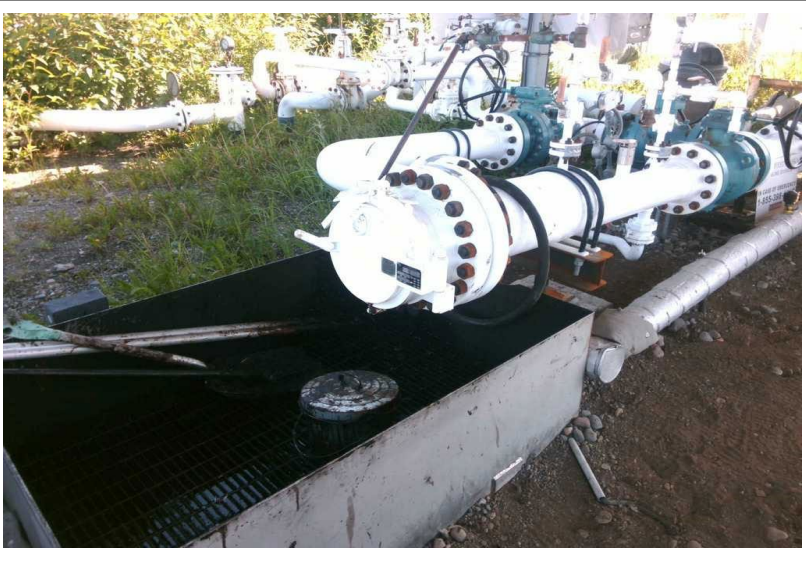
| <p>Pigging Station</p> | |

| <p>View of the pig receiver and trough at the Swanson River Oil Pipeline facility.</p> | |

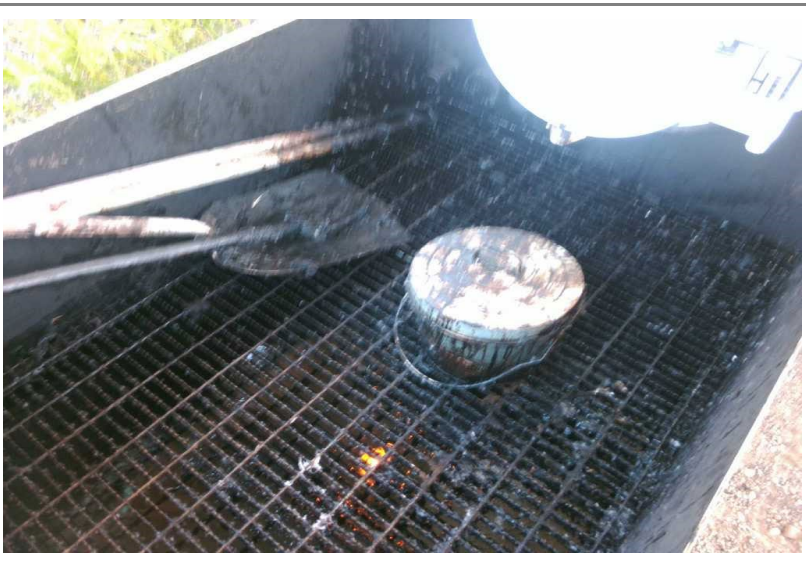
| <p>Pigging Station</p> | |

| <p>View of the trough and cleaning tools used to scrape pig wax off the pig.</p> | |

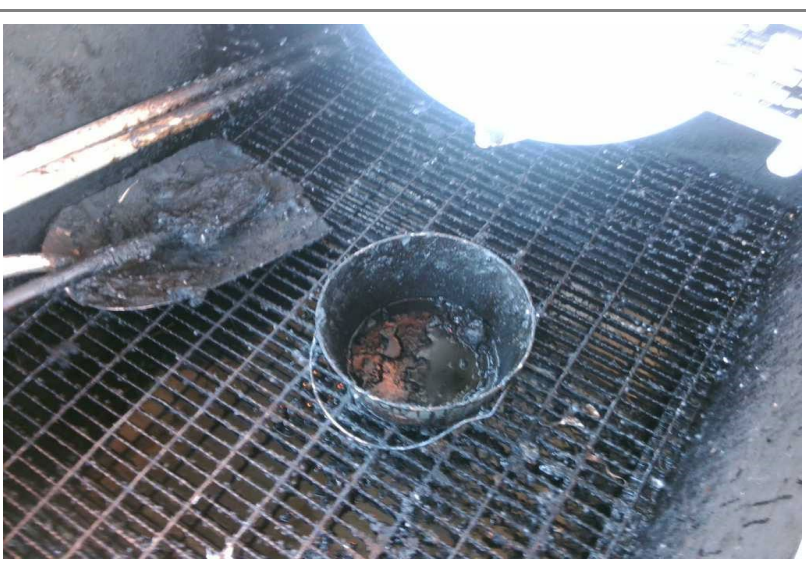
| <p>Pigging Station</p> | |

| <p>Mr. Gerow said pigs generally come through the pigging station from the Swanson River Production Facility every five to ten days. According to Mr. Gerow, pigs come out and five to ten gallons of pig wax is scrapped off inside the pig trough. Mr. Gerow said the pig wax is shoveled back into the pipeline where it goes back into the crude oil that is piped across the street to Marathon's (Tesoro Alaska Company, LLC - Kenai Refinery) crude tanks before going into the refinery.</p> <p>Mr. Gerow said the pig is taken across the street to the Harvest Midstream – KPL Junction (AKR000203125), formerly Kenai Pipeline (KPL) Junction, located at 48780 Kenai Spur Highway. According to Mr. Gerow, the pig is placed inside of a hot wash tank. Once inside the wash tank, all the solids float up to the top and are collected on absorbent pads. The absorbents pads are collected in a trash can and then taken to the Harvest Alaska-Midstream Pipeline Division-East Forelands facility and burned in the smart ash burner.</p> | |

On 7/27/21 I received an email from Mr. Hong that included the smart ash burner logs for the period from 2018 through 2021. After reviewing the smart ash burner log, I saw that starting in 2018 the facility was logging pig wax which was classified in the log with an "H." I asked Mr. Hong what the "H" signified and he said it signified that the waste to be incinerated in the smart ash burner was hazardous. It was at that time that I identified this as an area of concern. A review of the logs for the years 2019 through 2021 show the same waste either logged in as "N" (Non-hazardous) or as an "Exempt" waste. According to facility personnel on the day of the inspection, the pig wax is coming out of transportation lines and would not be exempt.

| <p>Close-up view of the pig wax solids in the bucket and trough at the Swanson River Oil Pipeline facility.</p> | |

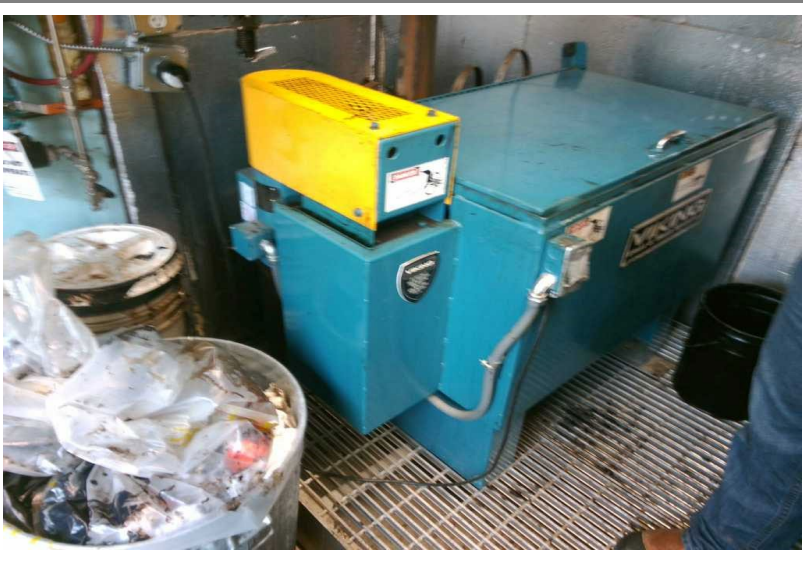
| KPL Junction Pig Cleaning Area | |

| View of the hot wash tank, adjacent to the trash can full of waste absorbent pads, at the KPL Junction. | |

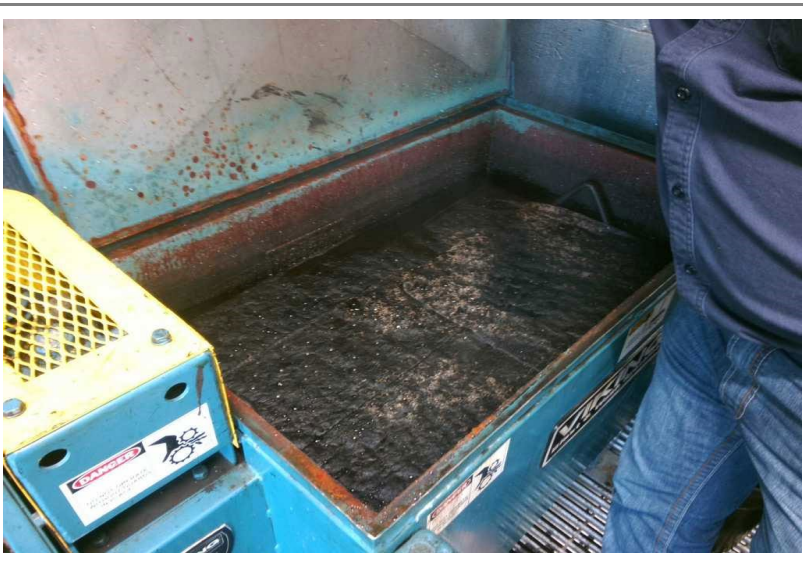
| KPL Junction Pig Cleaning Area | |

| View inside the hot wash tank, showing the absorbent pads floating on top of the water. | |

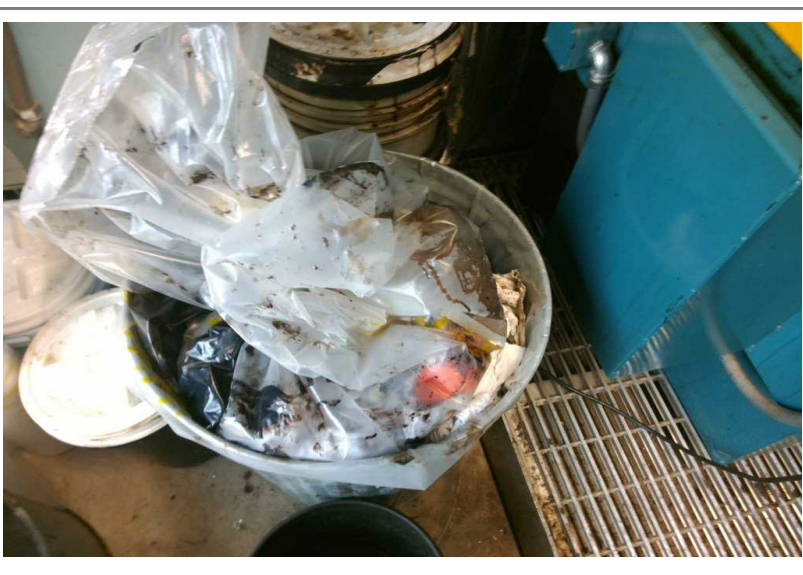
| KPL Junction Pig Cleaning Area | |

1. Piping diagram
2. Smart ash analytical results
3. Pig wash water is changed out every six months. US Ecology comes and pulls/disposes of those liquids for us.
4. It takes about 2-3 weeks for the trashcan in the pig wash station to fill up.
5. Jared, one of our operators is grabbing the log from East Forelands and we should have records scanned over to you tomorrow.

| View of the trash can, showing the accumulation of waste absorbent pads from the hot wash tank. | |
